Structural Engineer's Report Supplied  
by the Defenders of Thompson  
Square

**17 APRIL 2020**

**RE: EXISTING WINDSOR BRIDGE**

**RREPORT ON 11 MARCH 2020 INSPECTION**

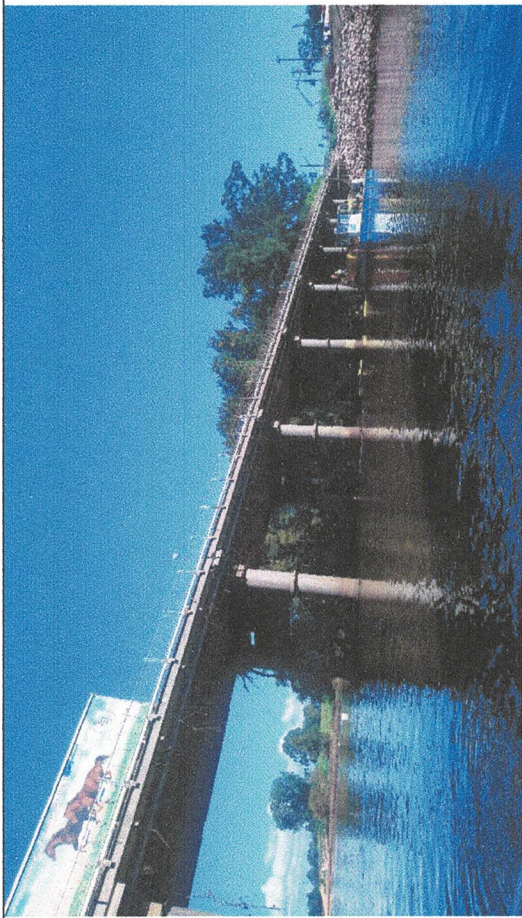
**Fig.1 - General View Downstream of Bridge : Articulated Vehicle Crossing**

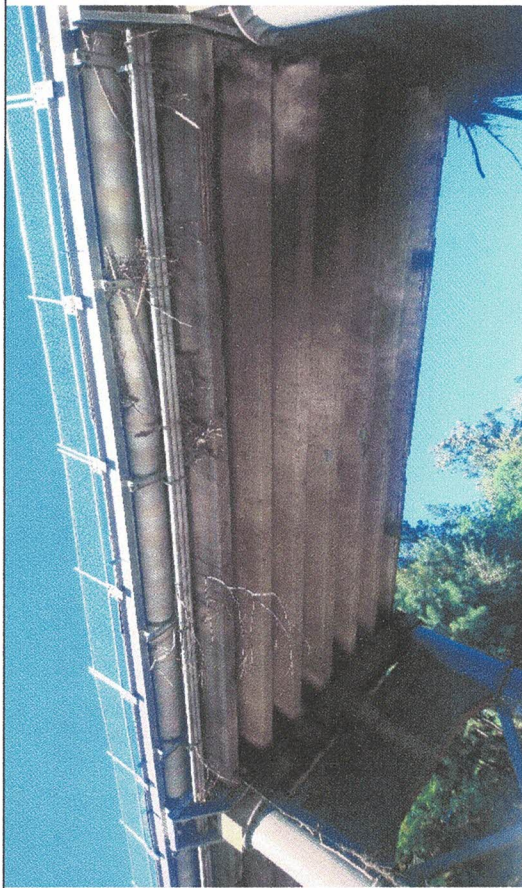
- There is no visible additional deterioration of the surfaces of the bridge structural elements referenced above
- The only visible impact of the flood I observed was the removal of several panels of the barrier fence along the bridge walkway on the downstream side and snagging of tree branches on pipework supported under the bridge deck.

**Fig.2 - Fourth Span from Southern Abutment: Entangled Debris**

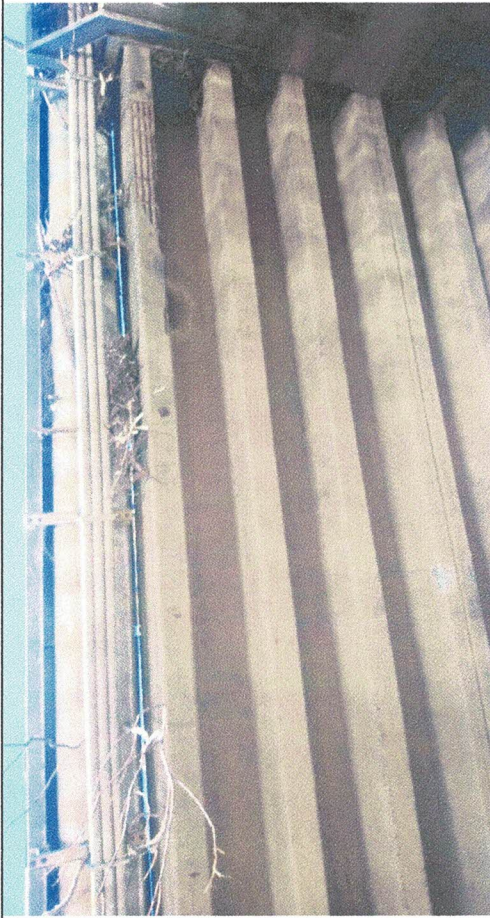
**Fig. 3 - Underside of Bridge Deck : Fourth Span from Southern Abutment**

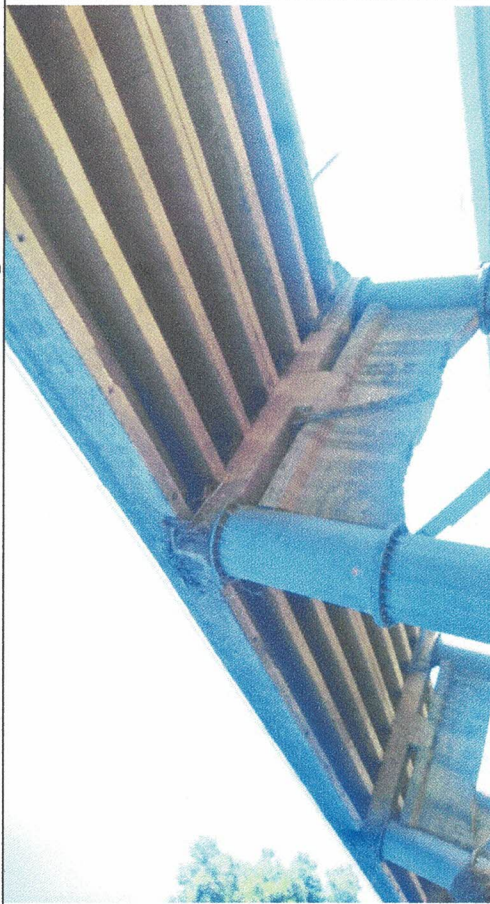
**Fig. 4 - Fourth and Fifth Spans from Southern Abutment**

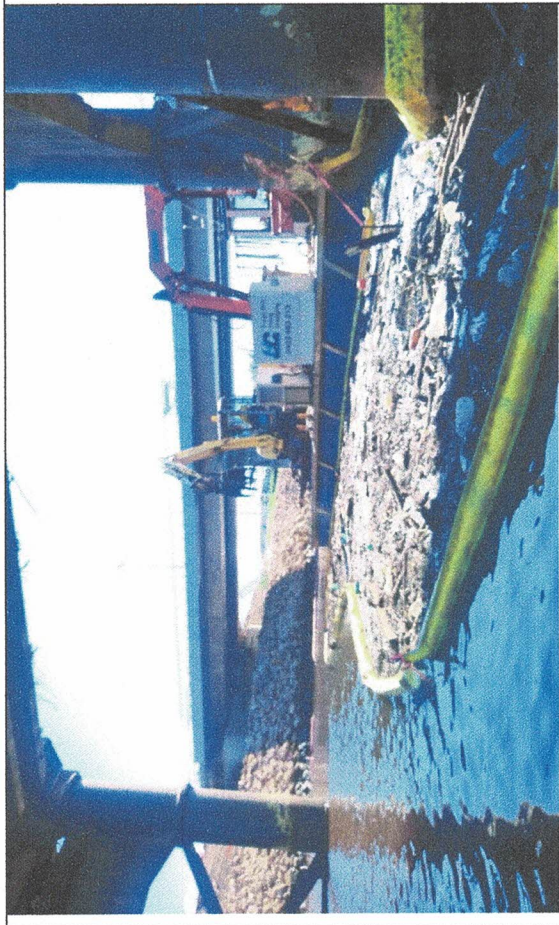
- Accumulated debris under the bridge and along the river embankment was being removed at the time of the inspection.

**Fig. 5 – Removal of Accumulated Debris : Sothern Abutment**

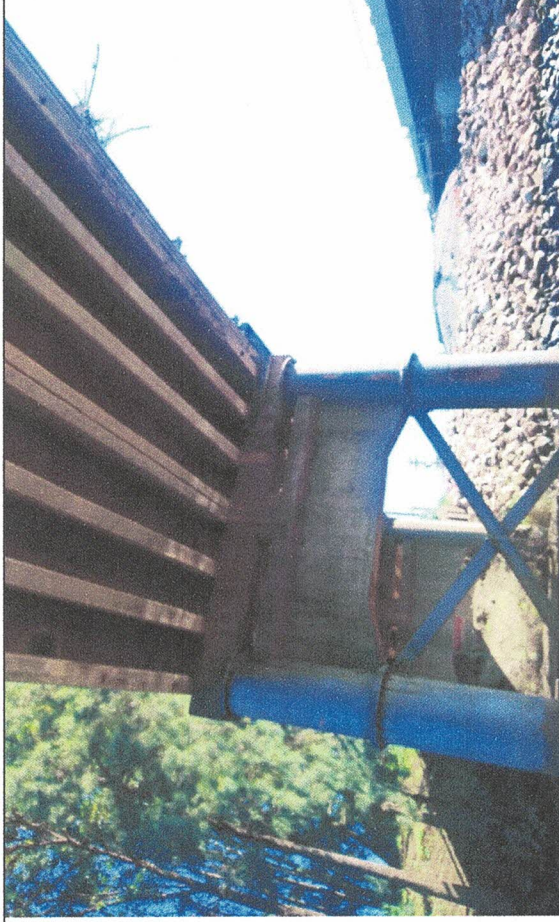
**Fig. 6 - First and Second Spans from Southern Abutment**

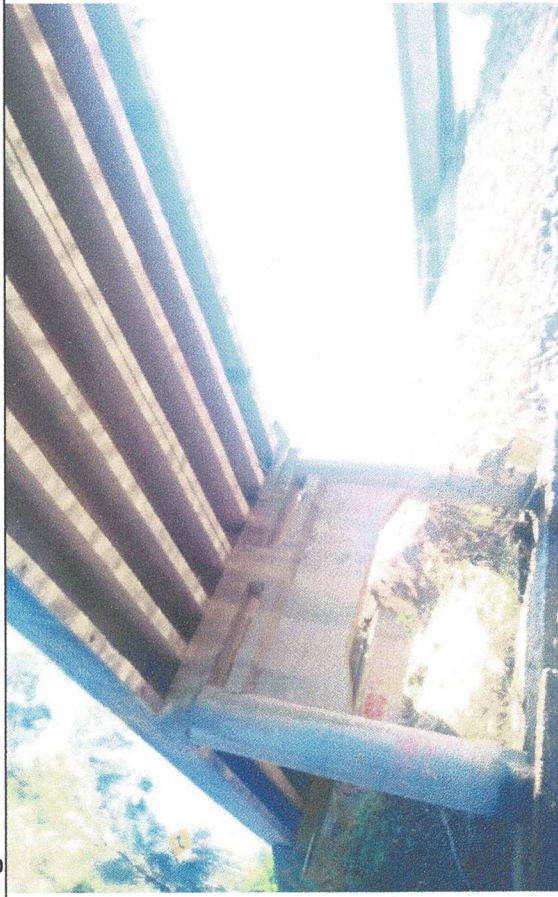
**Fig. 7 – First and Second Spans from Northern Abutment**

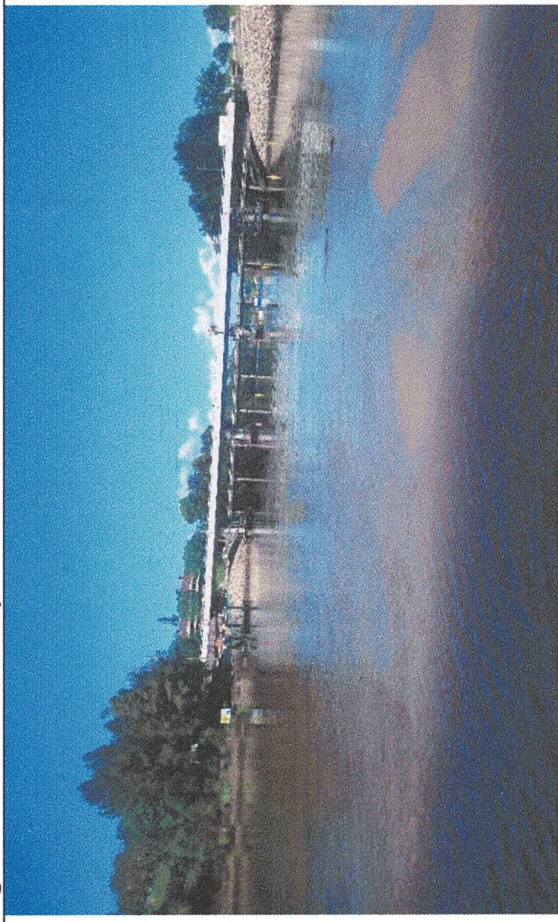
**Fig. 8 - General view Downstream of Existing and New Bridge**
