8 | IA1 Southern Drainage Route East

8.1 Drainage Issues

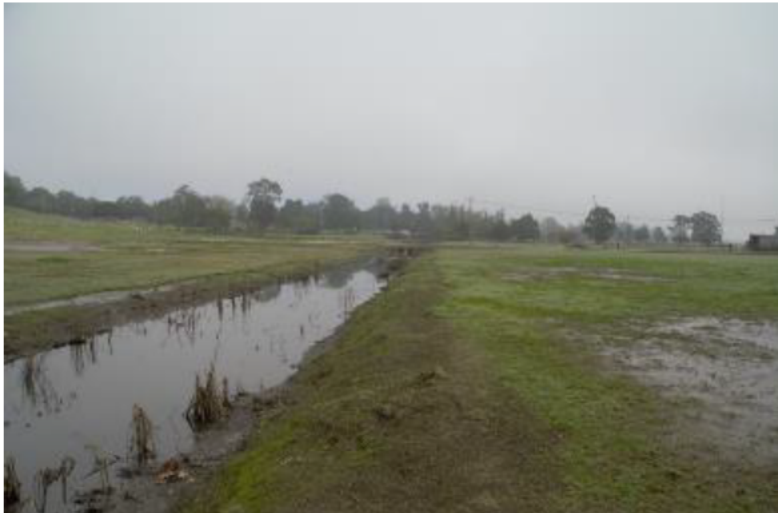
Photo 93

- paddock which cannot drain into the channel because the paddock is lower than the top bank of the drain (Photo 93)
- a disused channel crossing (Photo 105) which has substantially blocked flow and is causing ponding a long way upstream
- flood gates under Cupitts Lane would appear to not be working properly (Photo 118)

Where paddocks are lower than the bank of the drain, drainage points could be cut through the bank or the entire bank and paddock regraded so that it drains to the channel.

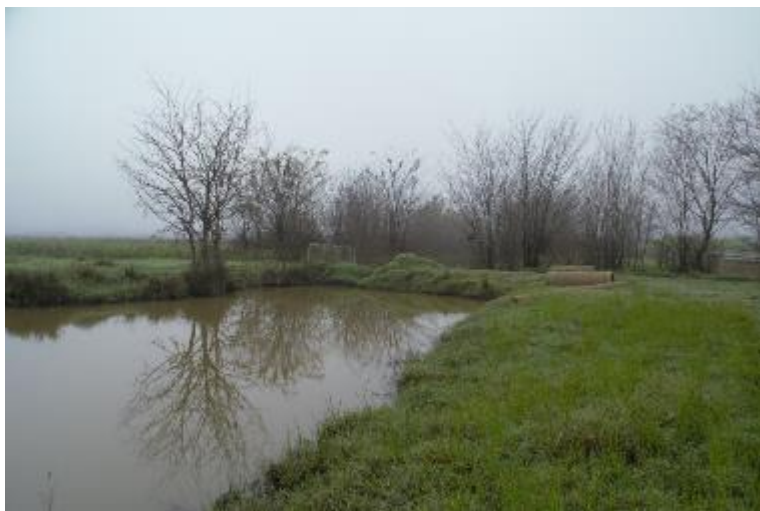
Photo 105

The mapped section of wetland appears to include the location where the disused crossing needs to be removed.

The choking of the channel with silt and vegetation can only be dealt with by using an excavator to remove them. The terrain is quite flat and the channel is not particularly wide or deep where most of the choke points occur. Along most of the channel length there are cleared paddocks. Where there are trees or shrubs preventing direct access to the channel the are mostly introduced species so their removal should not be an impediment to gaining access to the channel. If the work is to be done by Council then access will need to be arranged with property owners. The same earth moving equipment could be used to remove the disused channel crossing which is blocking flow. As the crossing is clearly no longer used this should not create a problem. If access needs to be maintained or restored at a later date then a bridge should be used.

Before development consent can be granted for any works conducted within the extent of this wetland the provisions set out in Part 6.5 (3) and (4) of the HLEP as well sections 2.7 and 2.8 of the R&H SEPP must be satisfied. These provisions are quoted in sections 3.5 and 3.6 of this report. This may mean that an EIS will be required for the removal of the disused crossing.

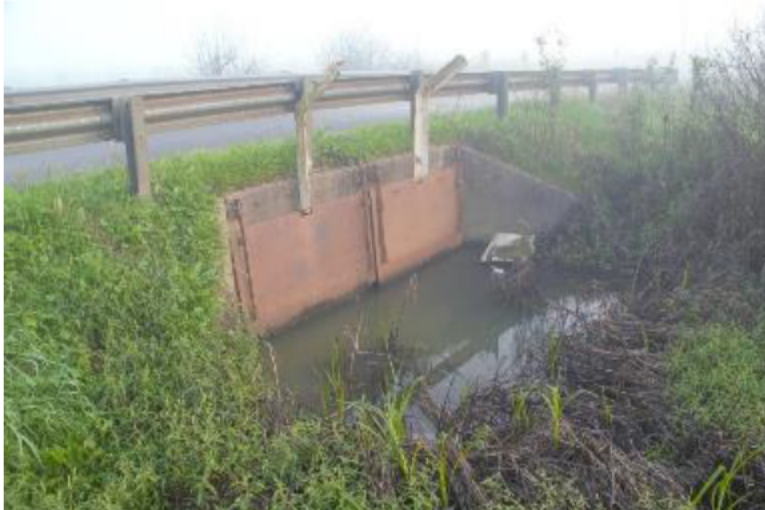
Photo 118

There are flood gates on the culvert (Photo 118) which were shut on the day of the inspection. It was not possible to tell whether this is because they are rusted and would not open or that there was insufficient head upstream to hold them open. It is noted that the bottom of one gate is rusted and would form an imperfect seal against the ingress of floodwaters.

A detailed inspection and testing of the flood gates would be needed before deciding on whether they need to be repaired or replaced.

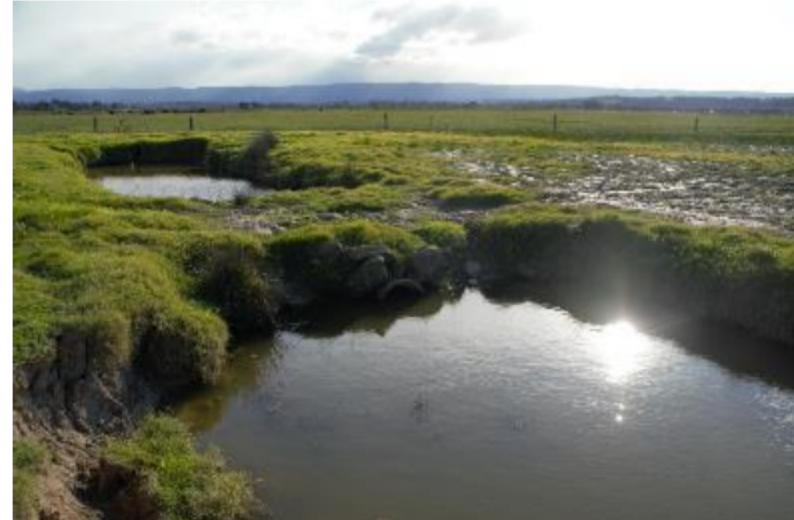
Photo 119

The other channel in this investigation area enters the main channel from the south. It starts as a deep, relatively wide channel in paddocks north of Dight Street (Photo 119) and heads east under a series of closely spaced crossing with pipes of various sizes under them (Photo 120). The water is ponded in this section of the channel by the invert of a pipe at the second of two closely spaced crossings (Photo 121 and Photo 122).

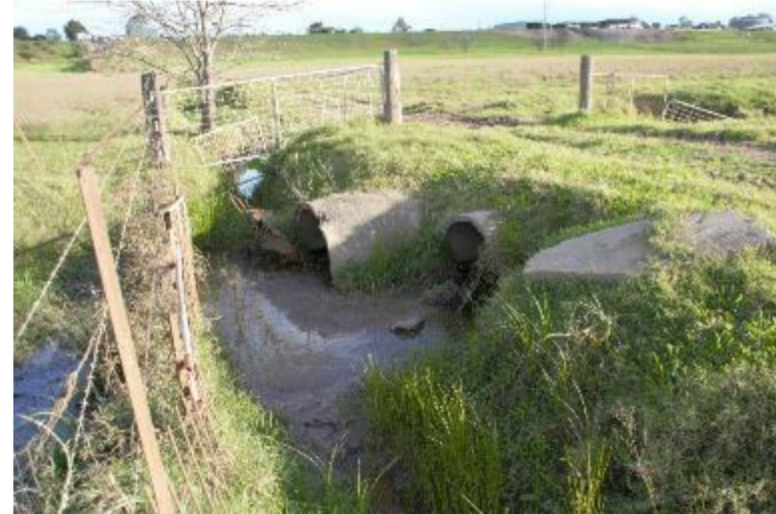
Photo 123

Downstream there are another two piped crossings (Photo 123 and Photo 124) but these do not appear to be controlling the water level in the channel. Downstream of this crossing there is considerable reed growth within the channel and in places this appears to be restricting flow and controlling upstream water levels (Photo 125 and Photo 126). Woody debris across the channel would also restrict flow at higher water levels (Photo 127). Reed growth is blocking flow at other points further downstream (Photo 128 and Photo 129). Just downstream of this point it turns north and flows to the main channel and is vegetated with another form of reed (Photo 130).

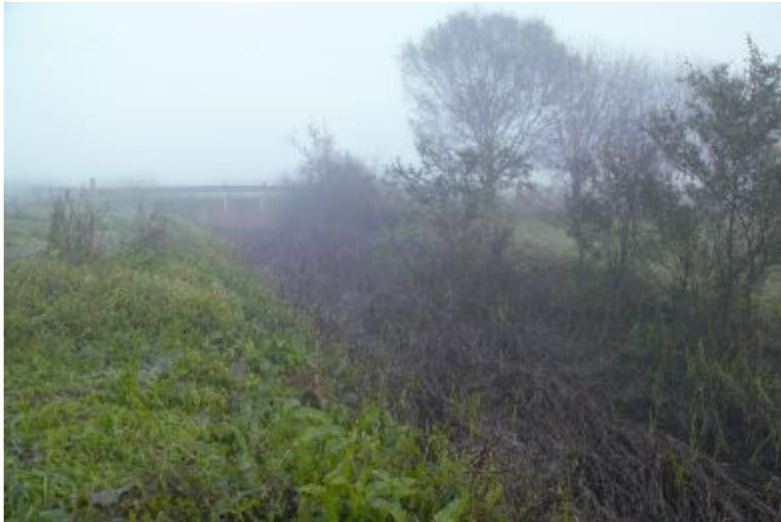
Photo 131

Downstream of Cupitts Lane the main channel is full of vegetation which is constricting flow (Photo 131) and further downstream there is plastic debris within the reeds which is further constricting the flow (Photo 132). The channel becomes deeper further along and there is evidence of numerous small bank slumps (Photo 133) which are pushing sediment into the channel.

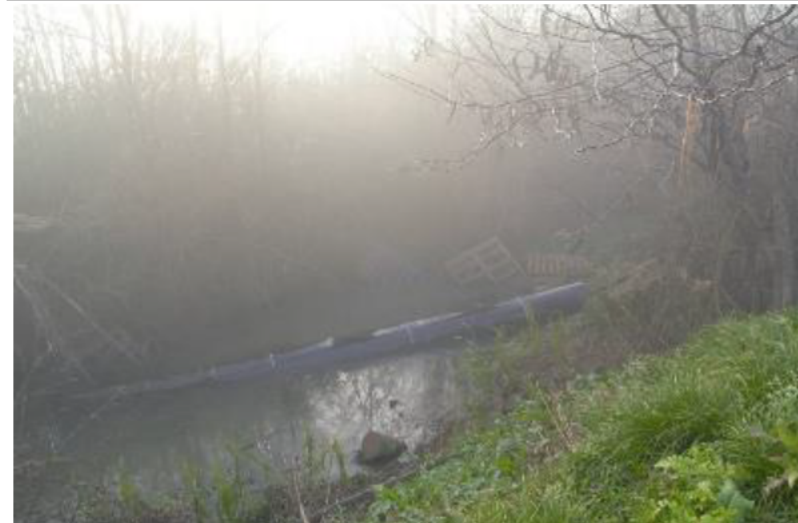
Photo 134

Just before the channel turns south there is less vegetation within the channel but there is a lot of debris (Photo 134). It was difficult to inspect the next reach of the channel because the banks were dense with Small-leaf Privet, except where there was a dilapidated bridge which has collapsed into the channel (Photo 135). A clear view of the channel was not possible from this point all the way to its confluence with Rickabys Creek.

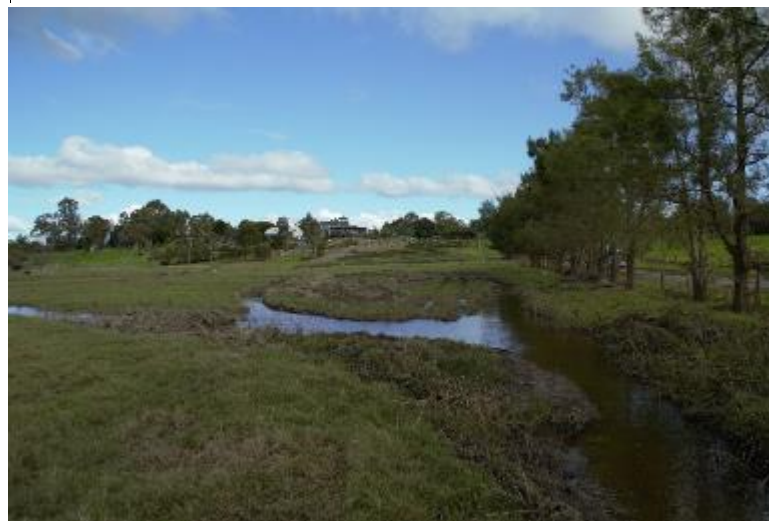
Photo 138

It is only on the eastern side of Cupitts Lane where it enters IA1SE that there is a more clearly defined channel (Photo 138) which was full of standing water on the day of the inspection. It heads south along the eastern side of the road (Photo 139) before turning in a south easterly direction. It flows under a piped access road (Photo 140) and into a wider channel (Photo 141) which leads into a complex area of standing water

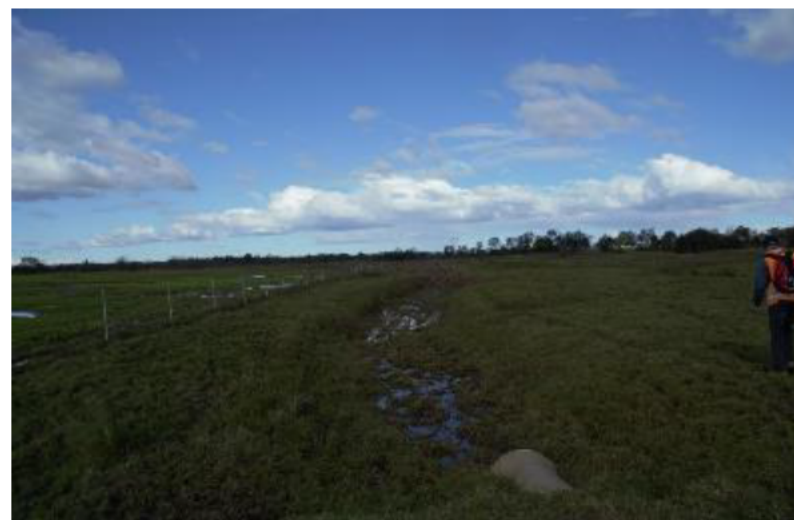
Photo 142

There is also another flow path starting further north on the eastern side of Cupitts Lane which also leads to the area of standing water. It is a shallow, channel which passes through some pipes (Photo 142) and is grassed lined until it becomes a wider area of open water (Photo 143) and flows into the complex area of standing water.

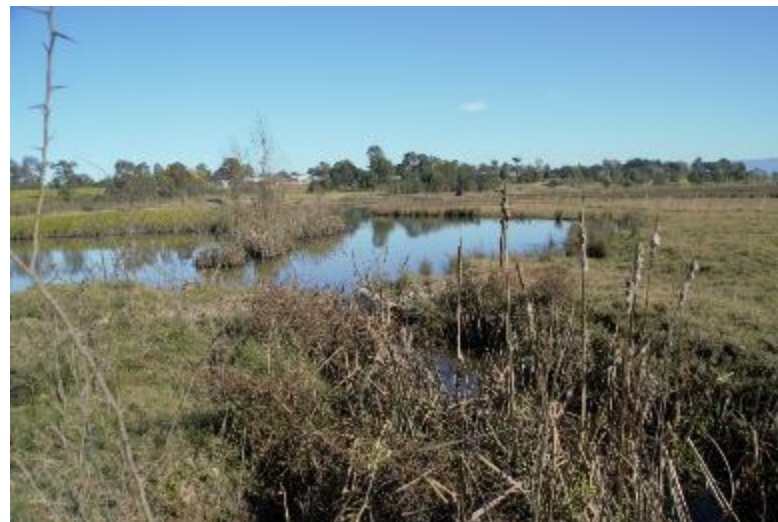
It would appear that the level in the body of standing water and the two flow paths entering it are controlled by a small outlet (Photo 144) but also by downstream water levels (Photo 145).
