# Upper Hawkesbury River Bank Erosion, Foreshore Structure and Weed Mapping

Reference: R.N20133.001.01.docx Date: November 2013

Prepared for:
 Hawkesbury City Council

Prepared by:
 BMT WBM Pty Ltd (Member of the BMT group of companies)

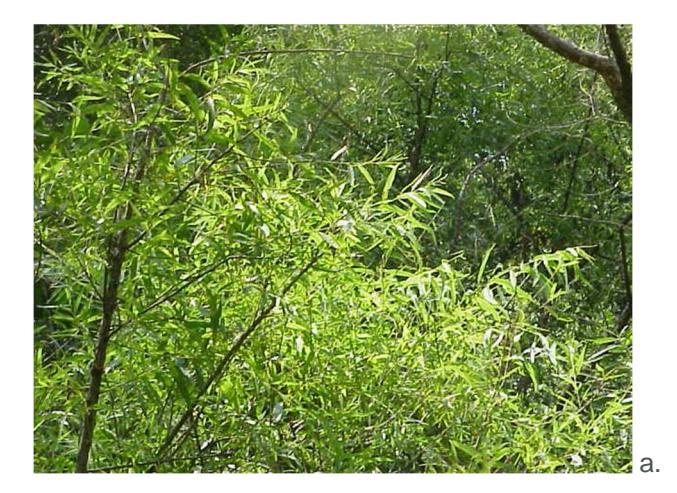
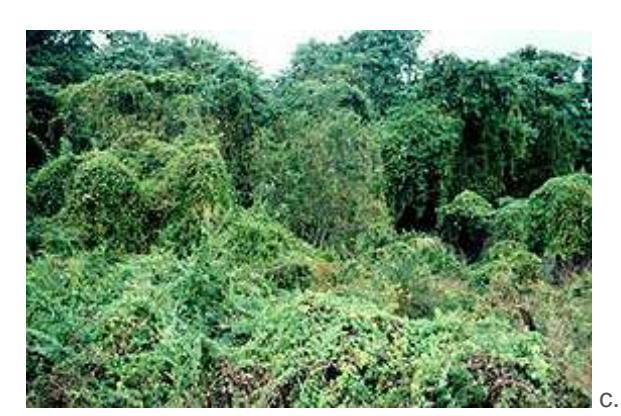
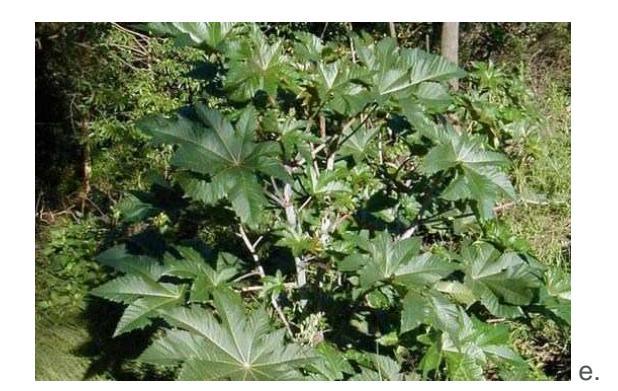
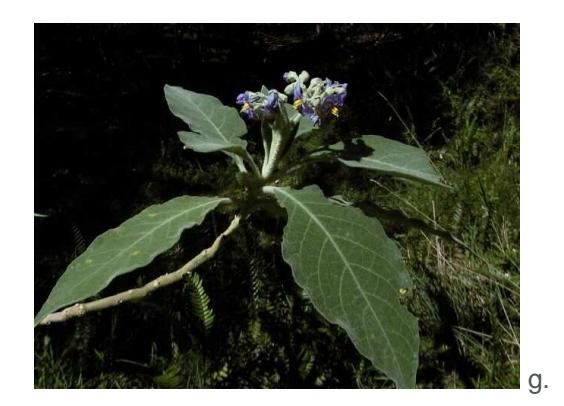
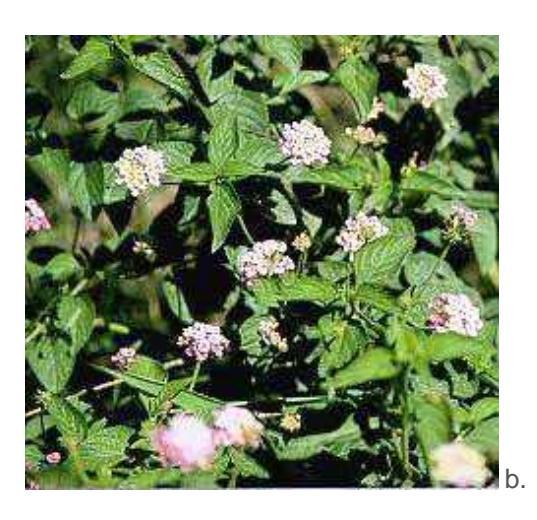
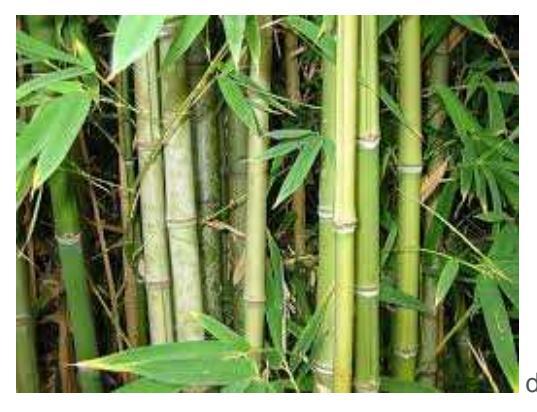
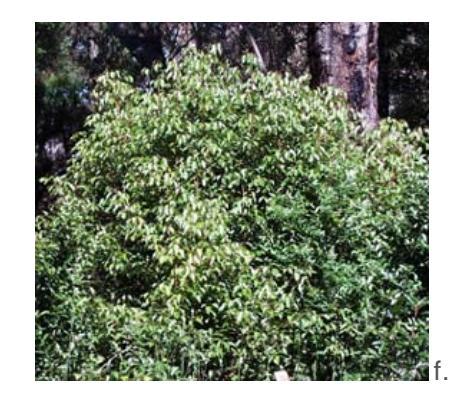
Figure 2-1 Terrestrial Weeds Common in the Study Area

A variety of terrestrial weeds including Willows (mainly Black and Crack), Lantana, Balloon Vine, Bamboo, Castor Oil, Camphor Laurel and Wild Tobacco common to the study area are shown in Figure 2-1. Several environmental weeds, i.e. weeds that are not declared noxious under the *Noxious Weeds Act 1993* but still pose a threat to environmental health are also present in the study area which is listed in Appendix C (Hawkesbury City Council, 2013).

- a. Black Willow
- b. Lantana
- c. Balloon Vine
- d. Bamboo
- e. Castor Oil
- f. Camphor laurel
- g. Wild Tobacco
