# **WATERCOURSE ASSESSMENT**

357, Bell's Line of Road, Kurmond, 2757

PREPARED FOR: Hardaker

ISSUE DATE: 24/10/2018

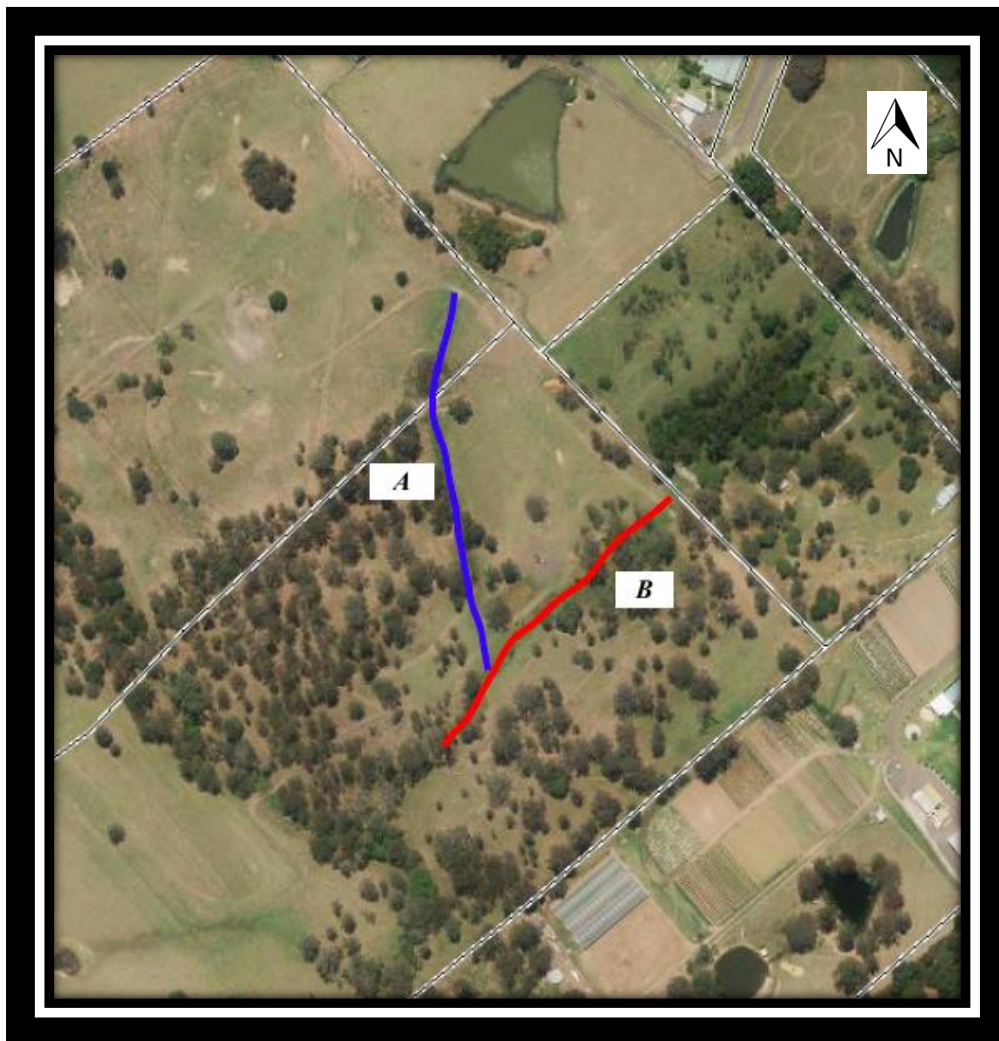
*Figure 1: Subject site – Watercourse A in blue and Watercourse B in Red (not to scale).*

This watercourse runs from a north west to a south west direction on the site (see Figure 1) with the topography downhill in the same direction. The watercourse appears as a depression in the landscape (see Photo 1 below).

This watercourse runs from the north east corner of the site towards the south west (Figure 1), and running into the riparian corridor, which is to be retained on site.

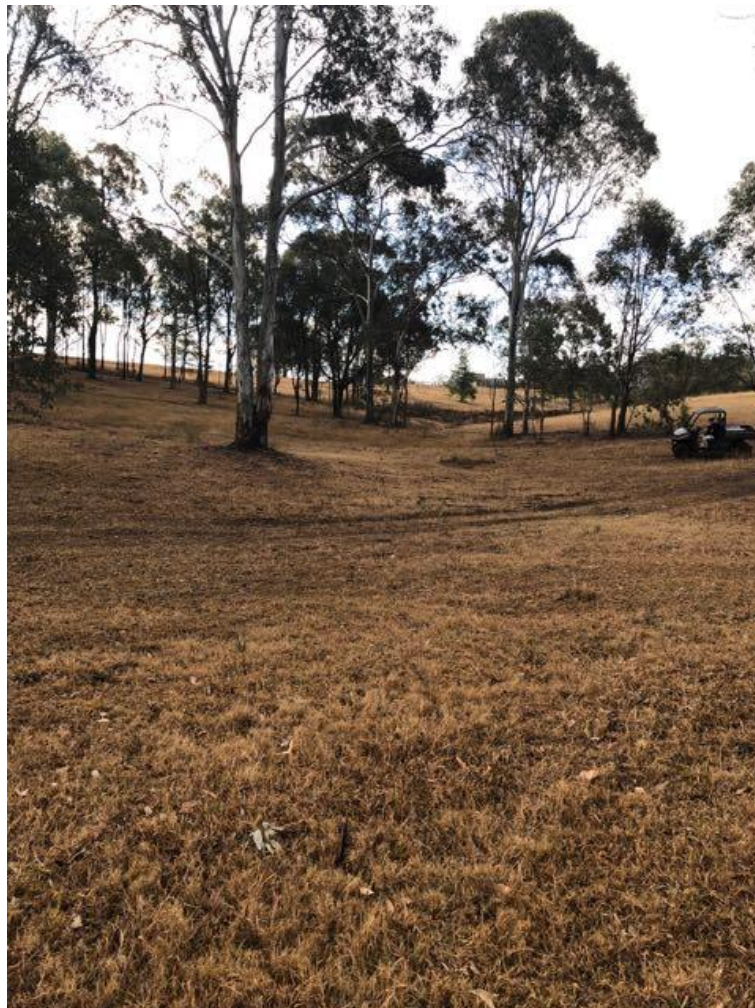
The vegetation that is found within this depression has been cleared over a long period of time; there is very minimal vegetation along the length of this area that is associated with a watercourse, for example sedges.

*Photograph 1: Watercourse A – Looking north to the northern boundary.*

This is not a significant watercourse on the site, as there are no defined banks and there is a lack of any vegetation associated with a watercourse.

Watercourse A - This watercourse due to a lack of defined banks and associated vegetation type is not significant and is ephemeral depending on the amount of rainfall.

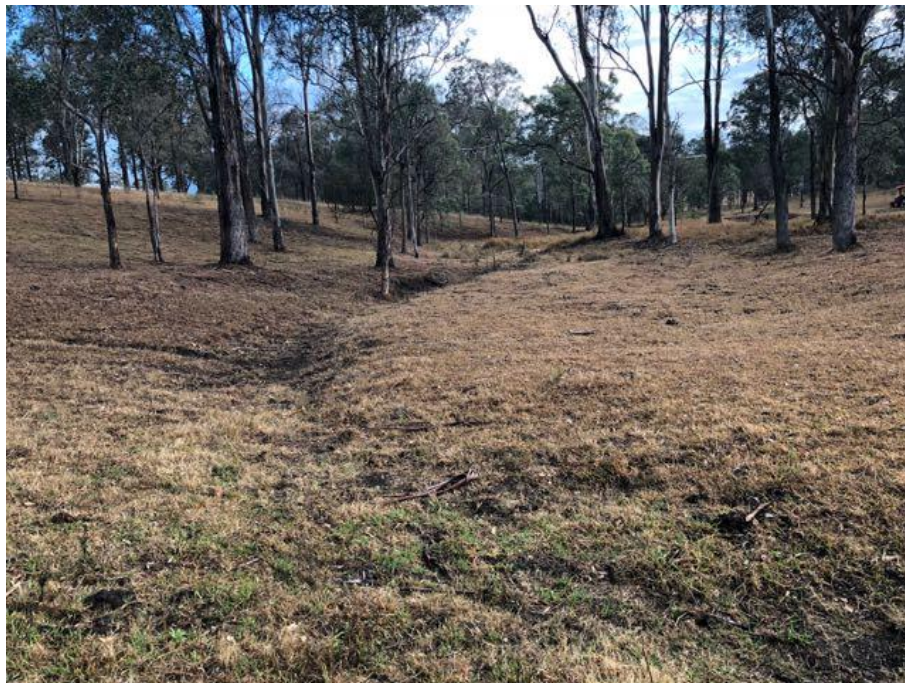
The vegetation along this watercourse has sedges in situ within areas that appear to be very flat allowing this vegetation type to be found (See Photos 2, 3 and 4). Note that this is not along the length of the watercourse (for example Photo 2).

*Photograph 2: Watercourse B: Looking from north east boundary towards south west.*

The watercourse B in Photo 2 represents a depression in the landscape in the area shown; with a lack of any vegetation associated with a watercourse. The vegetation in Photo 3 shows sedges in the flat areas of this watercourse. The vegetation is then missing (Photo 4), as the watercourse moves from this area towards the riparian retained area on the left of the photograph. This area has been eroded and is approximately 1 metre wide and less than 1 metre deep, until it reaches the area where the riparian habitat is to be retained.

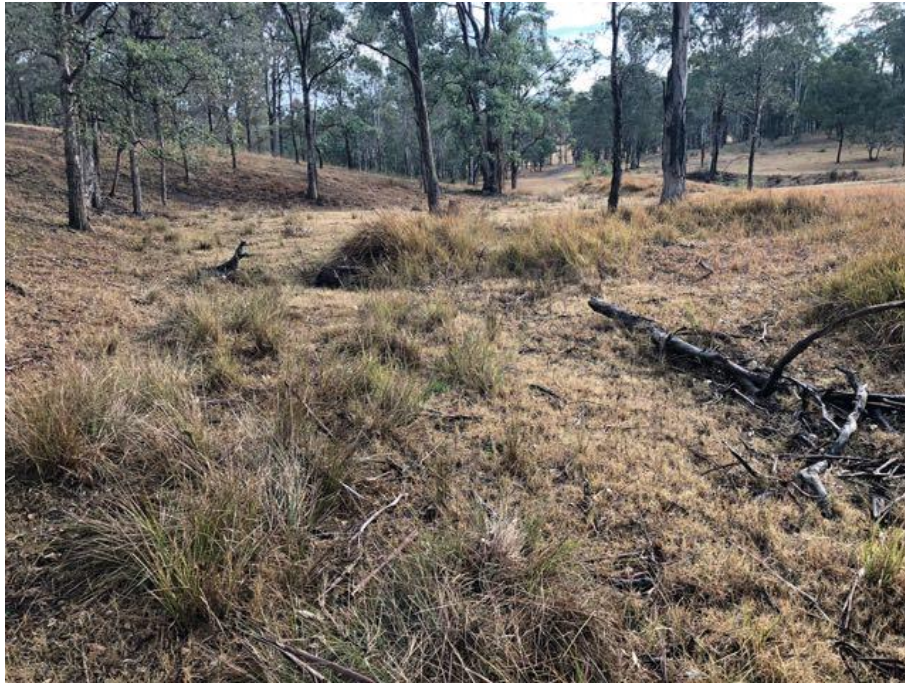
*Photograph 3: Watercourse B: Looking south west from the area in Photo 2.*

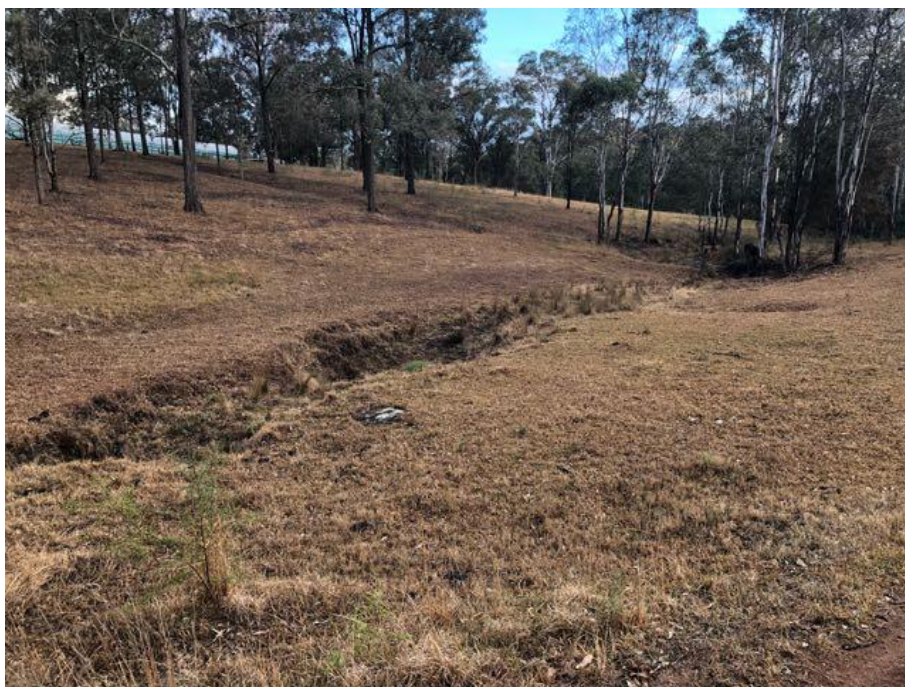
*Photograph 4: Watercourse B: Looking south west from the area in Photo 3.*

This watercourse has indications that it is not significant along its path for example defined banks, as well as the vegetation associated with a watercourse along the entire length.

Watercourse B - This watercourse has areas along its length that do not have defined banks and associated vegetation type, and also has some areas that have a form of bank and associated vegetation type. Indicating that the watercourse is not significant along the entire course for the site. Due to the down slope of the site the upslope damming or other works undertaken have also attributed to the changes in this watercourse.

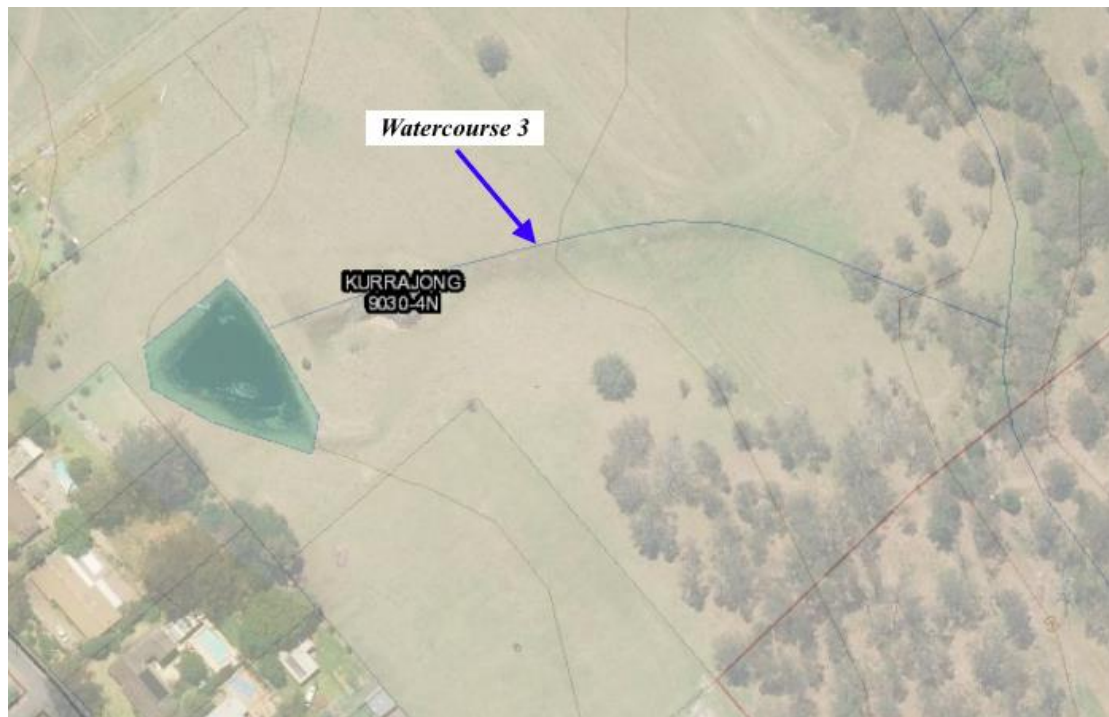
*Figure 2: Subject site – Watercourse C in blue.*

This watercourse is located behind the houses along Inverary Drive (which are adjacent to Bell's Line of Road), see Figure 2. The watercourse appears to be overflow from the dam located directly behind the houses, with very minimal vegetation along its path that is associated with a watercourse. This is not a significant watercourse on the site, as there are no defined banks and there is a lack of any vegetation associated with a watercourse.

Watercourse C - This watercourse due to a lack of defined banks and associated vegetation type is not significant and is ephemeral depending on the amount of rainfall. This watercourse appears to be overflow from the dam.
