WILBERFORCE CEMETERY

CONSERVATION MANAGEMENT PLAN

Prepared for:
HAWKESBURY CITY COUNCIL

7 April 2008

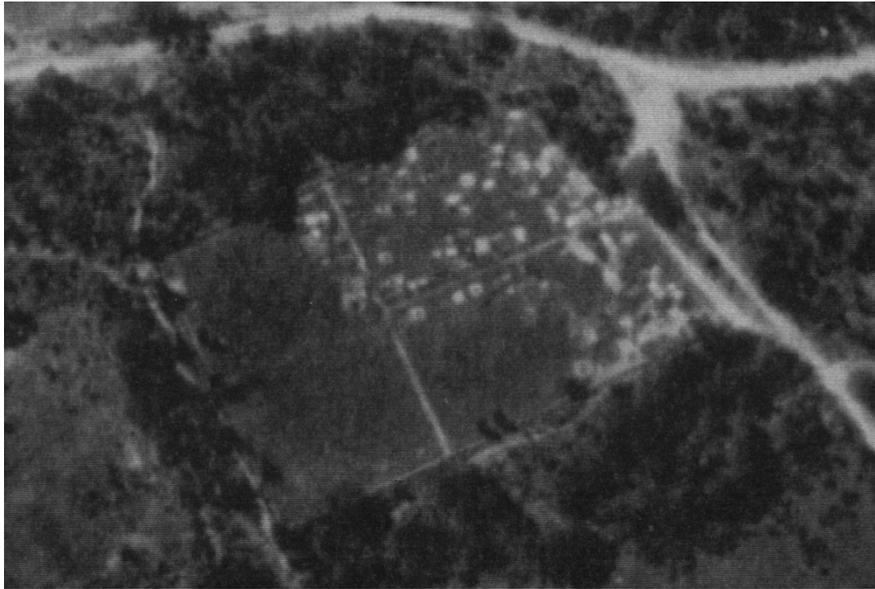
Figure 4
1947 Aerial photo showing Wilberforce Cemetery. At this time, north-south path was quite clear. There is no evidence in this photograph of burials in the Wesleyan/General Section. The perimeter of the cemetery was bounded by reasonably dense areas of native trees.
Source: Department of Lands

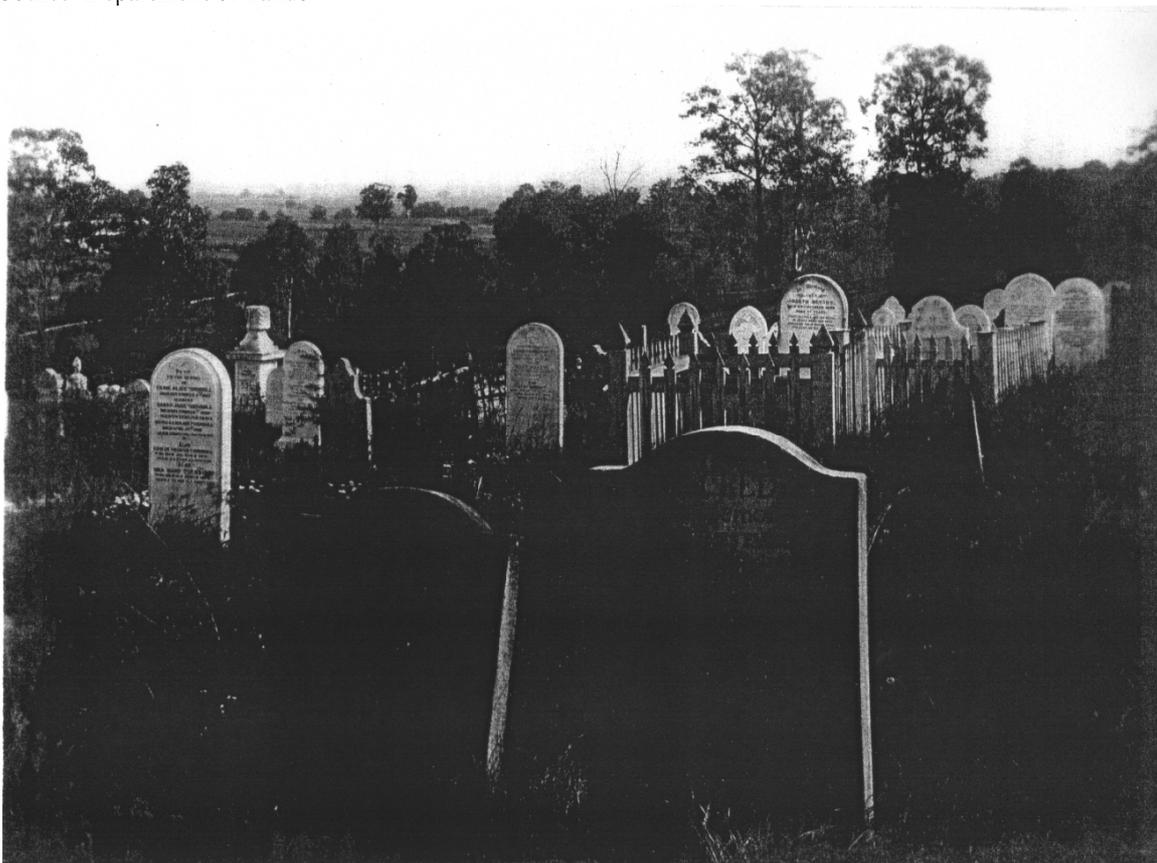
Figure 5
Wilberforce Cemetery 23 March 1953. At this time some timber picket fences survived around burial sites.
Source: Mitchell Library Small Pictures File

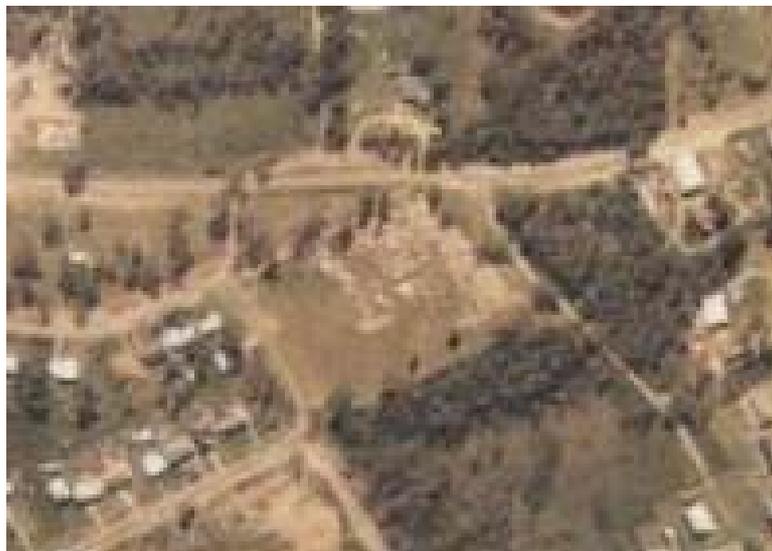
Figure 6
1975 Aerial photo showing Wilberforce Cemetery. By this time, many of the trees around the cemetery have been removed, particularly on the north and west sides.
Source: Hawkesbury City Council

There is no evidence that tree planting within Wilberforce Cemetery was ever a feature of the place. Native trees around the northwestern and northeastern sides (including those in the former Wesleyan section) of the cemetery have provided some visual enclosure. The southeastern and southwestern sides of the cemetery have had a less intensive planting, allowing views over the township and the farmlands to the south (Refer Figure 6).

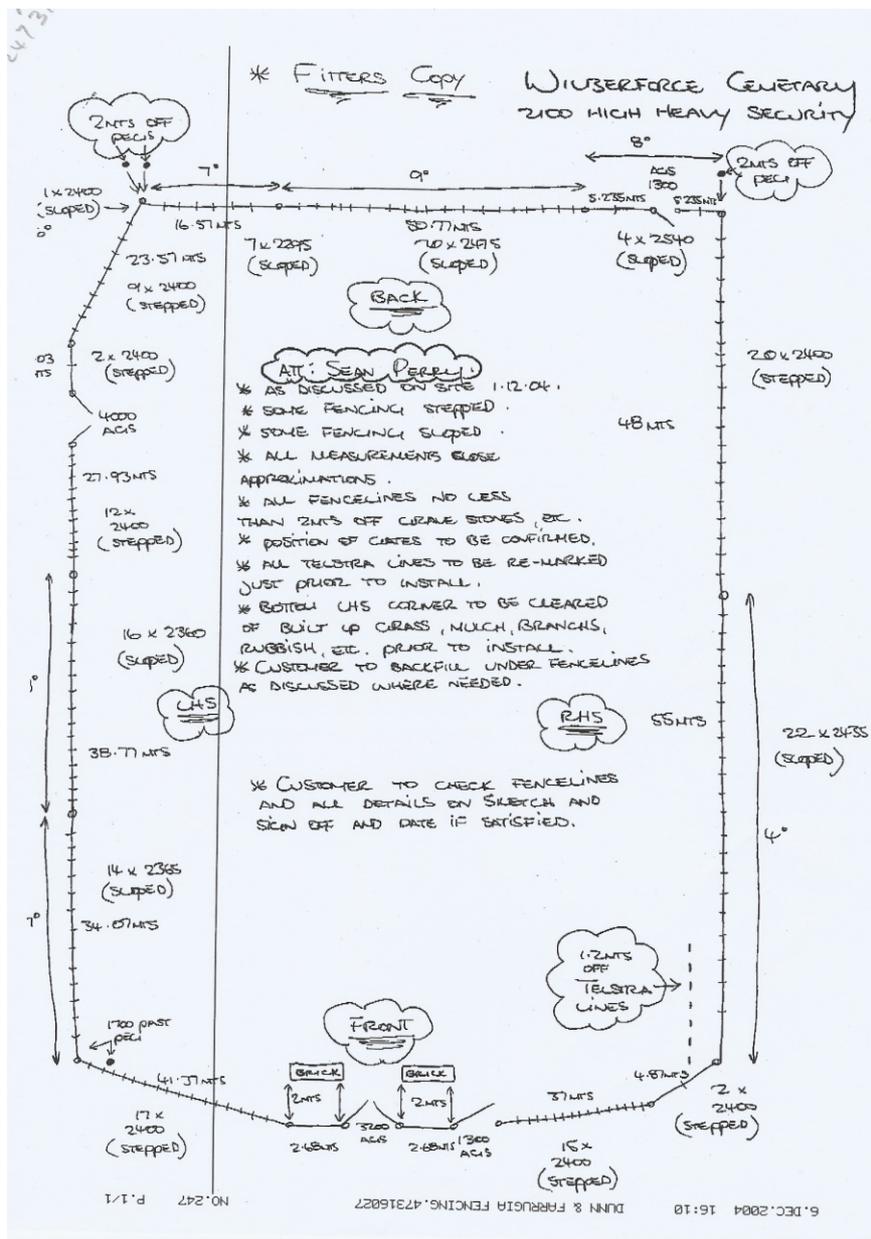
Figure 8
Drawing of fencing to Wilberforce Cemetery by Dunn & Farrugia Fencing
Source: Hawkesbury City Council Records

Paul Schoten of Dunn and Farrugia Fencing Company Penrith, successfully carried out the construction of the fencing from 21 February to 2 March 2005. Ever since, the Council has ensured that the gate to the Cemetery is locked every evening and reopened each morning and vandalism has abated.¹⁷²

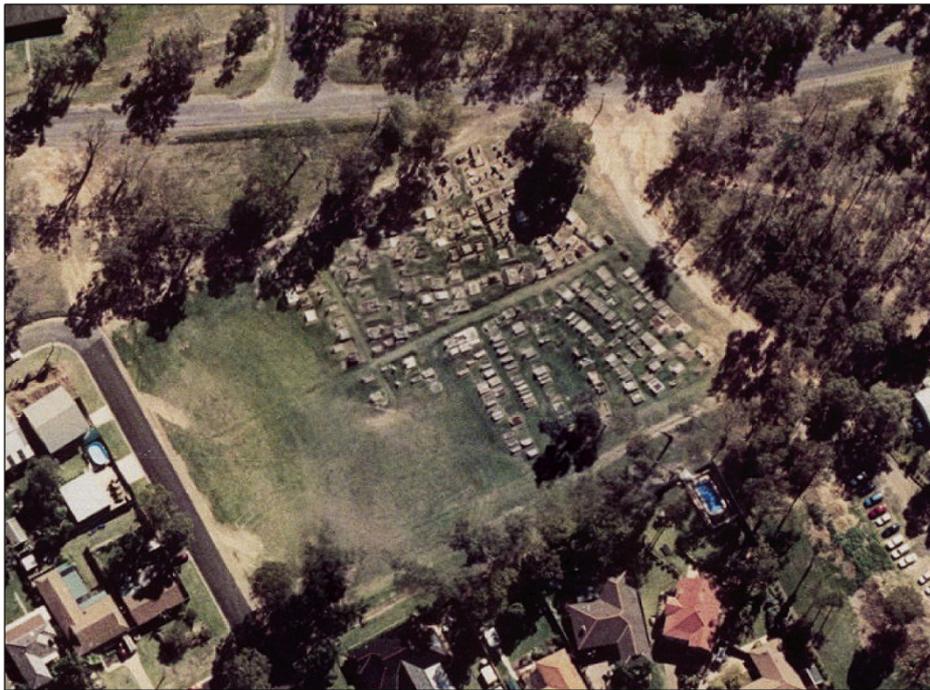
Figure 14

2003 aerial photograph of Wilberforce Cemetery.

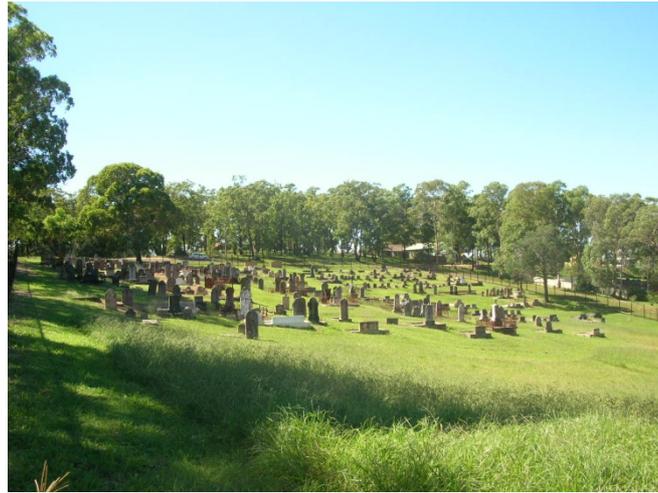
Figure 15
The former St John's Church of England section of Wilberforce Cemetery viewed from the western corner. The preferred selection of land on the higher ground for burials can be seen by the more intense use of the northwest side.

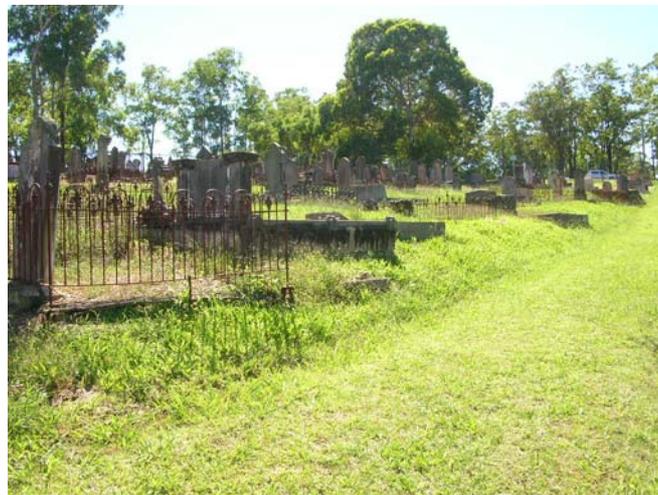
Figure 16
The northeast-southwest path through the cemetery. Many graves on the northwest side of this path are destabilised by the erosion of the path over time.

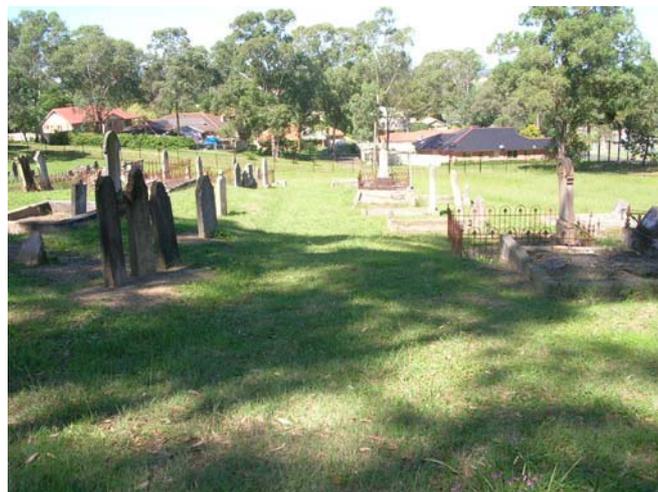
Figure 17
The northwest-southeast path through the cemetery.

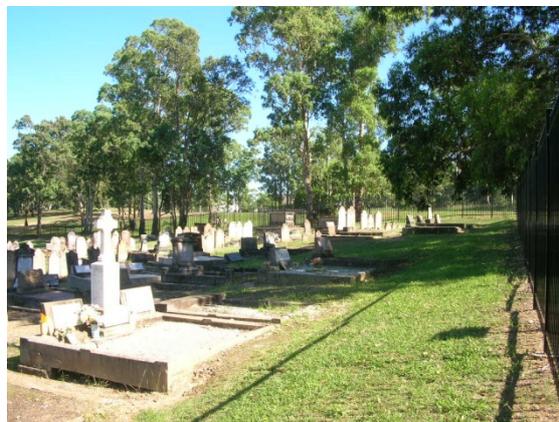
Figure 18

The graves at the northeastern end of the northern sector. A wedge shaped piece of land was added to this sector in 1911. Rows close to this boundary align with the new boundary. Rows behind that include earlier graves are aligned with the original boundary.

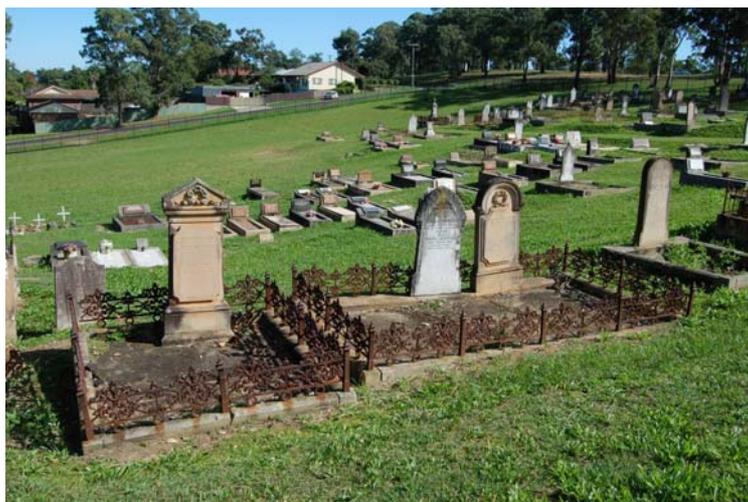
Figure 19

The eastern sector of the cemetery. Nineteenth century monuments including those of members of the King and Rutter families contrast with the twentieth century slab and desk style monuments.
Photo: Jan Barkley Jack 2007

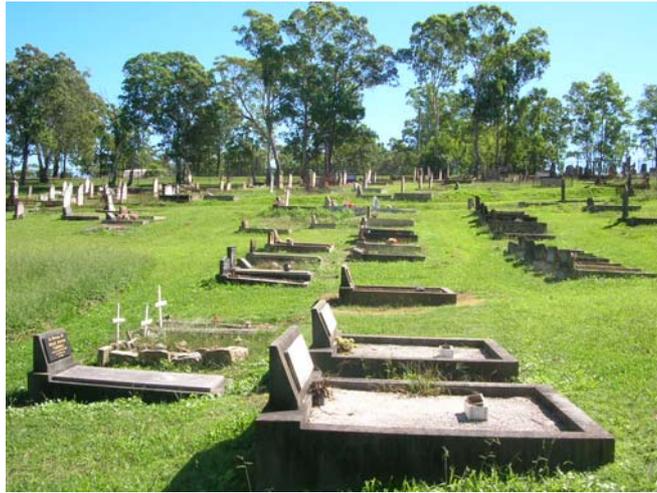
Figure 20

Graves at the southwestern end of the southern sector, mainly from the twentieth century, which are arranged in ordered northwest-southeast rows.

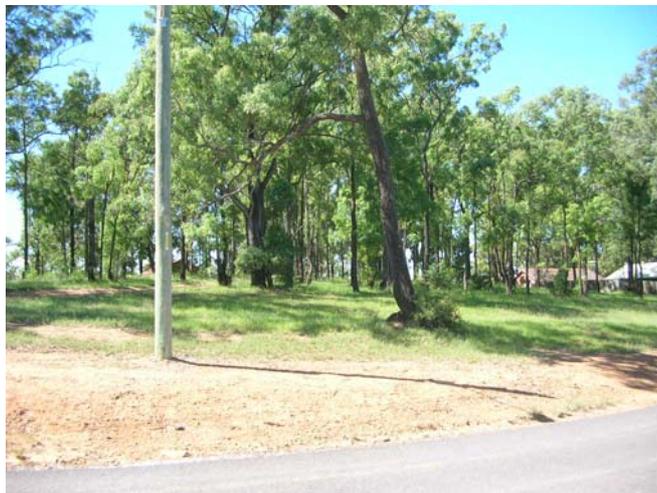
Figure 21

The Wesleyan Cemetery from the western corner.

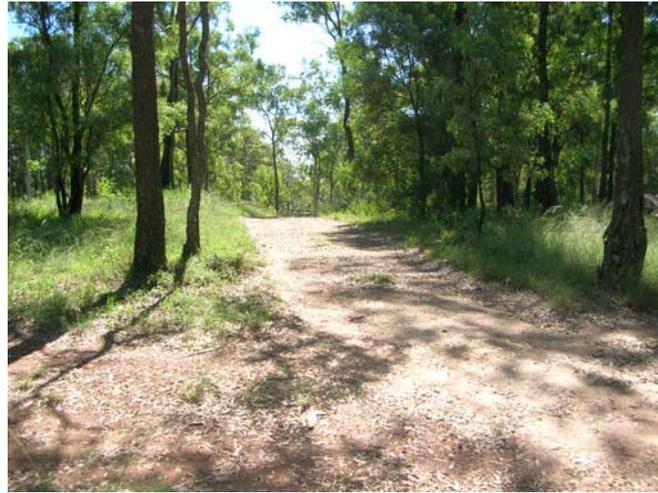
Figure 22
The former Wesleyan Cemetery from the western corner.

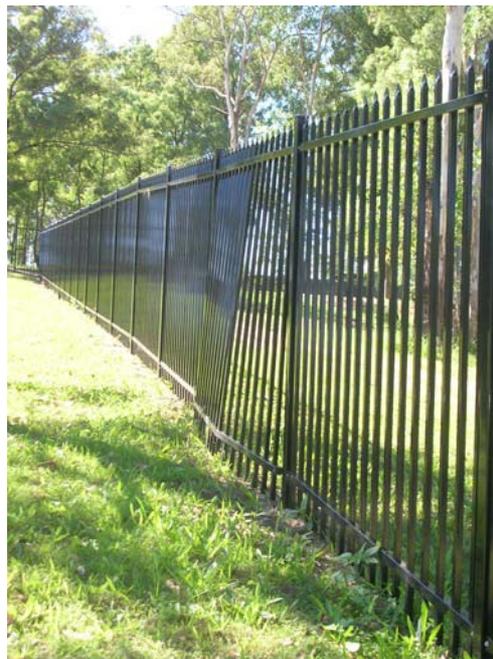
Figure 23
Boundary fence of the former St John's Church of England Cemetery

An aluminium spear picket fence marks the boundary of the former St John's Church of England Cemetery. Gates are located on the northeast and southeast sides, aligning with the main axial paths.

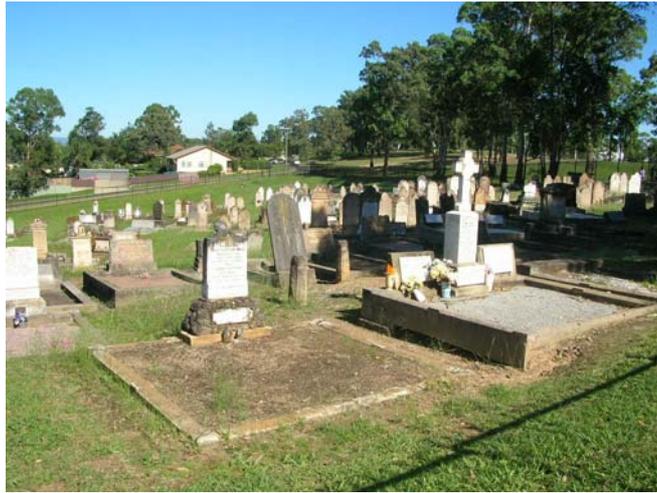
Figure 24

Overview of the northwestern side of the cemetery from near the columbarium walls. Most of the monuments on this side of the cemetery are sandstone and marble monuments from the nineteenth century.

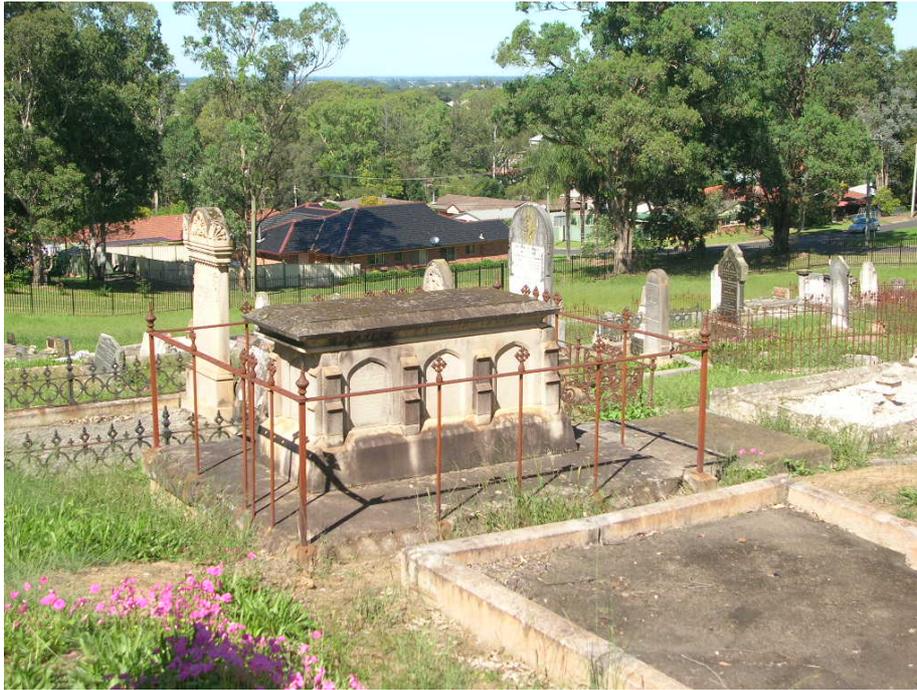
Figure 26

The Gothic style altar style slab monument for Robert Smith (d. 1858), Albert Matthias Smith (d. 1866), Margaret Smith (d. 1867), Isabella Margret (d. 1878), Robert Smith (d. 1888), Laura Smith (d. 1888), Margaret Smith (d. 1892), Henry James Smith (d. 1898).

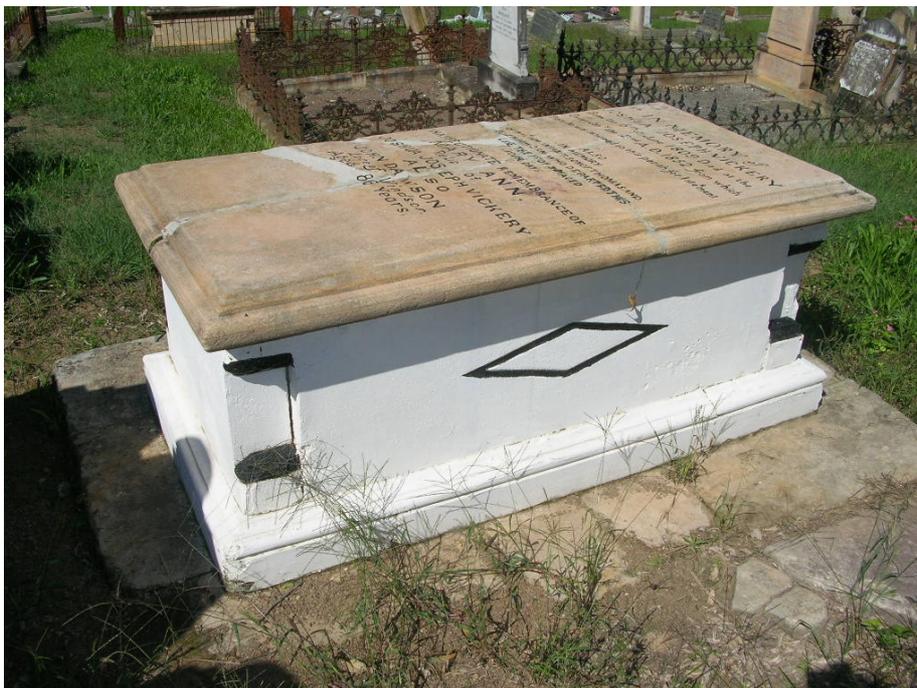
Figure 27

The altar style slab monument for Joshua Joseph Vickery (d. 1852), Mary Ann Vickery, Ellen Bowd (d. 1884), Thomas Bowd (d. 1906), Willam Bowd, John Dawson.

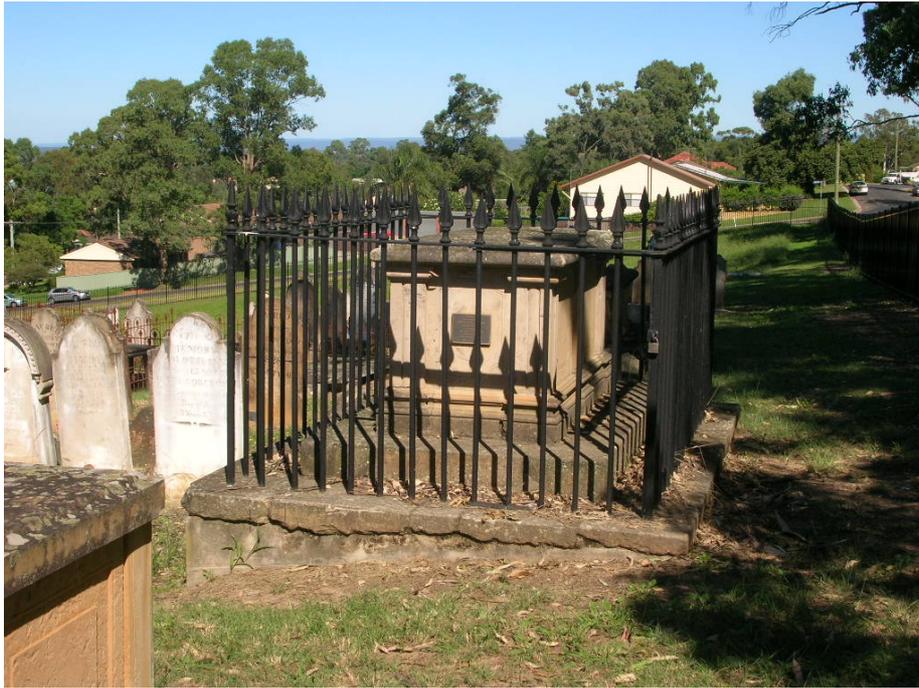
Figure 28
The 1830s altar style slab for members of the Dunstan family. The monument retains its original iron picket fence. A modern brass plaque on one side has reproduced the wording of the original inscription.

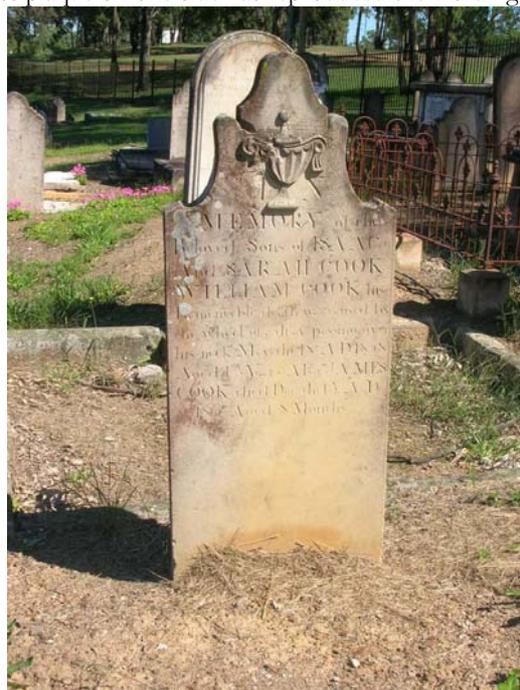
Figure 29
The stellae monument for James Cook (d. 1857) and William Cook (d. 1858). Monuments with carving of this quality are common in the cemetery.

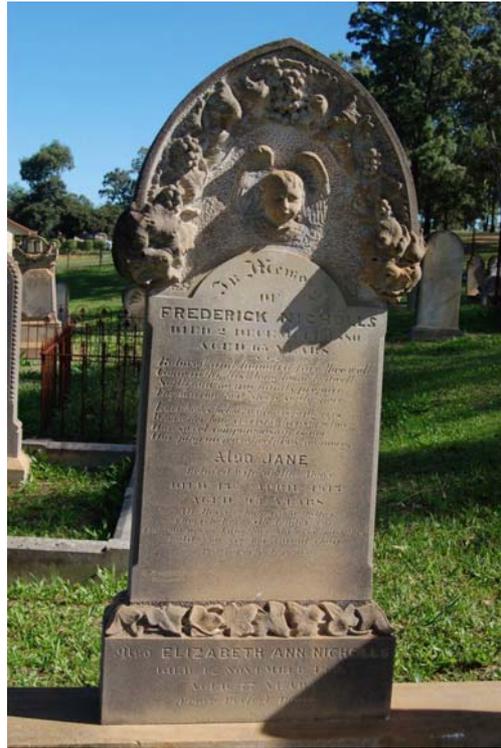
Figure 30
Monument for Frederick Nicholls, Jane Nicholls and Elizabeth Ann Nicholls. This monument is the work of the famous monumental mason, George Robertson of Windsor.

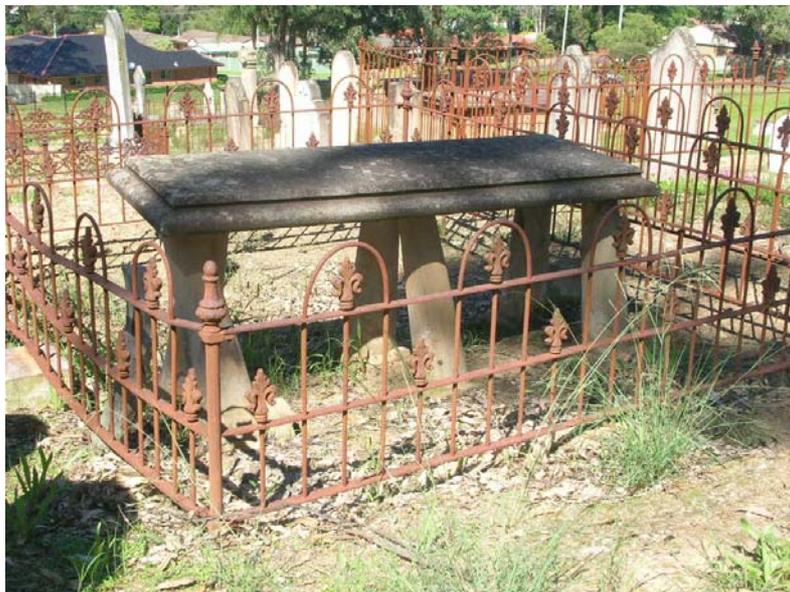
Figure 31
The surviving table style slab monument for Emily Robynson (d. 1849), Eliza Robynson (d. 1894) and Emily Louisa Robynson (d. 1928). This is a rare example of this style of monument.

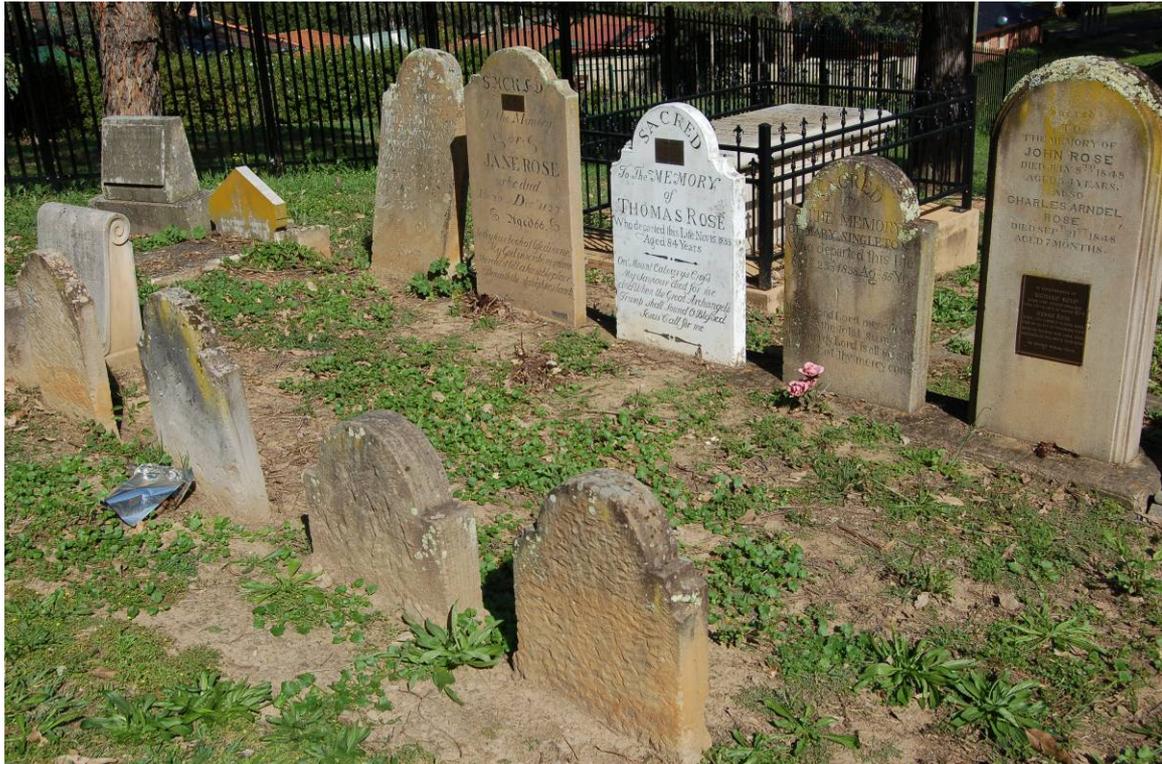
Figure 32

A grouping of stellae monuments for members of the Rose family. These monuments retain both the headstones and footstones. This grouping of monuments, along with others for the Rose family located nearby, is typical of the family groupings within the cemetery.

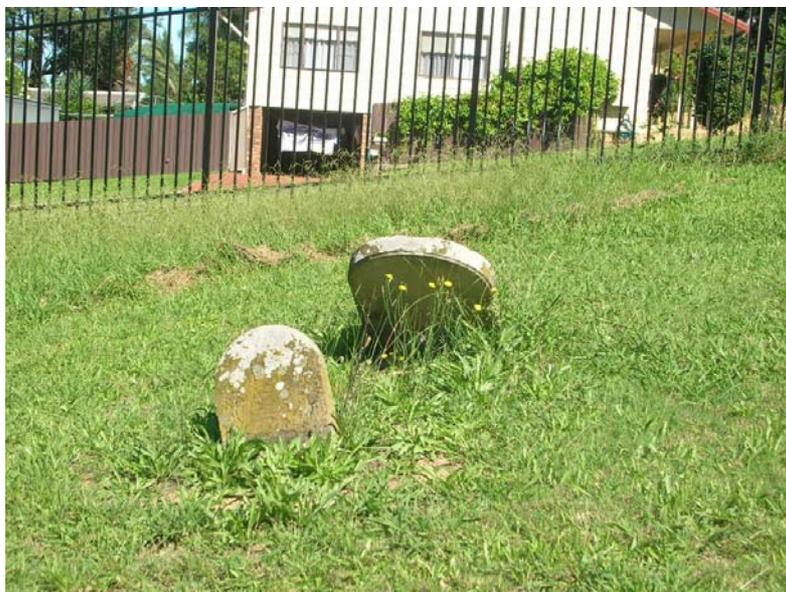
Figure 33

The headstone and footstone of Mary Gardner (d. 1856). This memorial is near the western corner of the cemetery. This and two other burials known to be nearby are separated from most of the known burials in the cemetery.

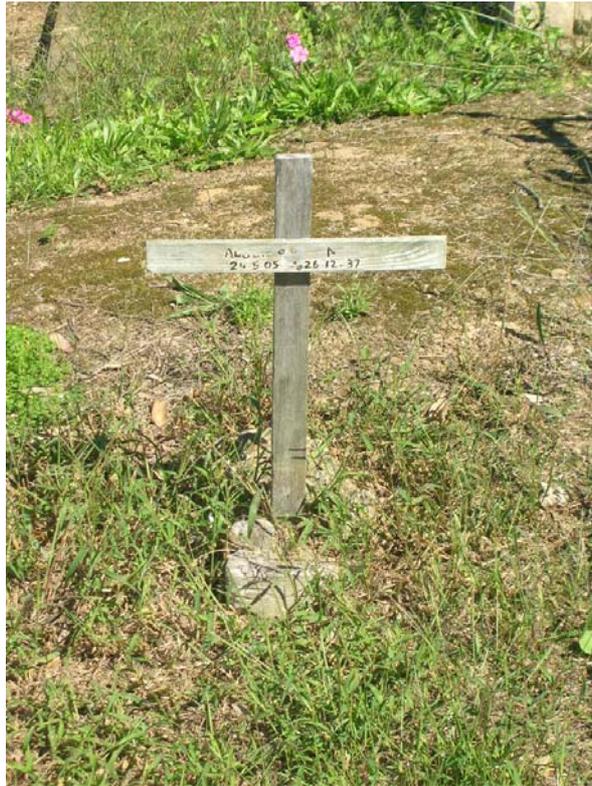
Figure 34
The simple wooden cross for Albert Wilfred Jones (d. 1937)

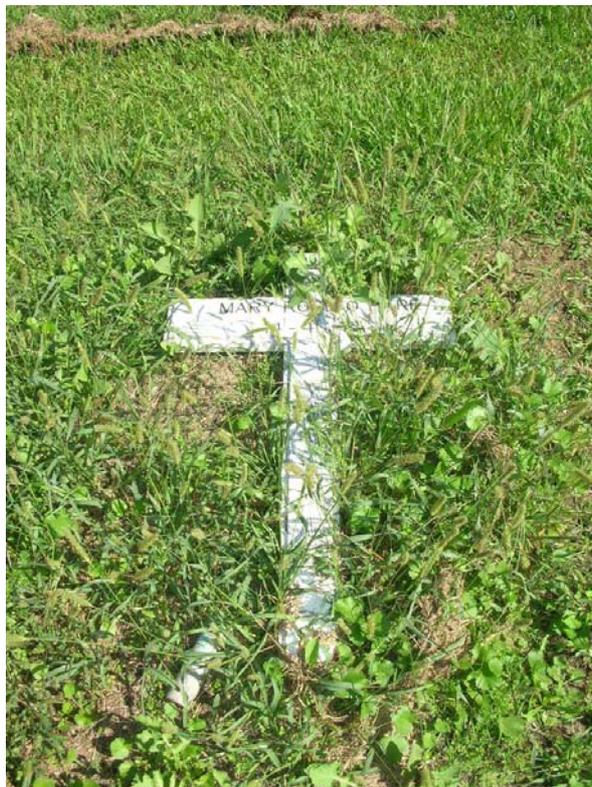
Figure 35
A simple cross used to mark the grave of Mary Rose O'Hare (d. 1973).

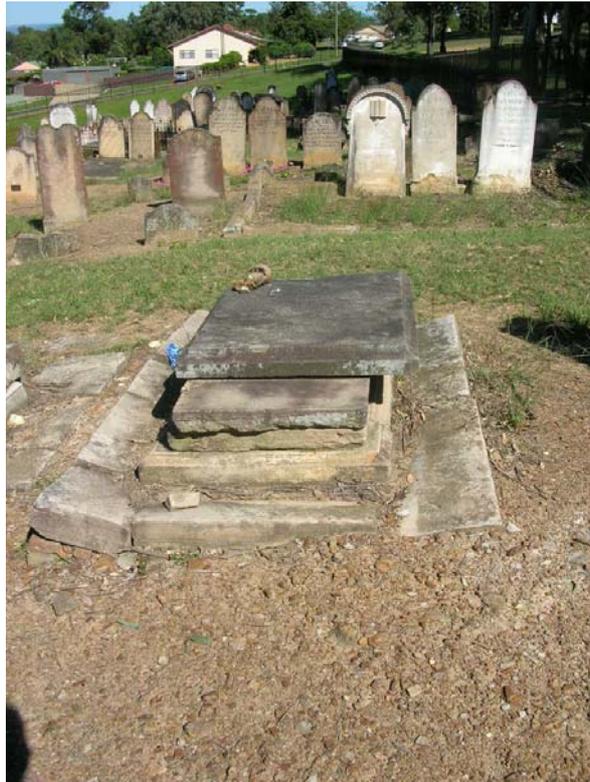
Figure 36

An altar style slab monument that has collapsed. The elements of the monument have been stacked together so that restoration might be possible.

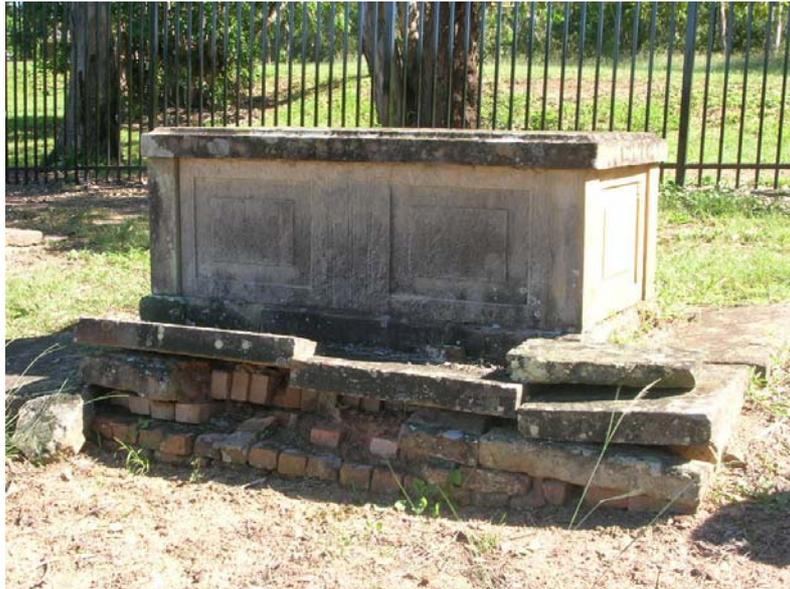
Figure 37
An altar style slab monument showing the problems of erosion on the downhill side of the monument. The brick footings for the base of this monument would originally have been below ground level.

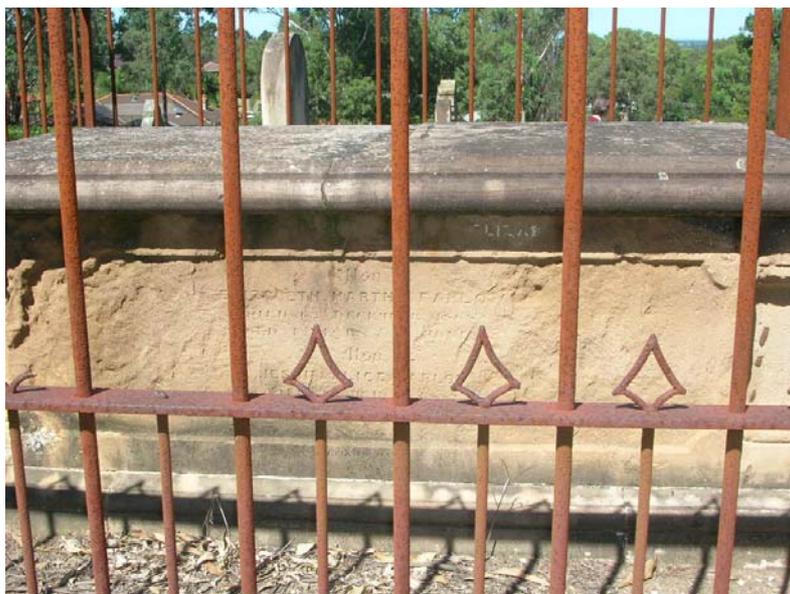
Figure 38
A monument to members of the Farlow family. Severe salt damage is causing the loss of the inscription on the face of this altar.

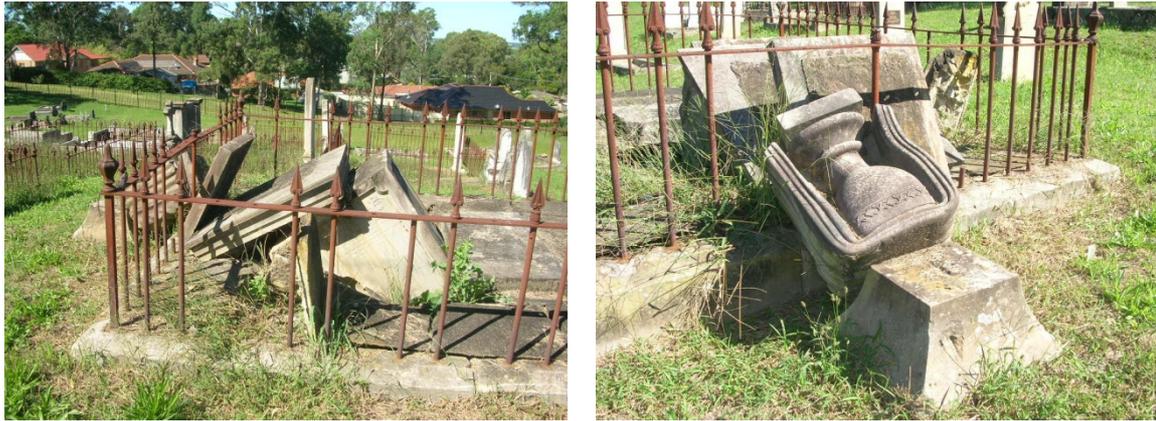
Figure 39

The monument for Margaret Chaseling (d. 1815) and Thomas Chaseling (d. 1847). This was a prominent pedestal monument with a draped urn within a picket fence enclosure. Subsidence under the monument has contributed to the collapse of the pedestal.

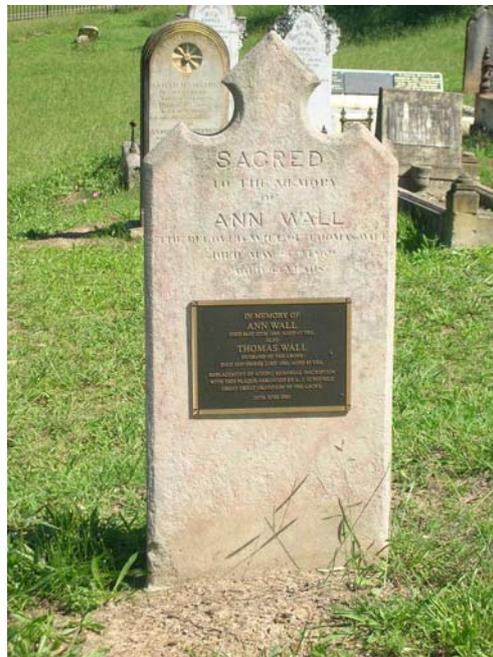
Figure 40

The stellae monument for Ann Wall (d. 1869) and Thomas Wall (d. 1870). A brass plaque has been added to “replace” the inscription that presumably had weathered.

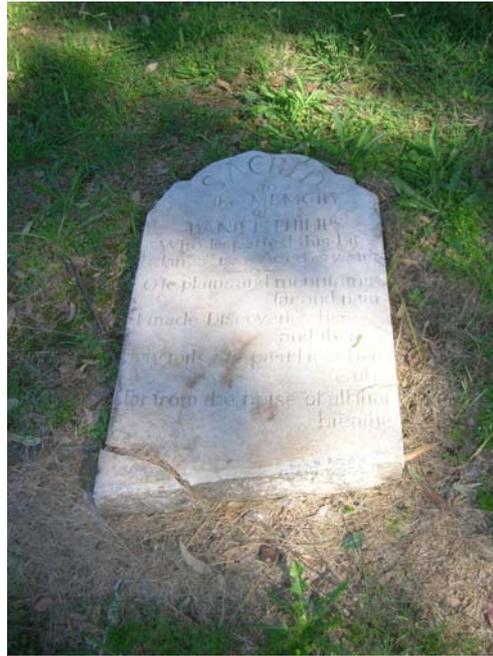
Figure 41
Stellae that have collapsed such as this monument for Daniel Phillips (d. 1833) risk accelerated weathering of the inscription.

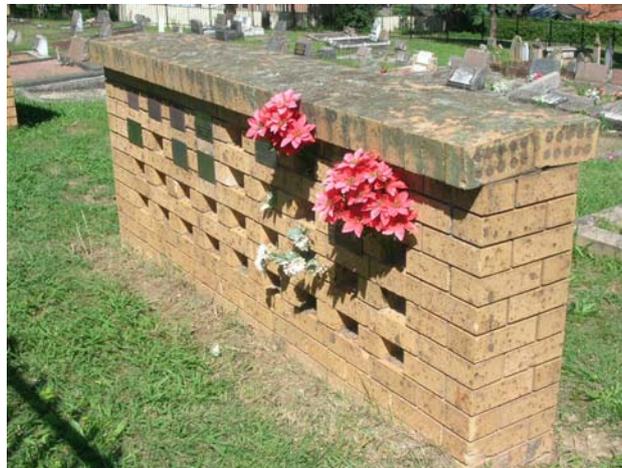
Figure 42
The northern columbarium wall

A pair of brick columbarium walls was built at the eastern entrance to the cemetery in the 1970s. They are simple cream brick walls with brick capping. The side of one wall has a plaque commemorating members of the First Fleet who lived in the area and were buried in the cemetery.

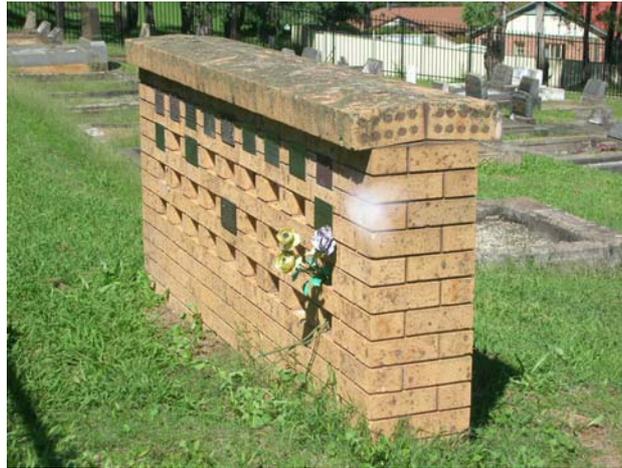
Figure 43
The southern columbarium wall

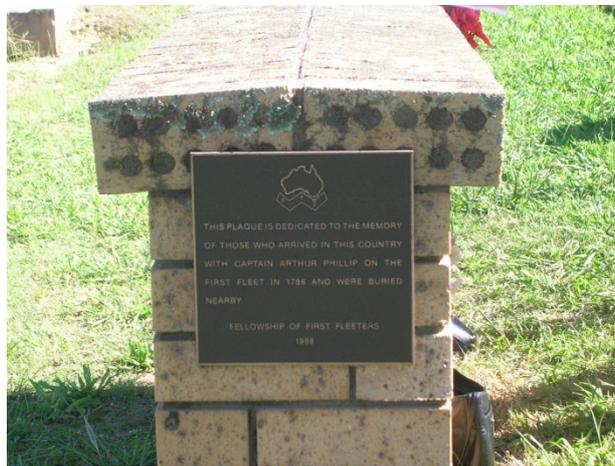
Figure 44
The plaque commemorating first fleters buried in Wilberforce Cemetery
