Non-Aboriginal Heritage Constraints

Belmont Park Estate, Grose Wold

11-Augt-2023
Development at Belmont Park Estate

AECOM Australia Pty Ltd

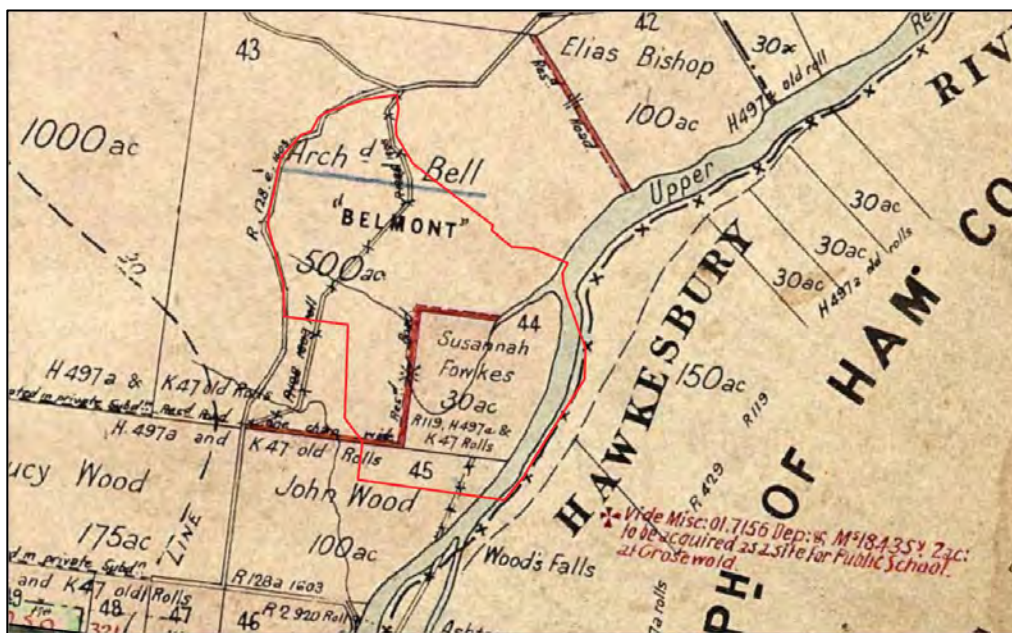
Figure 3-1: 1893 Detail of Parish Map of Kurrajong. Project area is indicated in red (Source: Historical Land Records Viewer)

The Project area is within the land grant of Archibald Bell, was granted a total of 2,000 acres in three separate lots: 500 acres in 1809, and two additional 1,000 and 500 acres lots in 1810. (Figure 3-1). In 1810 Governor Macquarie visited Belmont (Bell's farm) and noted a residence on the crest of the hill overlooking the Hawkesbury River. This first structure was built by Archibald Bell who lived there 1810-1849, of which only the foundations of this structure remain. The area continued to develop with Windsor, Richmond, Castlereagh, Wilberforce and Pitt Town being established.

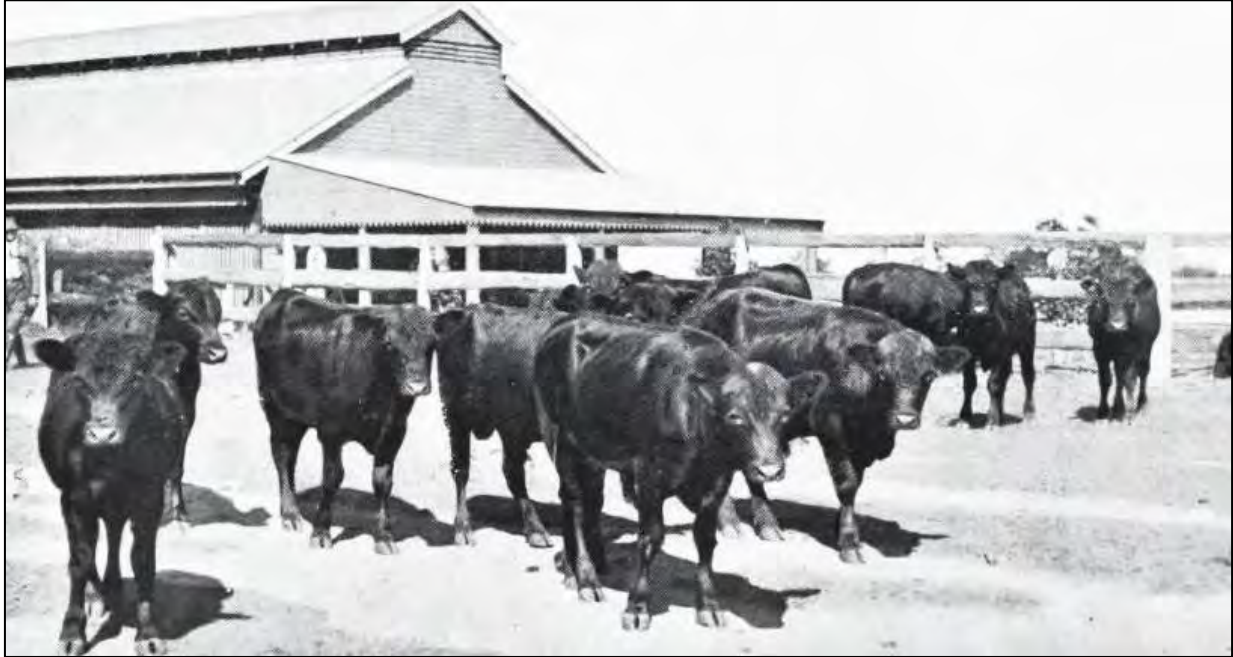
Plate 3-1: Pedigree yearling bulls bred at Belmont Park. Note form of barn (The Pastoralists' Review, 1910:1270)

Plate 3-26: South-western elevation of Building 2 (AECOM, 2022). Compare with Plate 3-1

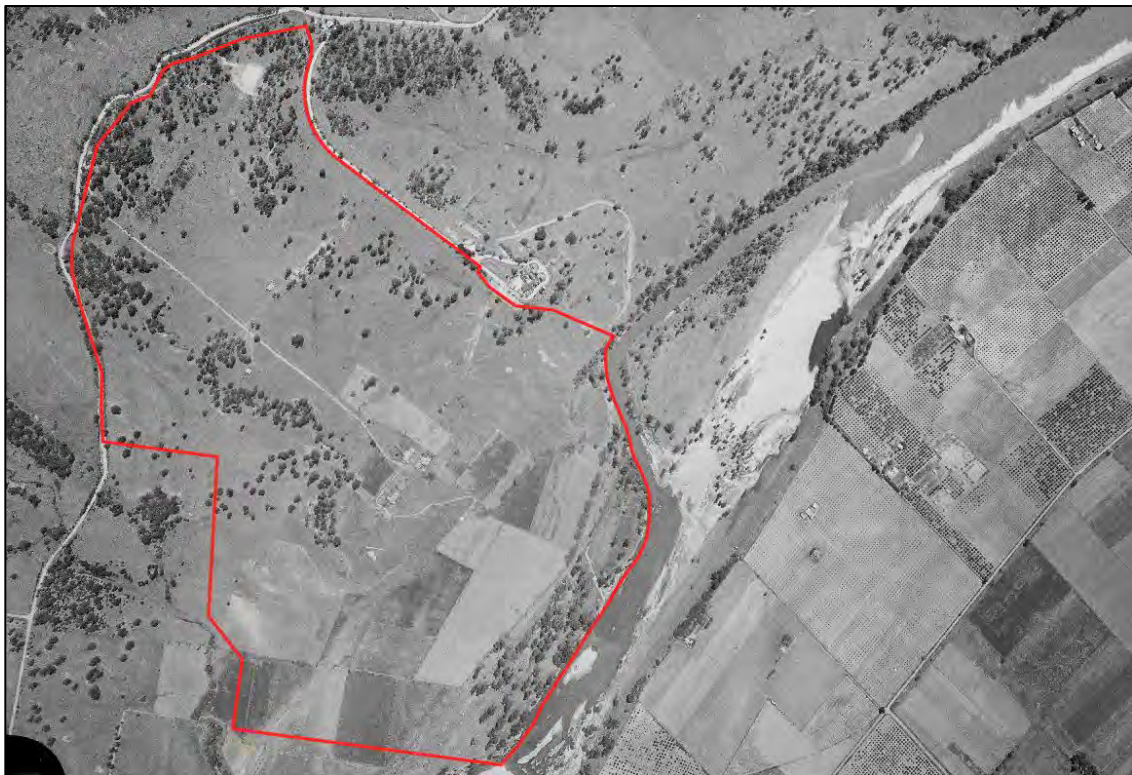
Figure 3-3 1955 aerial image of the Project area (Source: Historical Imagery)

By 1954 the subdivisions within the Project area are visible (see Figure 3-3). Belmont Park (operating as a psychiatric hospital) is visible immediately north of the Project area.

A number of structures are visible in the area currently occupied by a large stables complex. The old buildings (now demolished), possibly the 1896 stable block referred to in contemporary news reports (Figure 3-3). The two 1896 farm buildings are visible; Building 1 has not yet been added to (Figure 3-4).

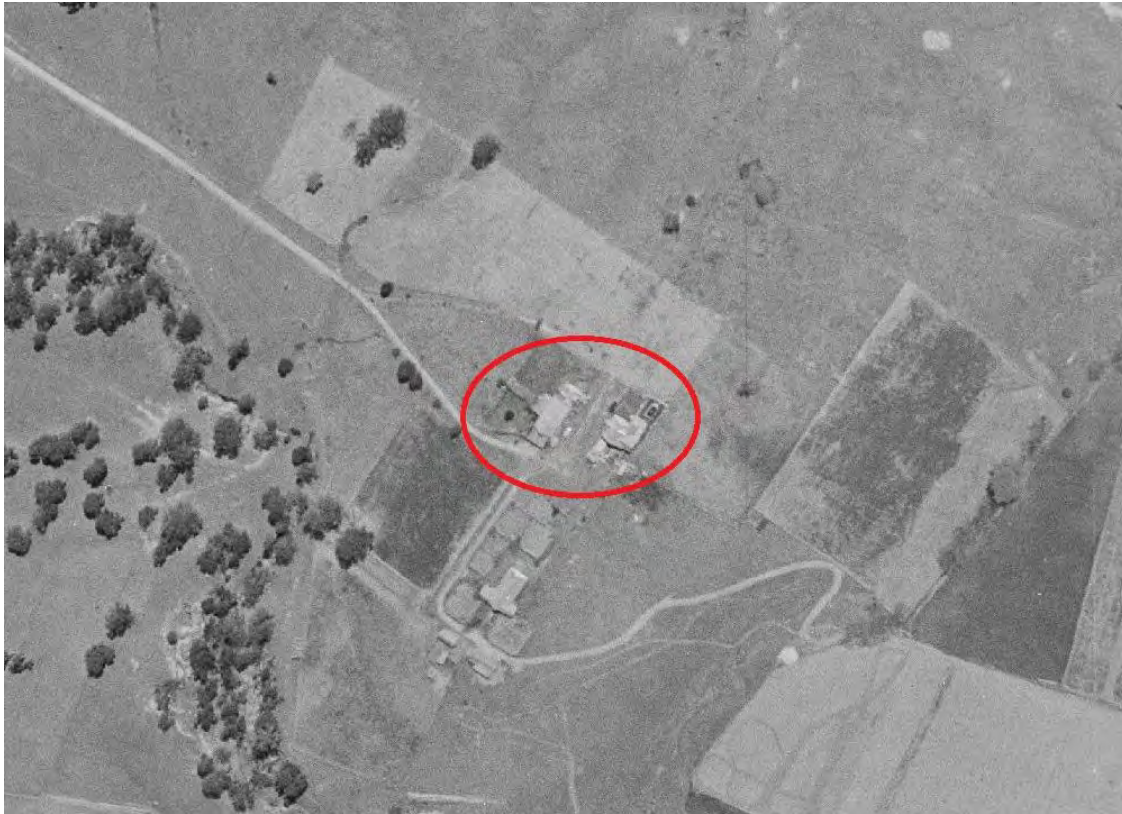
Figure 3-4: Detail of 1955 aerial showing 1896 farm buildings and garden

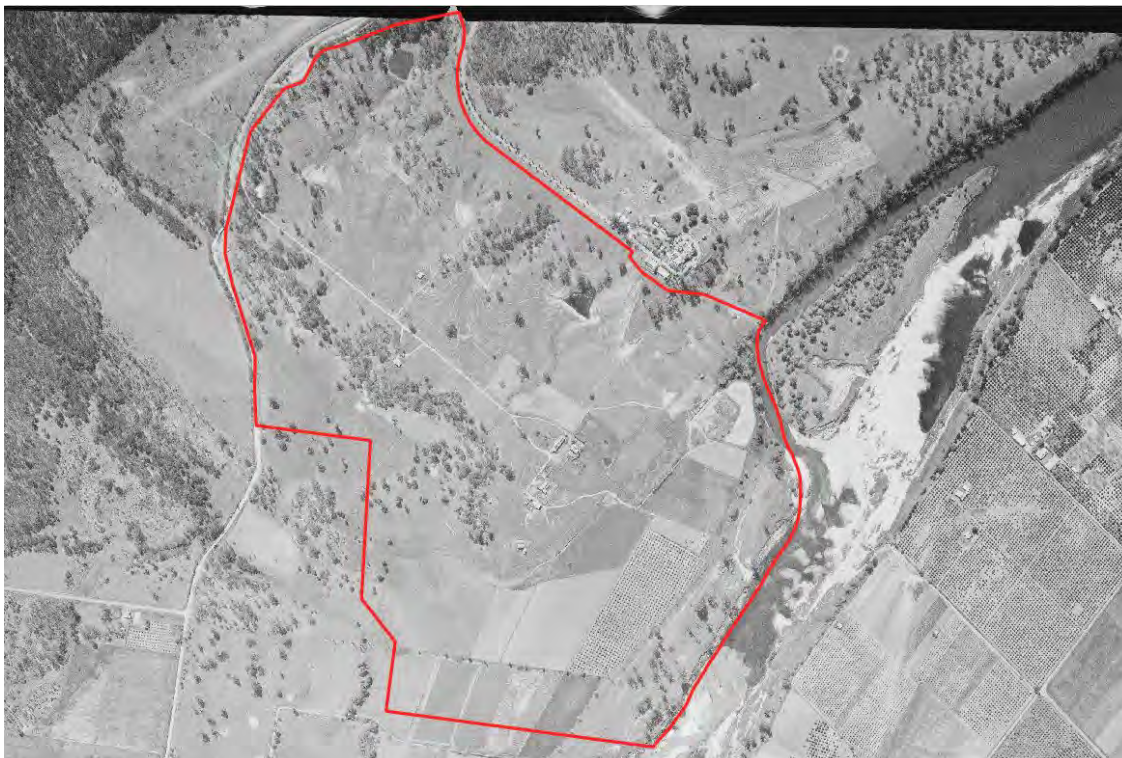
Figure 3-5 1965 aerial image of the Project area (Source: Historical Imagery)

By 1965, the three structures in the middle of the Project area were extended with evidence of drainage channels appearing across the Project area (see Figure 3-5). Also, note furrows to the north west and immediate south of the 1896 farm buildings, possible evidence of keyline farming.

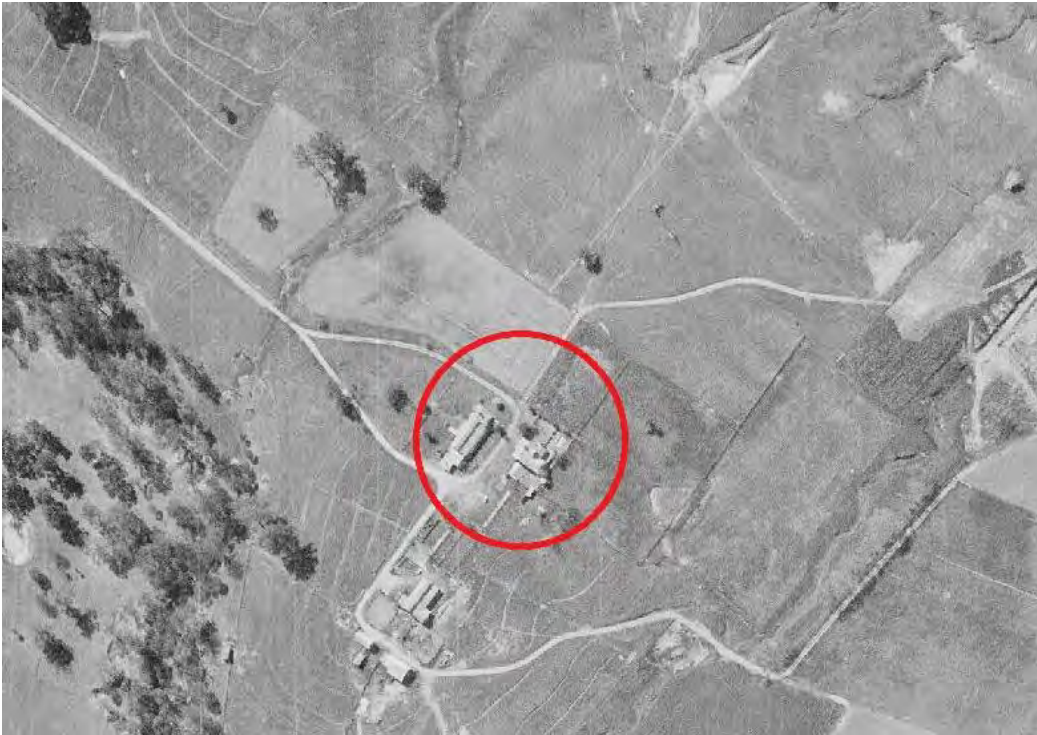
Figure 3-6: Detail of 1965 aerial with 1896 farm buildings and gardens circled

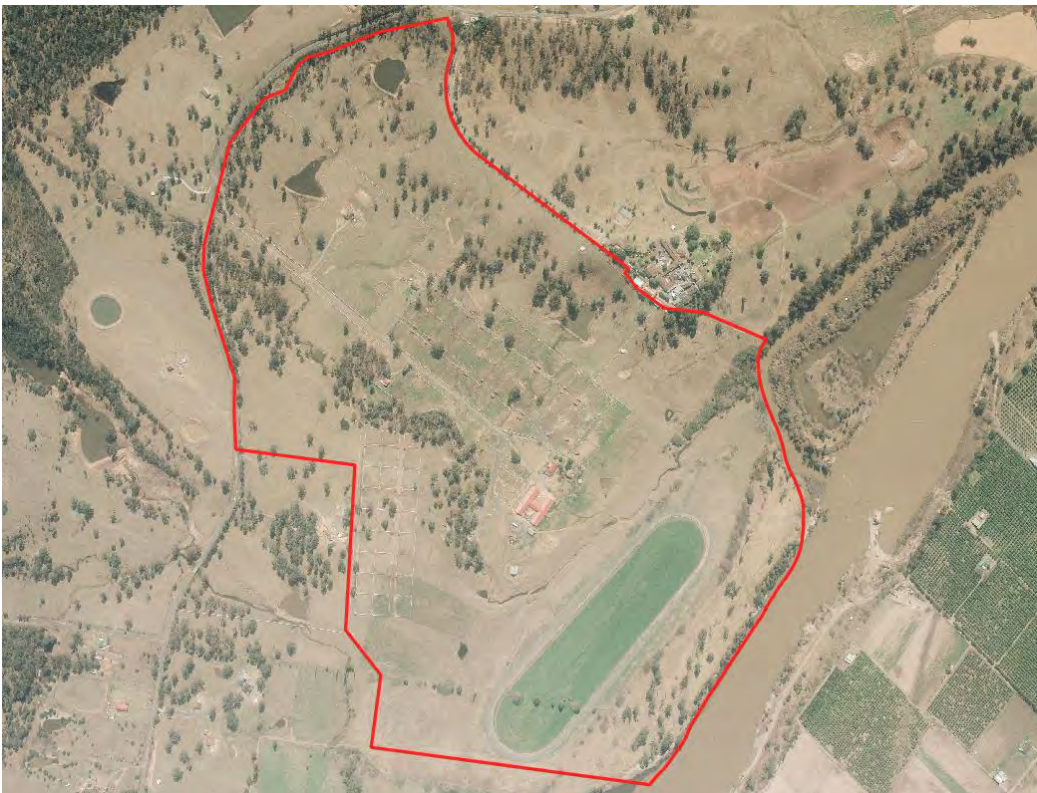
Figure 3-7 1986 aerial image of the Project area (Source: Historical Imagery)

By 1986 (Figure 3-7) the land around the former Belmont Park agricultural buildings has been modified, with evidence of individual fields and small outbuildings separated by fencing. Much of the central portion of the Project area has been divided into small, fenced paddocks with a single shelter in each, probably for the agistment of horses. Initially, these were confined to the northeast of the structures in the centre of the Project area (1984) but by 1986 expanded to the north and west of the property. The stables have also been modified, with the southernmost buildings having been replaced with a larger structure consisting of two joined parallel wings, in an "H" shape. It is likely the building which used to be in this location was demolished to between 1984-1986 when this larger structure was built. There is also a racetrack in the south-eastern corner of the Project area; until 2015 the property was used as a horse stud for the ruler of Dubai, Sheik Mohammed bin Rashid al-Maktoum (Chancellor, 2015).

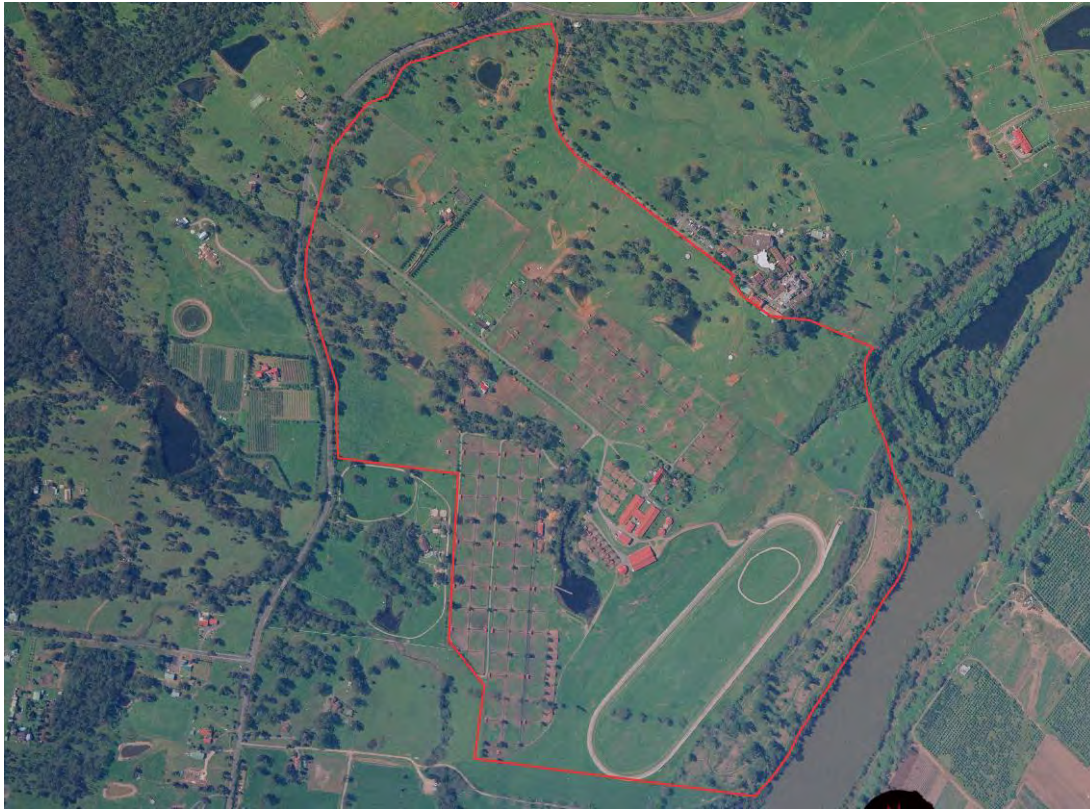
Figure 3-8 1998 aerial image of the Project area (Source: Historical Imagery)

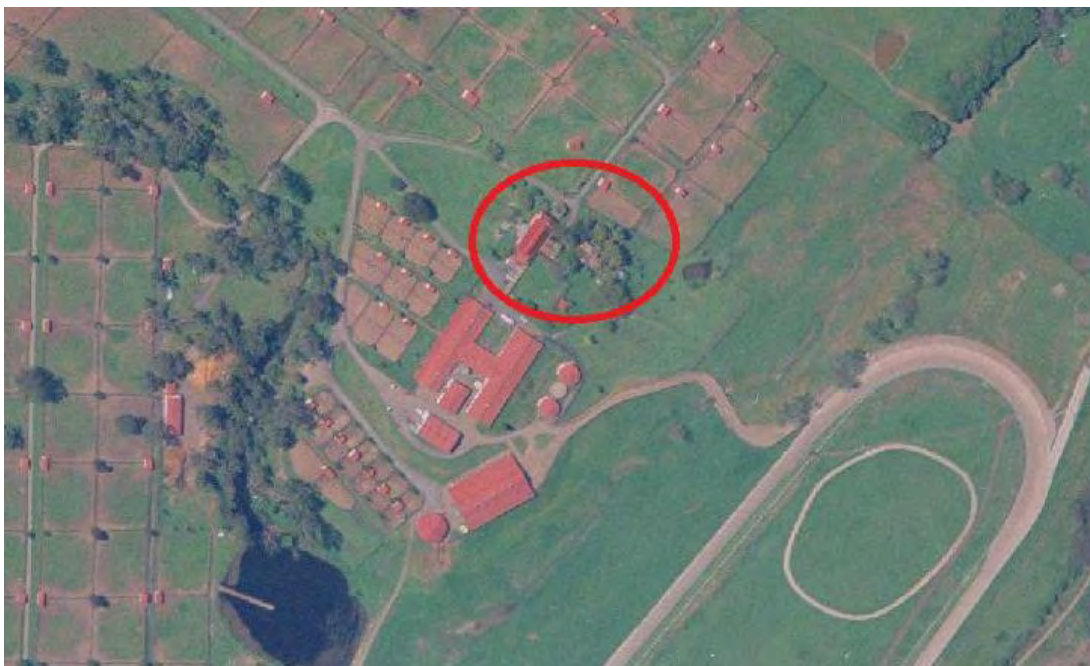
Figure 3-9: Detail of 1998 aerial image with 1896 farm buildings circled in red

The landscape stays relatively similar through to 1998, though a further three structures appear south of the large building in the centre of the Project area built in 1986. The grid pattern fields extend further south and a row of tree plantings is present on the approach to the property in the north of the Project area.

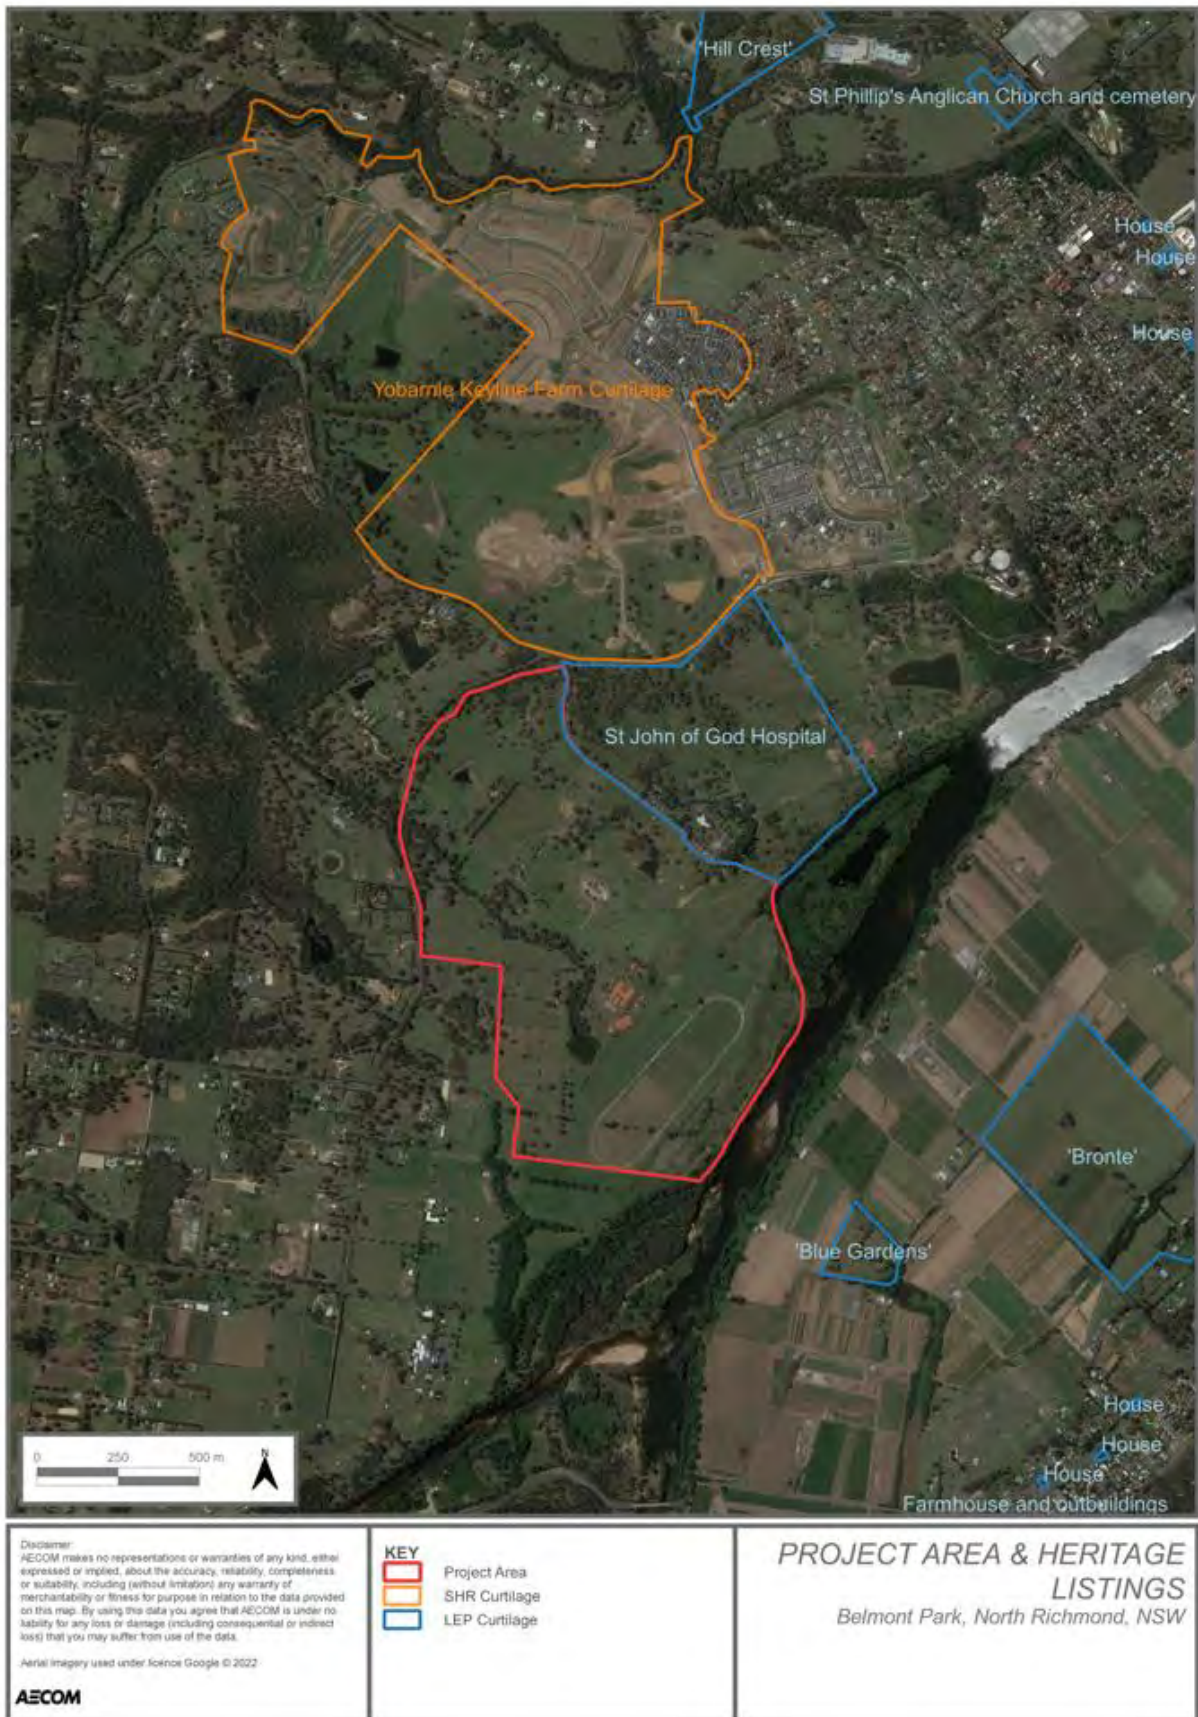
Figure 3-10: Heritage items in the vicinity of the Project area

For location of these items, see Figure 3-10.

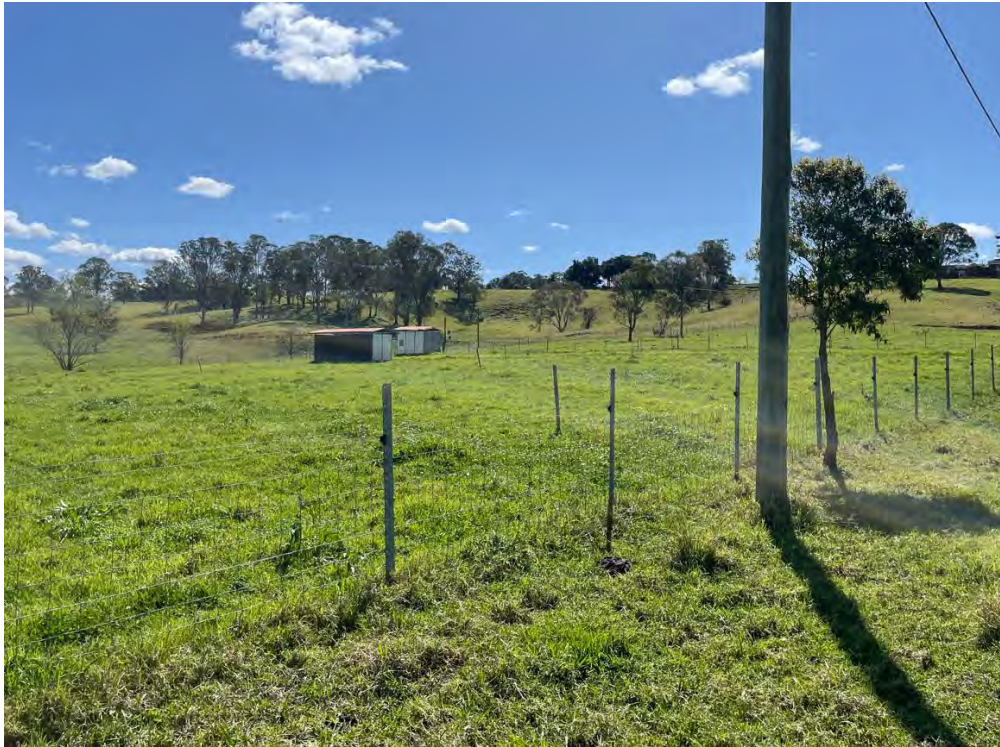
Plate 3-5: View north from 1896 farm buildings toward St John of God. Belmont House is located north of the ridge (AECOM, 2022)

As with the servants quarters, the workers engaged in the construction of Belmont House were likely to have lived close to the current Belmont House. Belmont House is located close to the boundary of the St John of God curtilage and the Project area. However, given the topography of the area, it is more likely that this construction camp was within the St John of God Hospital curtilage. Like many 19th century mansions, Belmont House is located atop a steep rise - if camped within the Project area, workers would have needed to walk up this incline to access the construction zone (Plate 3-5).

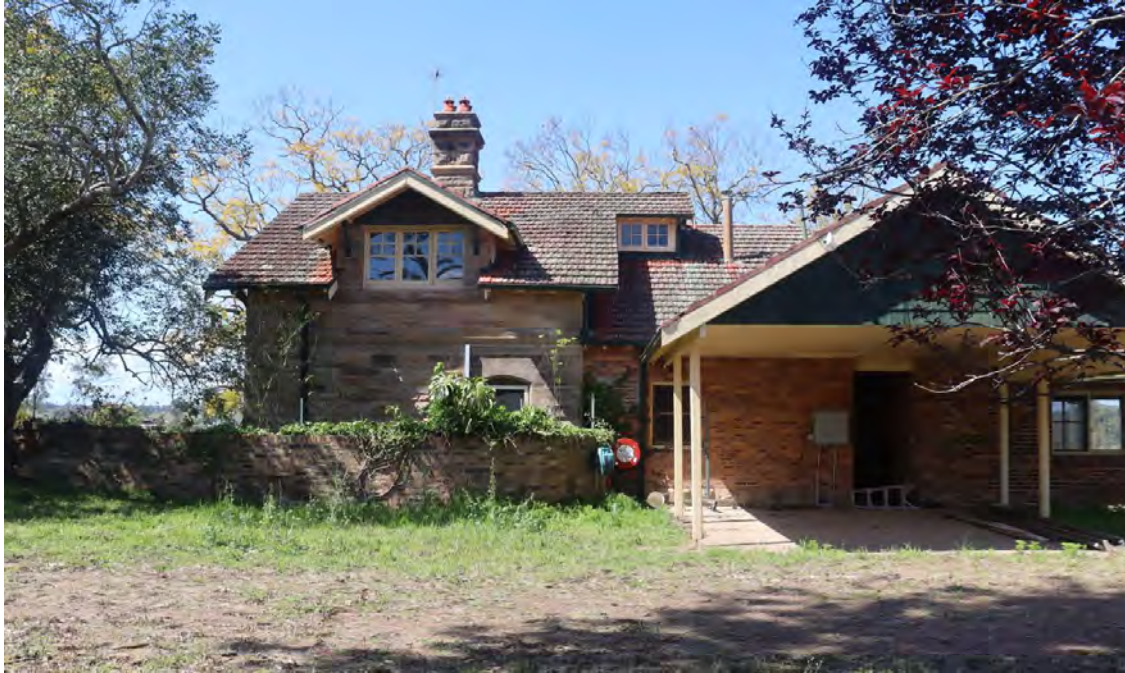
Plate 3-7: North western elevation of Building 1. This elevation faces building 2 (AECOM, 2022)

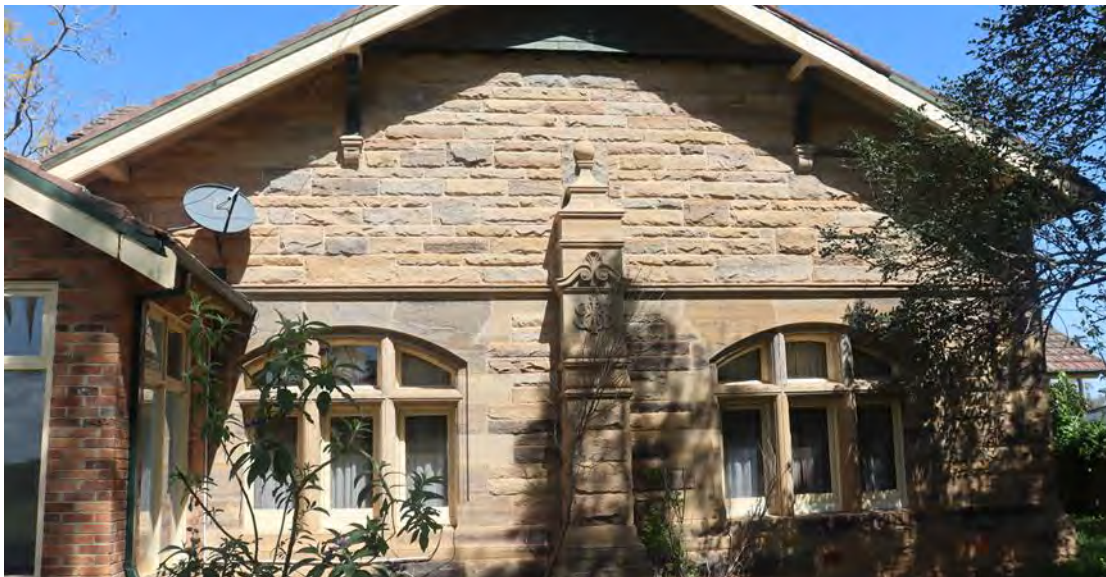
Plate 3-8: Finial in north-eastern elevation with the carving of entwined numbers "1896" (AECOM, 2022)

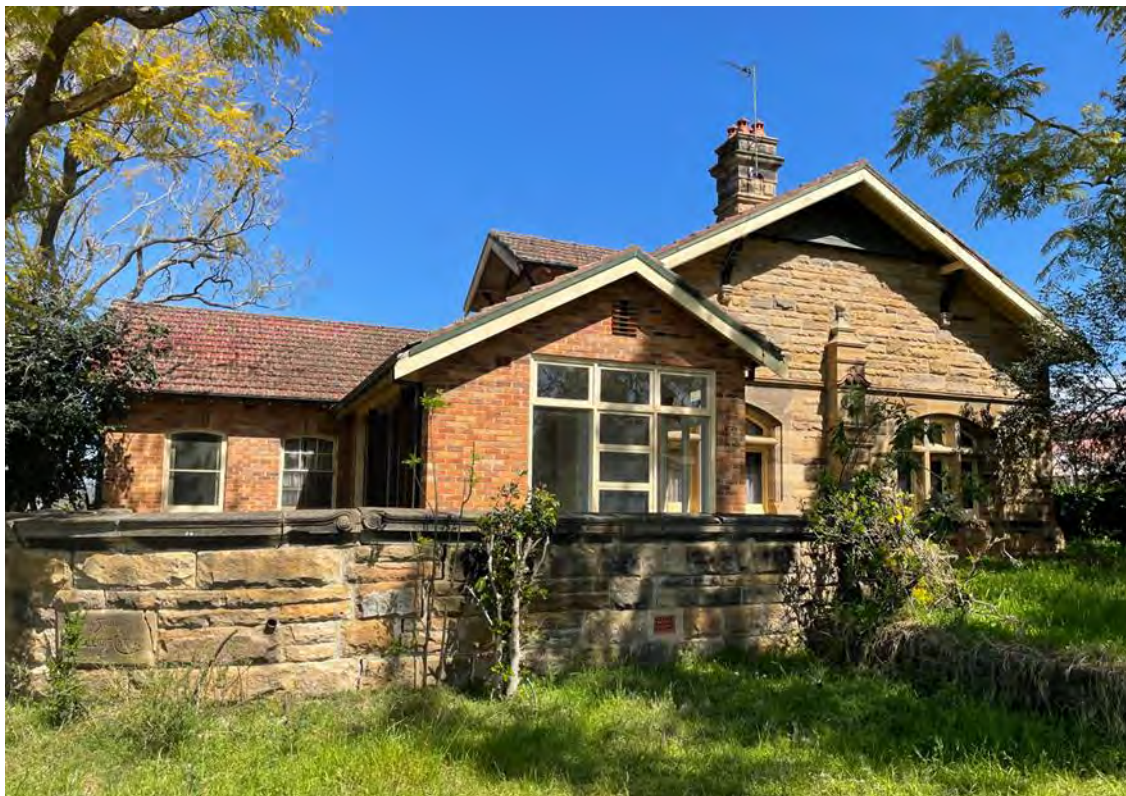
Plate 3-9: North eastern elevation of Building 1. Note commemorative stone in retaining wall at lower left (AECOM, 2022)

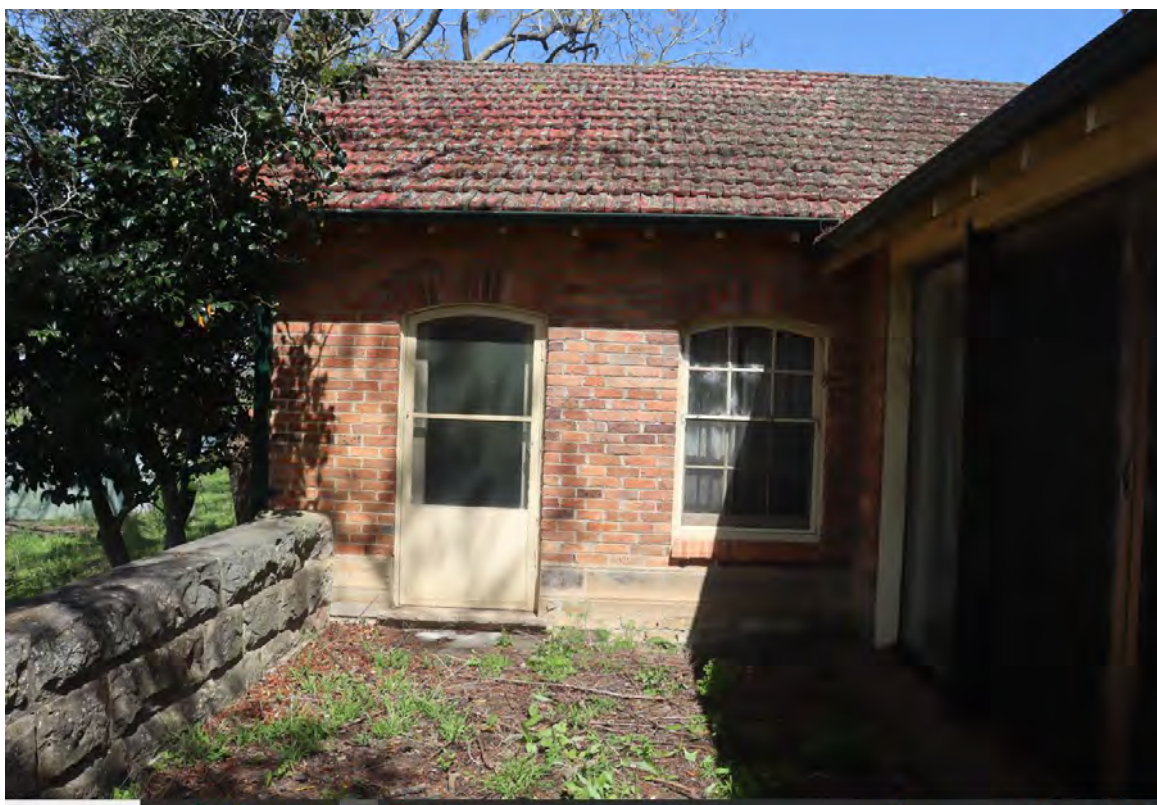
Plate 3-10: Brick addition to Building 1 at north east, however, note stone coping and wooden window and door (AECOM, 2022)

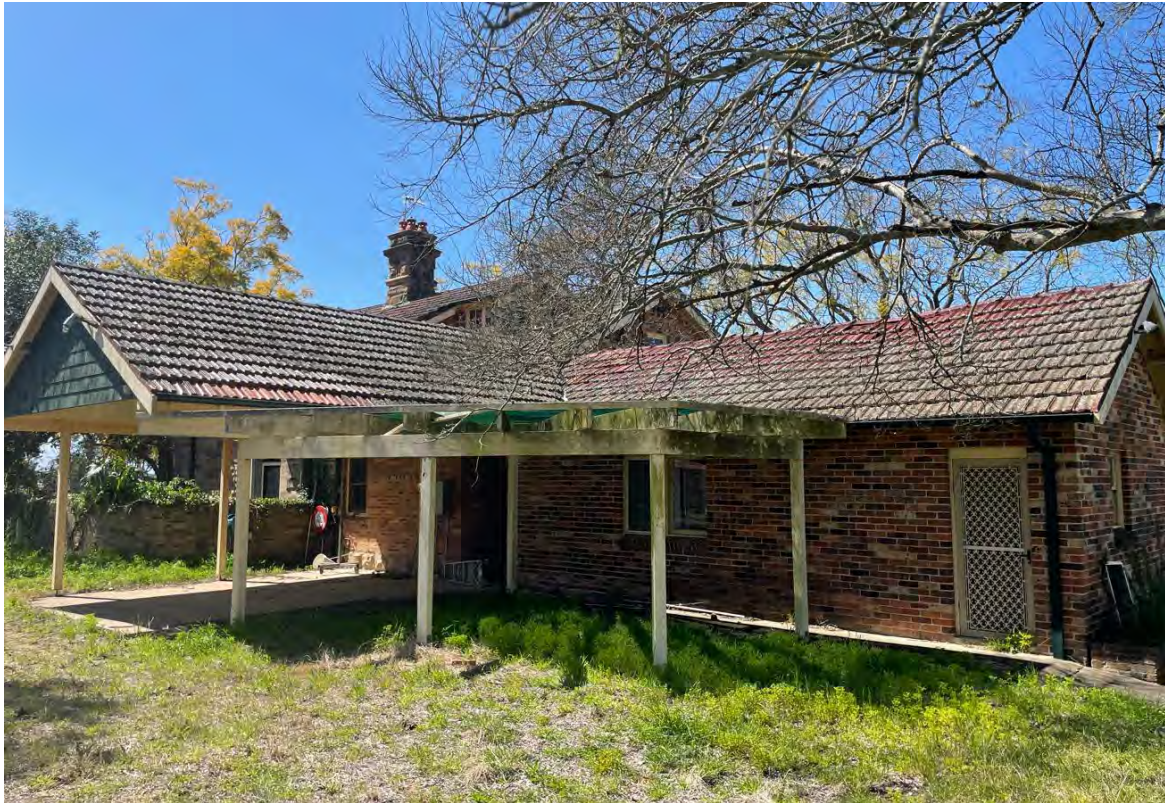
The modern additions are of brick construction and attached to the south west corner of Building 1. They comprise a portico in Building 1’s the north west elevation and a range leading south west (Plate 3-11).

Plate 3-11: Modern portico (left) and addition (right) to Building 1 (AECOM, 2022)

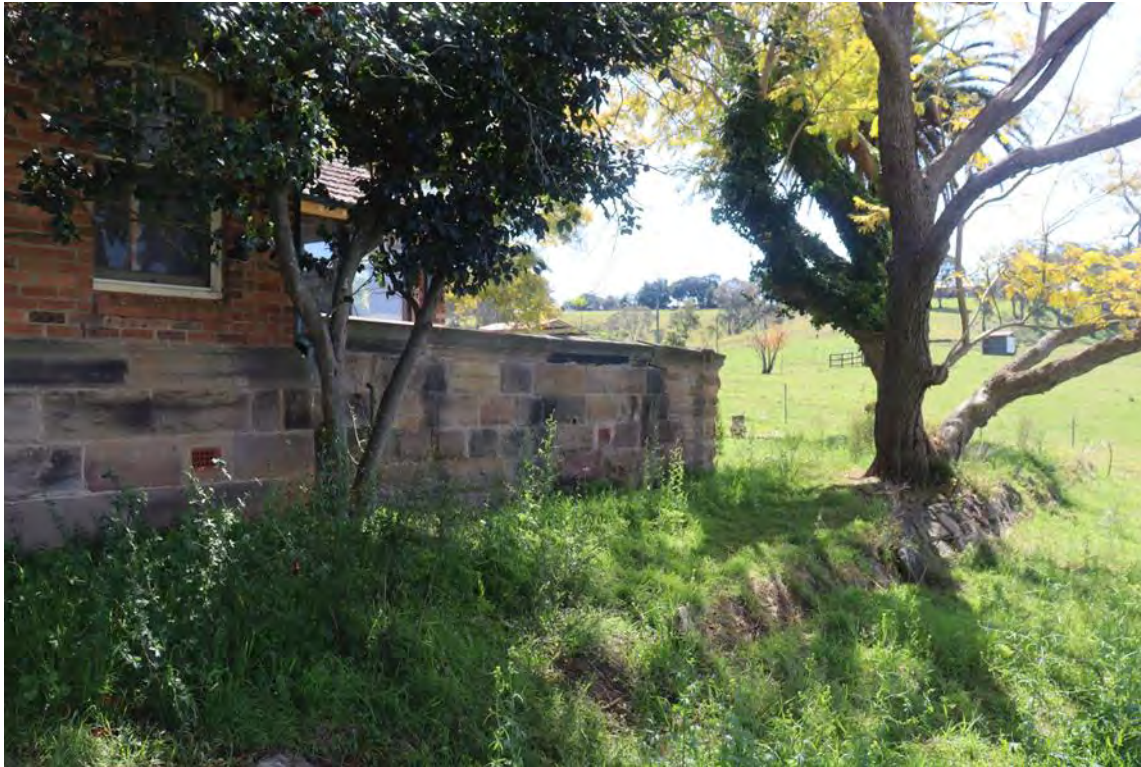
The principal external fabric is rough-shaped stone, of similar character to that used in the main residence of Belmont Park, and outbuildings such as the gatehouse. However, Building 1 also has two probable original brick ranges at the north-east and east, with the eastern elevation of the cottage built directly onto the retaining wall (Plate 3-12).

Plate 3-12: View north of the curved retaining wall (AECOM, 2022)

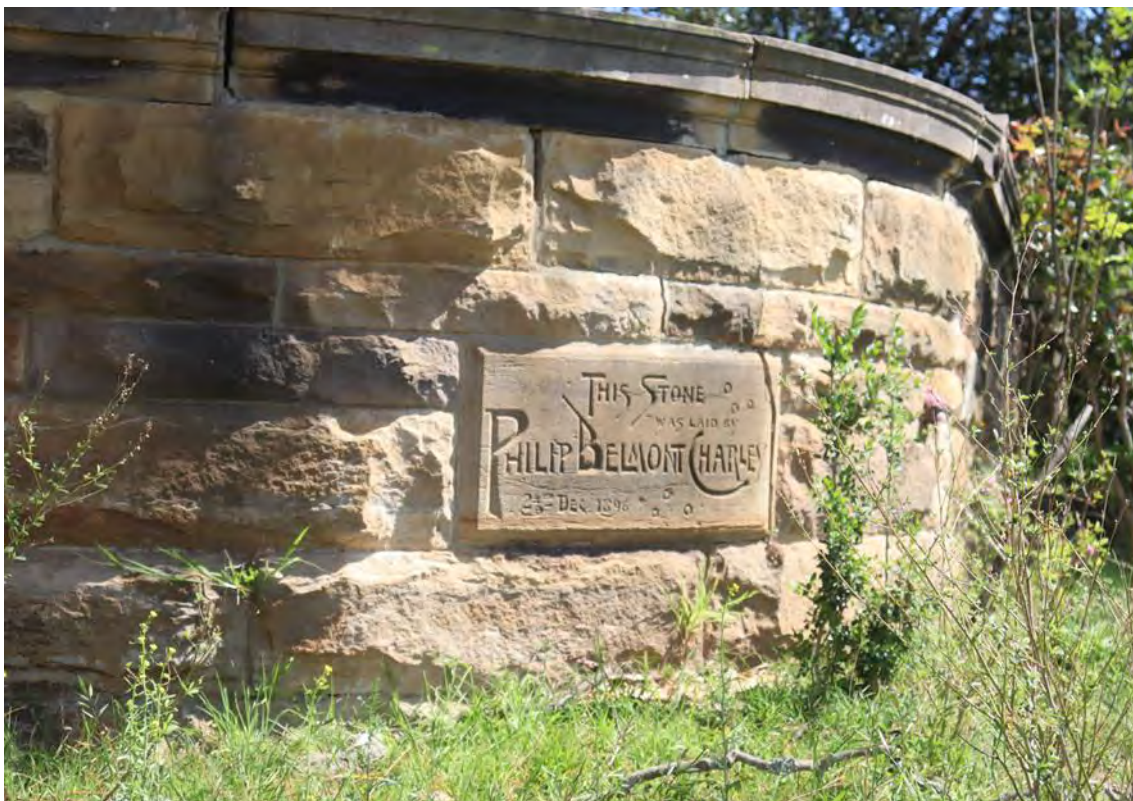
Plate 3-13: Commemorative stone laid by Philip Belmont Charley in retaining wall around the two 1896 farm buildings (AECOM, 2022)

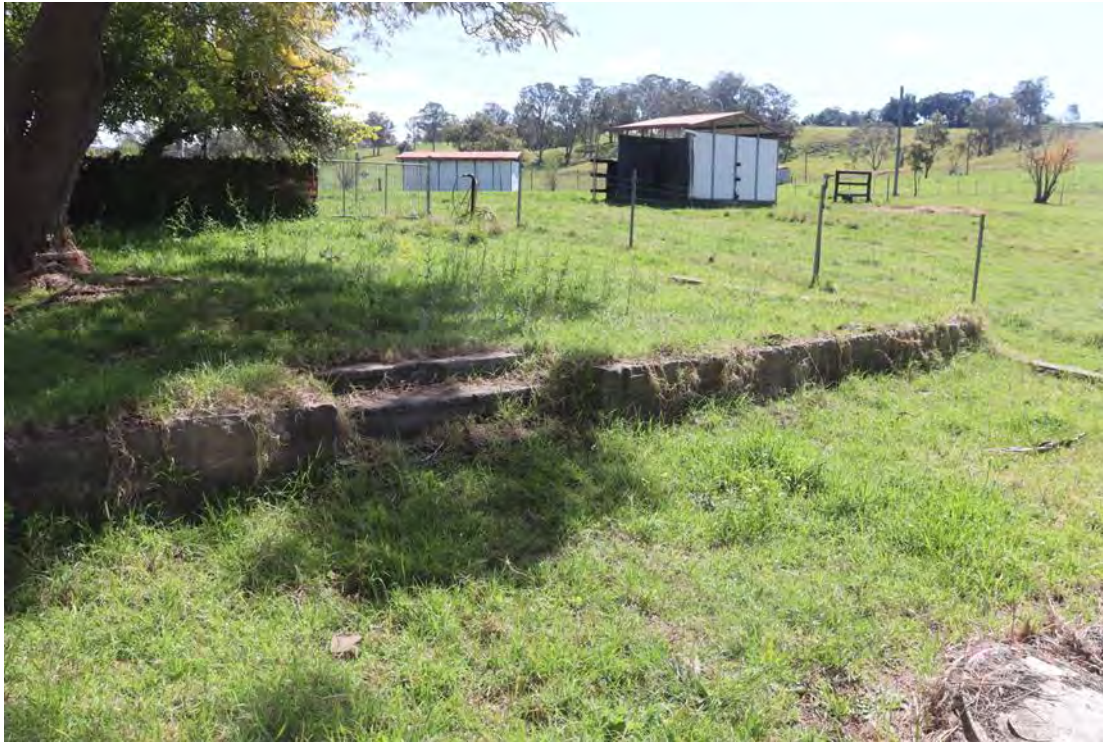
Plate 3-14: Stone retaining wall and steps. Note masonry from fountain in lower right of frame (AECOM, 2022)

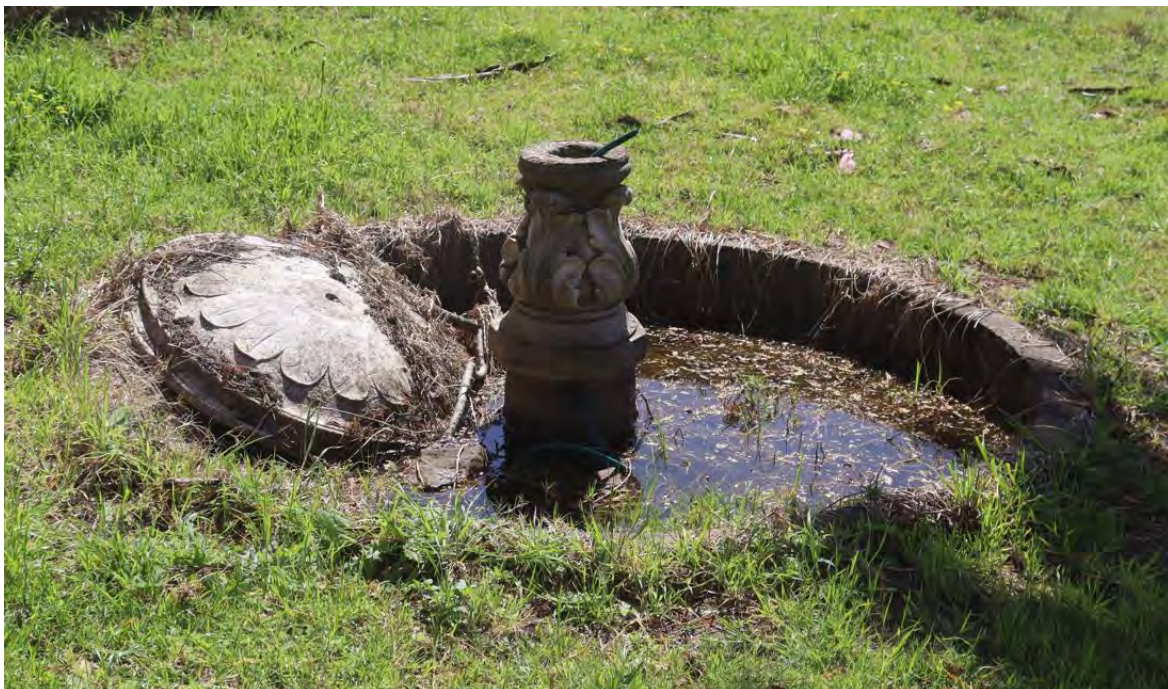
Plate 3-15: Ruins of fountain (AECOM, 2022)

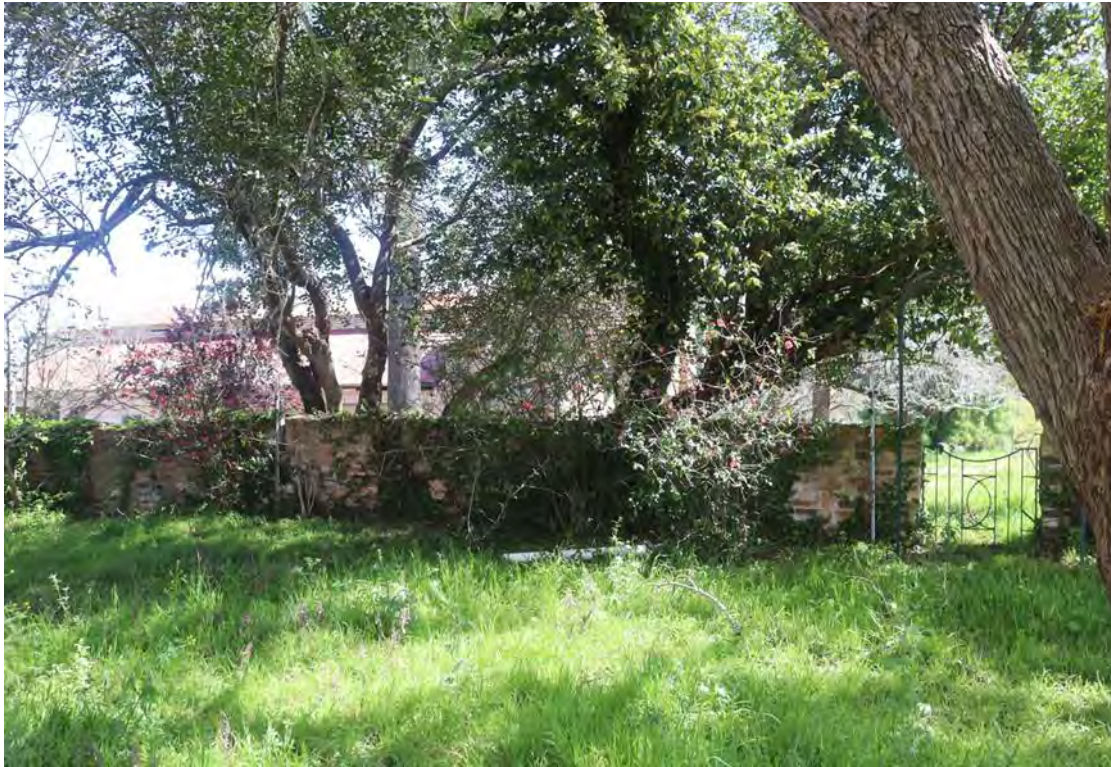
A terraced garden area is located to the north of Building 1. The garden includes a substantial curved stone retaining wall of a similar character as the stone sections of Buildings 1 and 2, the Belmont Park main residence and gate house (Plate 3-12). The retaining wall separates the garden from the house and contains a commemorative stone (Plate 3-13). In keeping with the main residence, the stone was laid by three-year old Philip Belmont Charley in December 1896. A low retaining wall similar in character to the curved retaining wall operates as a terrace, into which two stone steps are set, forming two terraces (Plate 3-14). On the lower terrace are the ruins of a fountain (Plate 3-15), and on the upper terrace is a shaded area with several exotic trees and flowering shrubs. Along the north western boundary of the upper terrace, a low, gated brick wall marks the boundary between Building 1 and the track separating Buildings 1 and 2 (Plate 3-16 and Plate 3-17).

Plate 3-16: Gated wall between building 2 (in background) and the garden of Building 1 (AECOM, 2022)

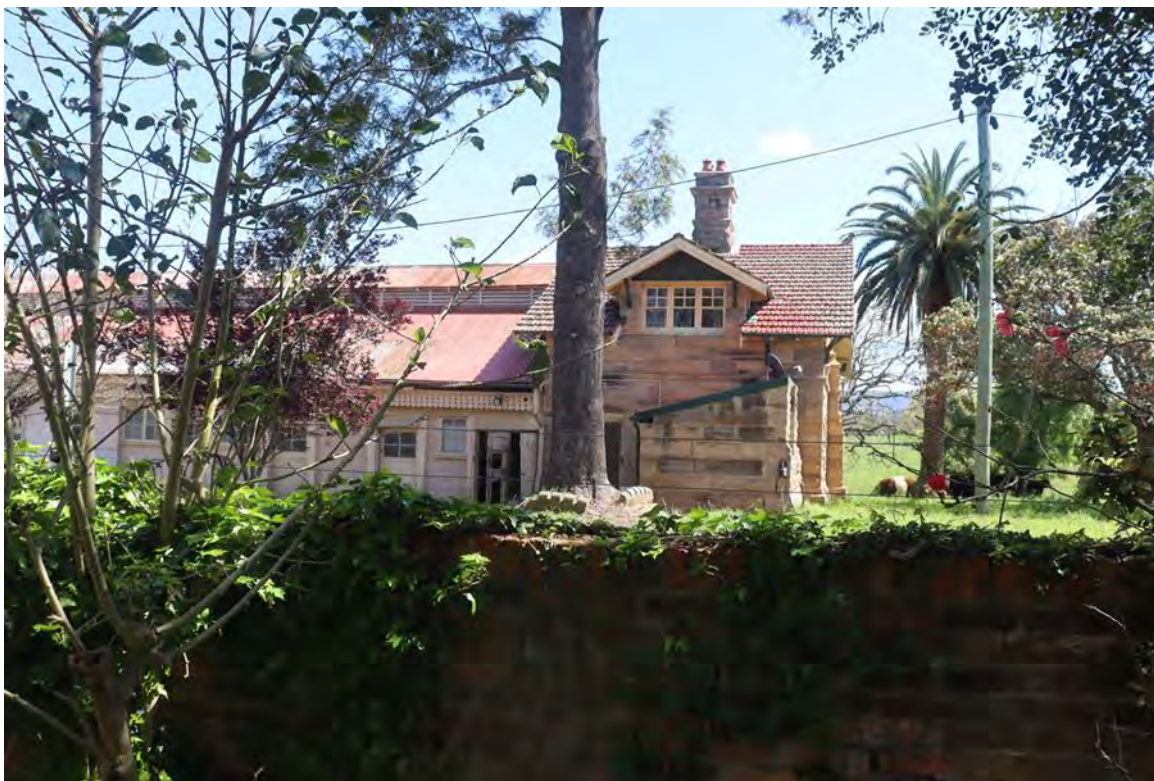
Plate 3-17: View south from garden wall of Building 1 to Building 2 (AECOM, 2022)

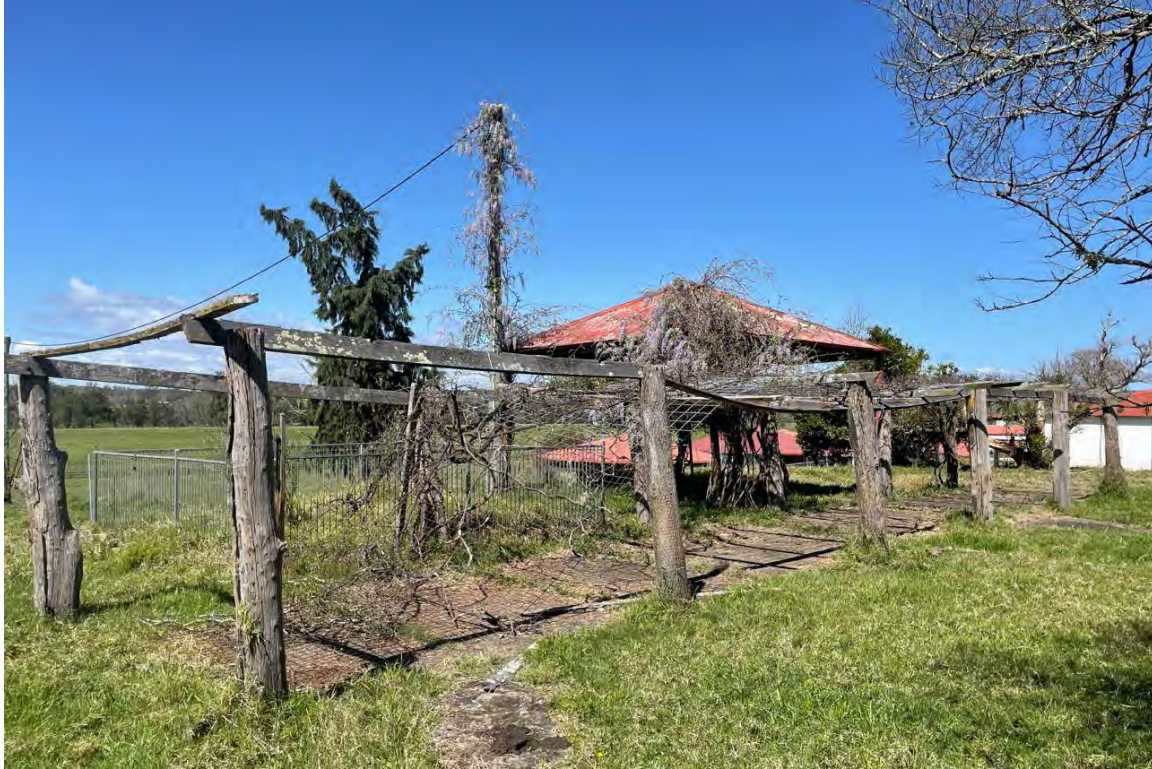
At the south of the building is a timber pergola, with wisteria growing nearby (Plate 3-18) and a pebbled path leading to a concrete foundation, possibly for a birdbath, sundial or similar garden ornament (Plate 3-19). The pergola and associated features appear to be of recent construction.

Plate 3-18: Pergola with wisteria at south of Building 1 (AECOM, 2022)
