Non-Aboriginal Heritage Constraints

Belmont Park Estate, Grose Wold

11-Augt-2023
Development at Belmont Park Estate

AECOM Australia Pty Ltd

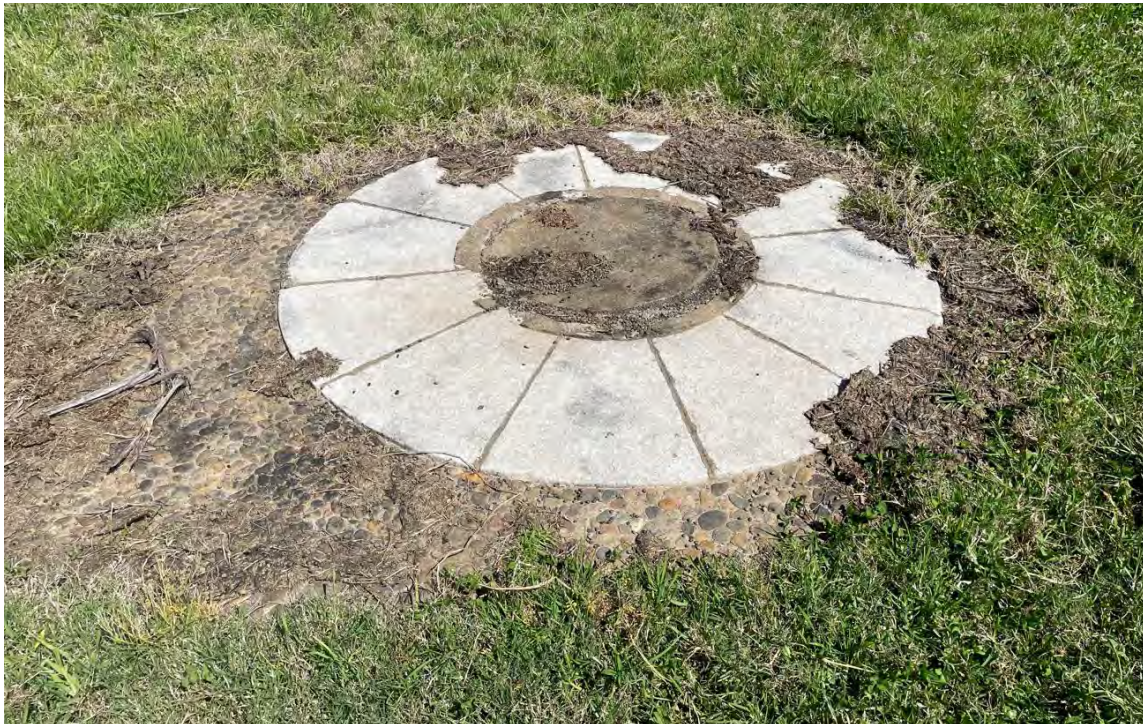
At the south of the building is a timber pergola, with wisteria growing nearby (Plate 3-18) and a pebbled path leading to a concrete foundation, possibly for a birdbath, sundial or similar garden ornament (Plate 3-19). The pergola and associated features appear to be of recent construction.

Plate 3-19: Portion of pebbled path and foundation (AECOM, 2022)

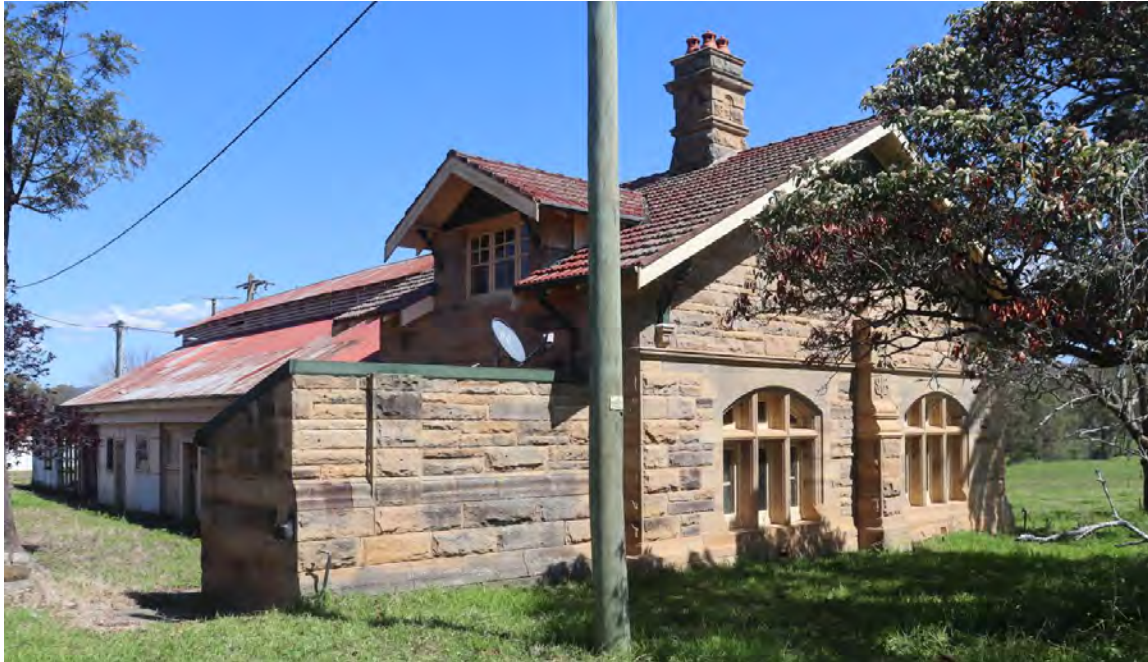
Plate 3-20: Building 2, looking south (AECOM, 2022)

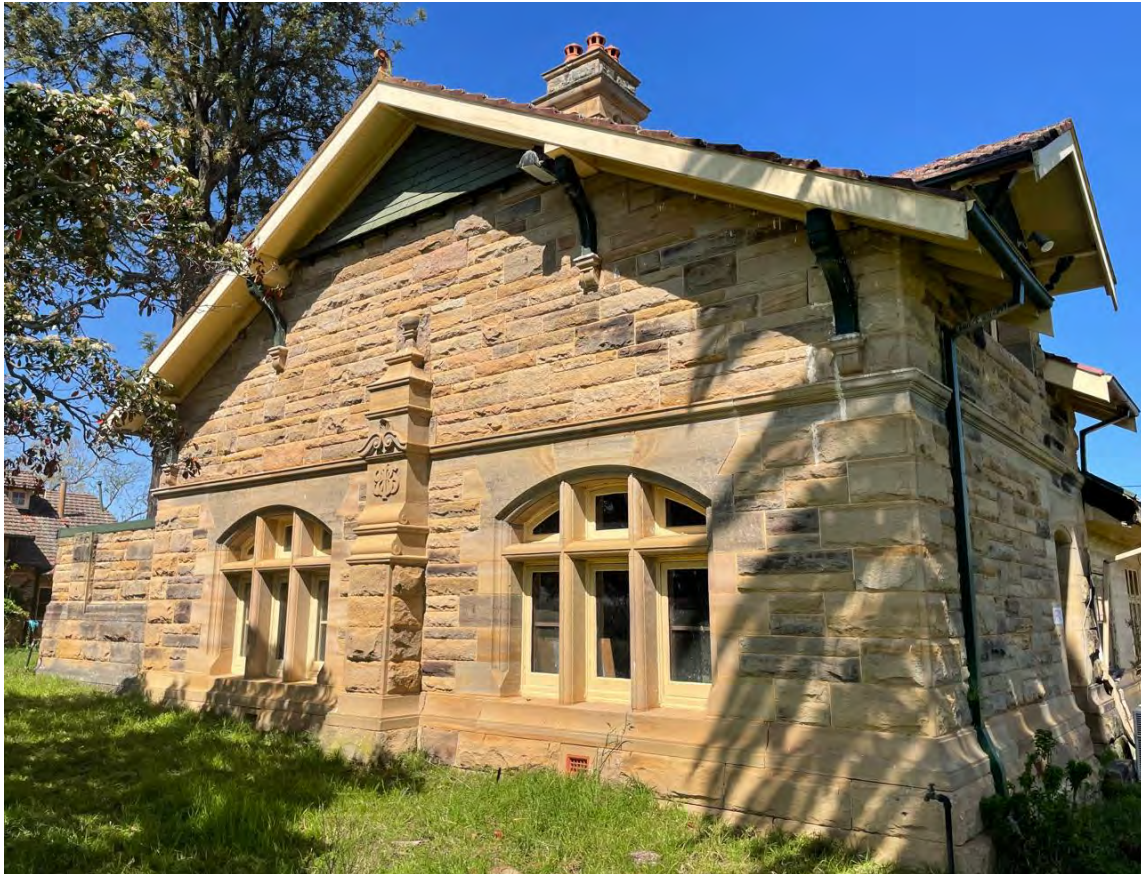
Plate 3-21: North eastern elevation with carved finial with "1896", identical to Building 1 (AECOM, 2022)

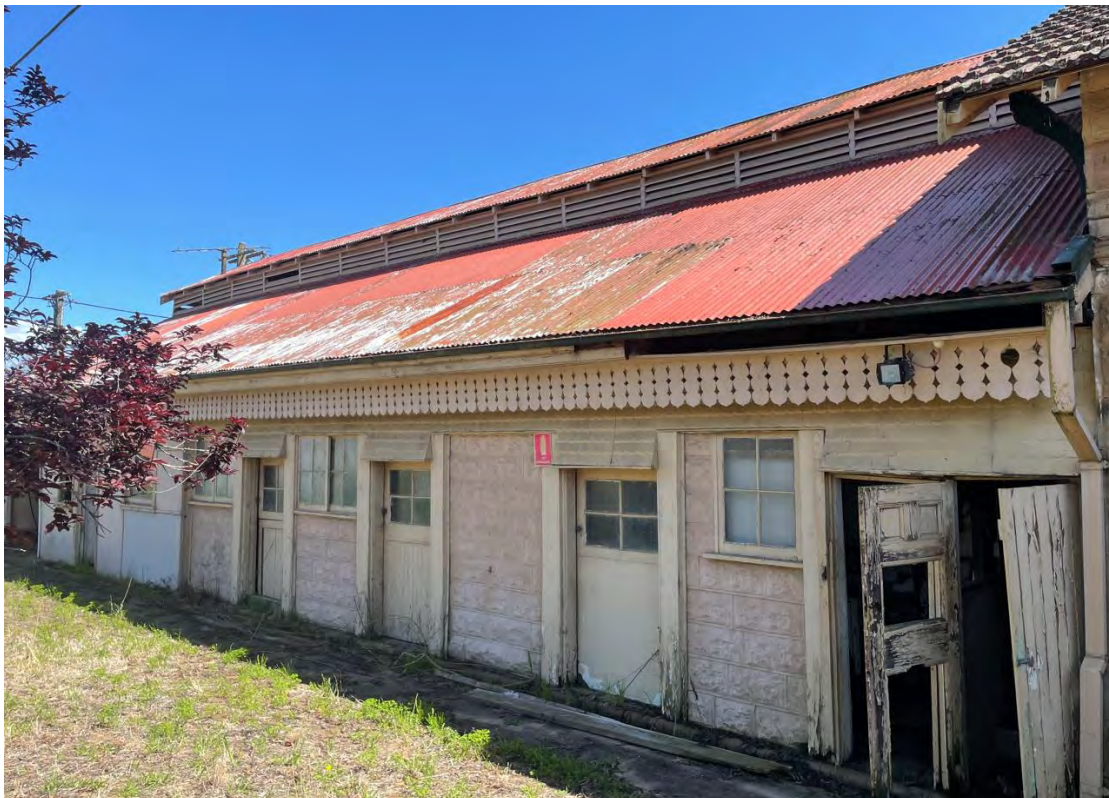
Plate 3-22: South-eastern elevation of Building 2 (AECOM, 2022)

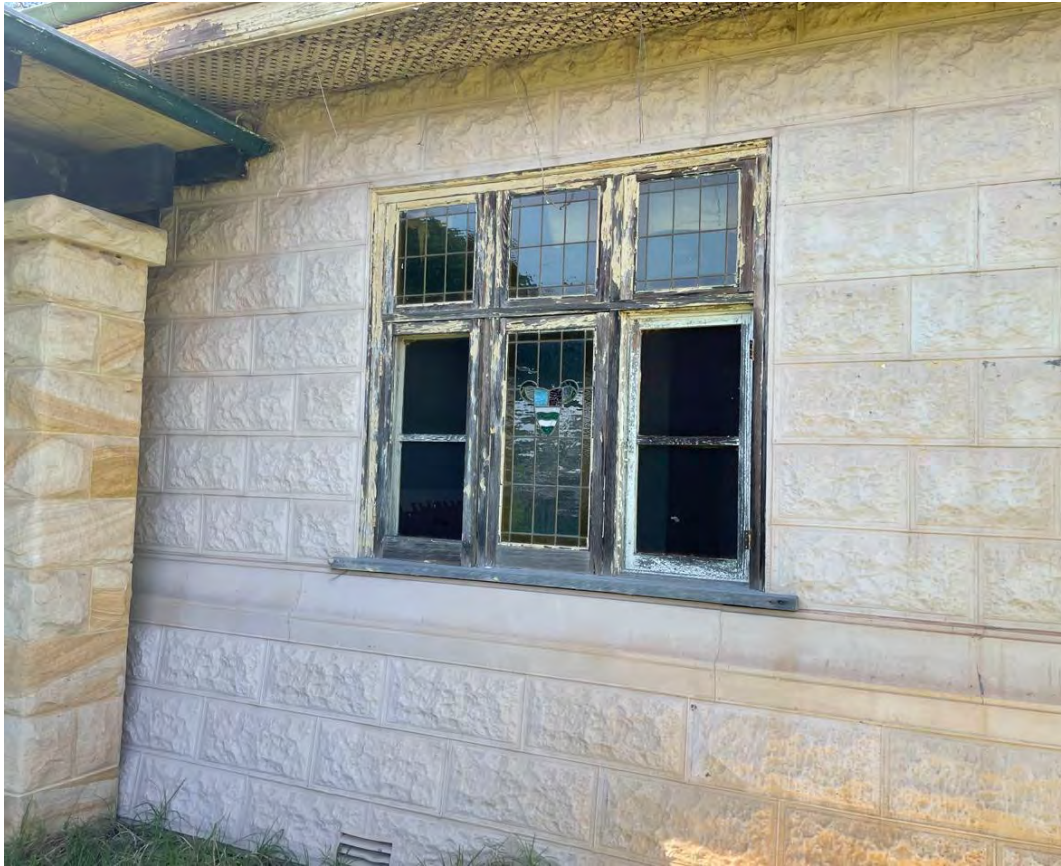
eastern elevation are simple, four-paned timber windows, however a window in the north-western elevation is a timber framed leadlight window, with the central pane comprising a stylised shield in green, white, blue and purple glass, surrounded by multiple panes of clear glass and bordered with light green glass (Plate 3-23).

Plate 3-23: Detail of leadlight window in north western elevation of Building 2 (AECOM, 2022)

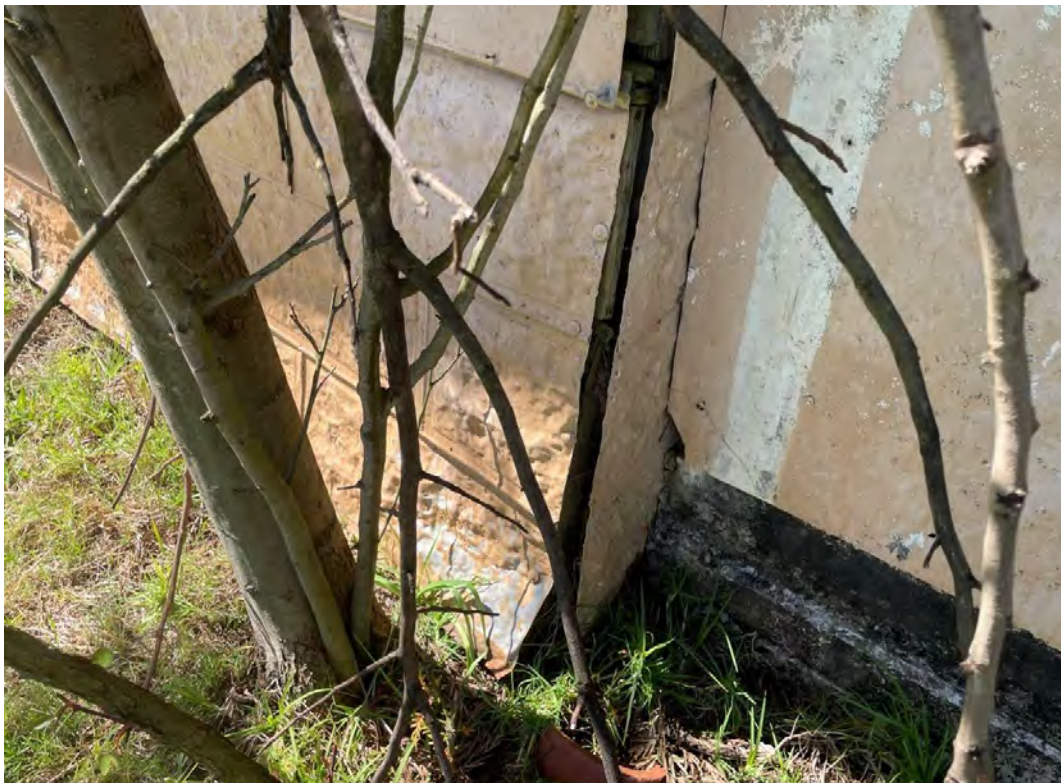
The walls of the long building comprise pressed tin cladding in an ashlar pattern, mimicking the pattern of the stone buildings of Belmont Park. areas of deterioration of the cladding indicate that it is attached to a timber frame (Plate 3-24).

Plate 3-24: Detail of pressed tin cladding with ashlar pattern on external walls of Building 2 (AECOM, 2022)

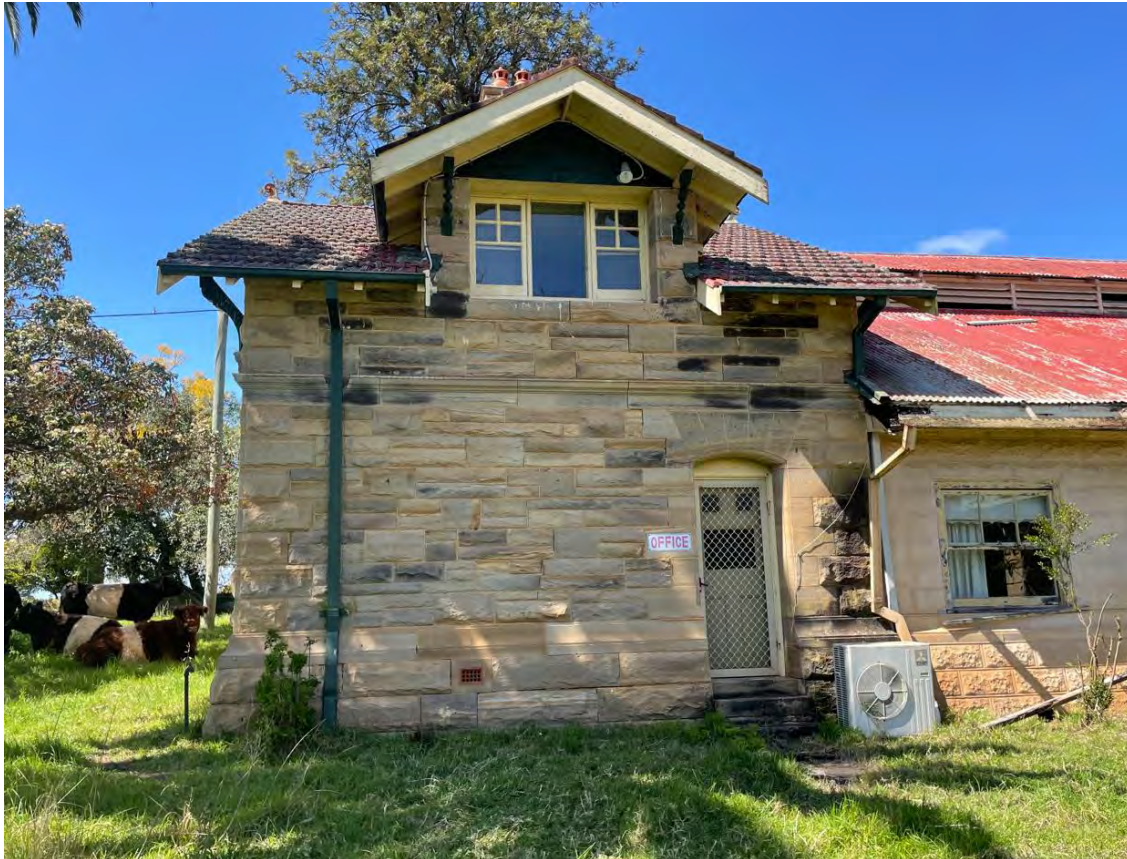
Plate 3-25: Dormer window in stone section of Building 2 (AECOM, 2022)

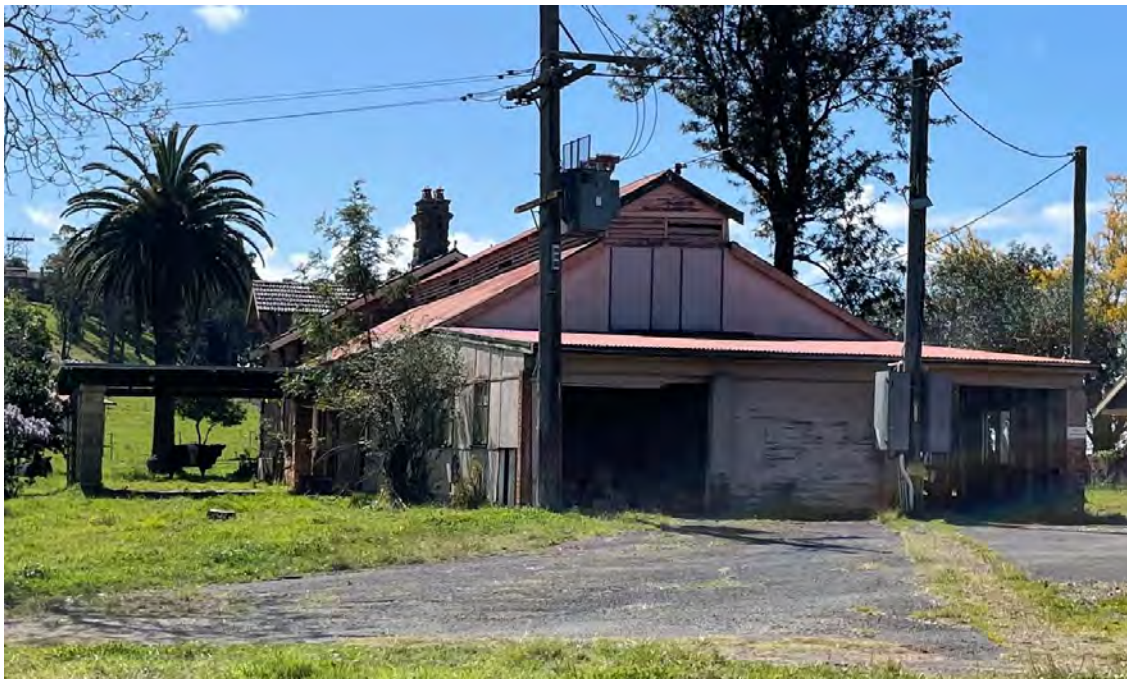
Plate 3-26: South-western elevation of Building 2 (AECOM, 2022). Compare with Plate 3-1

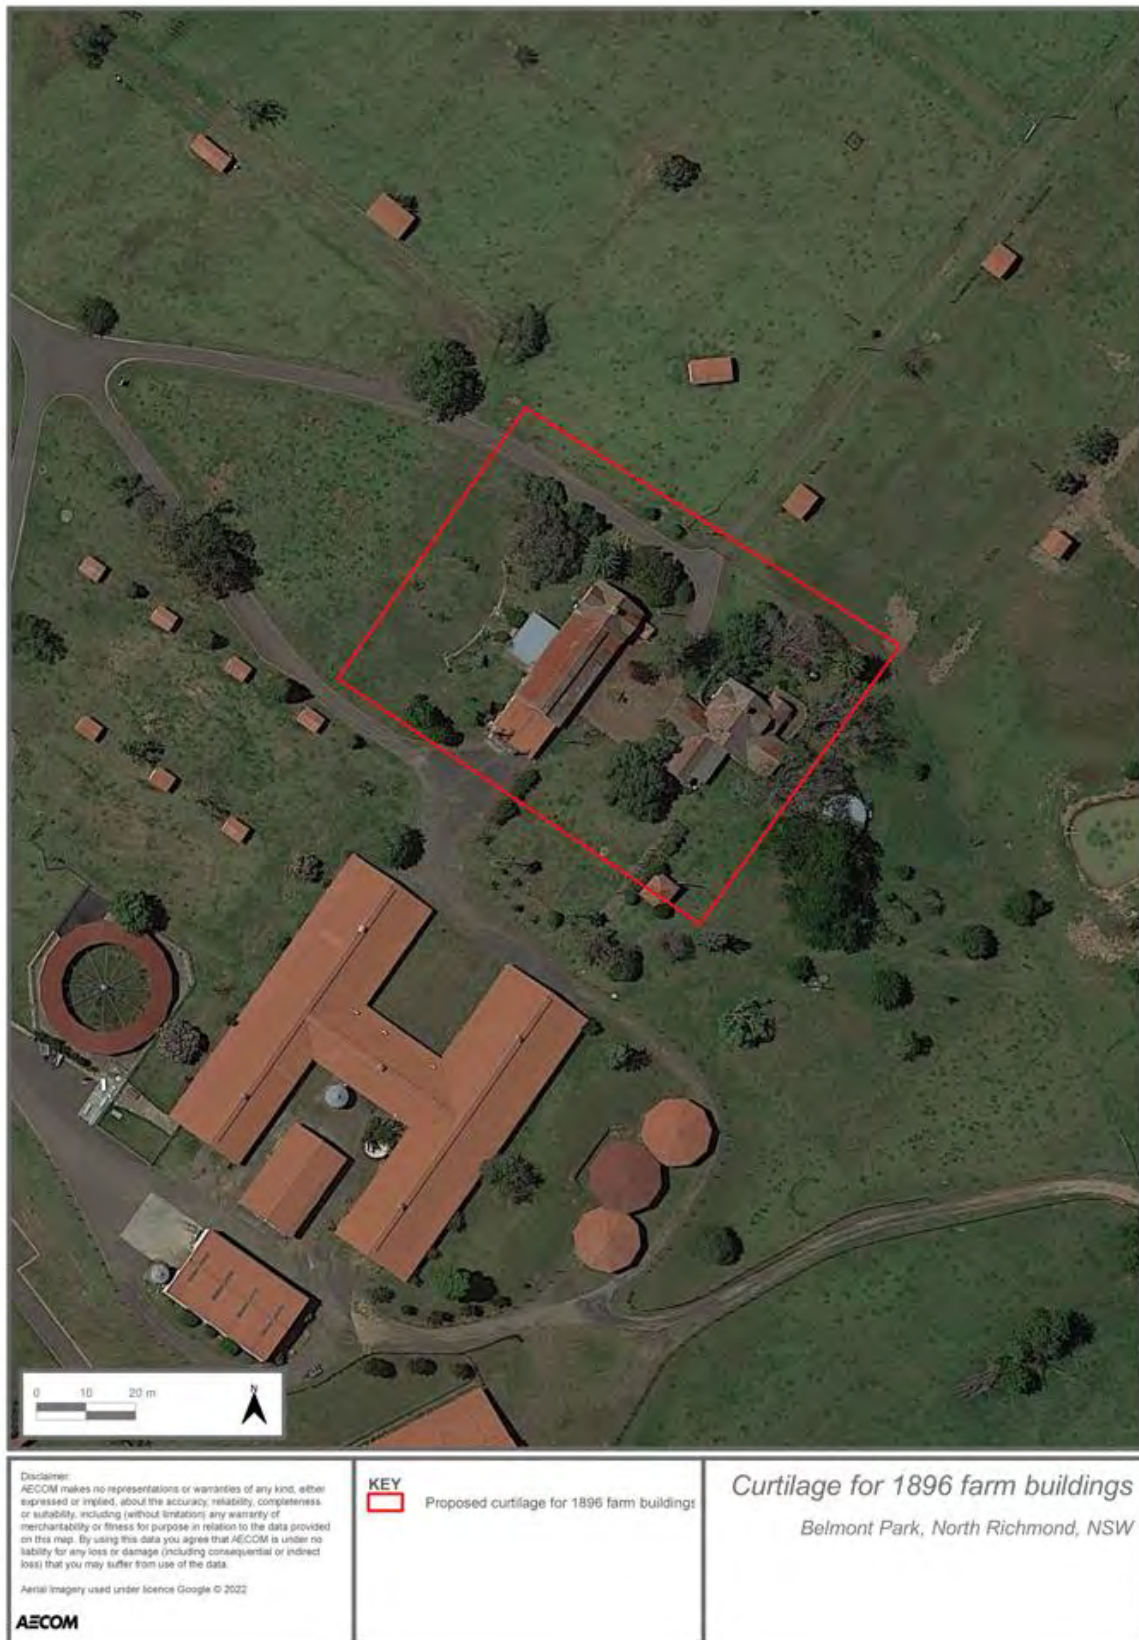
Figure 4-1: Curtilage of 1896 farm buildings
