15 | Investigation Area 6

15.1 Drainage Issues

15.1.2 Probable causes

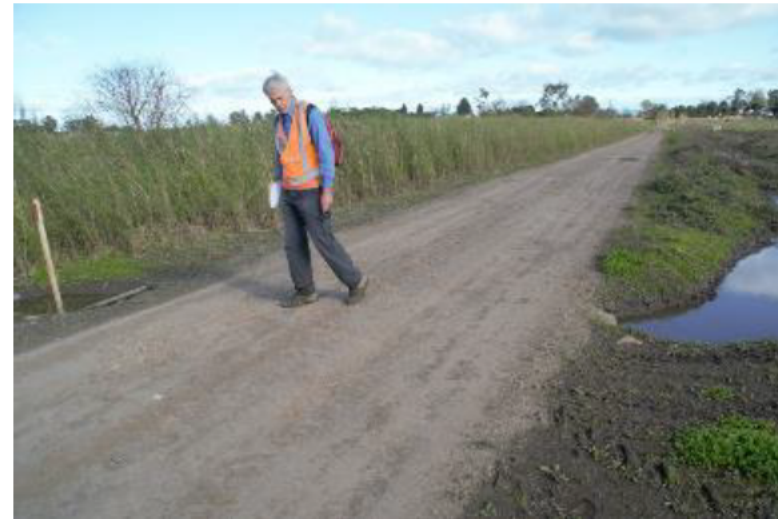
Photo 372

On the upper reaches of the northern most arm the flooding of market gardens upstream of the reedbeds appears to be caused by the reed beds inhibiting flow and the lowest parts of the paddocks not being much higher than the reed beds (Photo 372).

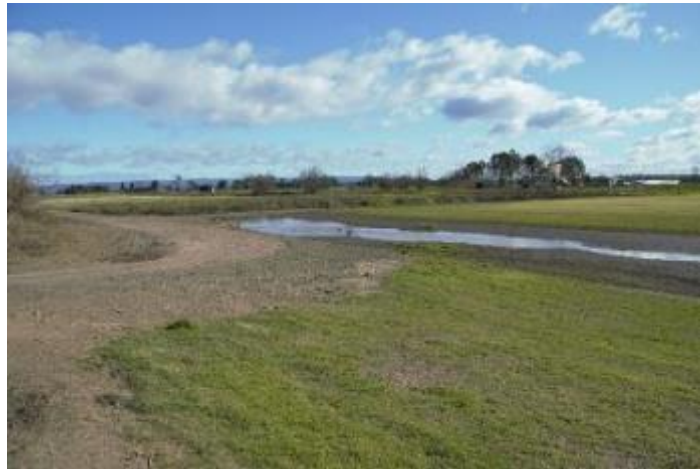
Photo 375

Further downstream, paddocks opposite the model airplane club grounds (Photo 375) appear to be unable to drain because they are lower than the top of the channel. This may have been caused by the gradual stripping of the soil through turf farming.

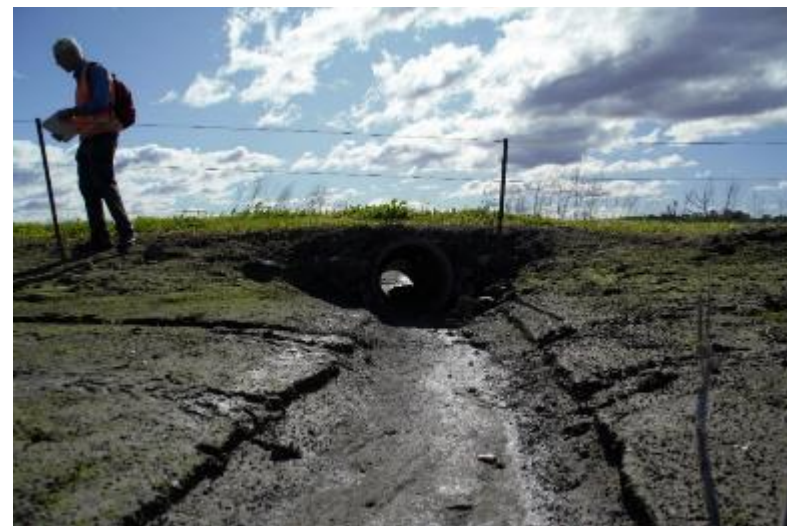
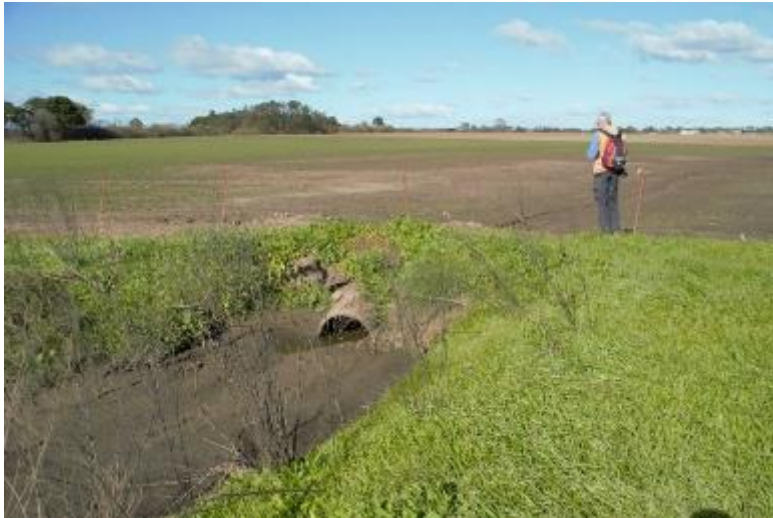
Similar problems occur throughout the southern most sub catchment for the same reasons. However, there is an additional problem in this subcatchment where an embankment across the drain (Photo 398 and Photo 399) essentially dams the area upstream with only a 600mm pipe as an outlet. As there is minimal fall on this part of the floodplain the water would take considerable time to drain through the pipe and so the upstream paddock will be under water for a prolonged period, killing the grass (Photo 399 and Photo 400). If the upstream paddock is continued to be used for turf farming then over time it level will be lowered and the time it takes to drain will increase. If it is lowered too far its level will be below the bottom of the pipe and it will need to rely upon evaporation for the last of the standing water to be removed.

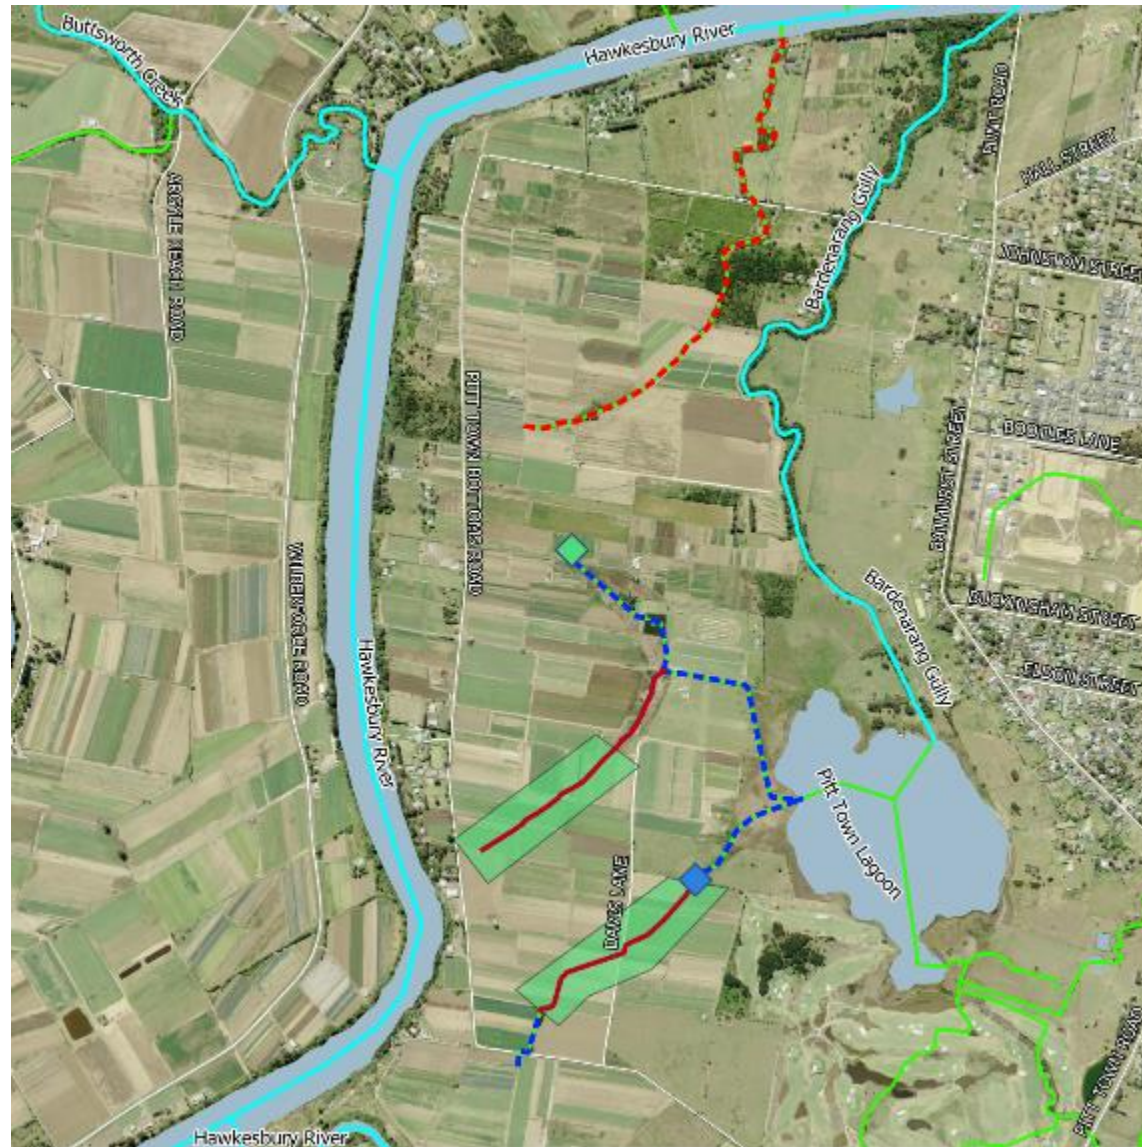
Figure 133: Solutions for IA5

- Solutions for IA5
- Regrade paddock
 - Keep channel clear
 - ◆ Regrade paddock
 - ◆ Remove road embankment
- Investigated Drainage Routes
- IA5N
 - IA5S
- Hydrography
- Named watercourse
 - Hydrolines
 - Waterbodies

Possible solutions for IA5S are shown in Figure 133.

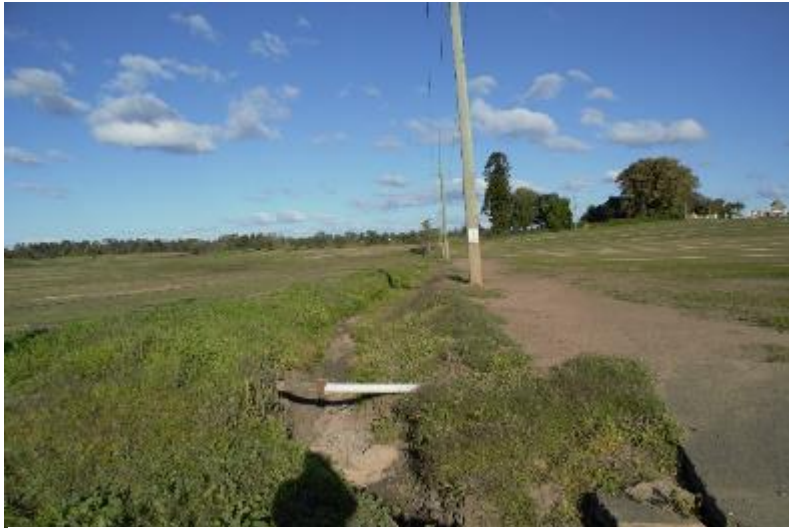
Photo 403

At the western end of Pitt Street there is a drain running south from the road (Photo 403) before turning sharply east (Photo 404). The corner of the paddock is at about the same level as the invert of the drain at this point and does not drain efficiently (Photo 405). There is a parallel drain in the paddock but the water was standing in it and now draining discernibly (Photo 406 and Photo 407). The drain again turns south but is very shallow and barely flowing and the surrounding paddocks are saturated.

Cleaning sediment and reeds from the drains may improve drainage from the paddocks upstream but the longer term solution for those paddocks may be to regrade them and possibly lift them with imported material.

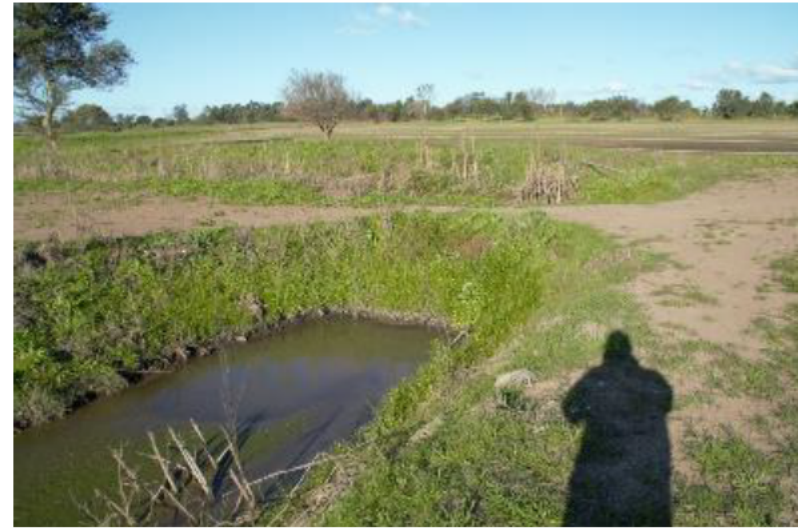
Photo 408

Further downstream there is a crossing where no pipe under the crossing could be observed (Photo 408). The channel adjacent to the crossing (Photo 408) and immediately upstream of that (Photo 409) was very badly silted. It is possible that if there is a pipe under the crossing it is mostly silted up.

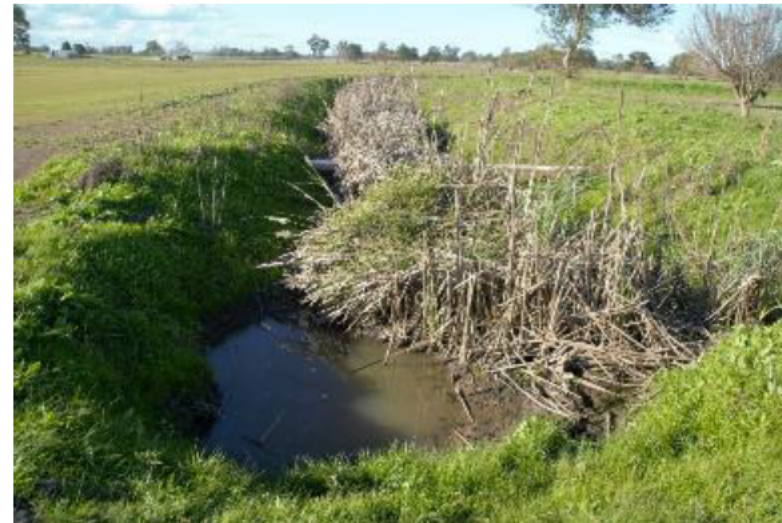
Photo 410

Downstream of the crossing the channel is choked with reeds (Photo 410 and Photo 411). The channel becomes progressively deeper but is remains very silted up and the next pipe under a crossing appears to be mostly blocked with silt (Photo 412). Downstream of here the channel is choked with reeds and water is ponding (Photo 413). It is more difficult to see the bottom of the channel further downstream as it becomes deeper and the banks become more heavily weed infested but there is standing water in the channel (Photo 414). The channel passes through the natural levee bank on South Creek through a flood gated culvert (Photo 415).

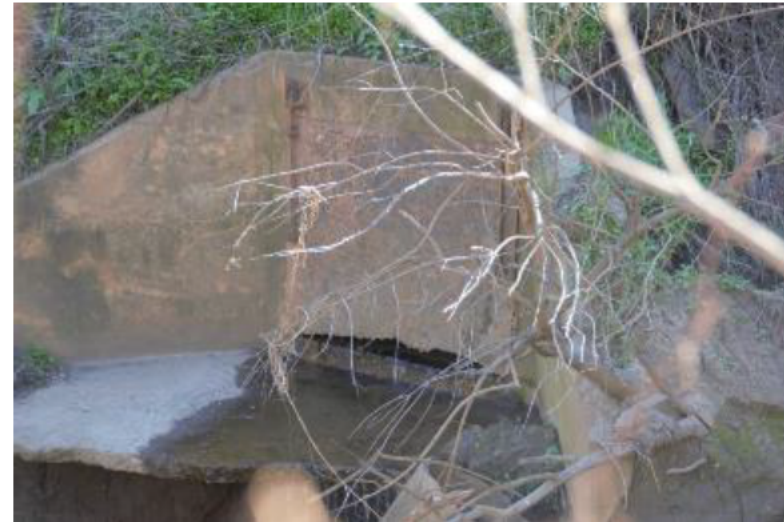
Photo 416

The flood gate is badly damaged. It is rusted across the bottom (Photo 416) so would no longer seal the culvert when flood waters are rising and therefore water would leak into the areas behind the levee. There has been significant bank collapse around the culvert head wall (Photo 415 and Photo 417) and the headwall itself is at a point of imminent collapse. It was assessed to be too hazardous to climb down to the floodgate but it is quite possible that the floodgate has rusted shut and therefore has significantly slowed the draining of the paddocks behind the levee.

The deteriorated condition of the flood gate is due to lack of maintenance.

The flood gate needs to be replaced otherwise it will let floodwaters in as the flood rises and inhibit drainage behind the levee as the floodwaters drop. This should be undertaken in conjunction with repair and stabilisation of the levee. If this is not done then it is possible that there could be a breach of the levee as occurred at Cornwallis in 2021 and the size of the repair will become much greater.

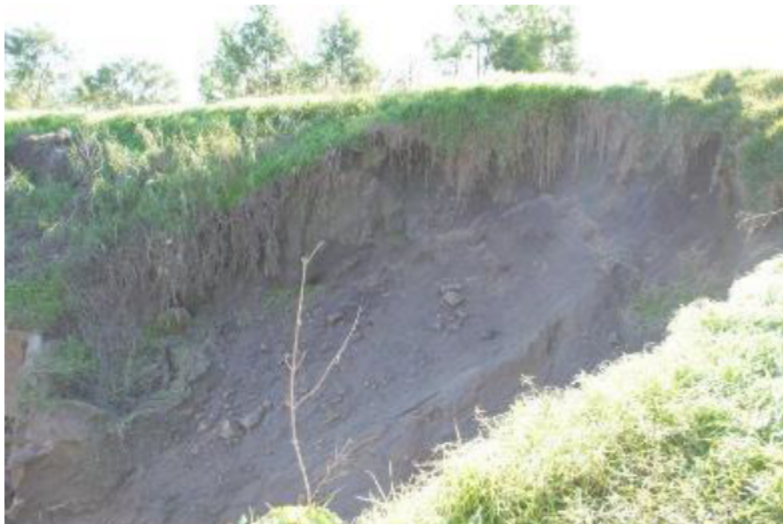
Photo 417

The bank slumping around the flood gate has been caused by the same process observed throughout the floodplain. Steep banks of unconsolidated sediments become saturated during prolonged flooding and then cannot dissipate the pore water pressure quickly enough as the river level drops, resulting in material which slumps under its own weight and that of the water it holds.

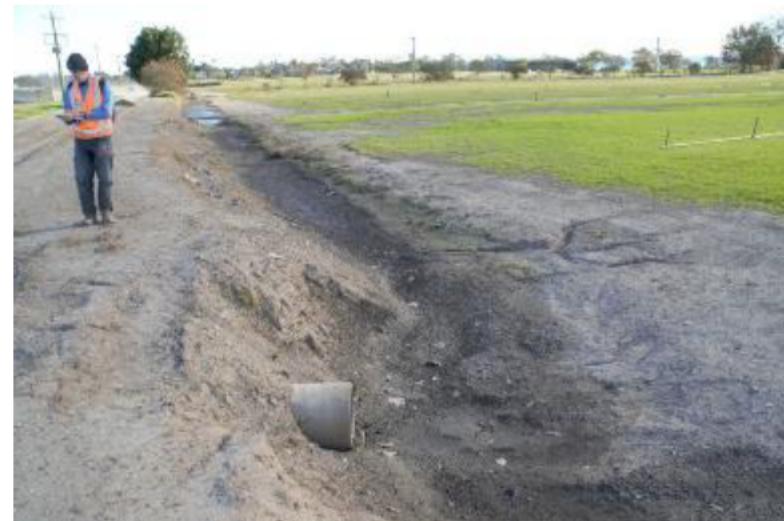
Photo 418

At the eastern end of Pitt Street there is an embankment along its northern side (Photo 418) which does not appear to have a clear purpose. There is a pipe through the embankment (Photo 419) which allows the paddocks to drain but the pipe for conveying this outflow under Pitt Street is considerably smaller so it is likely that most of the drainage would flow across the road surface.

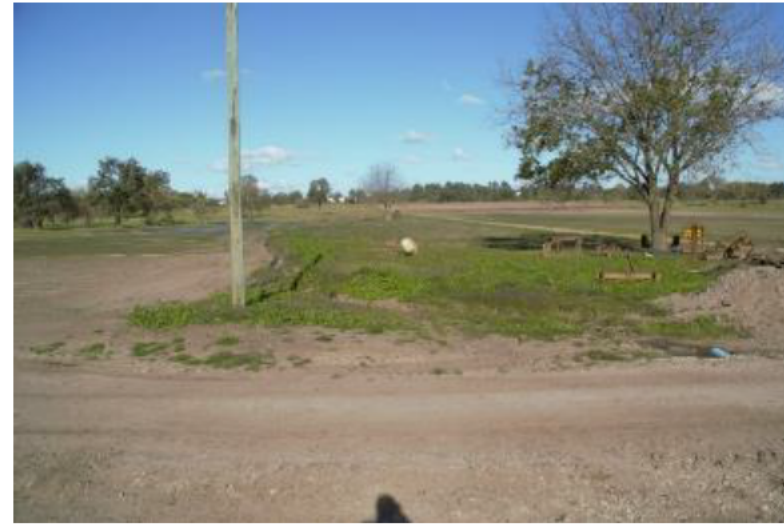
Photo 420

The pipe under the road discharges into a small drainage channel (Photo 420) which peters out to have no depth (Photo 421) and its invert is higher than the adjoining paddock. Immediately downstream of this is another low lying portion of paddock with standing water (Photo 422). There is no discernible channel from this point about 120m south (Photo 423) where a pipe passes under and access road (Photo 424).

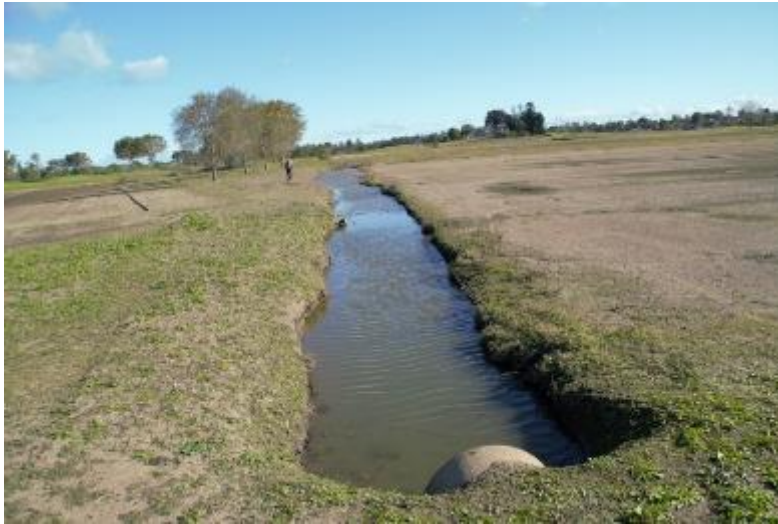
Photo 425

Downstream of the road the channel is clearly defined and relatively with but was almost full (Photo 425) down to the next crossing where the water level was almost to the obvert of the pipe under the road. Downstream of this point the channel is choked with reeds (Photo 426) almost to the point where it joins the other channel from the west (Photo 427).

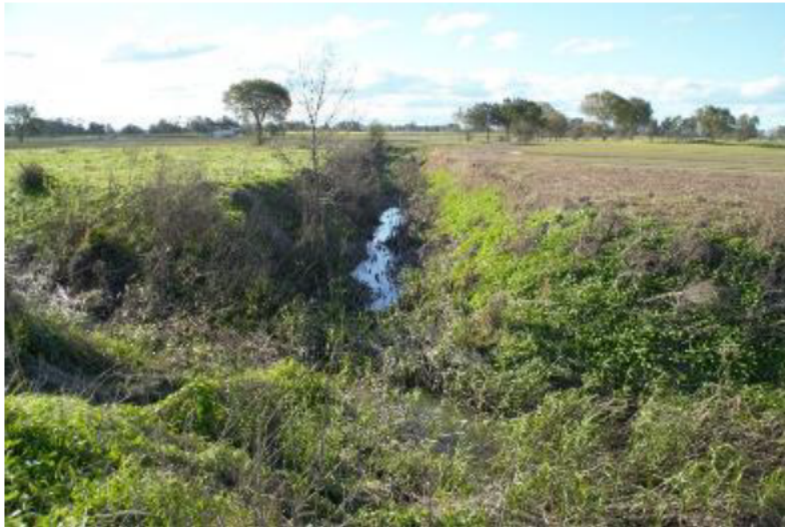
Photo 429

About 50m to the south of this reach of channel there is what appears to be an overflow channel excavated through the levee (Photo 428). It has a concrete apron at its northern end (Photo 429) and is grass lined and sinuous (Photo 430). It ends at a saddle in the levee (Photo 431)

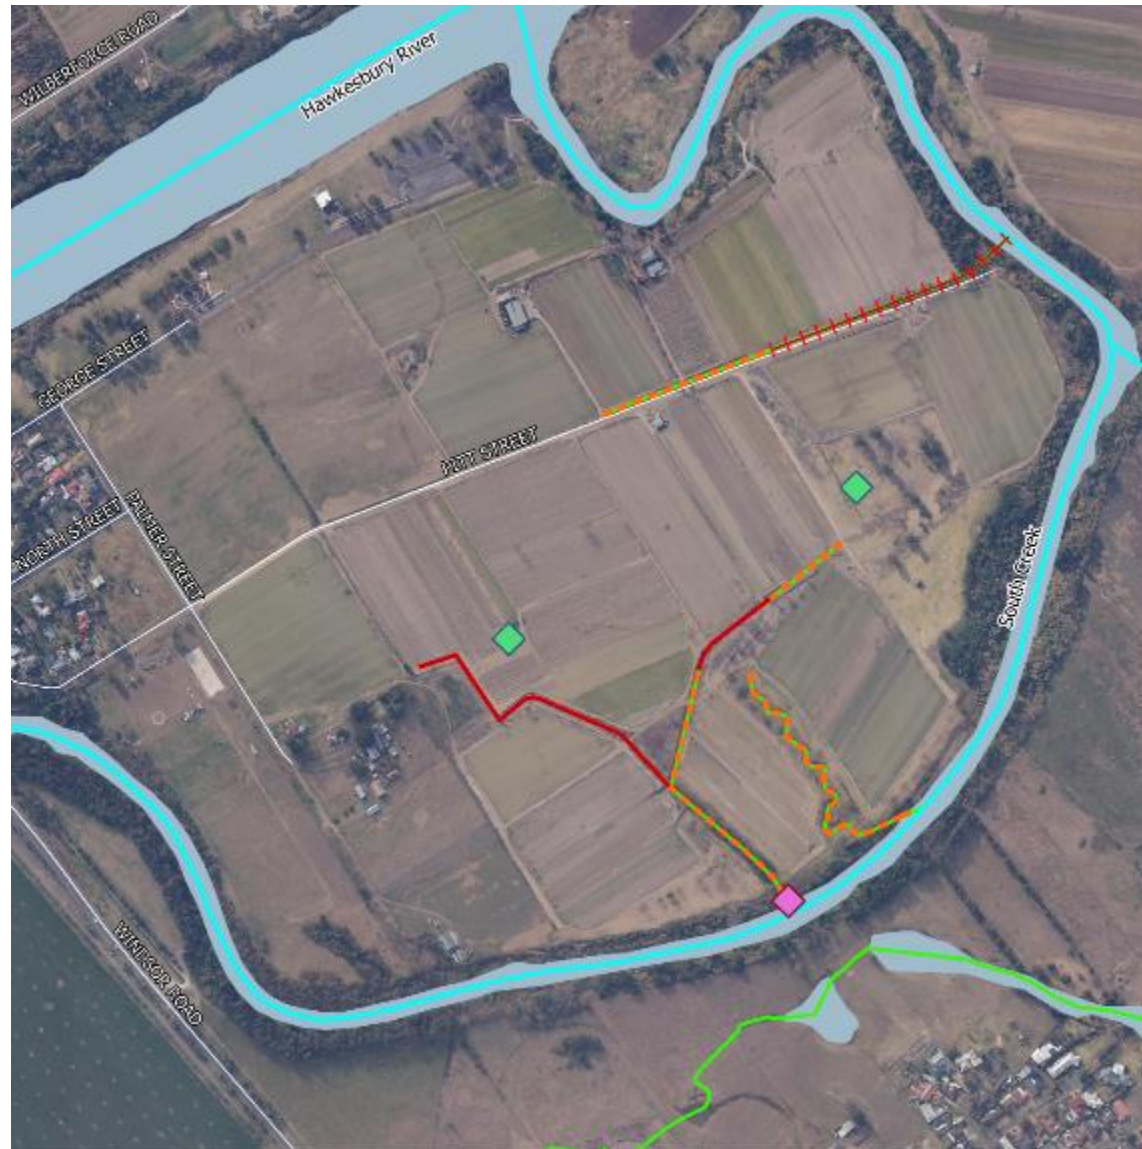
Figure 146: Solutions for IA6

- Solutions for IA6
- ◆ Regrade paddocks
 - ◆ Repair or replace flood gates
 - Clear channel
- Investigated Drainage Routes
- - - IA6
- Hydrography
- Named watercourse
 - Hydrolines
 - ++ Hydrolines (mapped but missing)
 - Waterbodies

Possible Solutions for IA6 are shown in Figure 146.

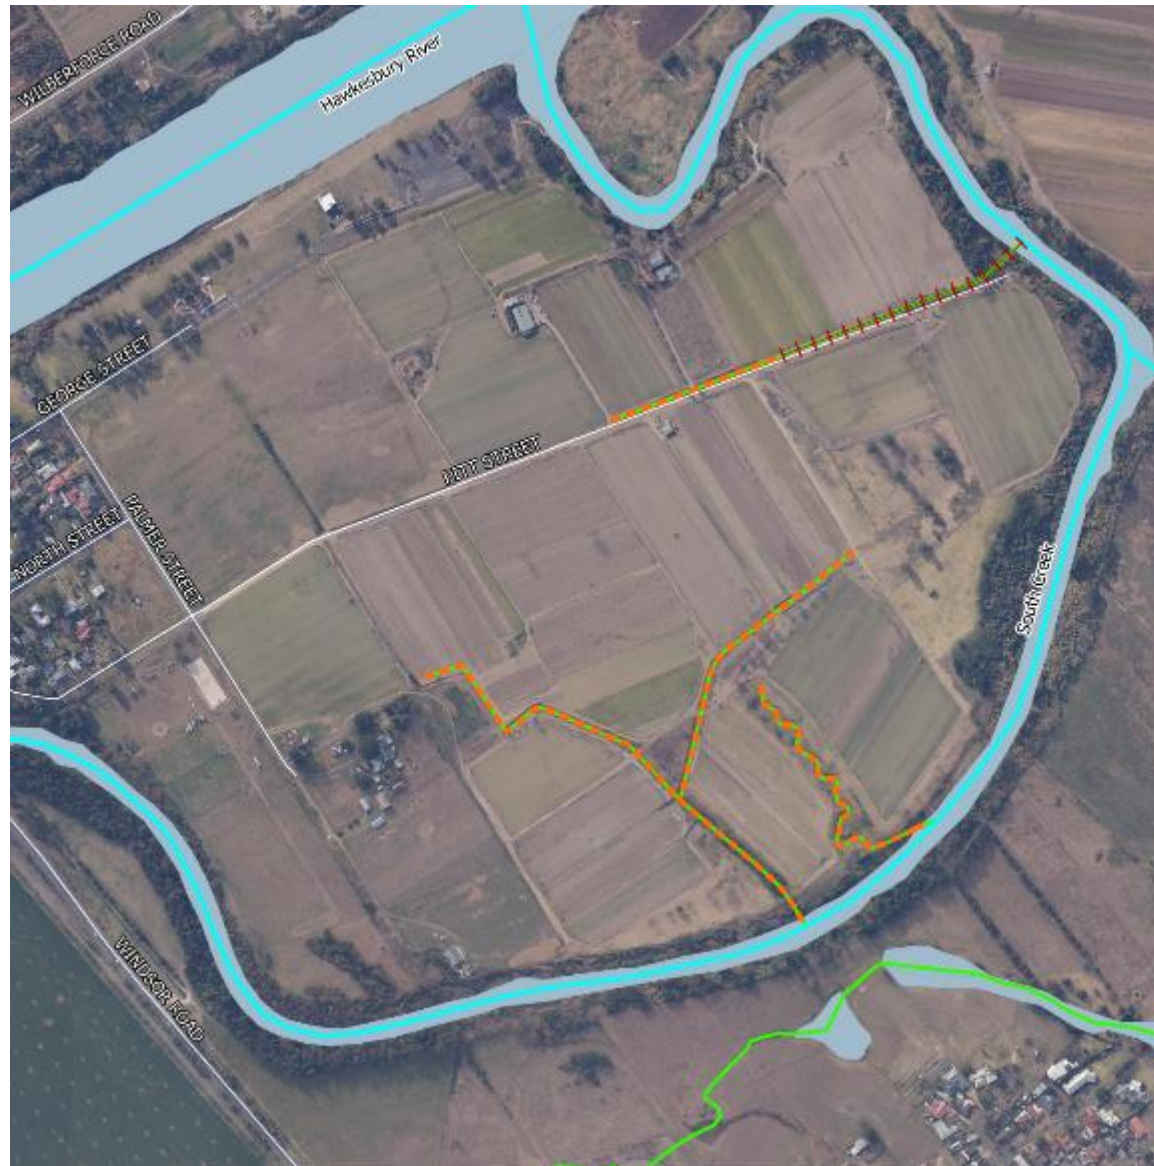
Figure 149: HLEP Heritage Places, Areas and Items (Extent H)

IA6 does not traverse any heritage items, although General Heritage Item I00028 is in close proximity (Figure 149). The details of this heritage item are shown in Table 10 (HLEP 2012 Schedule 5).
