Slab Barns and Outbuildings Heritage Listing Planning
Proposal - Appendix A,B and C

LEP001/25 Hawkesbury Slab Barns and Outbuildings LEP Amendment

Appendix A – Heritage Items
Appendix B – Heritage Inventory Sheets
Appendix C – Heritage Items Maps

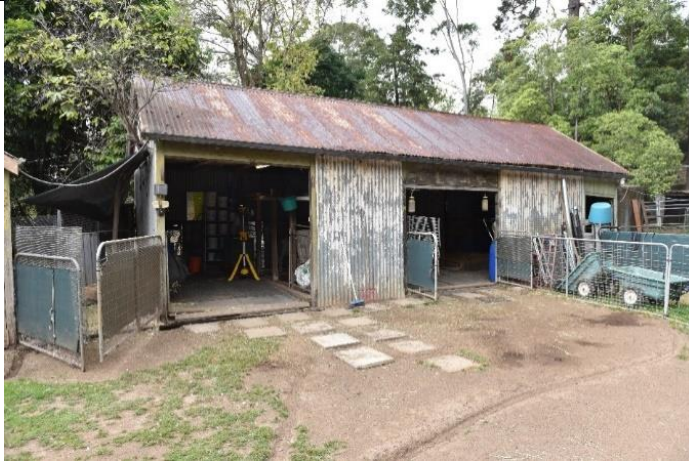
Caption: Barn at 13 Serpentine Lane, Bowen Mountain (exterior)
Photographer: S. Johnson
Copyright Owner: Lucas Stapleton Johnson & Partners Pty Ltd
Date: August 2023

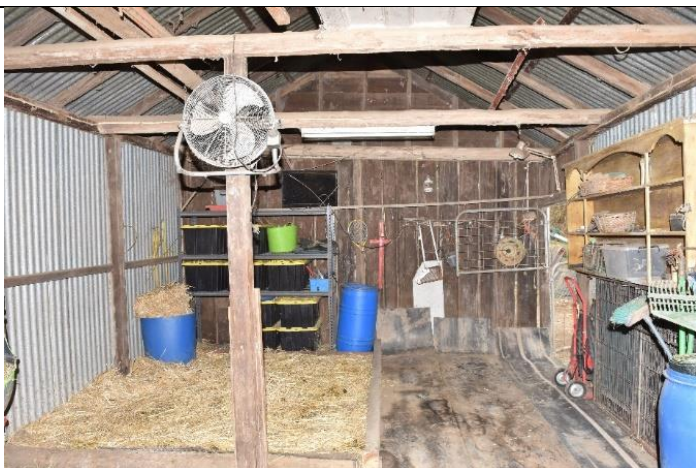
Caption: Barn at 13 Serpentine Lane, Bowen Mountain (interior)
Photographer: S. Johnson
Copyright Owner: Lucas Stapleton Johnson & Partners Pty Ltd
Date: August 2023

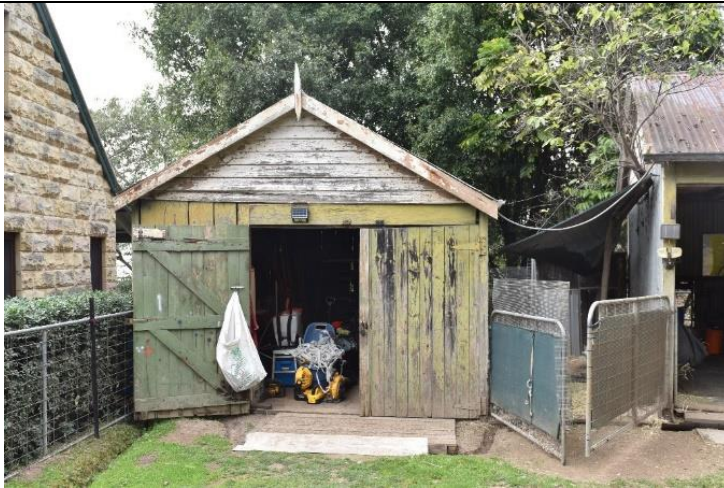
Caption: Shed at
13 Serpentine
Lane, Bowen
Mountain
(exterior)
Photographer: S.
Johnson
Copyright Owner:
Lucas Stapleton
Johnson & Partners
Pty Ltd
Date: August 2023

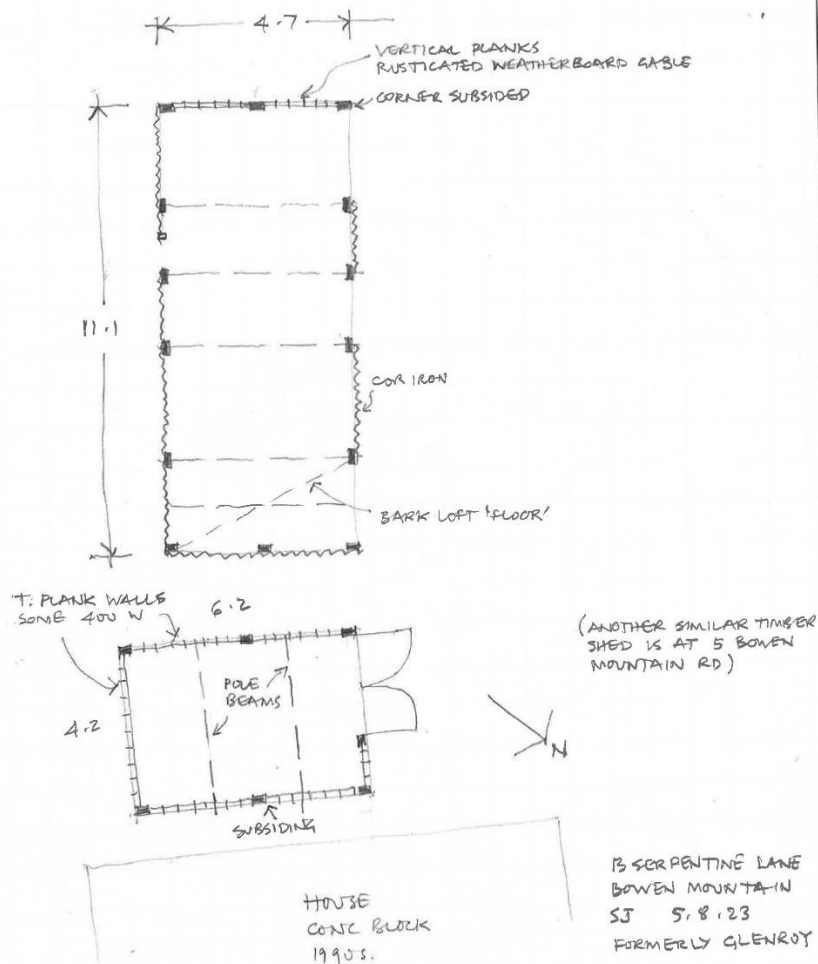
Caption: Sketch floor plans of barn and shed at 13 Serpentine Lane, Bowen Mountain
Copyright Owner: Lucas Stapleton Johnson & Partners

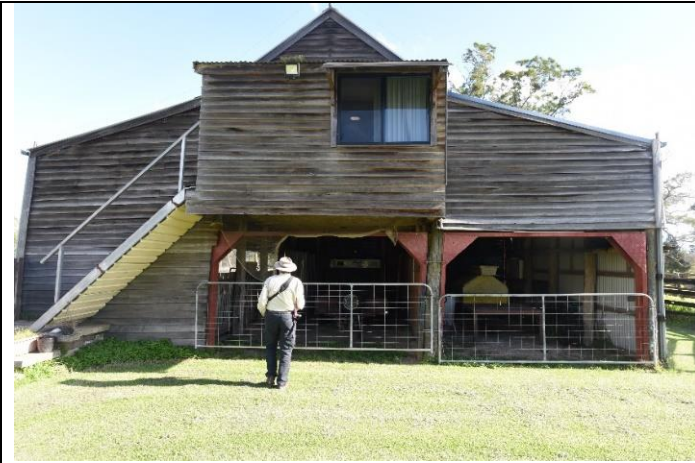
Caption: Barn at 331
Cattai Road, Cattai
(exterior)
Photographer: S. Johnson
Copyright Owner: Lucas
Stapleton Johnson &
Partners Pty Ltd
Date: May 2023

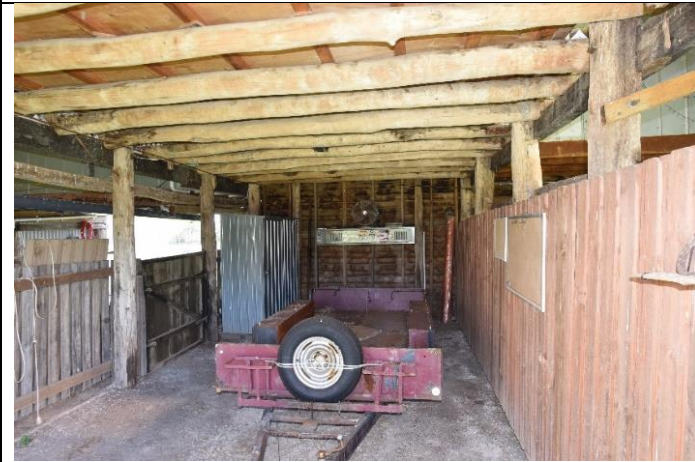
Caption: Barn at 331
Cattai Road, Cattai
(interior)
Photographer: S. Johnson
Copyright Owner: Lucas
Stapleton Johnson &
Partners Pty Ltd
Date: May 2023

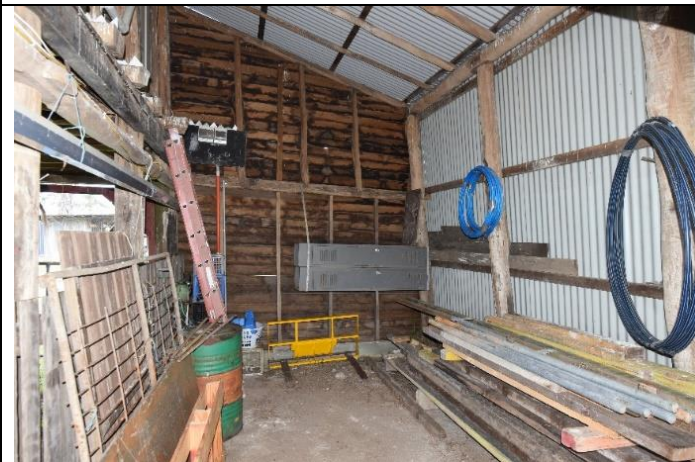
Caption: Barn at 331
Cattai Road, Cattai
(interior)
Photographer: S. Johnson
Copyright Owner: Lucas
Stapleton Johnson &
Partners Pty Ltd
Date: May 2023

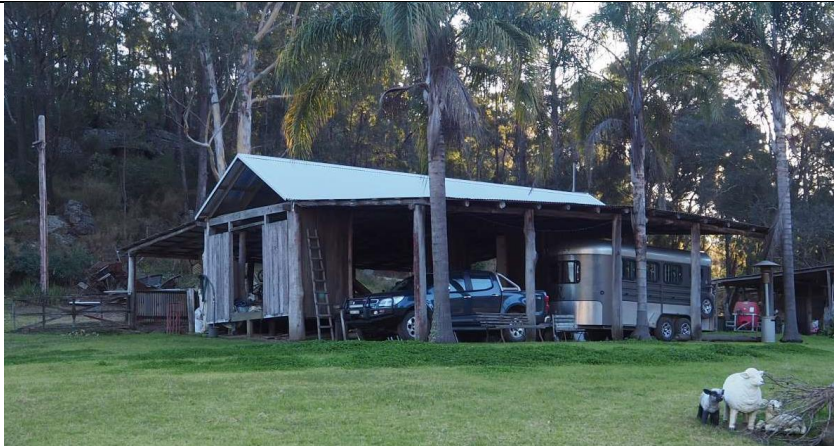
Caption: Barn
at No. 753
Upper Colo
Road, Upper
Colo
(exterior)
Photographer:
S. Johnson
Copyright
Owner: Lucas
Stapleton
Johnson &
Partners
Date: June
2023

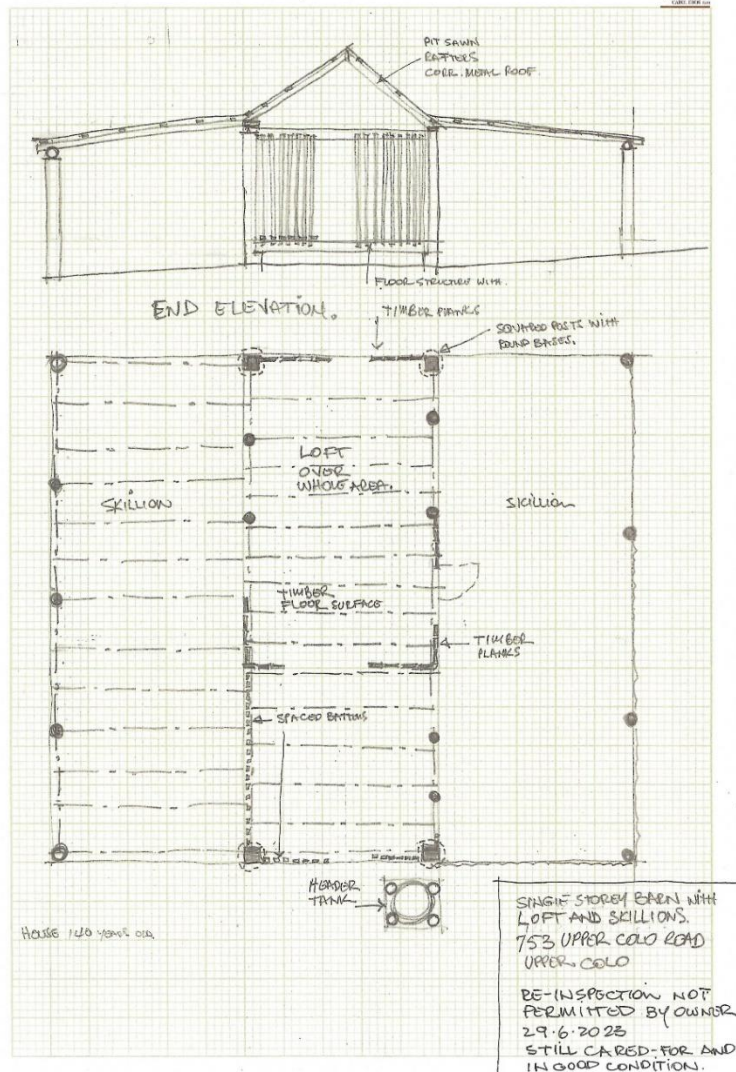
Caption: Measured drawing of Barn at No. 753 Upper Colo Road, Upper Colo.

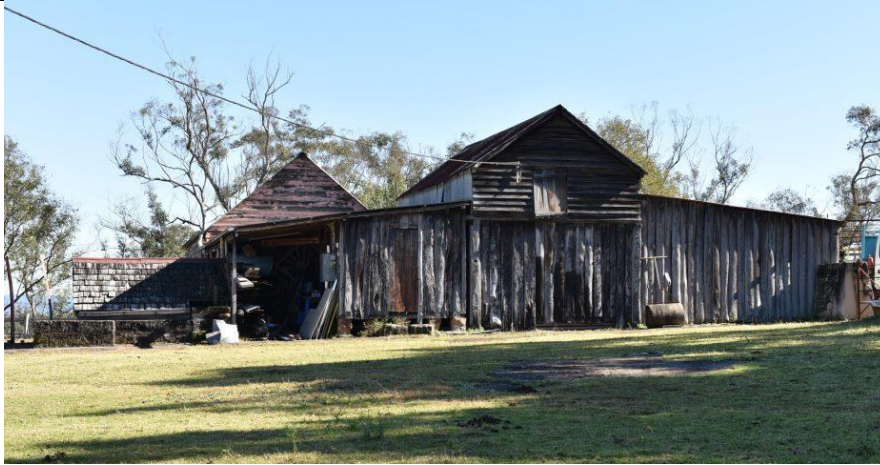
Caption: Barn
307 Tizzana
Road,
Ebenezer
(exterior)
Photographer:
S. Johnson
Copyright
Owner: Lucas
Stapleton
Johnson &
Partners Pty
Ltd

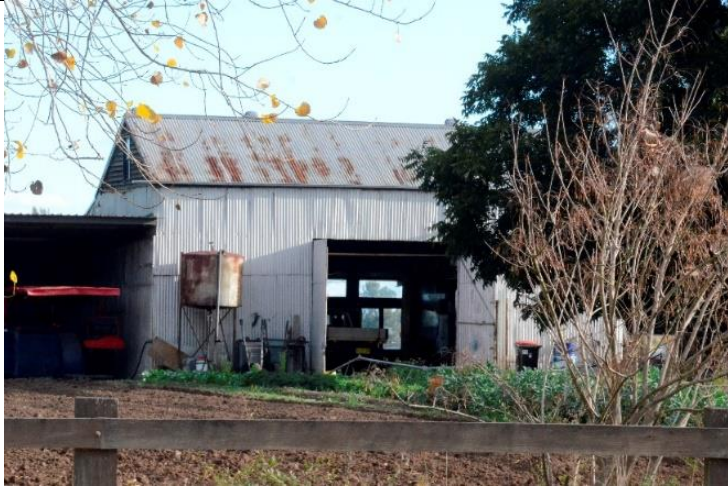
Caption: Barn at 279
Freemans Reach
Road, Freemans
Reach (exterior)
Photographer: G. Edds
Copyright Owner:
Graham Edds &
Associates
Date: June 2023

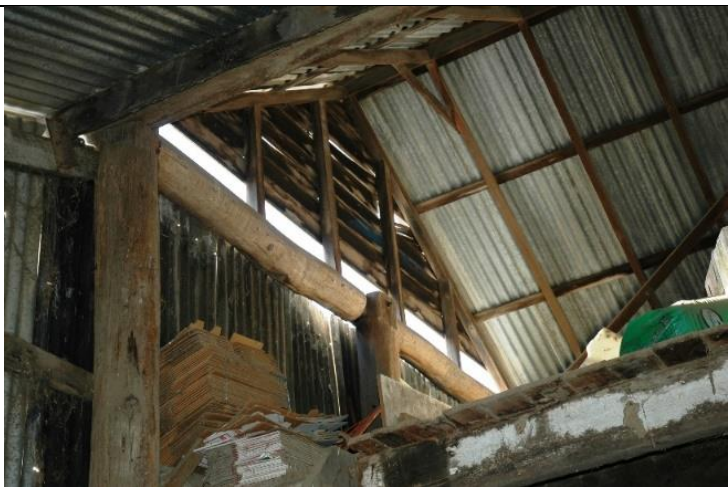
Caption: Barn at 279
Freemans Reach
Road, Freemans
Reach (interior)
Photographer: G. Edds
Copyright Owner:
Graham Edds &
Associates
Date: 2009

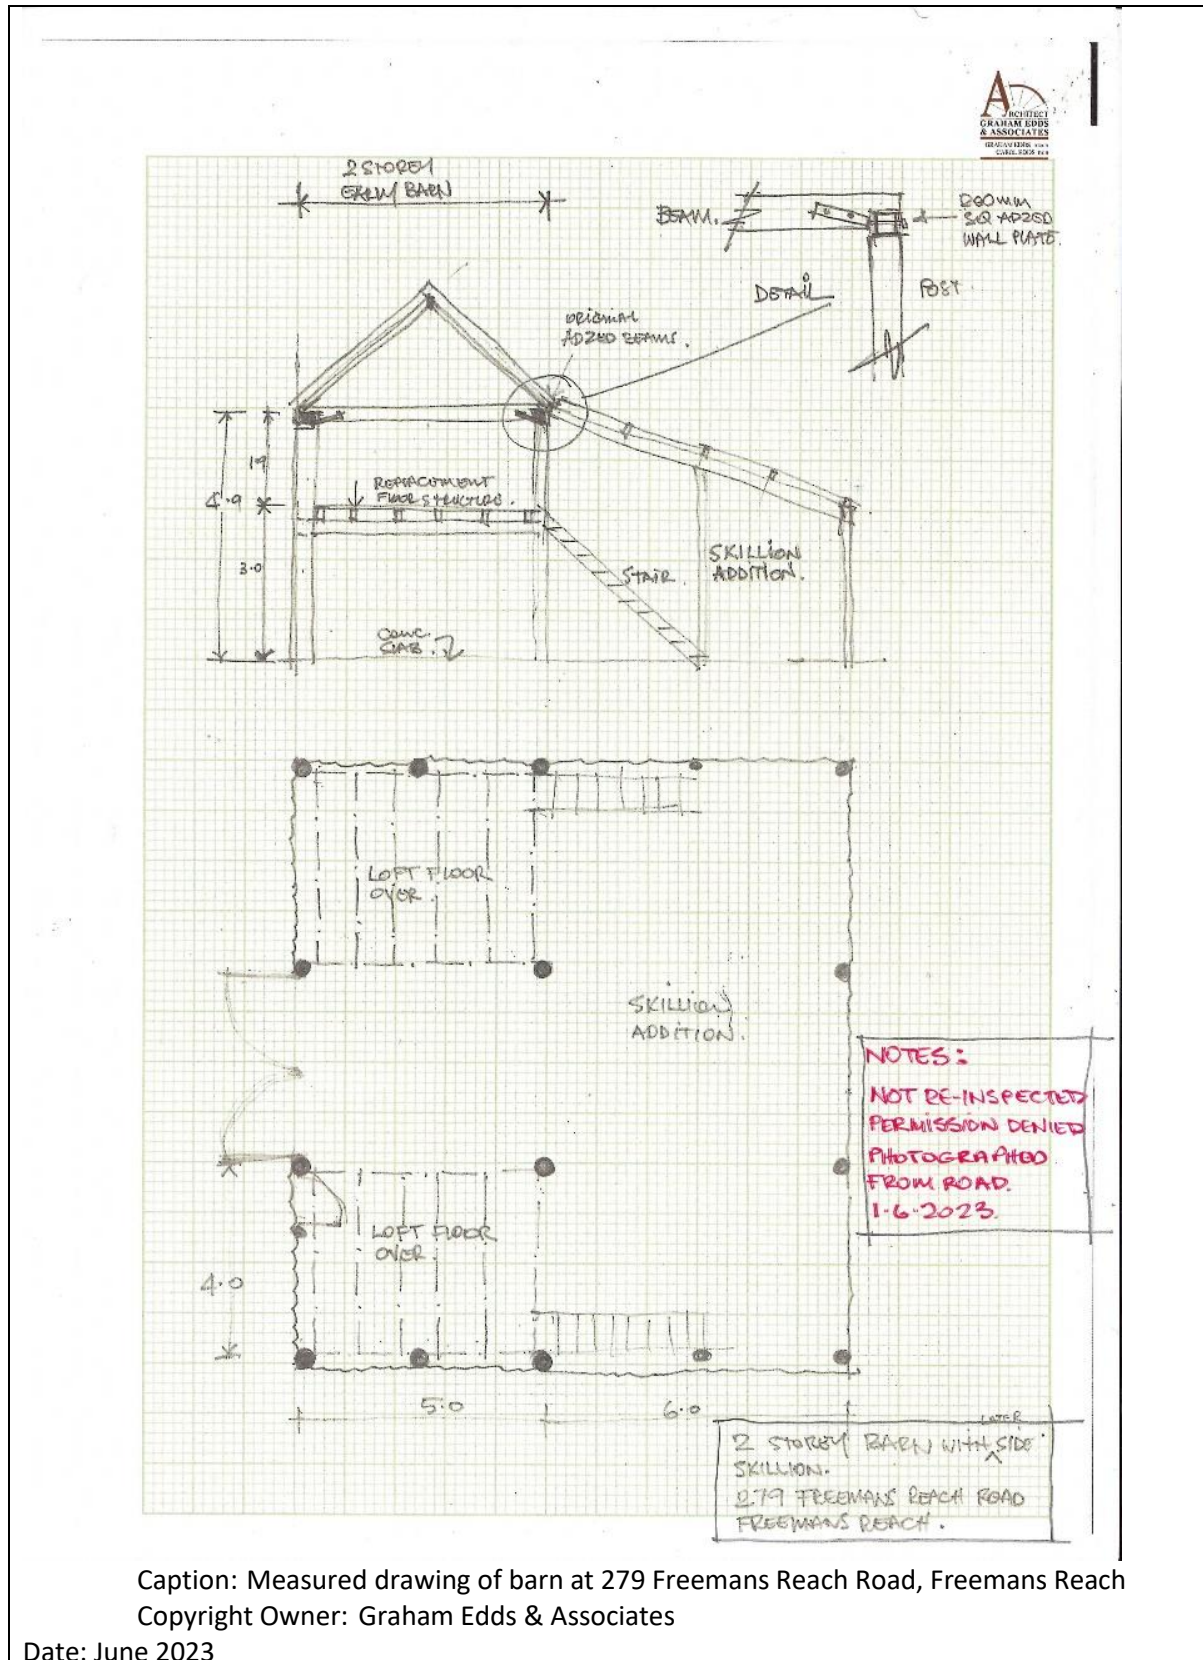
Caption: Measured drawing of barn at 279 Freemans Reach Road, Freemans Reach

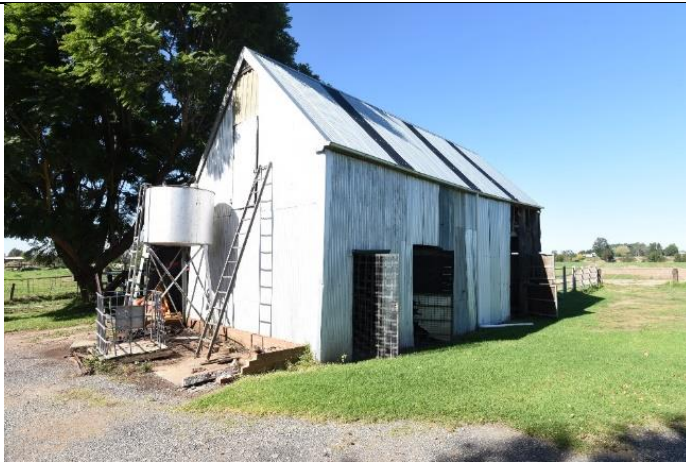
Caption: Barn A at 331
Freemans Reach Road,
Freemans Reach
(exterior)
Photographer: LSJ
Copyright Owner: Lucas
Stapleton Johnson &
Partners Pty Ltd
Date: May 2023

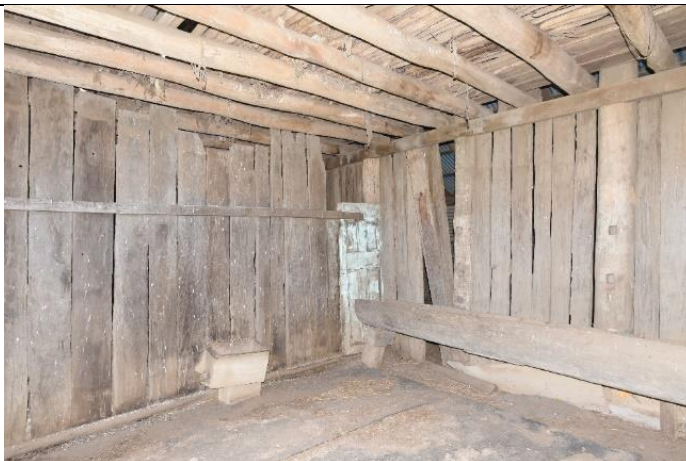
Caption: Barn A at 331
Freemans Reach Road,
Freemans Reach
(interior)
Photographer: LSJ
Copyright Owner: Lucas
Stapleton Johnson &
Partners Pty Ltd
Date: May 2023

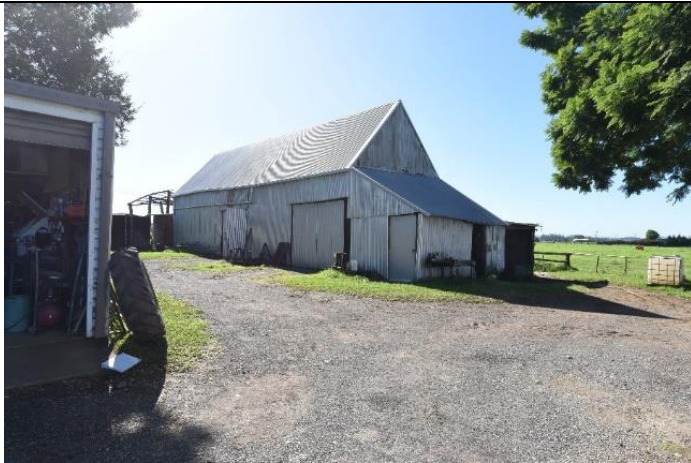
Caption: Barn B at 331
Freemans Reach Road,
Freemans Reach
(exterior)
Photographer: LSJ
Copyright Owner: Lucas
Stapleton Johnson &
Partners Pty Ltd
Date: May 2023

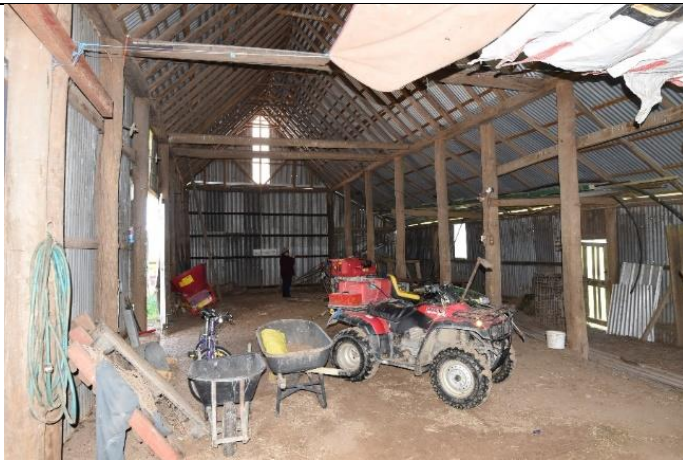
Caption: Barn B at 331
Freemans Reach Road,
Freemans Reach
(interior)
Photographer: LSJ
Copyright Owner: Lucas
Stapleton Johnson &
Partners Pty Ltd
Date: May 2023

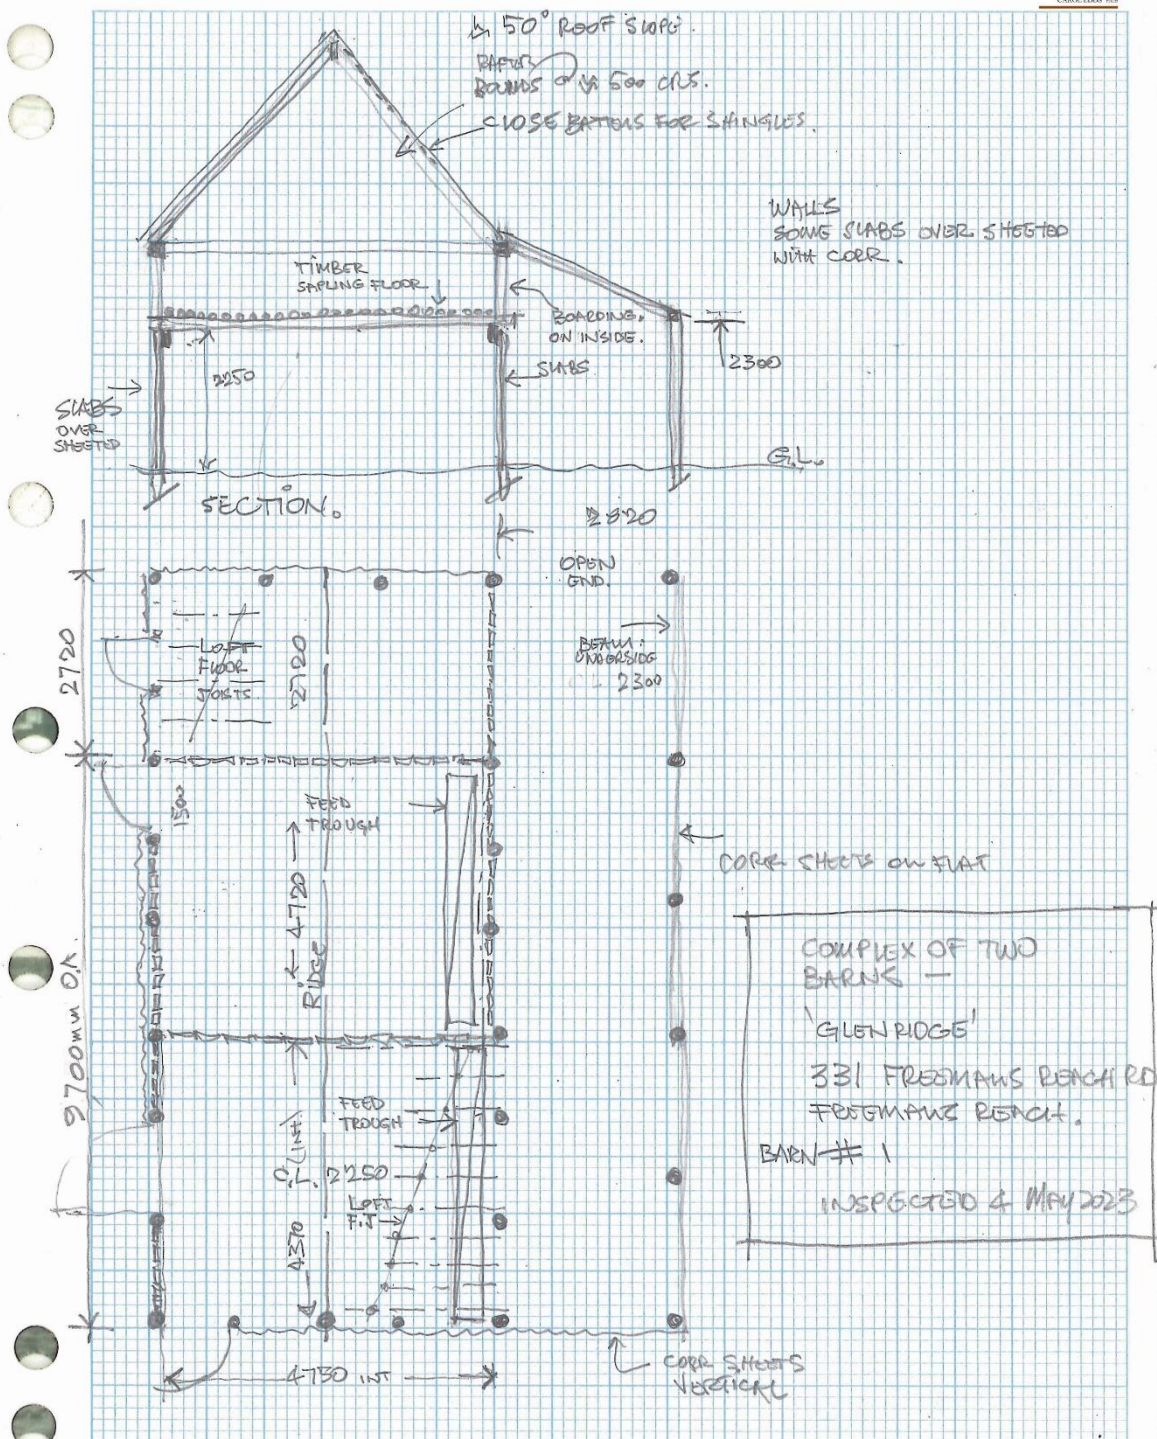
Caption: Measured drawing of Barn A at 331 Freemans Reach Road, Freemans Reach

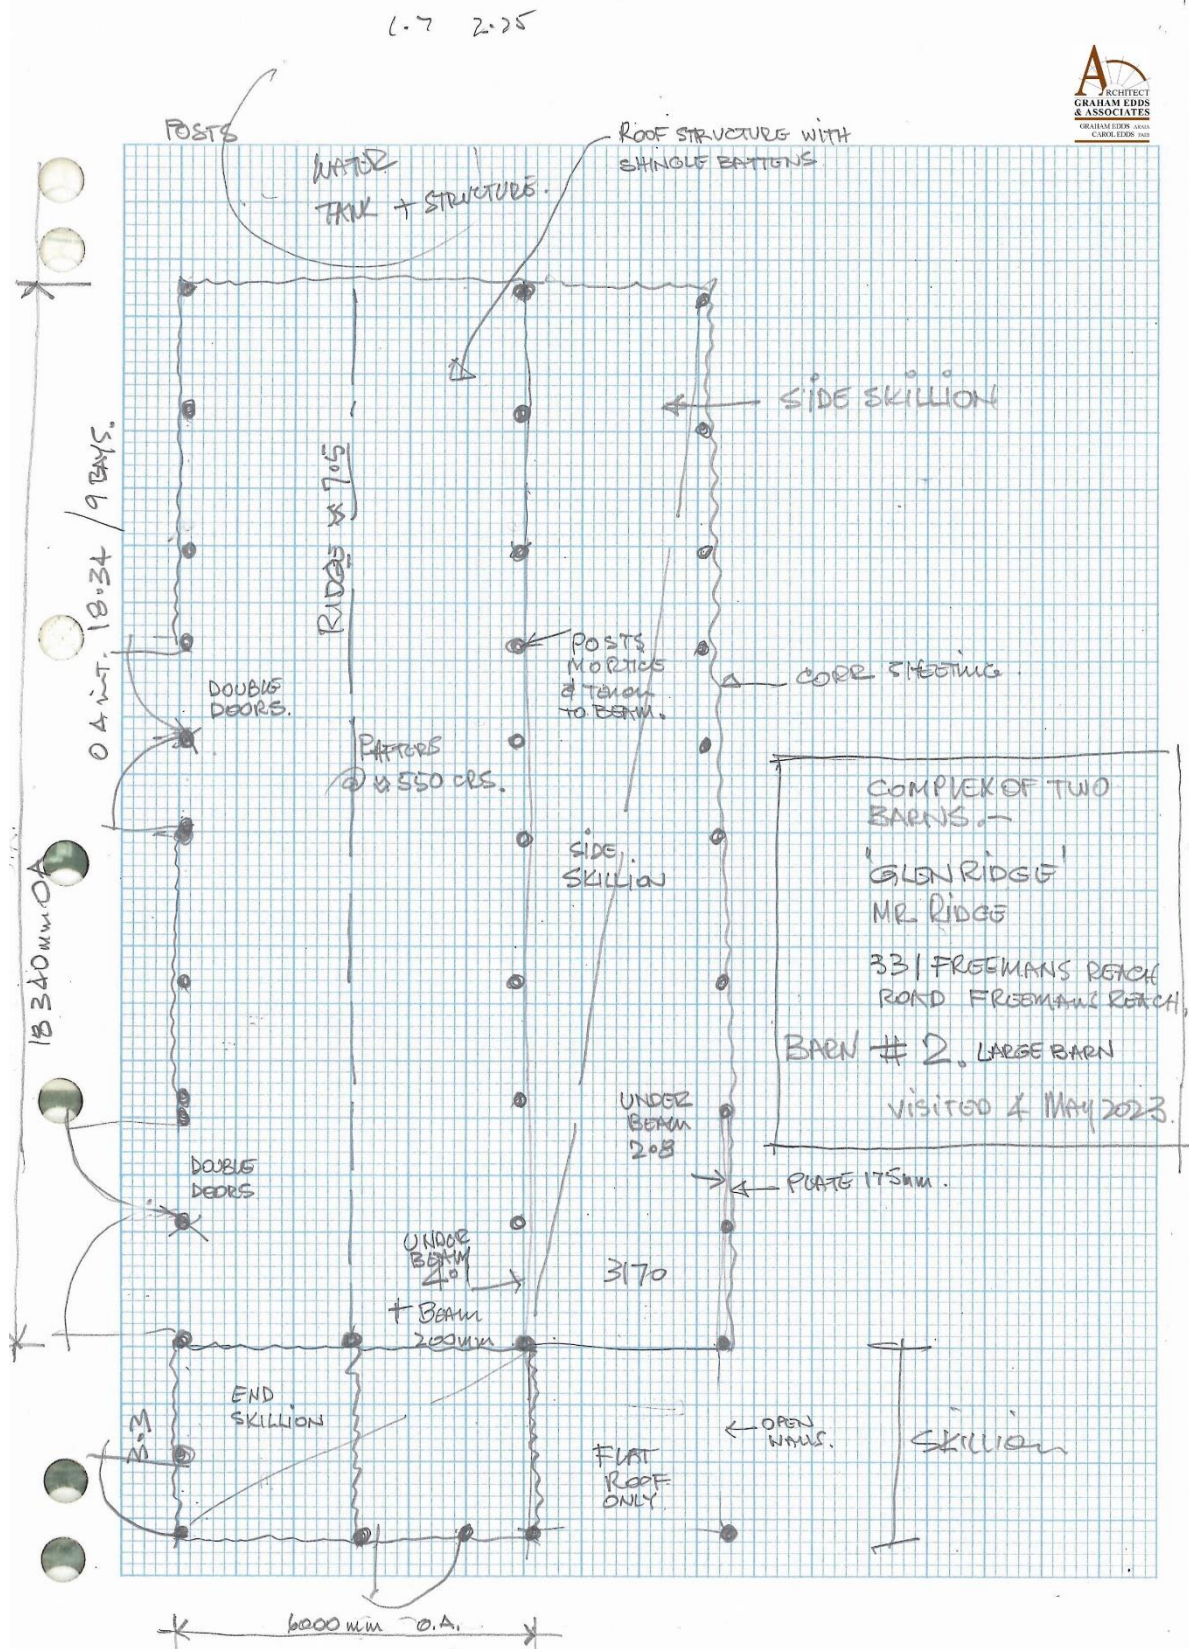
Caption: Measured drawing of Barn B at 331 Freemans Reach Road, Freemans Reach

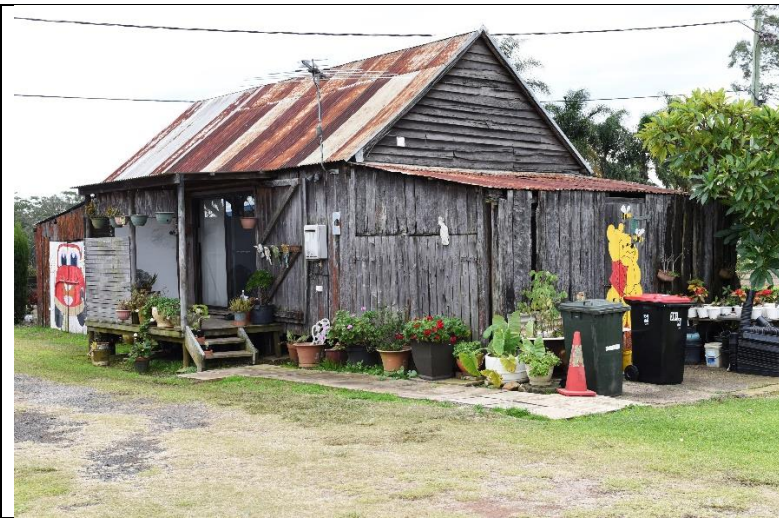
Caption: Barn at 307 Kurmond Road, Freemans Reach
Photographer: S. Johnson
Copyright Owner: Lucas Stapleton Johnson & Partners Pty Ltd
Date: June 2023

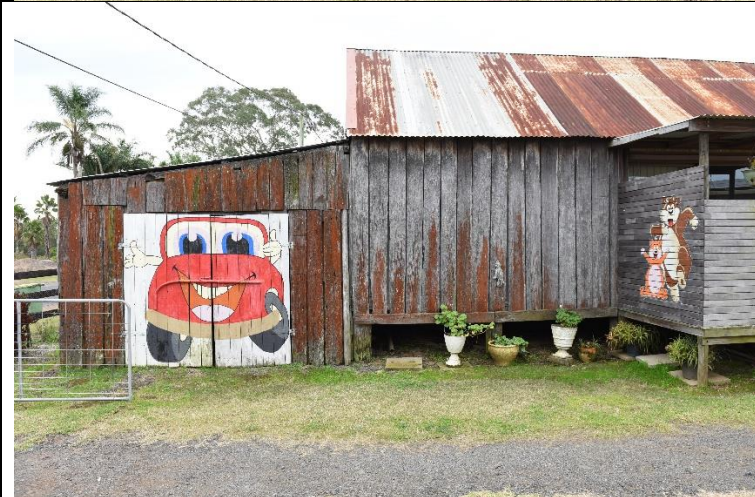
Caption: Barn at 307 Kurmond Road, Freemans Reach
Photographer: S. Johnson
Copyright Owner: Lucas Stapleton Johnson & Partners Pty Ltd
Date: June 2023

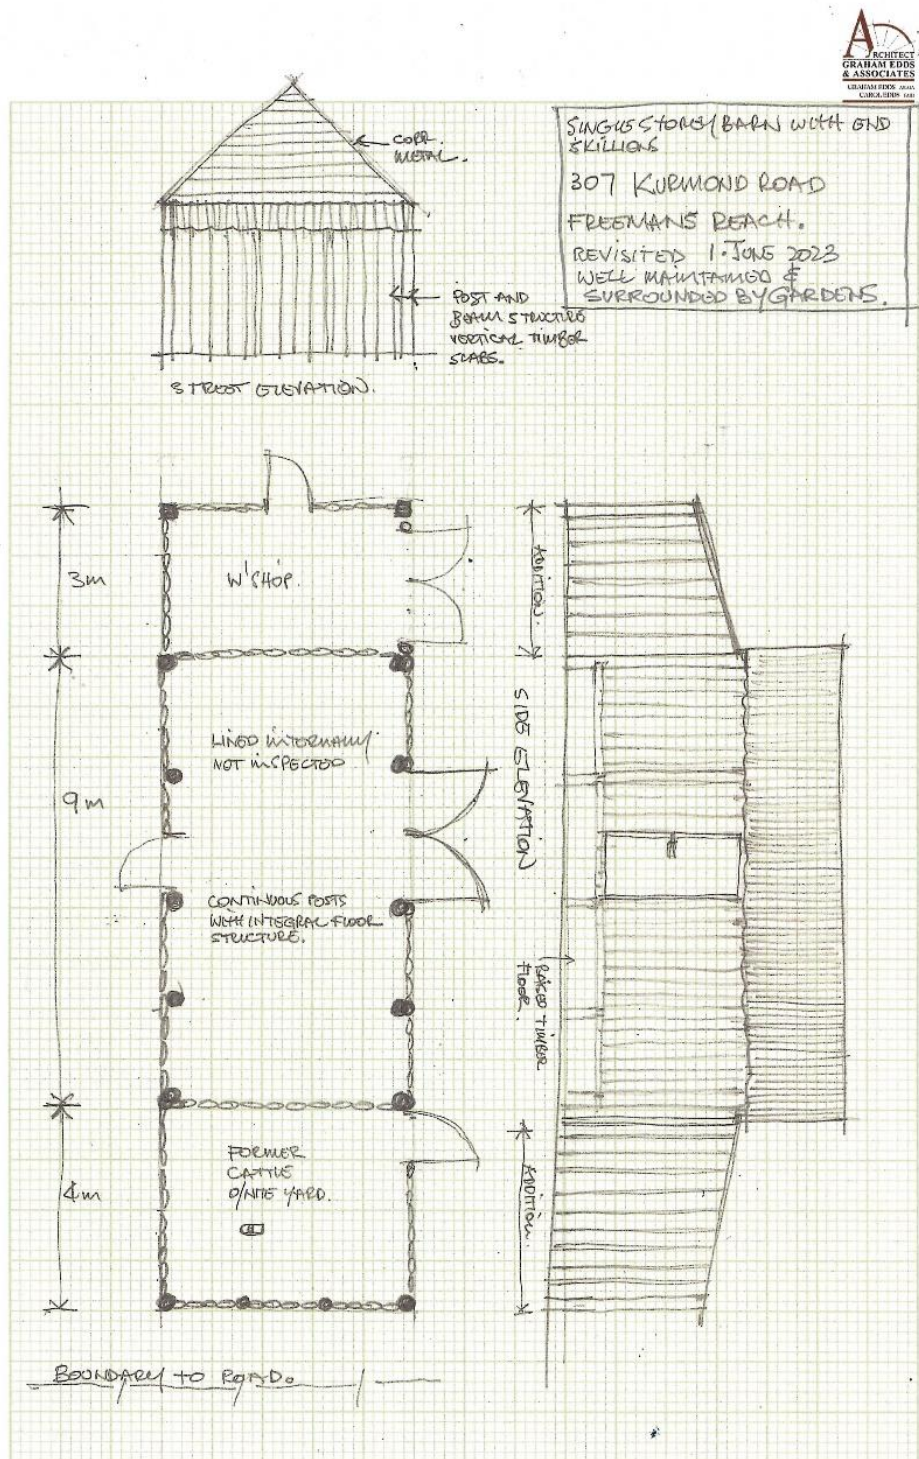
Caption: Measured drawing of barn at 307 Kurmond Road, Freemans Reach

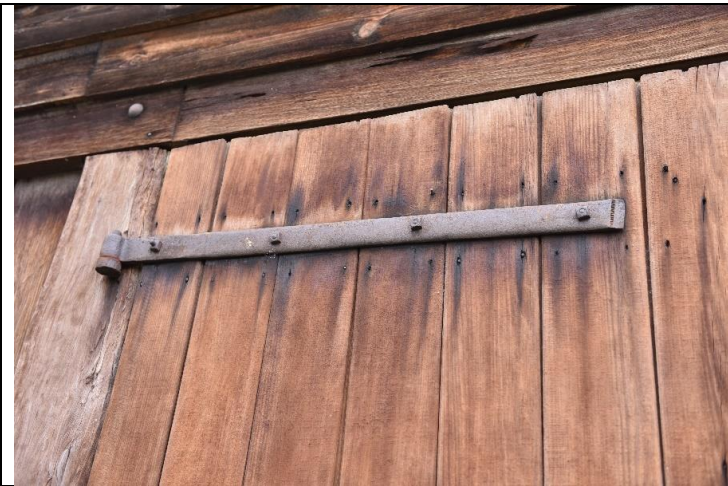
Caption: Detail of
forged iron
hinge of Stables
and Coach house
at 4 Bensons
Lane, Richmond
Photographer: S.
Johnson
Copyright Owner:
Lucas Stapleton
Johnson & Partners
Date: June 2023

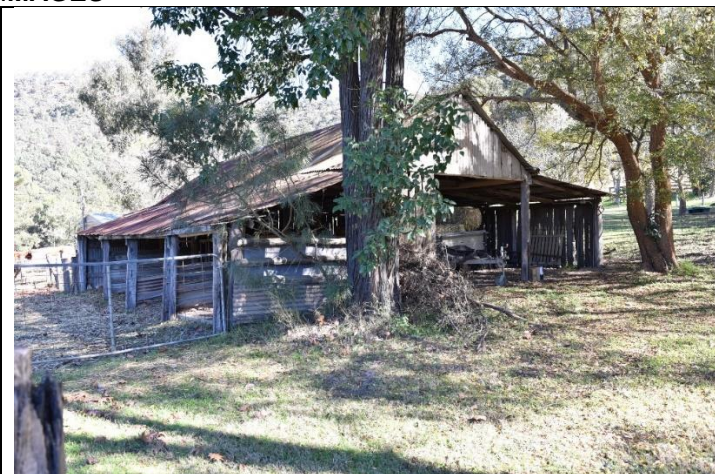
Caption: Milking Shed at
 No. 239 Upper
 Macdonald Road, St
 Albans (exterior)
 Photographer: S. Johnson
 Copyright Owner: Lucas
 Stapleton Johnson &
 Partners
 Date: June 2023

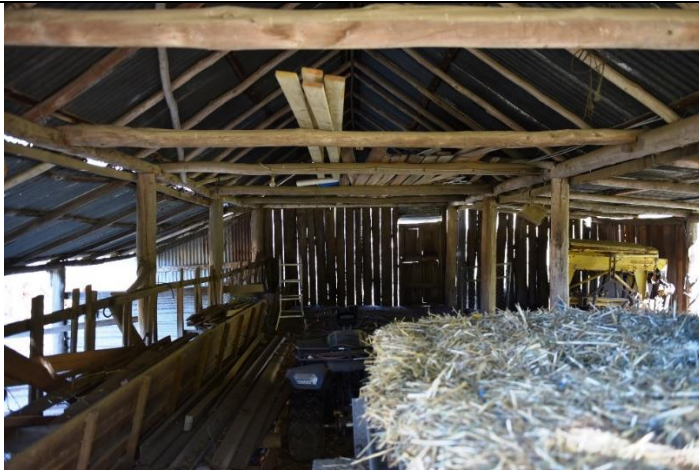
Caption: Milking Shed at
No. 239 Upper
Macdonald Road, St
Albans (interior)
Photographer: S. Johnson
Copyright Owner: Lucas
Stapleton Johnson &
Partners

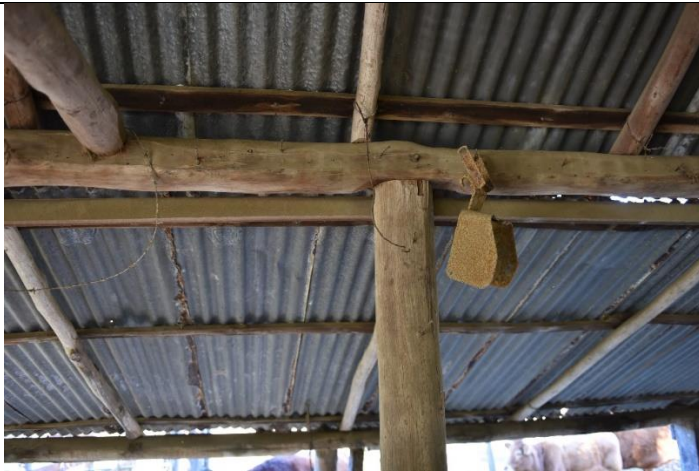
Caption: Detail of
Milking Shed at No.
239 Upper Macdonald
Road, St Albans
(exterior)
Photographer: S. Johnson
Copyright Owner: Lucas
Stapleton Johnson &
Partners

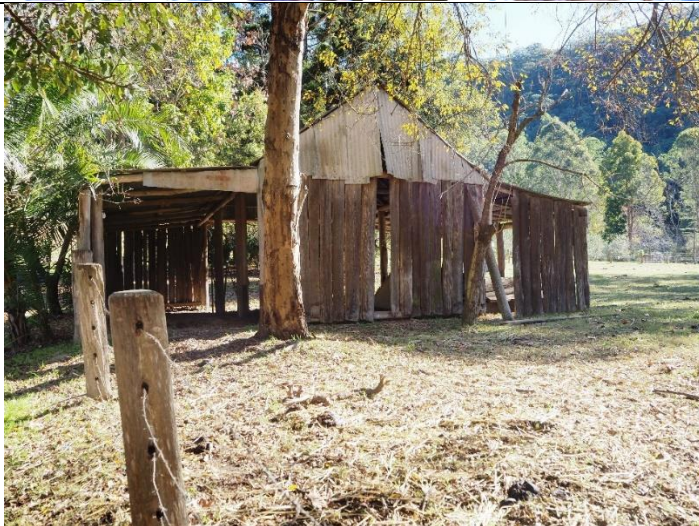
Caption: Barn at No. 239
Upper Macdonald
Road, St Albans
(exterior)
Photographer: S. Johnson
Copyright Owner: Lucas
Stapleton Johnson &
Partners

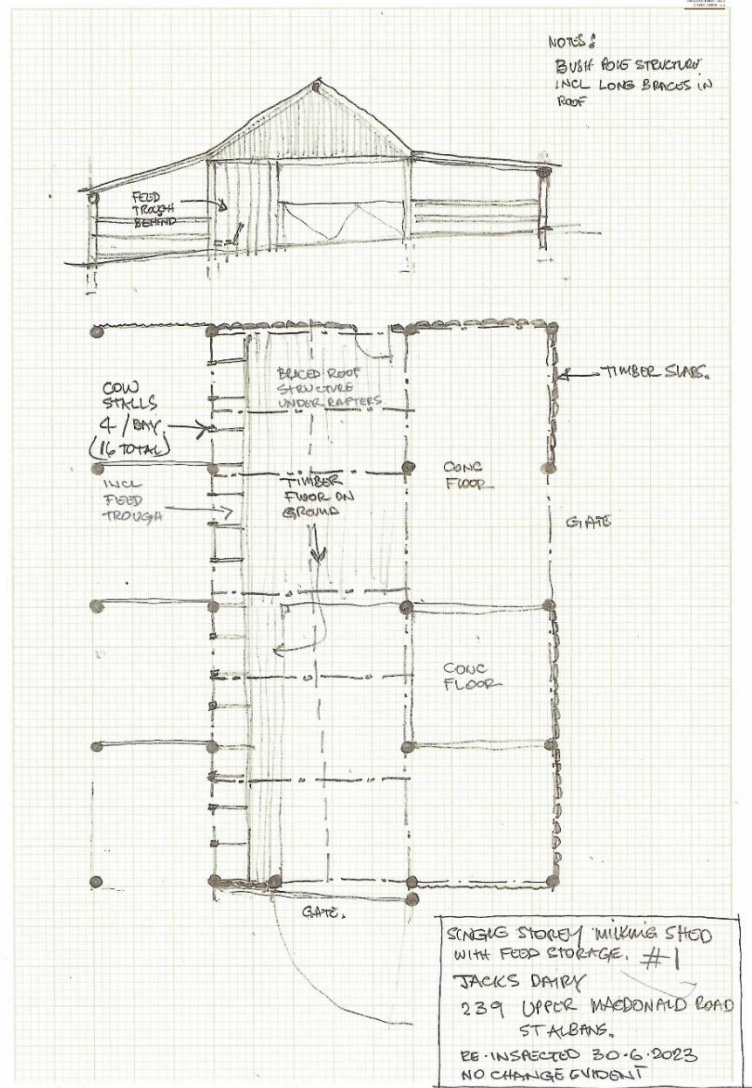
Caption: Measured drawing of milking shed at No. 239 Upper Macdonald Road, St Albans

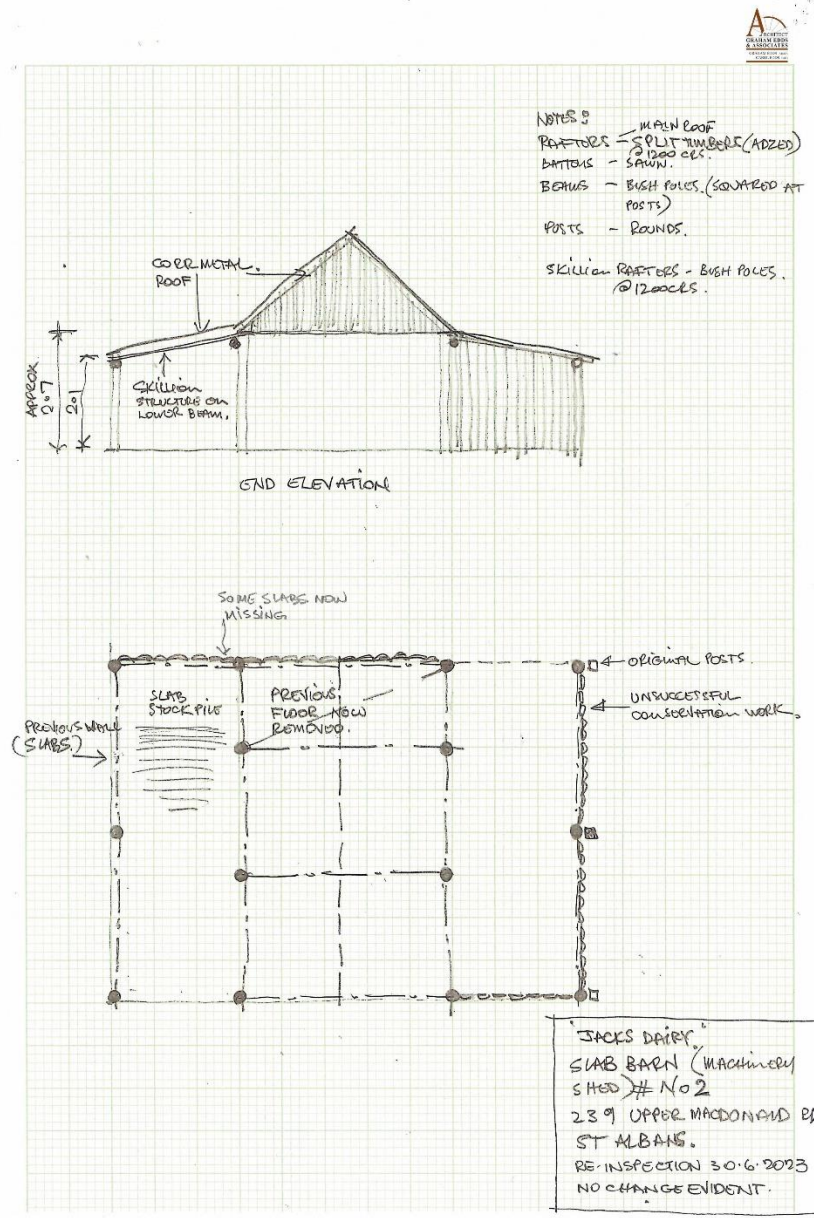
Caption: Measured drawing of barn at No. 239 Upper Macdonald Road, St Albans
Copyright Owner: Graham Edds & Associates
Date: June 2023

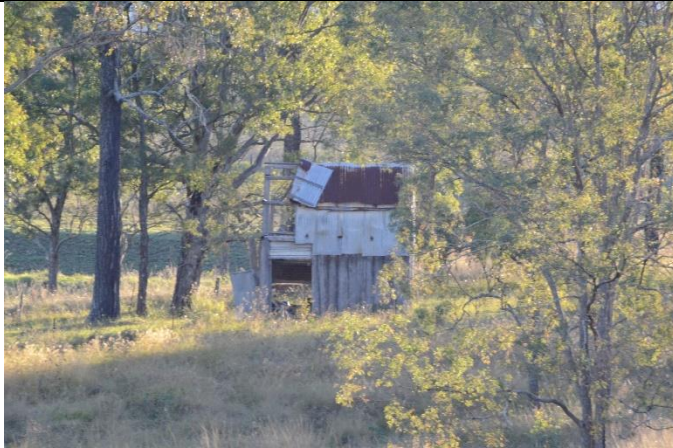
Caption: Barn at No. 33
 Griffins Rd, Tennyson
 Photographer: G. Edds
 Copyright Owner: Graham Edds
 & Associates
 Date: June 2023

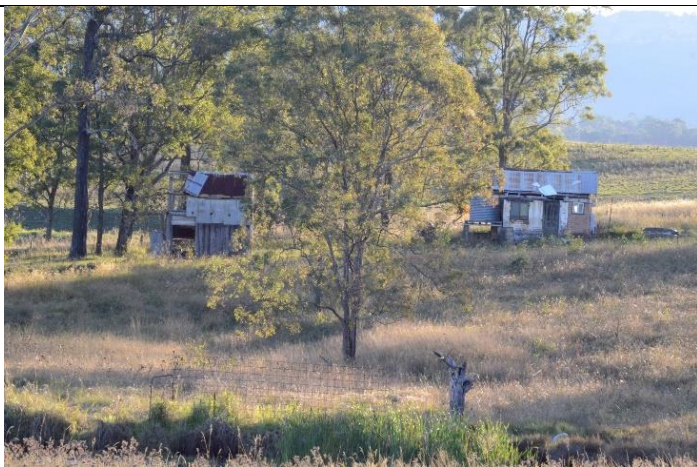
Caption: Barn at No. 33
 Griffins Rd, Tennyson
 Photographer: G. Edds
 Copyright Owner: Graham Edds
 & Associates
 Date: June 2023

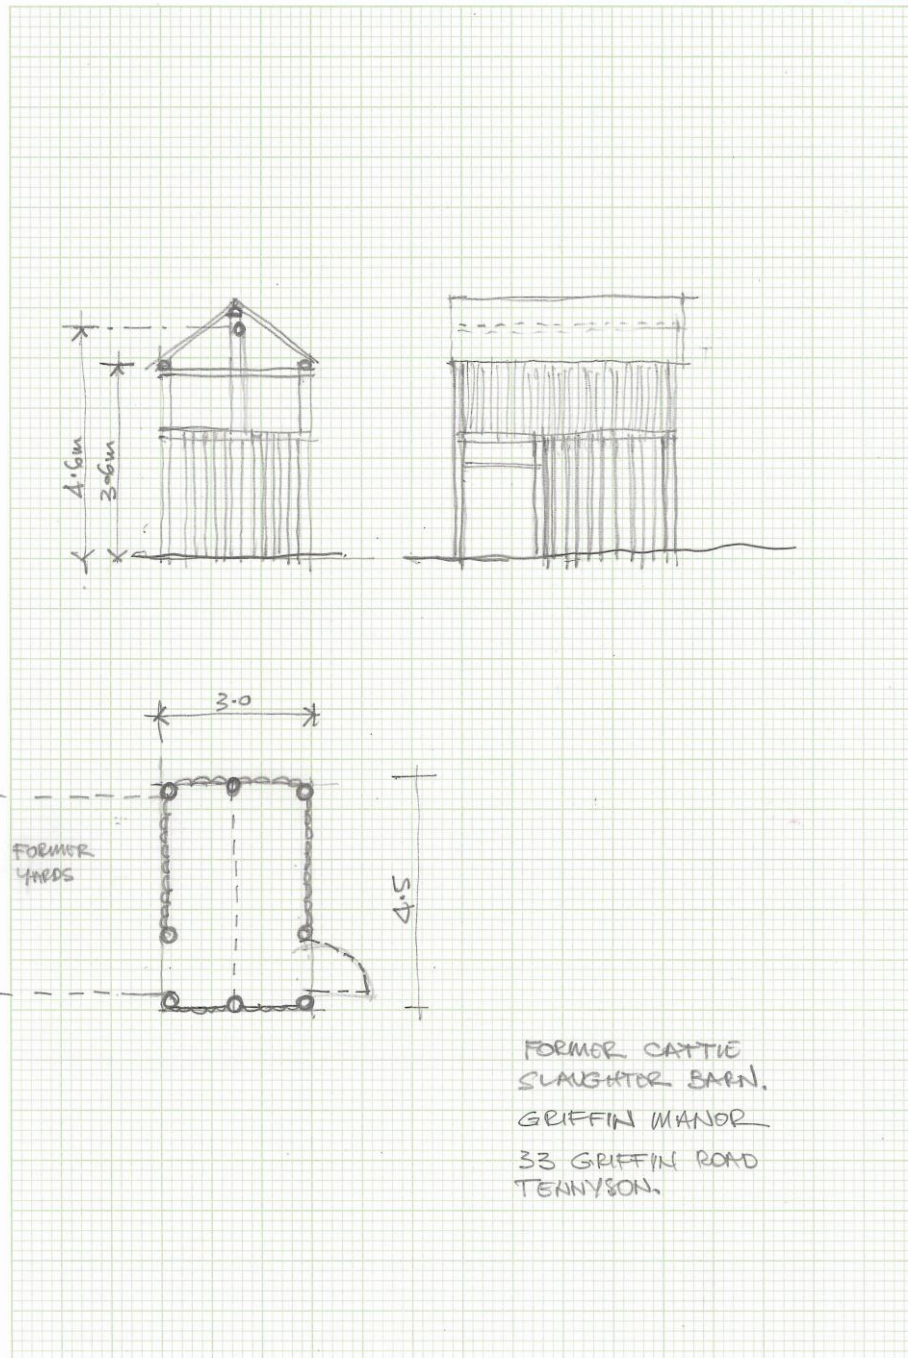
Caption: Measured drawing of Barn at 33 Griffins Road, Tennyson
Copyright Owner: Graham Edds & Associates

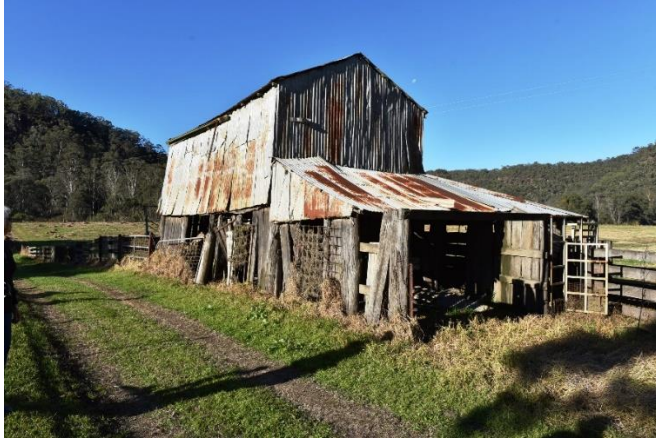
Caption: Barn at No. 995
Upper Colo Road, Upper
Colo (exterior)
Photographer: S. Johnson
Copyright Owner: Lucas
Stapleton Johnson & Partners
Date: June 2023

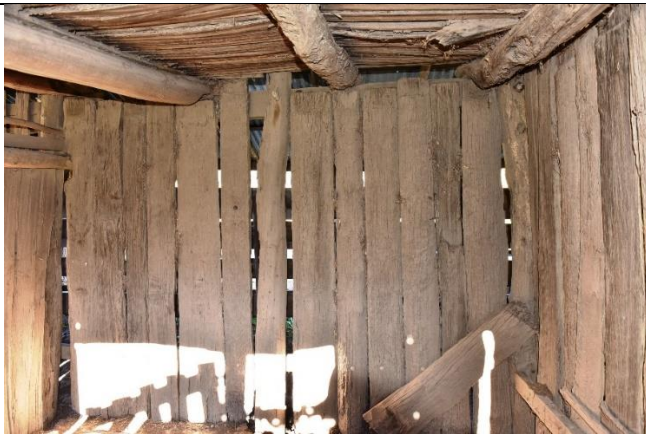
Caption: Interior detail of
barn at No. 995 Upper
Colo Road, Upper Colo
Photographer: S. Johnson
Copyright Owner: Lucas
Stapleton Johnson & Partners
Date: June 2023

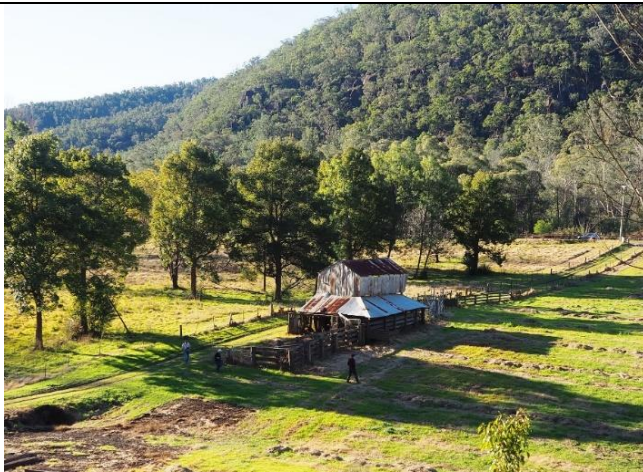
Caption: Barn at No. 995
Upper Colo Road, Upper
Colo (exterior)
Photographer: S. Johnson
Copyright Owner: Lucas
Stapleton Johnson & Partners
Date: June 2023

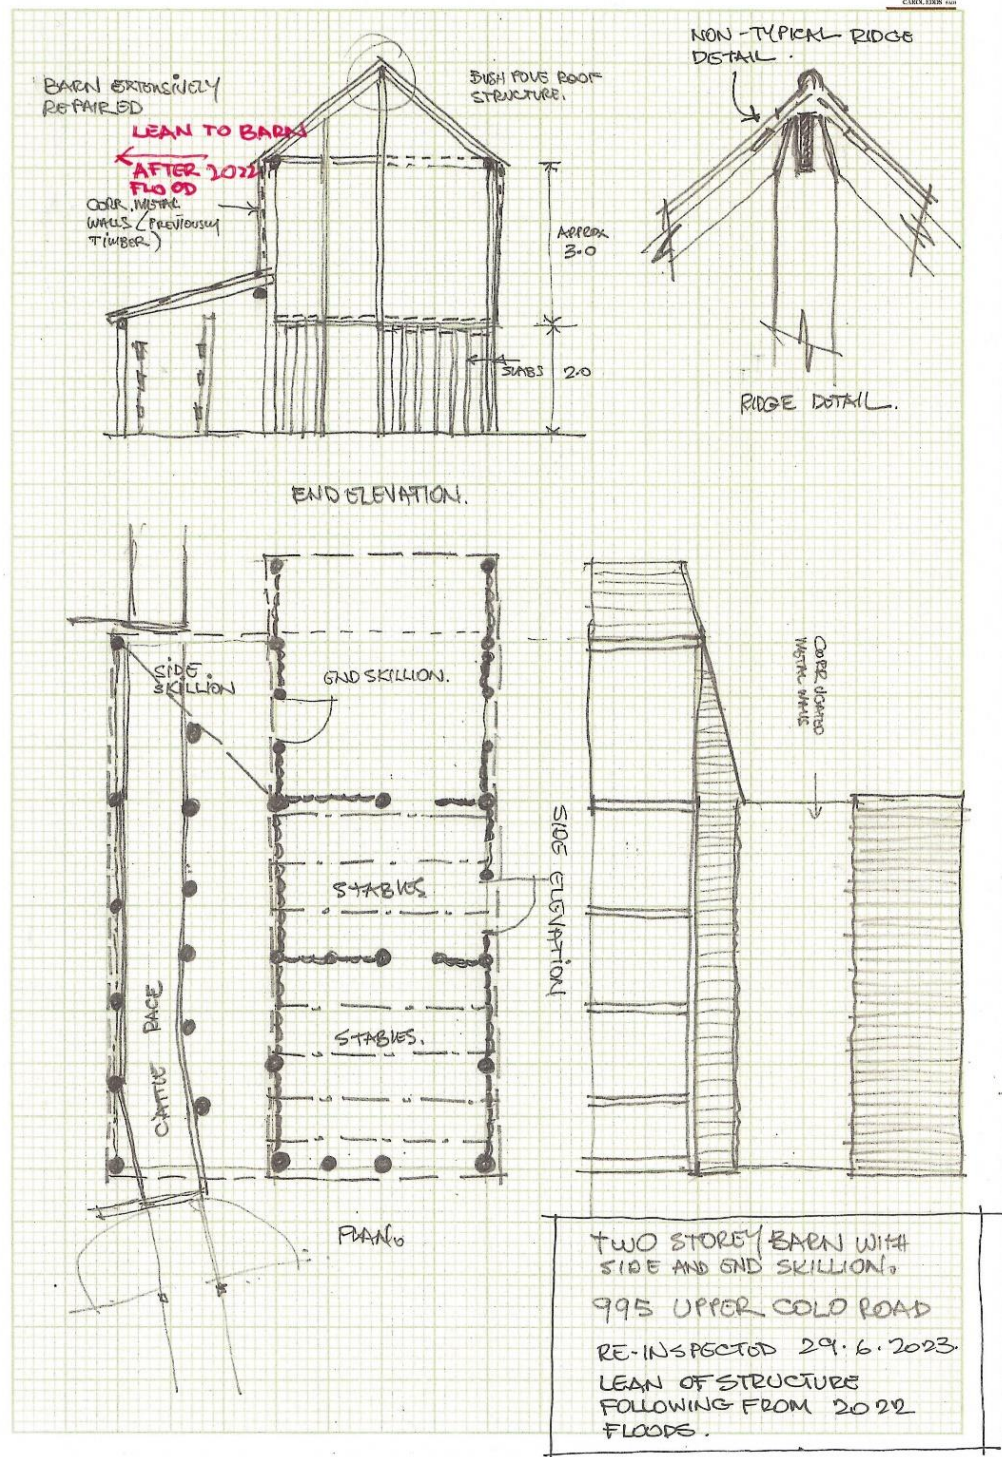
Caption: Measured drawing of barn at No. 995 Upper Colo Road, Upper Colo
Copyright Owner: Graham Edds & Associates
