Slab Barns and Outbuildings Heritage Listing Planning
Proposal - Appendix A,B and C

LEP001/25 Hawkesbury Slab Barns and Outbuildings LEP Amendment

Appendix A – Heritage Items
Appendix B – Heritage Inventory Sheets
Appendix C – Heritage Items Maps

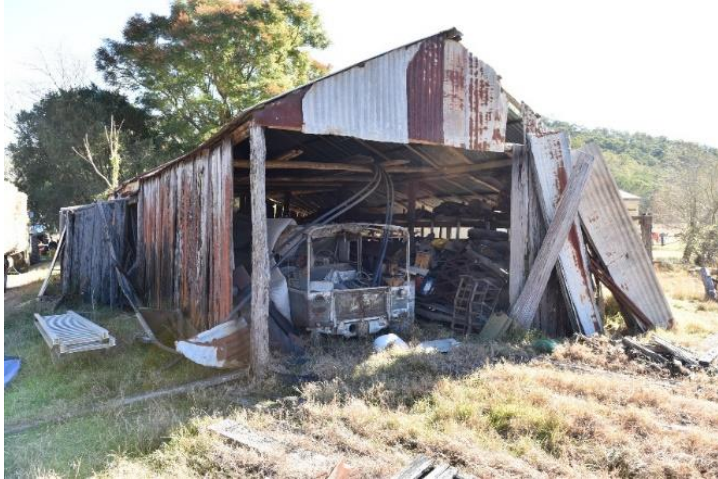
Caption: Barn at 1764
Upper Macdonald
Road, Higher
Macdonald (exterior)
Photographer: S. Johnson
Copyright Owner: Lucas
Stapleton Johnson &
Partners Pty Ltd
Date: June 2023

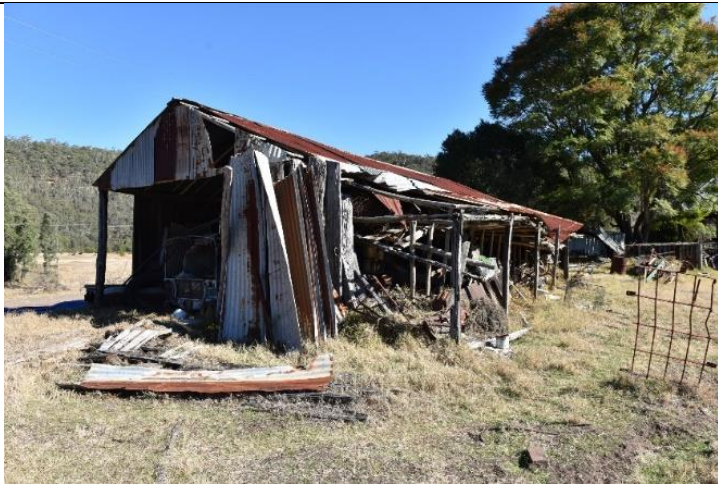
Caption: Barn at 1764
Upper Macdonald
Road, Higher
Macdonald (exterior)
Photographer: S. Johnson
Copyright Owner: Lucas
Stapleton Johnson &
Partners Pty Ltd
Date: June 2023

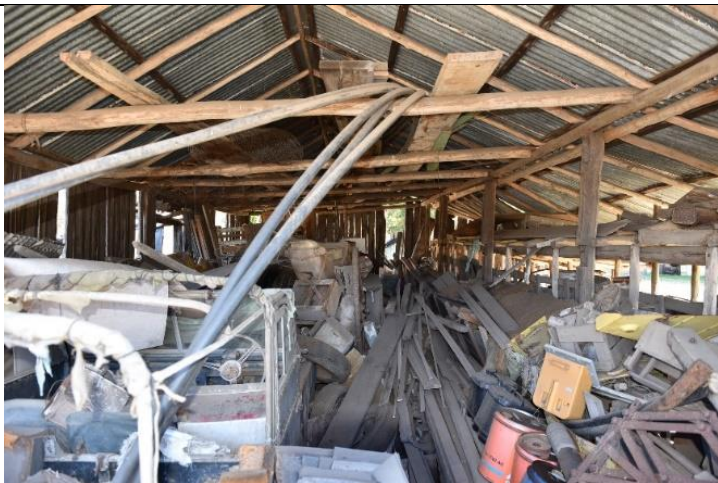
Caption: Barn at 1764
Upper Macdonald
Road, Higher
Macdonald (interior)
Photographer: S. Johnson
Copyright Owner: Lucas
Stapleton Johnson &
Partners Pty Ltd
Date: June 2023

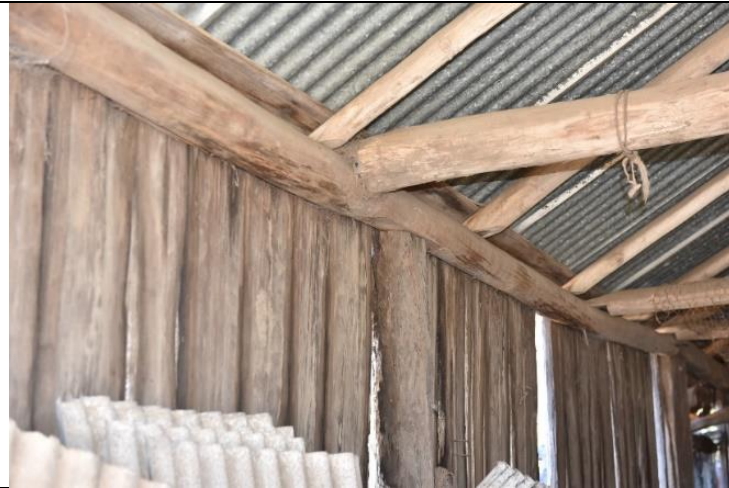
Caption: Detail of
post/beam junction in
barn at 1764 Upper
Macdonald Road,
Higher Macdonald
Photographer: S. Johnson
Copyright Owner: Lucas
Stapleton Johnson &
Partners Pty Ltd

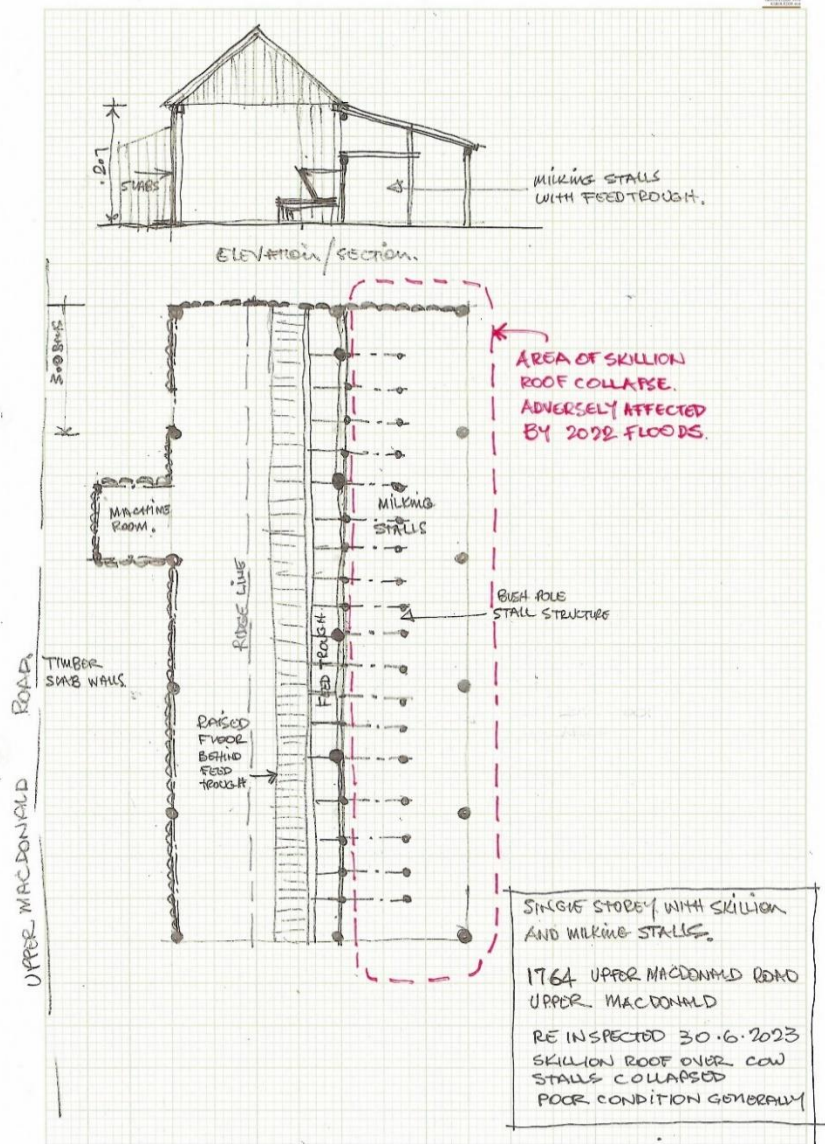
Caption: Measured drawing of Barn with milking shed at 1764 Upper Macdonald Road,
Higher Macdonald

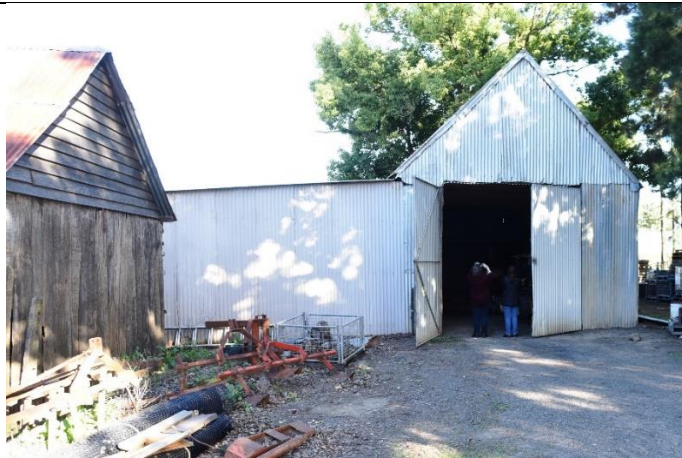
Caption: Barn A at 253 Wilberforce Road, Wilberforce (exterior)
Photographer: S. Johnson
Copyright Owner: Lucas Stapleton Johnson & Partners Pty Ltd
Date: May 2023

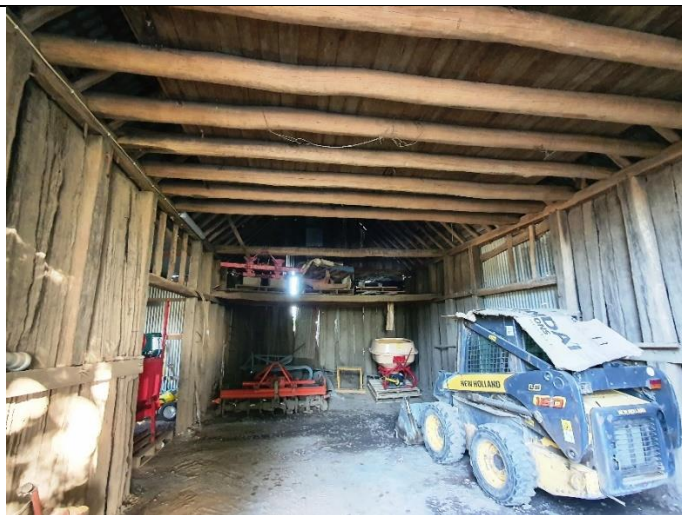
Caption: Barn A at 253 Wilberforce Road, Wilberforce (interior)
Photographer: S. Johnson
Copyright Owner: Lucas Stapleton Johnson & Partners Pty Ltd
Date: May 2023

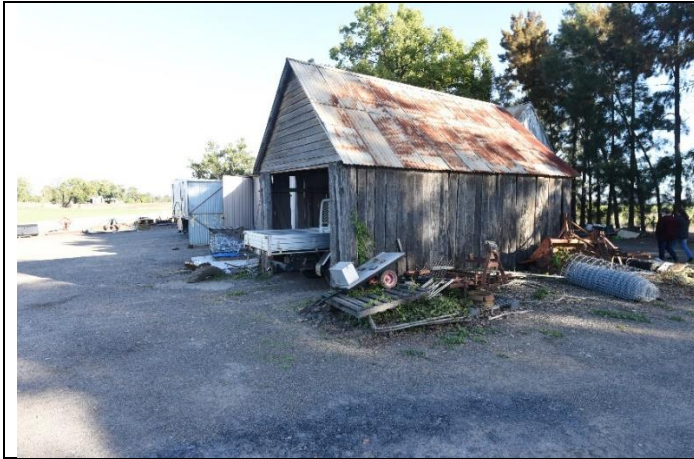
Caption: Barn B at 253
Wilberforce Road,
Wilberforce (exterior)
Photographer: S. Johnson
Copyright Owner: Lucas Stapleton
Johnson & Partners Pty Ltd
Date: May 2023

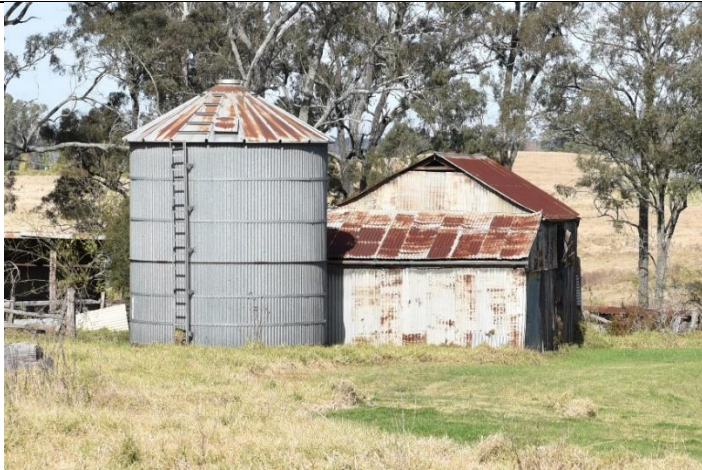
Caption: Barn and silo at 86 King Road, Wilberforce Road, Freemans Reach (exterior)
 Photographer: S. Johnson
 Copyright Owner: Lucas Stapleton Johnson & Partners Pty Ltd
 Date: June 2023

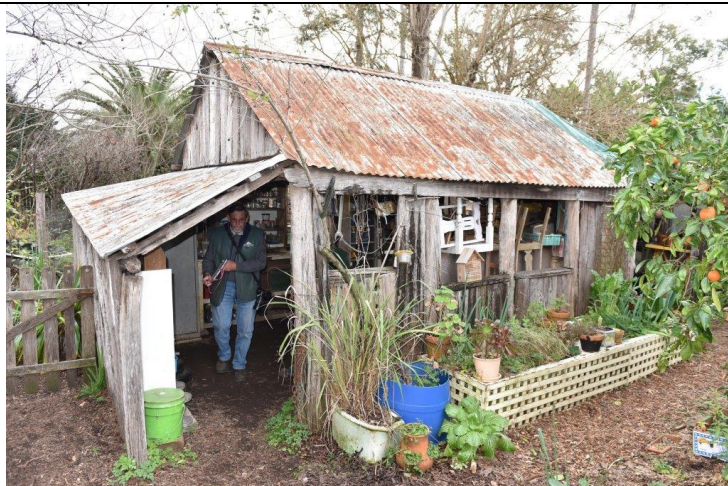
Caption: Barn at No. 87 King Road, Wilberforce (exterior)
 Photographer: S. Johnson
 Copyright Owner: Lucas Stapleton Johnson & Partners
 Date: July 2023

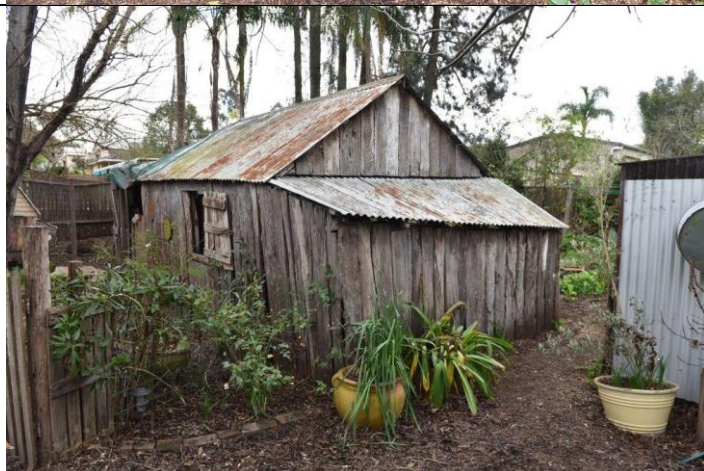
Caption: Barn at No. 87 King Road, Wilberforce (exterior)
 Photographer: S. Johnson
 Copyright Owner: Lucas Stapleton Johnson & Partners
 Date: July 2023

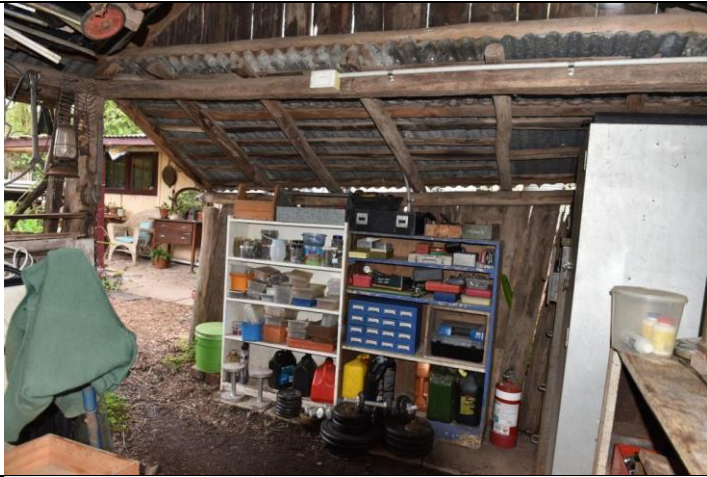
Caption: Barn at No. 87
King Road,
Wilberforce (interior)
Photographer: S. Johnson
Copyright Owner: Lucas
Stapleton Johnson &
Partners

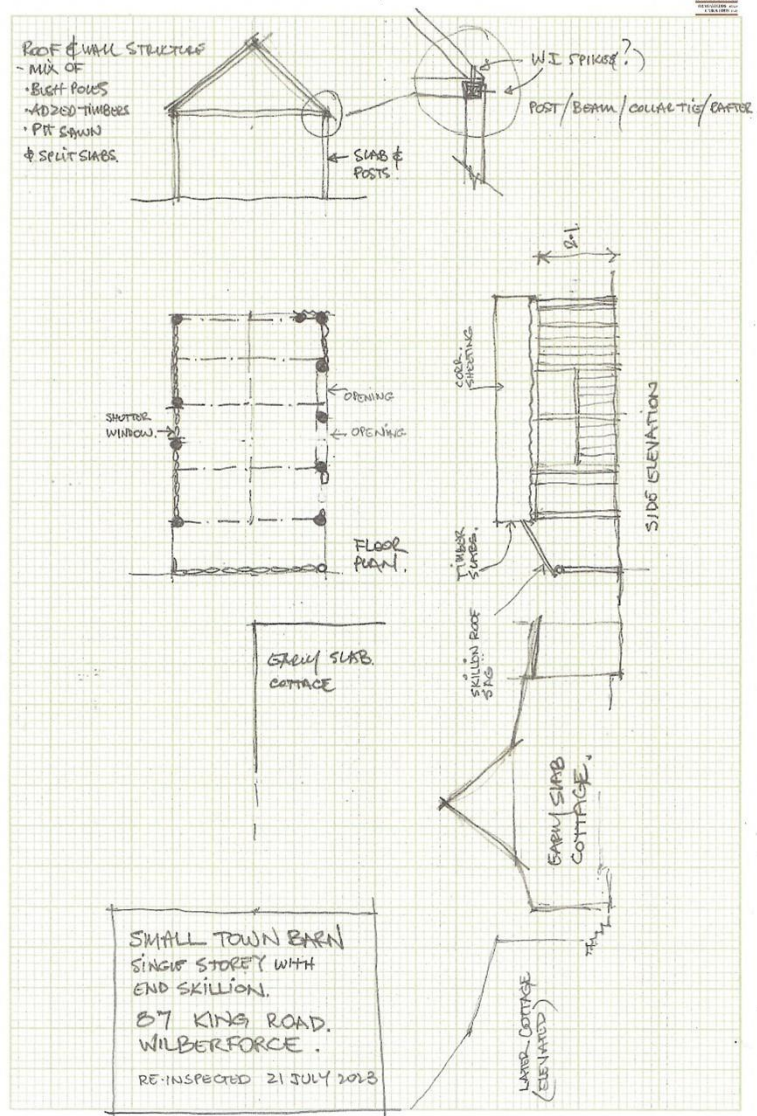
Caption: Measured drawing of Barn at 87 King Road, Wilberforce
Copyright Owner: Graham Edds & Associates

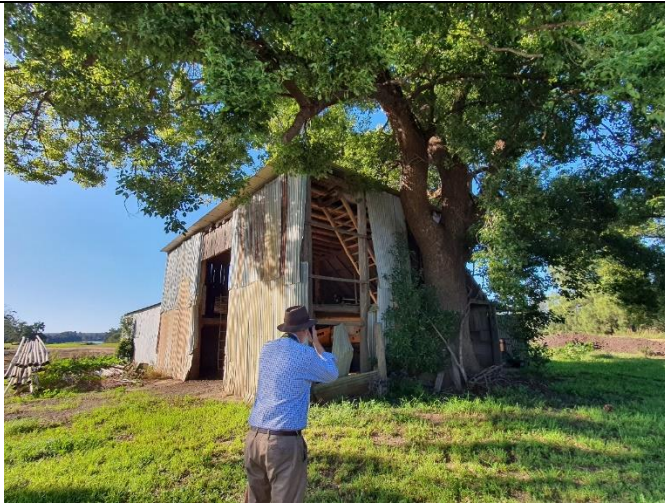
Caption: Barn at
191 Wilberforce
Road, Wilberforce
(exterior)
Photographer: K.
Denny
Copyright Owner:
Lucas Stapleton
Johnson & Partners
Date: May 2023

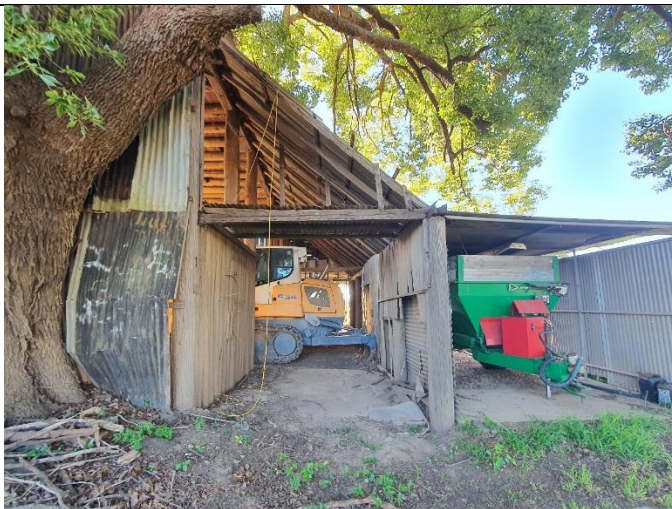
Caption: Barn at
191 Wilberforce
Road, Wilberforce
(exterior and
skillion)
Photographer: K.
Denny
Copyright Owner:
Lucas Stapleton
Johnson & Partners
Date: May 2023

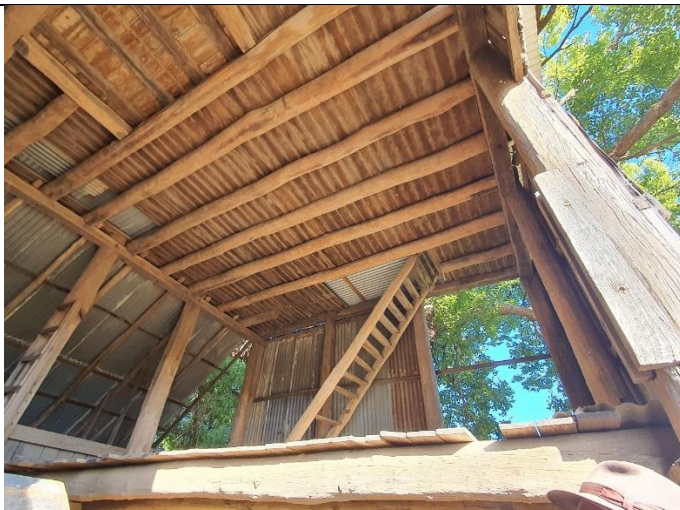
Caption: Barn at
191 Wilberforce
Road, Wilberforce
(interior)
Photographer: K.
Denny
Copyright Owner:
Lucas Stapleton
Johnson & Partners
Date: May 2023

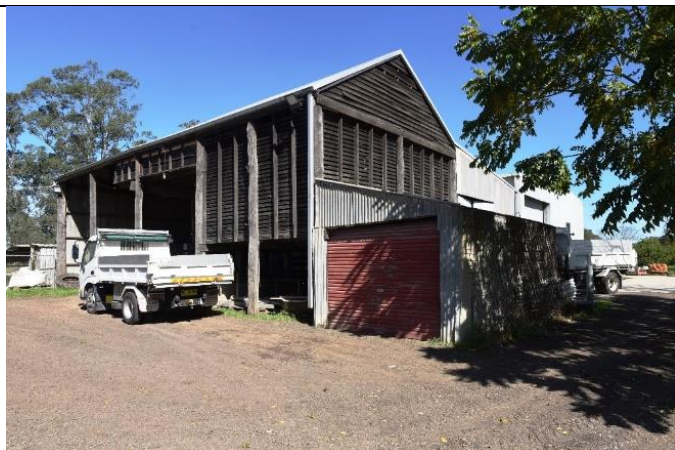
Caption: Barn at 63 Wilberforce Road, Wilberforce (exterior)
Photographer: S. Johnson
Copyright Owner: Lucas Stapleton Johnson & Partners
Date: May 2023

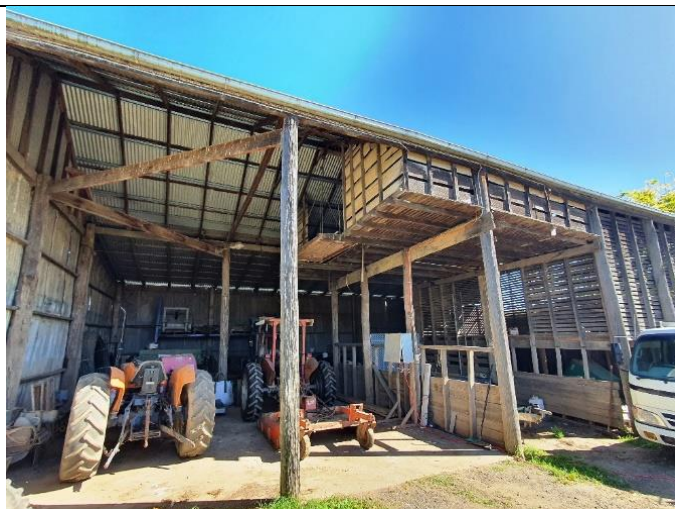
Caption: Barn at 63 Wilberforce Road, Wilberforce (interior)
Photographer: S. Johnson
Copyright Owner: Lucas Stapleton Johnson & Partners
Date: May 2023

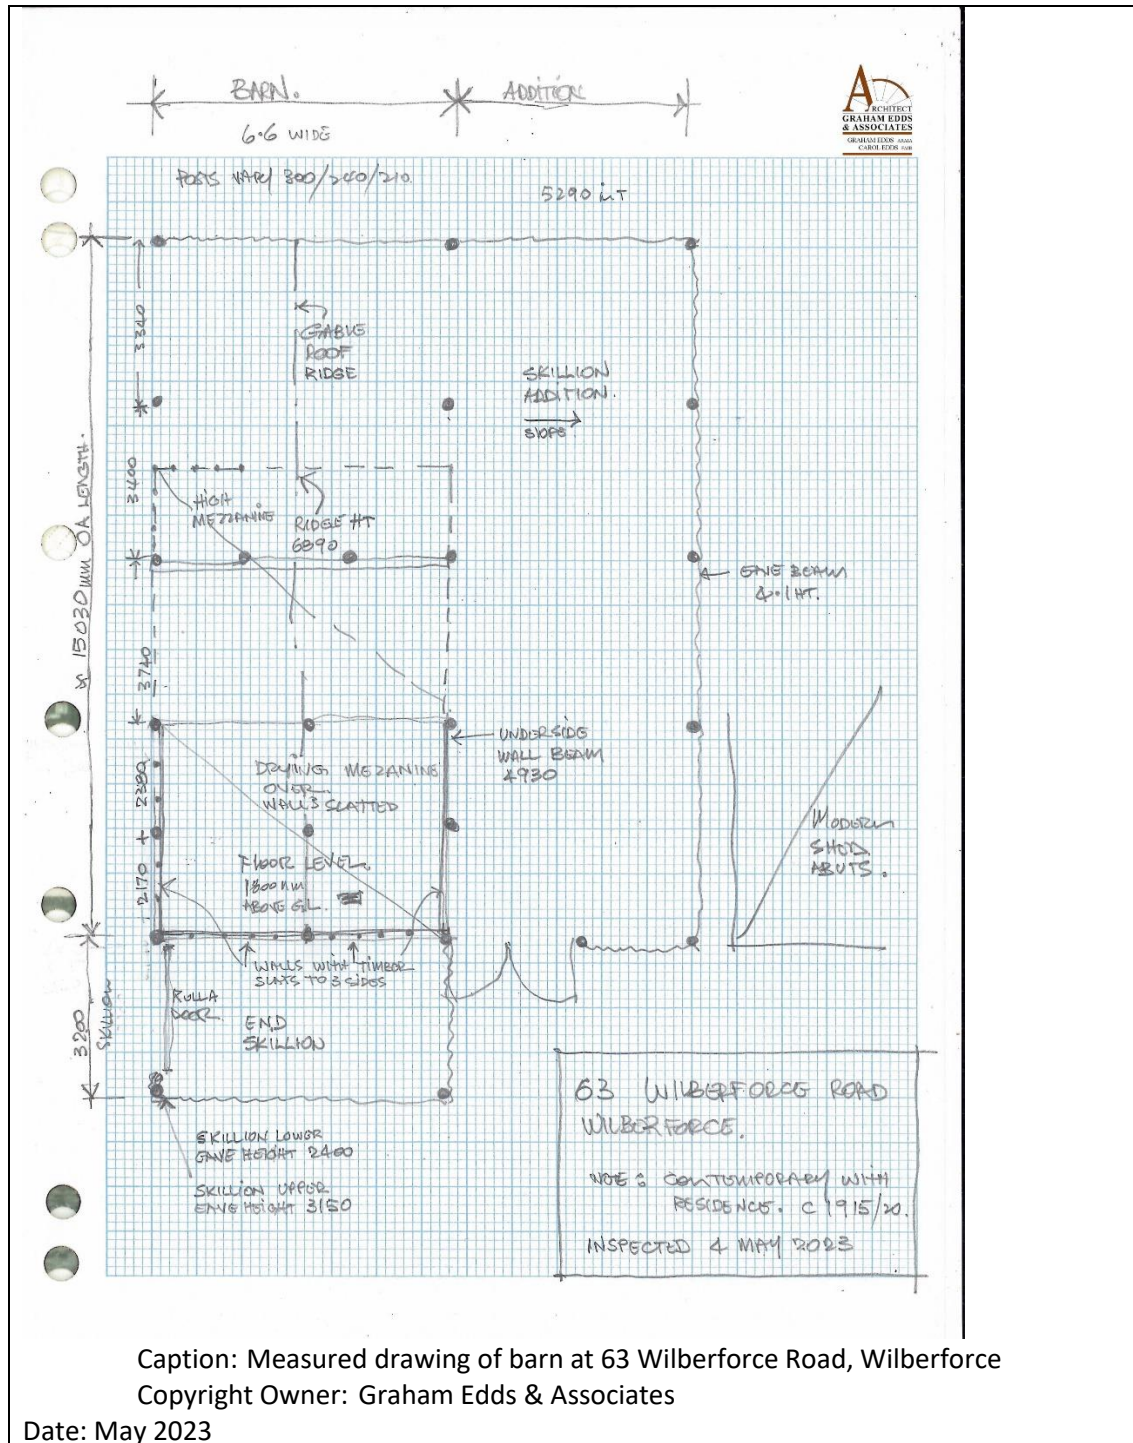
Caption: Measured drawing of barn at 63 Wilberforce Road, Wilberforce

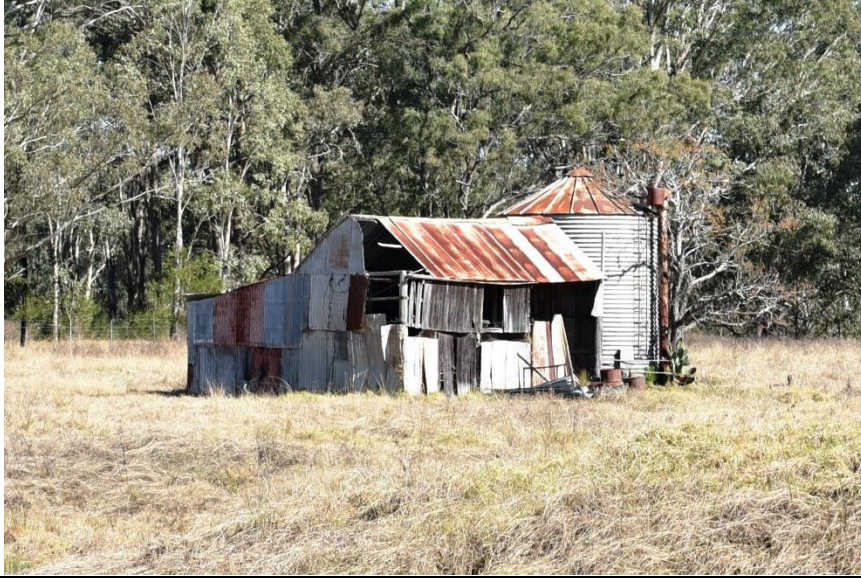
Caption: Barn at
No. 55
McKinnons
Road,
Wilberforce.
Photographer: S.
Johnson
Copyright Owner:
Lucas Stapleton
Johnson &
Partners
Date: July 2023
