Volume 3 - Hawkesbury City Council
Cemeteries Strategic Conservation
Management Plan
Appendices

Volume 3: Appendices

Strategic Conservation Management Plan

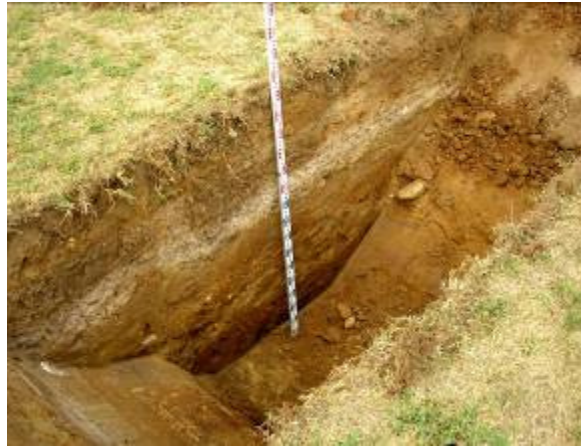
Figure 4.16 MTT4 general view looking southeast.

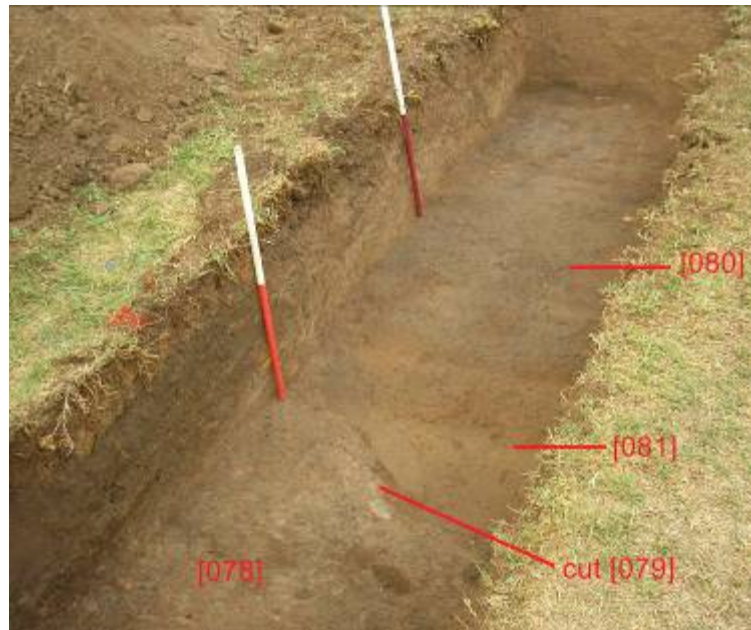
Figure 4.22 MTT7 general view looking southeast showing cut filled with crushed shale (foreground) and natural soil horizons (background).

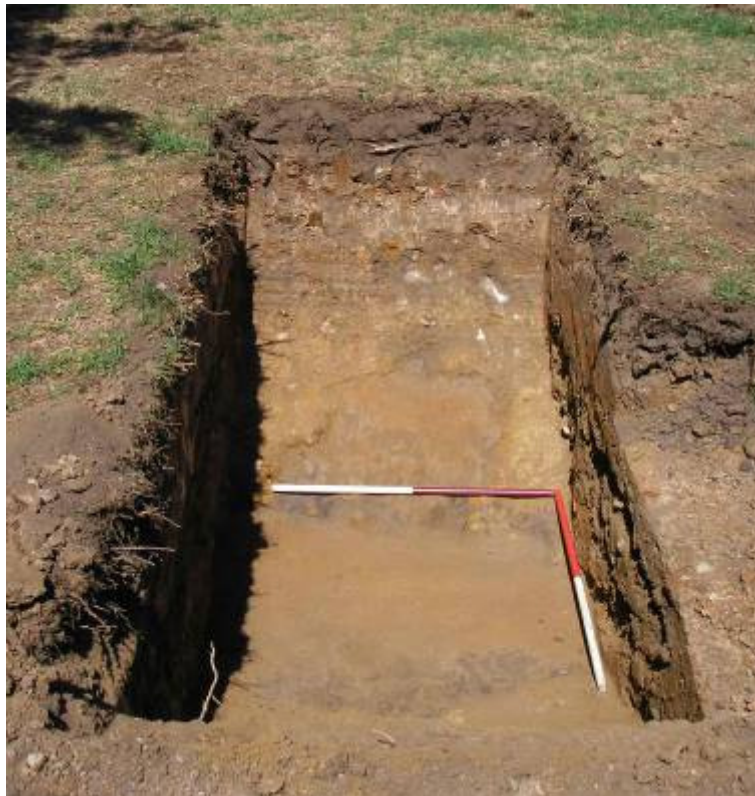
Figure 4.27 MTT8 general view looking south showing trimmed B horizon clay (base).

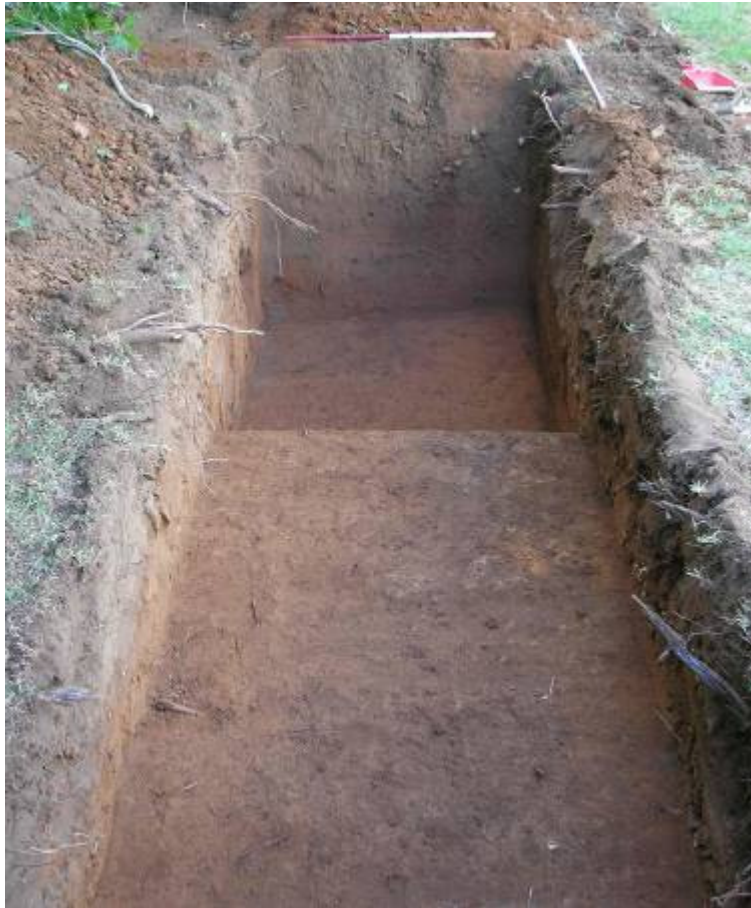
Figure 4.31 MTT10 general view looking east prior to manual excavation showing laminated silts and clays [095] in foreground and in far section.

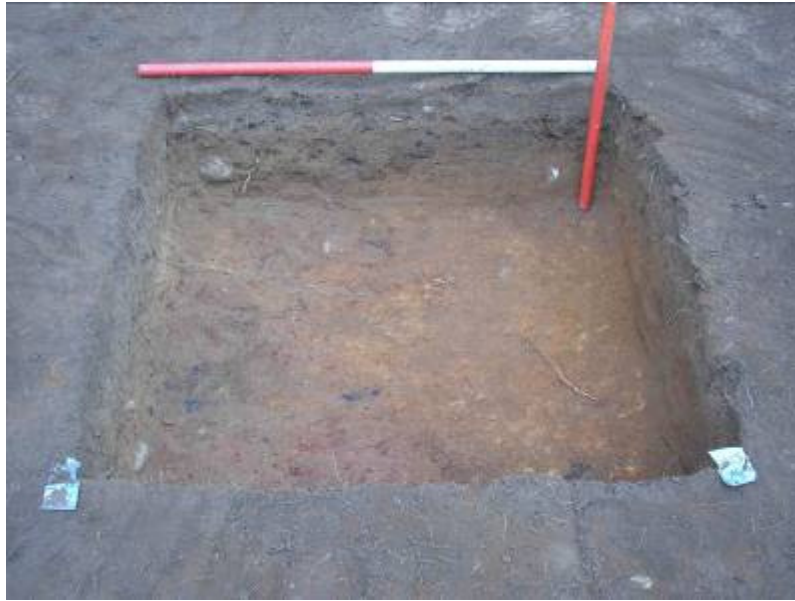
Figure 4.39 HT5 (looking west) showing the burnt subsoil deposit [099] in base.

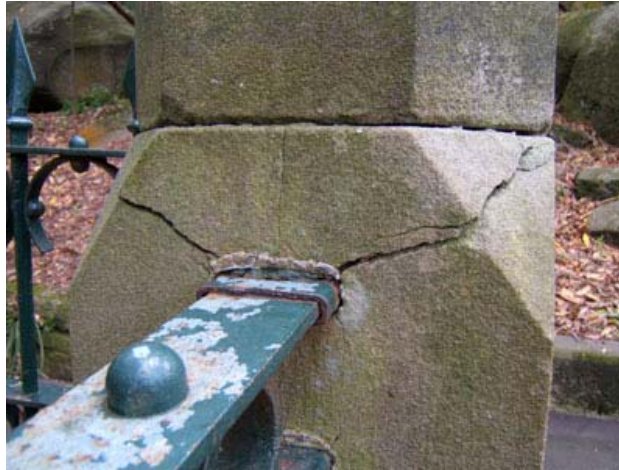
One of the major causes of monument damage is the expansion of iron fittings due to rusting

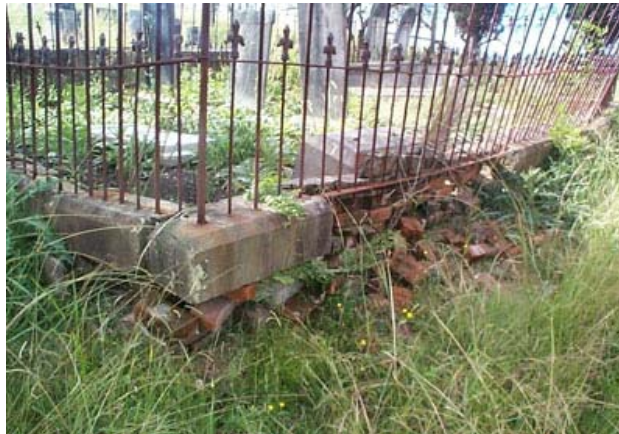
When combined with poor footings, damage can be severe

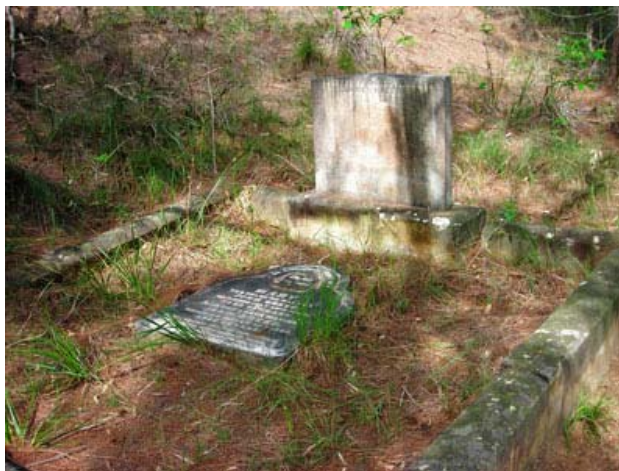
Unfortunately, vandalism is the main cause of this kind of breakage

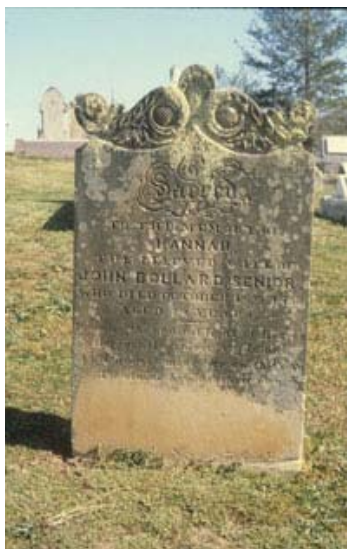
A common, but easily avoidable problem is damage by whipper-snippers

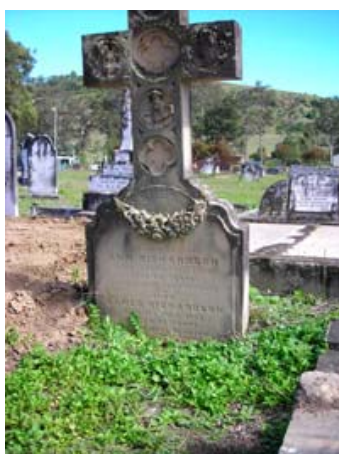
Allowing soil build-up can introduce dampness, which starts the process of surface deterioration

Other stones, especially sandstone, will spall, fret and split. This is usually the result of natural salts depositing due to rising damp, but can also occur from simple wetting and drying over time. In these cases the problem is that the stone is absorbing water and then drying out, either in the same zone or at some point to which the absorbed dampness has moved. The main question here is where the water is entering the stone: at ground surface, below the surface, or perhaps through open joints in the stonework.

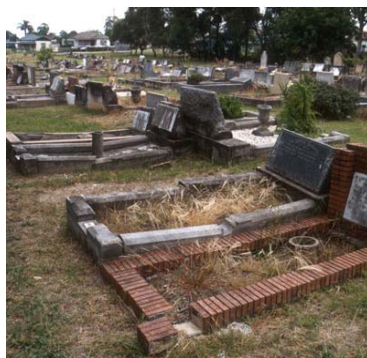
Coffin collapse can cause leaning headstones or broken kerbing

Leaning and fallen monuments comprise some of the commonest cemeteries problems due to failure of footings and/or foundations. The commonest cause is subsidence after the coffin deteriorates (“coffin collapse”). Other causes can involve compaction of loose grave fill, underground vault distortion or collapse, water erosion, rabbit or wombat burrows. Other factors can be tree roots raising one side, differential compaction, (as where part of the monument is over rock and the other on fill). Soil creep on a hillside is another frequent cause.

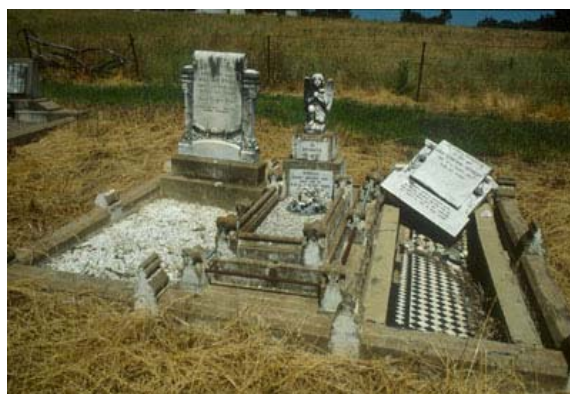
.... and in severe cases, toppling of monuments

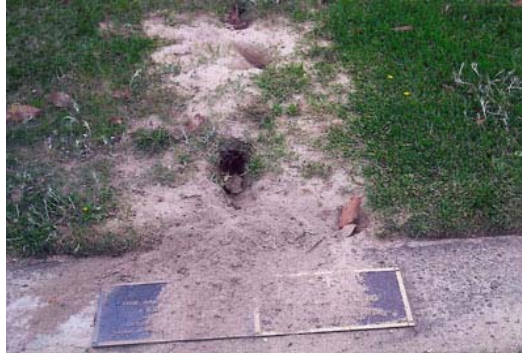
Rabbit activity is another potential cause of grave subsidence

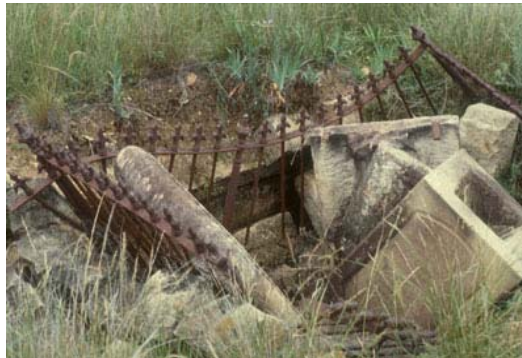
Generally hidden until it happens, the inward collapse of the underground walls of a vault can be disastrous

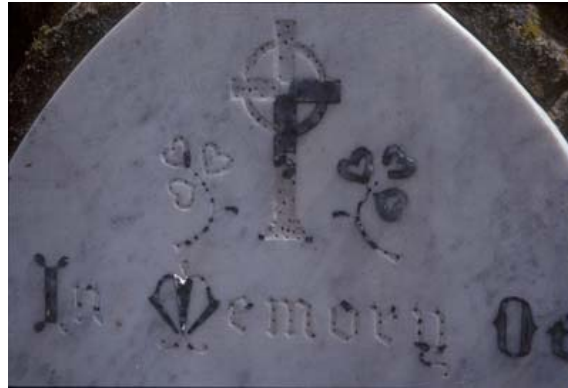
Poorly executed lead lettering can be saved if an expert mason re-fixes the lead before extensive failure

Deterioration of leaded lettering on marble monuments usually results from weathering of marble adjacent to the letters, but repeated heating and cooling can cause crevices at the edges of the lead, in which mould can grow to cause further loosening.

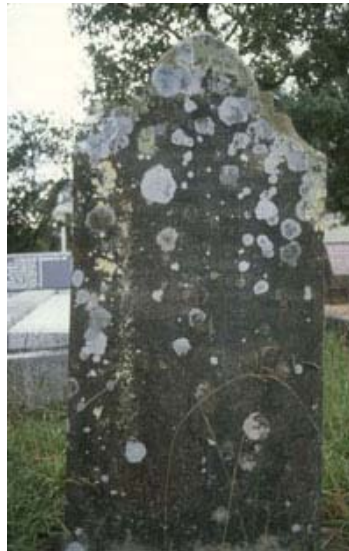
Lichen on sandstone can be slightly damaging, but careless removal is much more so

Growth of mosses, lichens and fungus on monuments offer some physical protection to the stone and at the same time do slight damage. On balance they may be left unless they are unsightly or obscure the lettering.

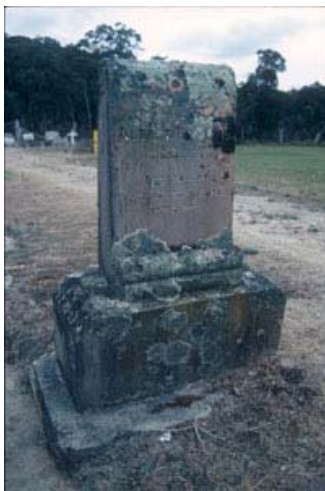
Harder granite, however, is generally undamaged by either lichen or by gentle methods of removal

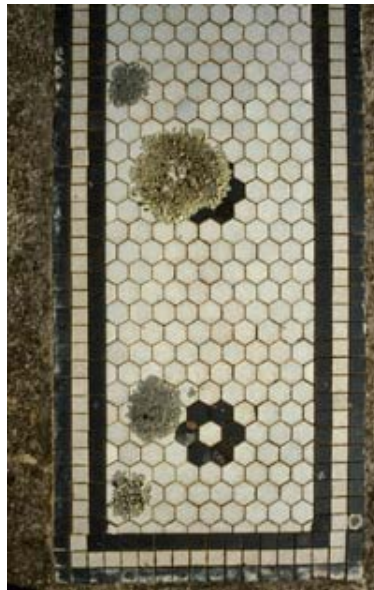
Here cleaning is unnecessary, and may cause damage

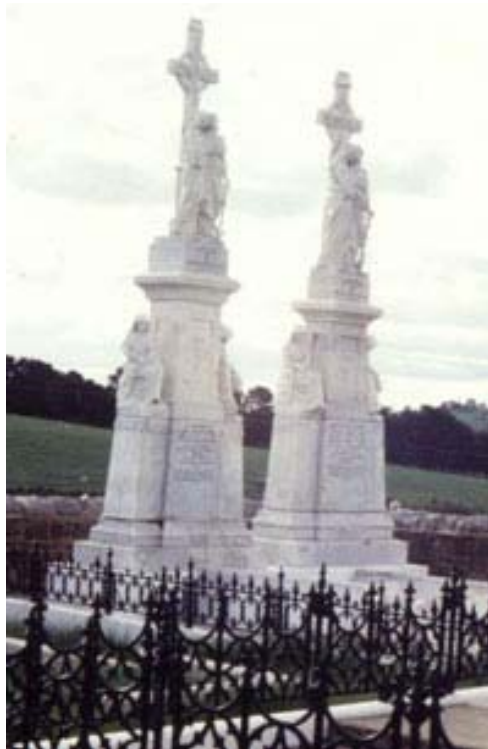
Whatever method is used, overcleaning can spoil the character of an old monument

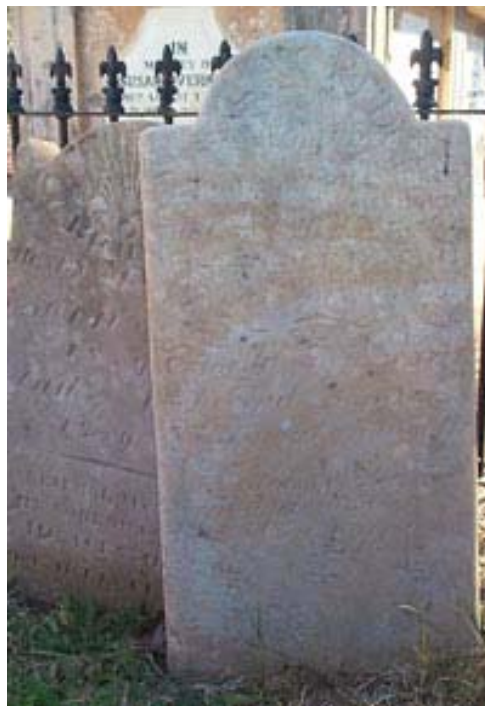
Acid cleaning of marble almost always causes both physical and aesthetic problems

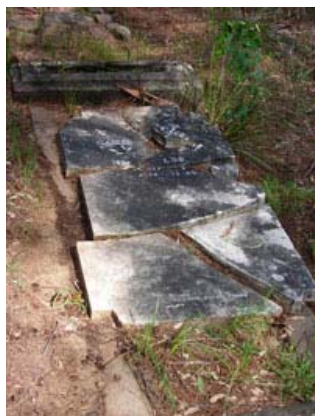
The most common reason for breakage is vandalism

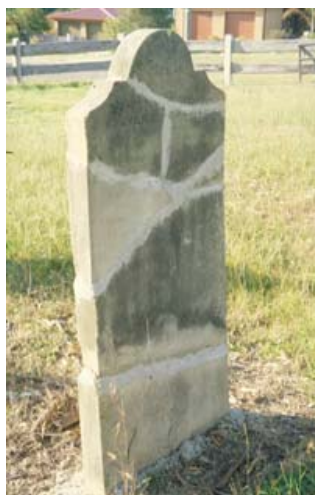
Amateur repairs can have unfortunate results

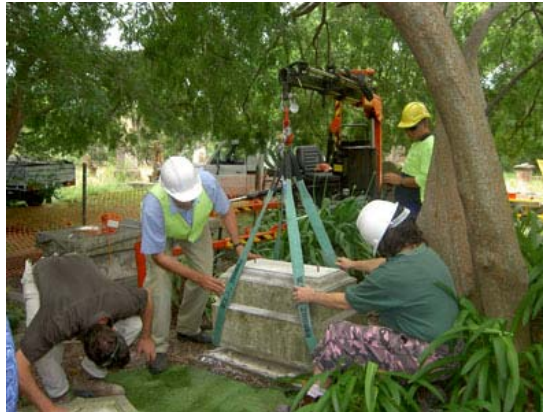
The first step in repair was to re-erect the monument base

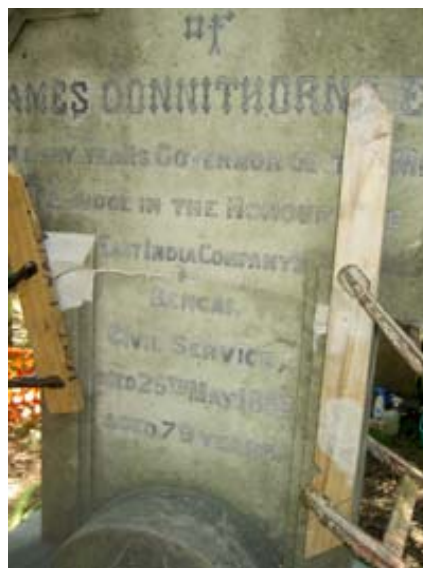
Joining the stone was then a difficult task involving hidden dowels and clamping of the parts

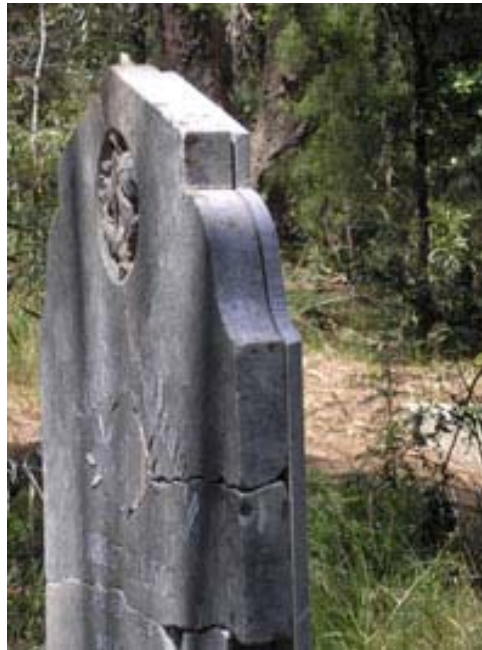
An alternative, where there are many breaks, involves assembling the pieces onto a fibreboard backing

The backing plate may be of stainless steel plate with an angle fixed to the stone plinth or base-block; or it may be of compressed fibre cement sheeting, preferably 15 mm or more. In either case the backing plate should be cut to the outline of the stone edge, and be soundly fixed to each piece of the broken monument.

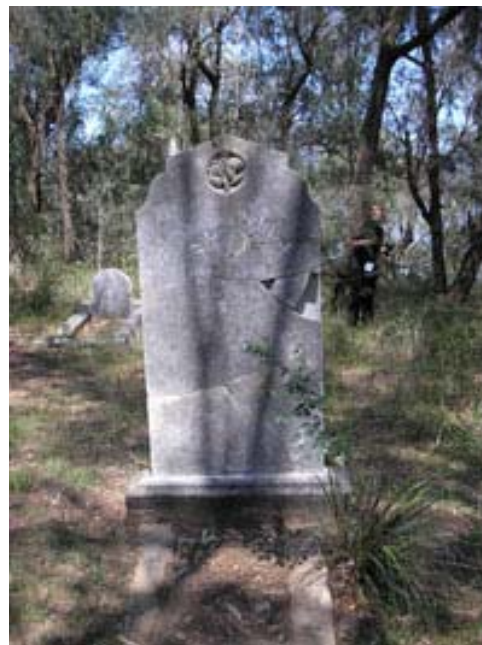
This is possible even where some parts cannot be found
