Slab Barn and Outbuildings Heritage Listing Planning Proposal - Appendix A, B and C

LEP001/25 Hawkesbury Slab Barns and Outbuildings LEP Amendment

Appendix A – Heritage Items Appendix B – Heritage Inventory Sheets Appendix C – Heritage Items Maps

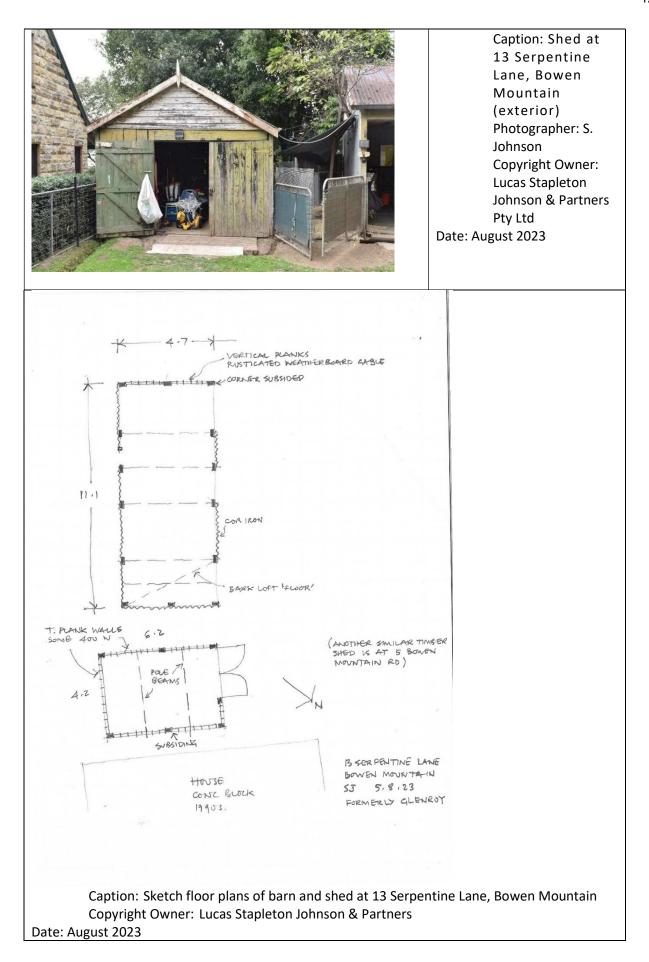
Caption: Barn at 13 Serpentine Lane, Bowen Mountain (exterior) Photographer: S. Johnson Copyright Owner: Lucas Stapleton Johnson & Partners Pty Ltd Date: August 2023
Caption: Barn at 13 Serpentine Lane, Bowen Mountain (interior) Photographer: S. Johnson Copyright Owner: Lucas Stapleton Johnson & Partners Pty Ltd Date: August 2023

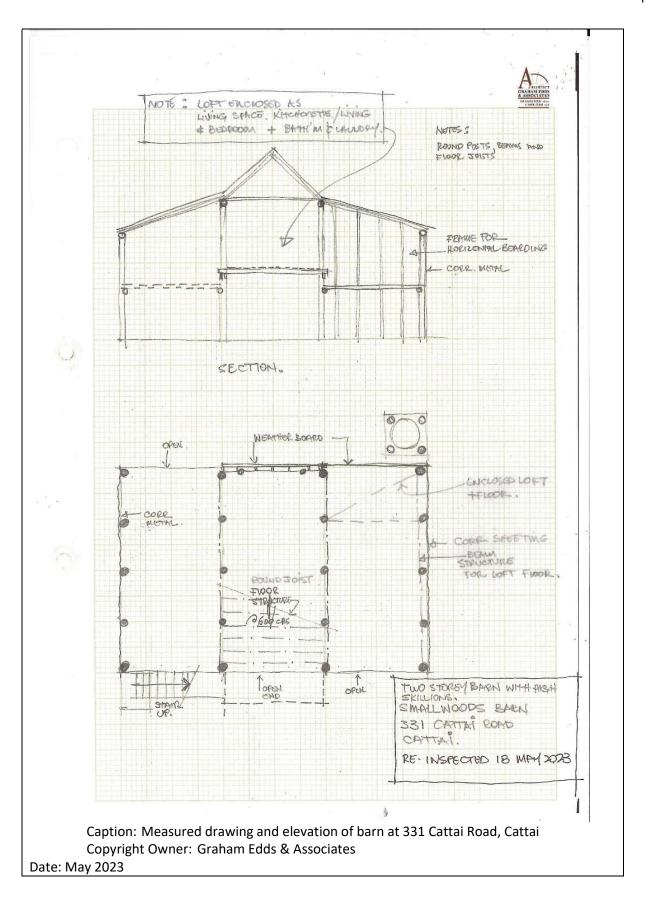
Caption: Barn at 331 Cattai Road, Cattai (exterior) Photographer: S. Johnson Copyright Owner: Lucas Stapleton Johnson & Partners Pty Ltd Date: May 2023
Caption: Barn at 331 Cattai Road, Cattai (interior) Photographer: S. Johnson Copyright Owner: Lucas Stapleton Johnson & Partners Pty Ltd Date: May 2023
Caption: Barn at 331 Cattai Road, Cattai (interior) Photographer: S. Johnson Copyright Owner: Lucas Stapleton Johnson & Partners Pty Ltd Date: May 2023

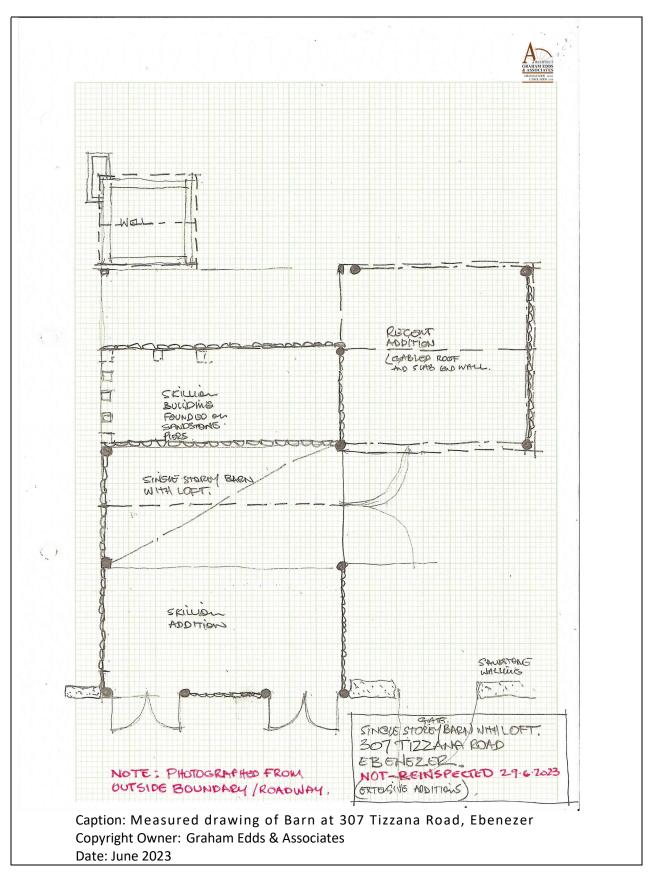
Caption: Barn 307 Tizzana Road, Ebenezer (exterior) Photographer: S. Johnson Copyright Owner: Lucas Stapleton Johnson & Partners Pty Ltd Date: June 2023

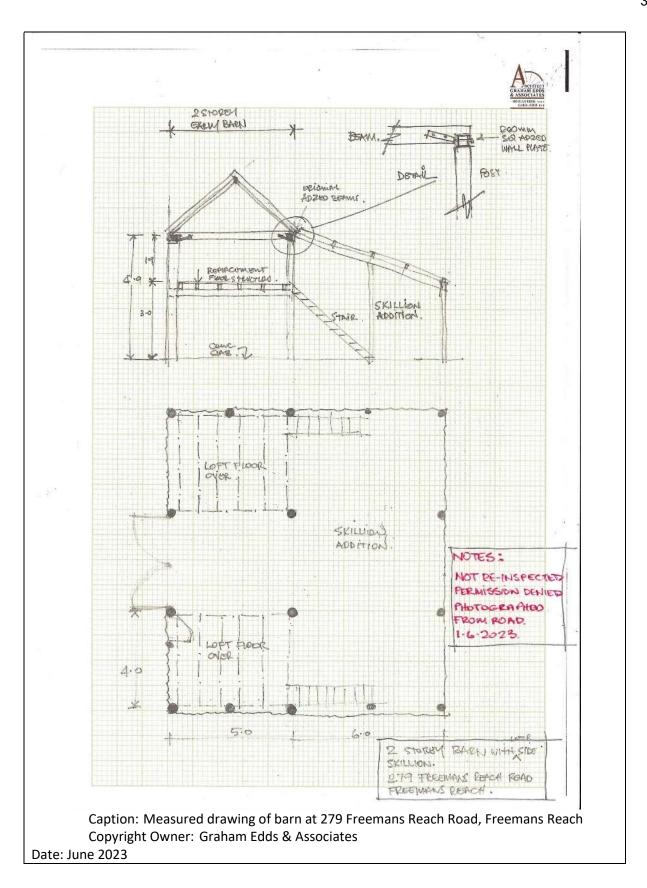
Caption: Barn at 279 Freemans Reach Road, Freemans Reach (exterior) Photographer: G. Edds Copyright Owner: Graham Edds & Associates Date: June 2023
Caption: Barn at 279 Freemans Reach Road, Freemans Reach (interior) Photographer: G. Edds Copyright Owner: Graham Edds & Associates Date: 2009

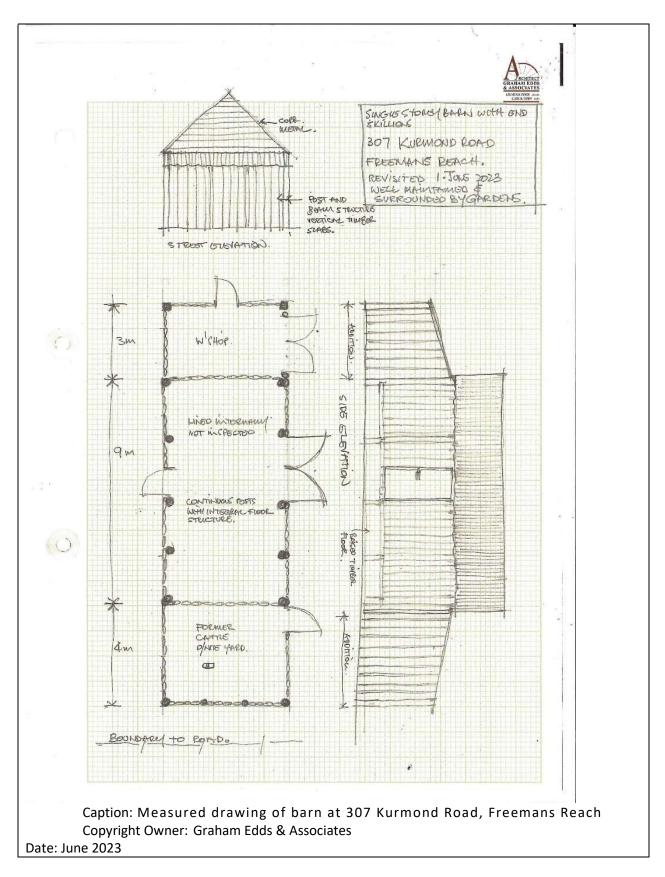
Caption: Barn at 307 Kurmond Road, Freemans Reach Photographer: S. Johnson Copyright Owner: Lucas Stapleton Johnson & Partners Pty Ltd Date: June 2023
Caption: Barn at 307 Kurmond Road, Freemans Reach Photographer: S. Johnson Copyright Owner: Lucas Stapleton Johnson & Partners Pty Ltd Date: June 2023

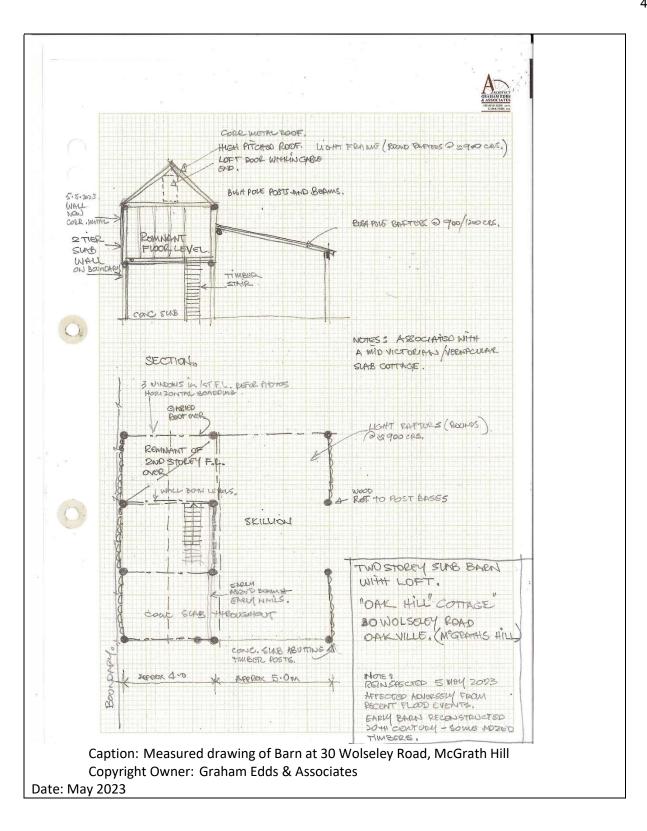
Caption: Barn at 30 Wolseley Road, McGraths Hill (exterior) Photographer: K. Denny Copyright Owner: Lucas Stapleton Johnson & Partners Pty Ltd Date: May 2023
Caption: Barn at 30 Wolseley Road, McGraths Hill (interior) Photographer: K. Denny Copyright Owner: Lucas Stapleton Johnson & Partners Pty Ltd Date: May 2023

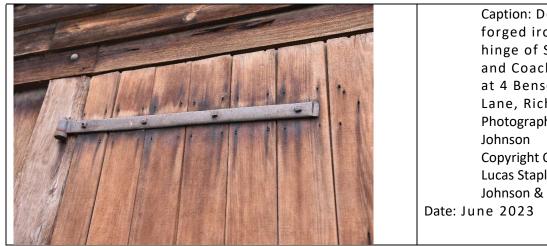
IMAGES	
	Caption: Stables and Coach house at 4 Bensons Lane, Richmond (exterior) Photographer: S. Johnson Copyright Owner: Lucas Stapleton Johnson & Partners Date: June 2023
	Caption: Detail of log floor to Stables at 4 Bensons Lane, Richmond Photographer: S. Johnson Copyright Owner: Lucas Stapleton Johnson & Partners Date: June 2023

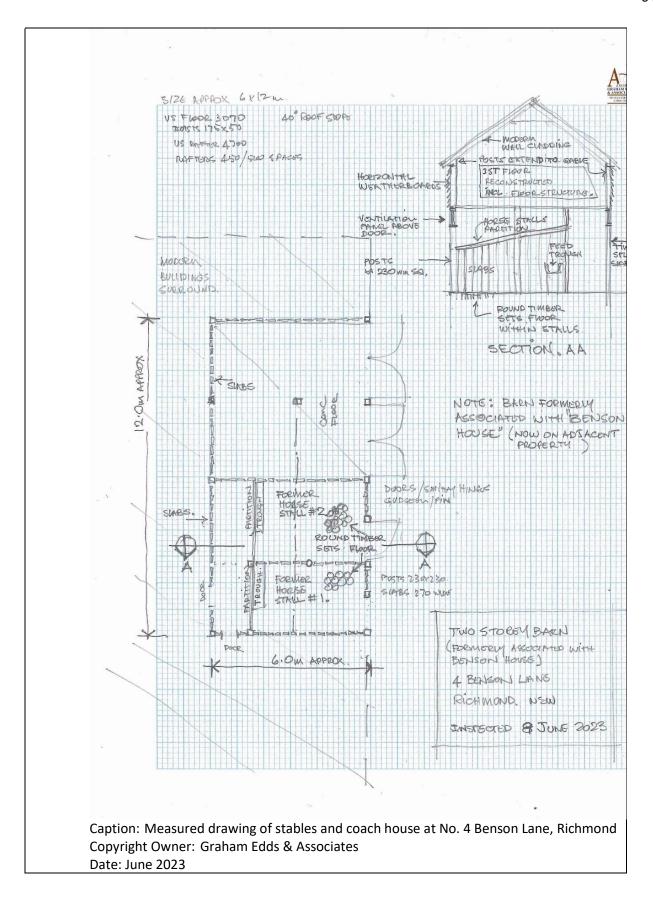
Caption: Detail of forged iron hinge of Stables and Coach house at 4 Bensons Lane, Richmond Photographer: S. Copyright Owner: Lucas Stapleton Johnson & Partners

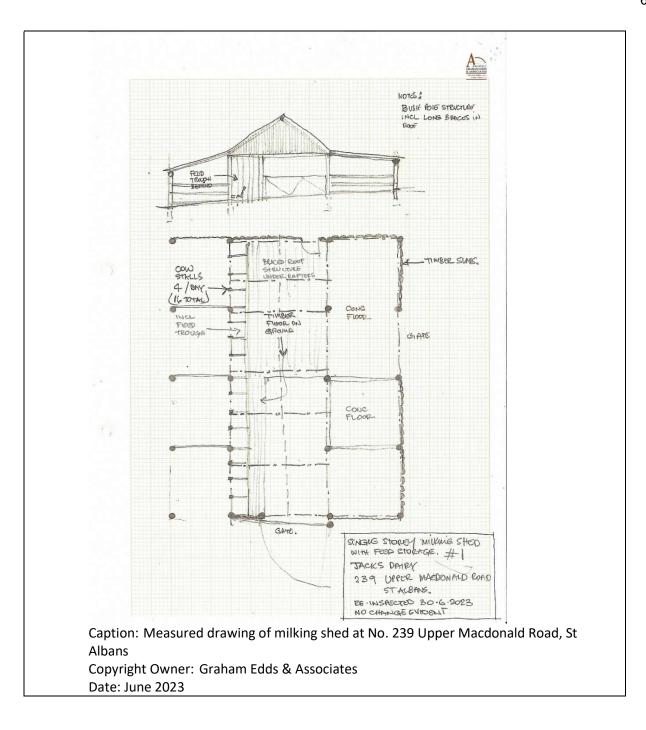
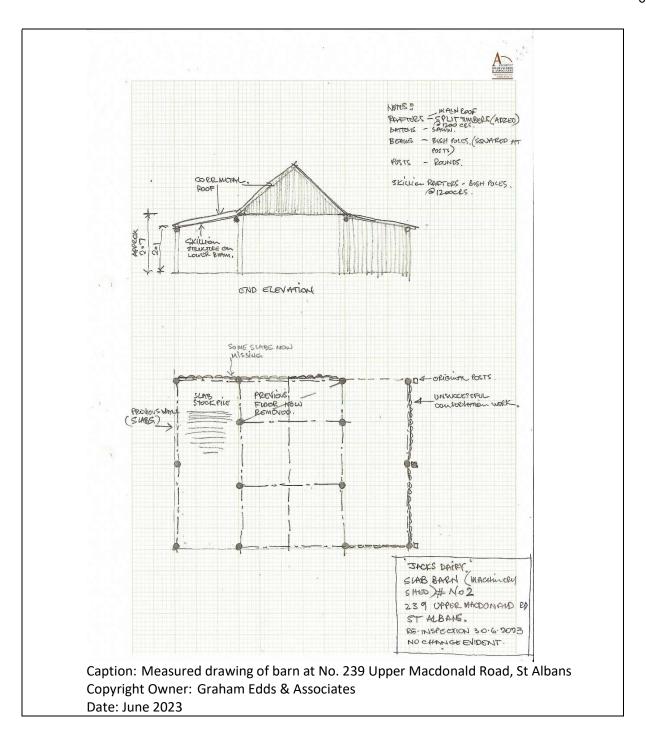
Caption: Milking Shed at No. 239 Upper Macdonald Road, St Albans (interior) Photographer: S. Johnson Copyright Owner: Lucas Stapleton Johnson & Partners Date: June 2023
Caption: Detail of Milking Shed at No. 239 Upper Macdonald Road, St Albans (exterior) Photographer: S. Johnson Copyright Owner: Lucas Stapleton Johnson & Partners Date: June 2023
Caption: Barn at No. 239 Upper Macdonald Road, St Albans (exterior) Photographer: S. Johnson Copyright Owner: Lucas Stapleton Johnson & Partners Date: June 2023

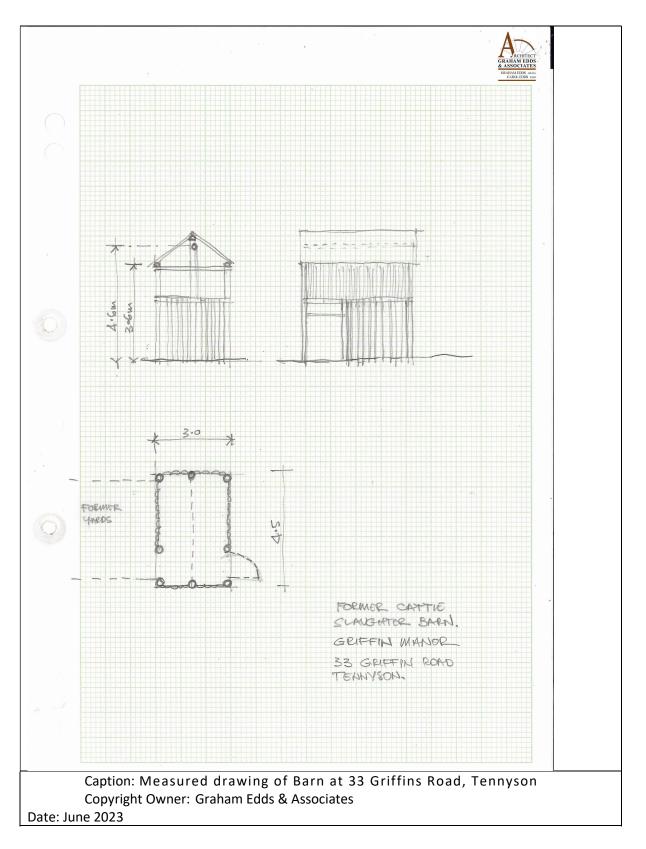
IMAGES	
	Caption: Barn at No. 33 Griffins Rd, Tennyson Photographer: G. Edds Copyright Owner: Graham Edds & Associates Date: June 2023
	Caption: Barn at No. 33 Griffins Rd, Tennyson Photographer: G. Edds Copyright Owner: Graham Edds & Associates Date: June 2023

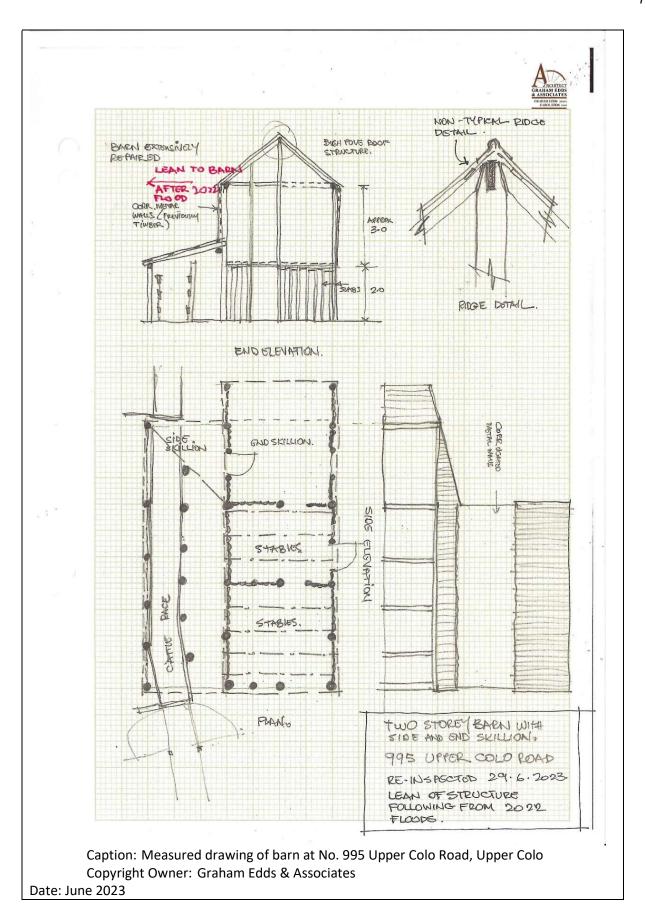
Caption: Barn at No. 995 Upper Colo Road, Upper Colo (exterior) Photographer: S. Johnson Copyright Owner: Lucas Stapleton Johnson & Partners Date: June 2023
Caption: Interior detail of barn at No. 995 Upper Colo Road, Upper Colo Photographer: S. Johnson Copyright Owner: Lucas Stapleton Johnson & Partners Date: June 2023
Caption: Barn at No. 995 Upper Colo Road, Upper Colo (exterior) Photographer: S. Johnson Copyright Owner: Lucas Stapleton Johnson & Partners Date: June 2023

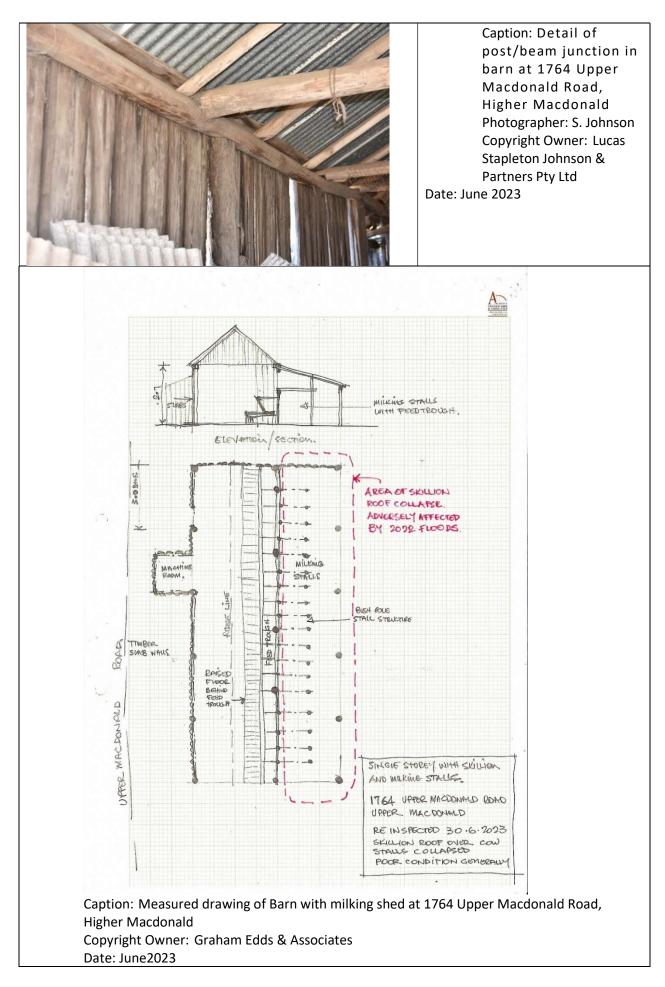
<section-header></section-header>	Caption: Barn at 1764 Upper Macdonald Road, Higher Macdonald (exterior) Photographer: S. Johnson Copyright Owner: Lucas Stapleton Johnson & Partners Pty Ltd Date: June 2023
	Caption: Barn at 1764 Upper Macdonald Road, Higher Macdonald (exterior) Photographer: S. Johnson Copyright Owner: Lucas Stapleton Johnson & Partners Pty Ltd Date: June 2023
	Caption: Barn at 1764 Upper Macdonald Road, Higher Macdonald (interior) Photographer: S. Johnson Copyright Owner: Lucas Stapleton Johnson & Partners Pty Ltd Date: June 2023

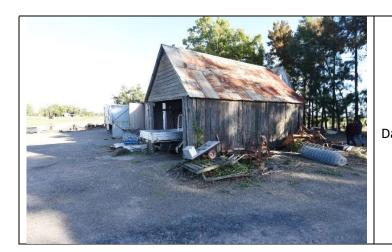
Caption: Barn A at 253 Wilberforce Road, Wilberforce (exterior) Photographer: S. Johnson Copyright Owner: Lucas Stapleton Johnson & Partners Pty Ltd Date: May 2023
Caption: Barn A at 253 Wilberforce Road, Wilberforce (interior) Photographer: S. Johnson Copyright Owner: Lucas Stapleton Johnson & Partners Pty Ltd Date: May 2023

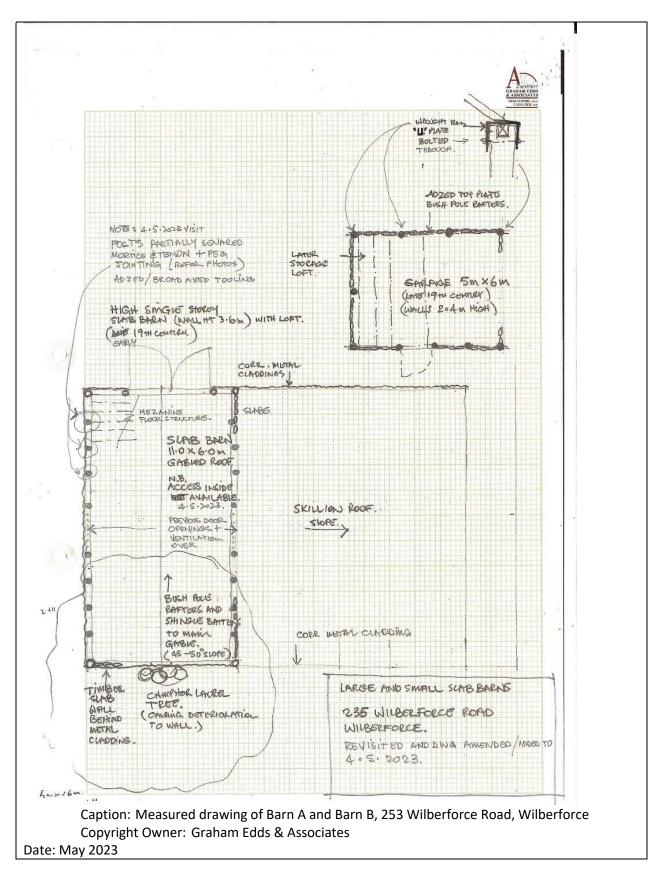
Caption: Barn B at 253 Wilberforce Road, Wilberforce (exterior) Photographer: S. Johnson Copyright Owner: Lucas Stapleton Johnson & Partners Pty Ltd Date: May 2023

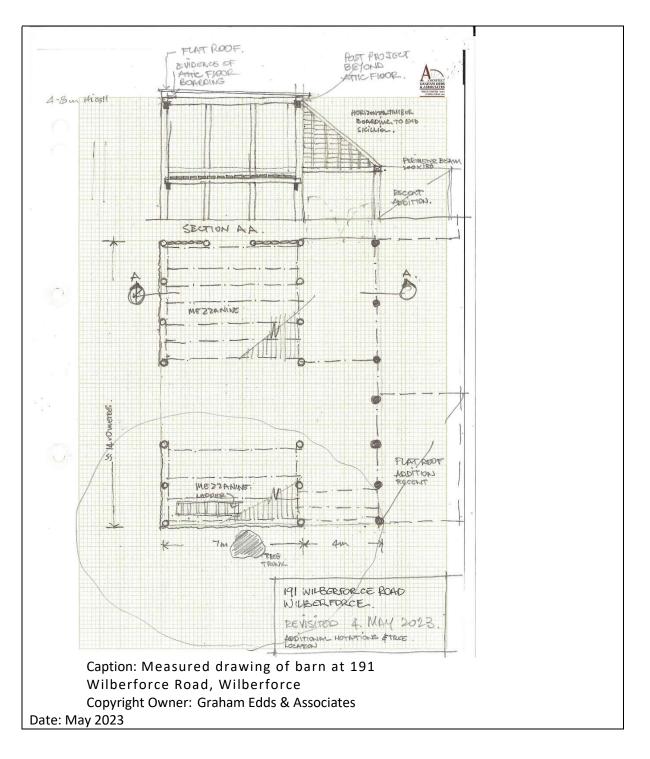
Caption: Barn at 191 Wilberforce Road, Wilberforce (exterior) Photographer: K. Denny Copyright Owner: Lucas Stapleton Johnson & Partners Date: May 2023
	Caption: Barn at 191 Wilberforce Road, Wilberforce (exterior and skillion) Photographer: K. Denny Copyright Owner: Lucas Stapleton Johnson & Partners Date: May 2023
<image/>	Caption: Barn at 191 Wilberforce Road, Wilberforce (interior) Photographer: K. Denny Copyright Owner: Lucas Stapleton Johnson & Partners Date: May 2023

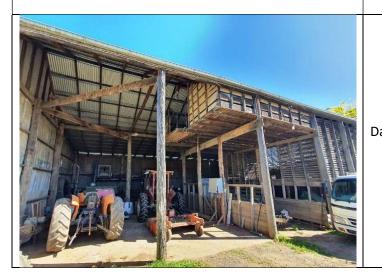
Caption: Barn at 63 Wilberforce Road, Wilberforce (exterior) Photographer: S. Johnson Copyright Owner: Lucas Stapleton Johnson & Partners Date: May 2023

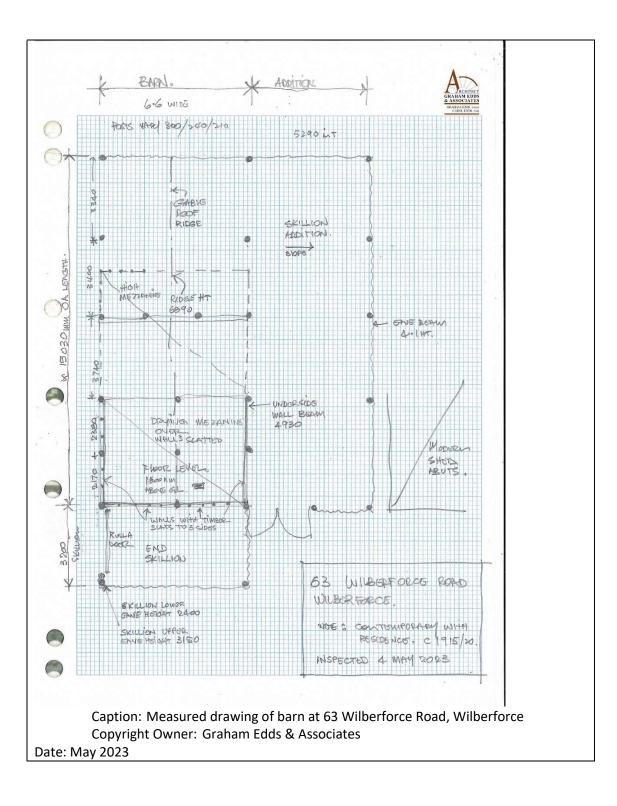
Caption: Barn at 63 Wilberforce Road, Wilberforce (interior) Photographer: S. Johnson Copyright Owner: Lucas Stapleton Johnson & Partners Date: May 2023
