Hawkesbury Masterplan: Windsor
Historical Heritage Assessment and
Constraints Analysis Final Report

Hawkesbury Masterplan: Richmond Historical Heritage Assessment and Constraints Analysis

FINAL REPORT

Prepared for Place Group Design

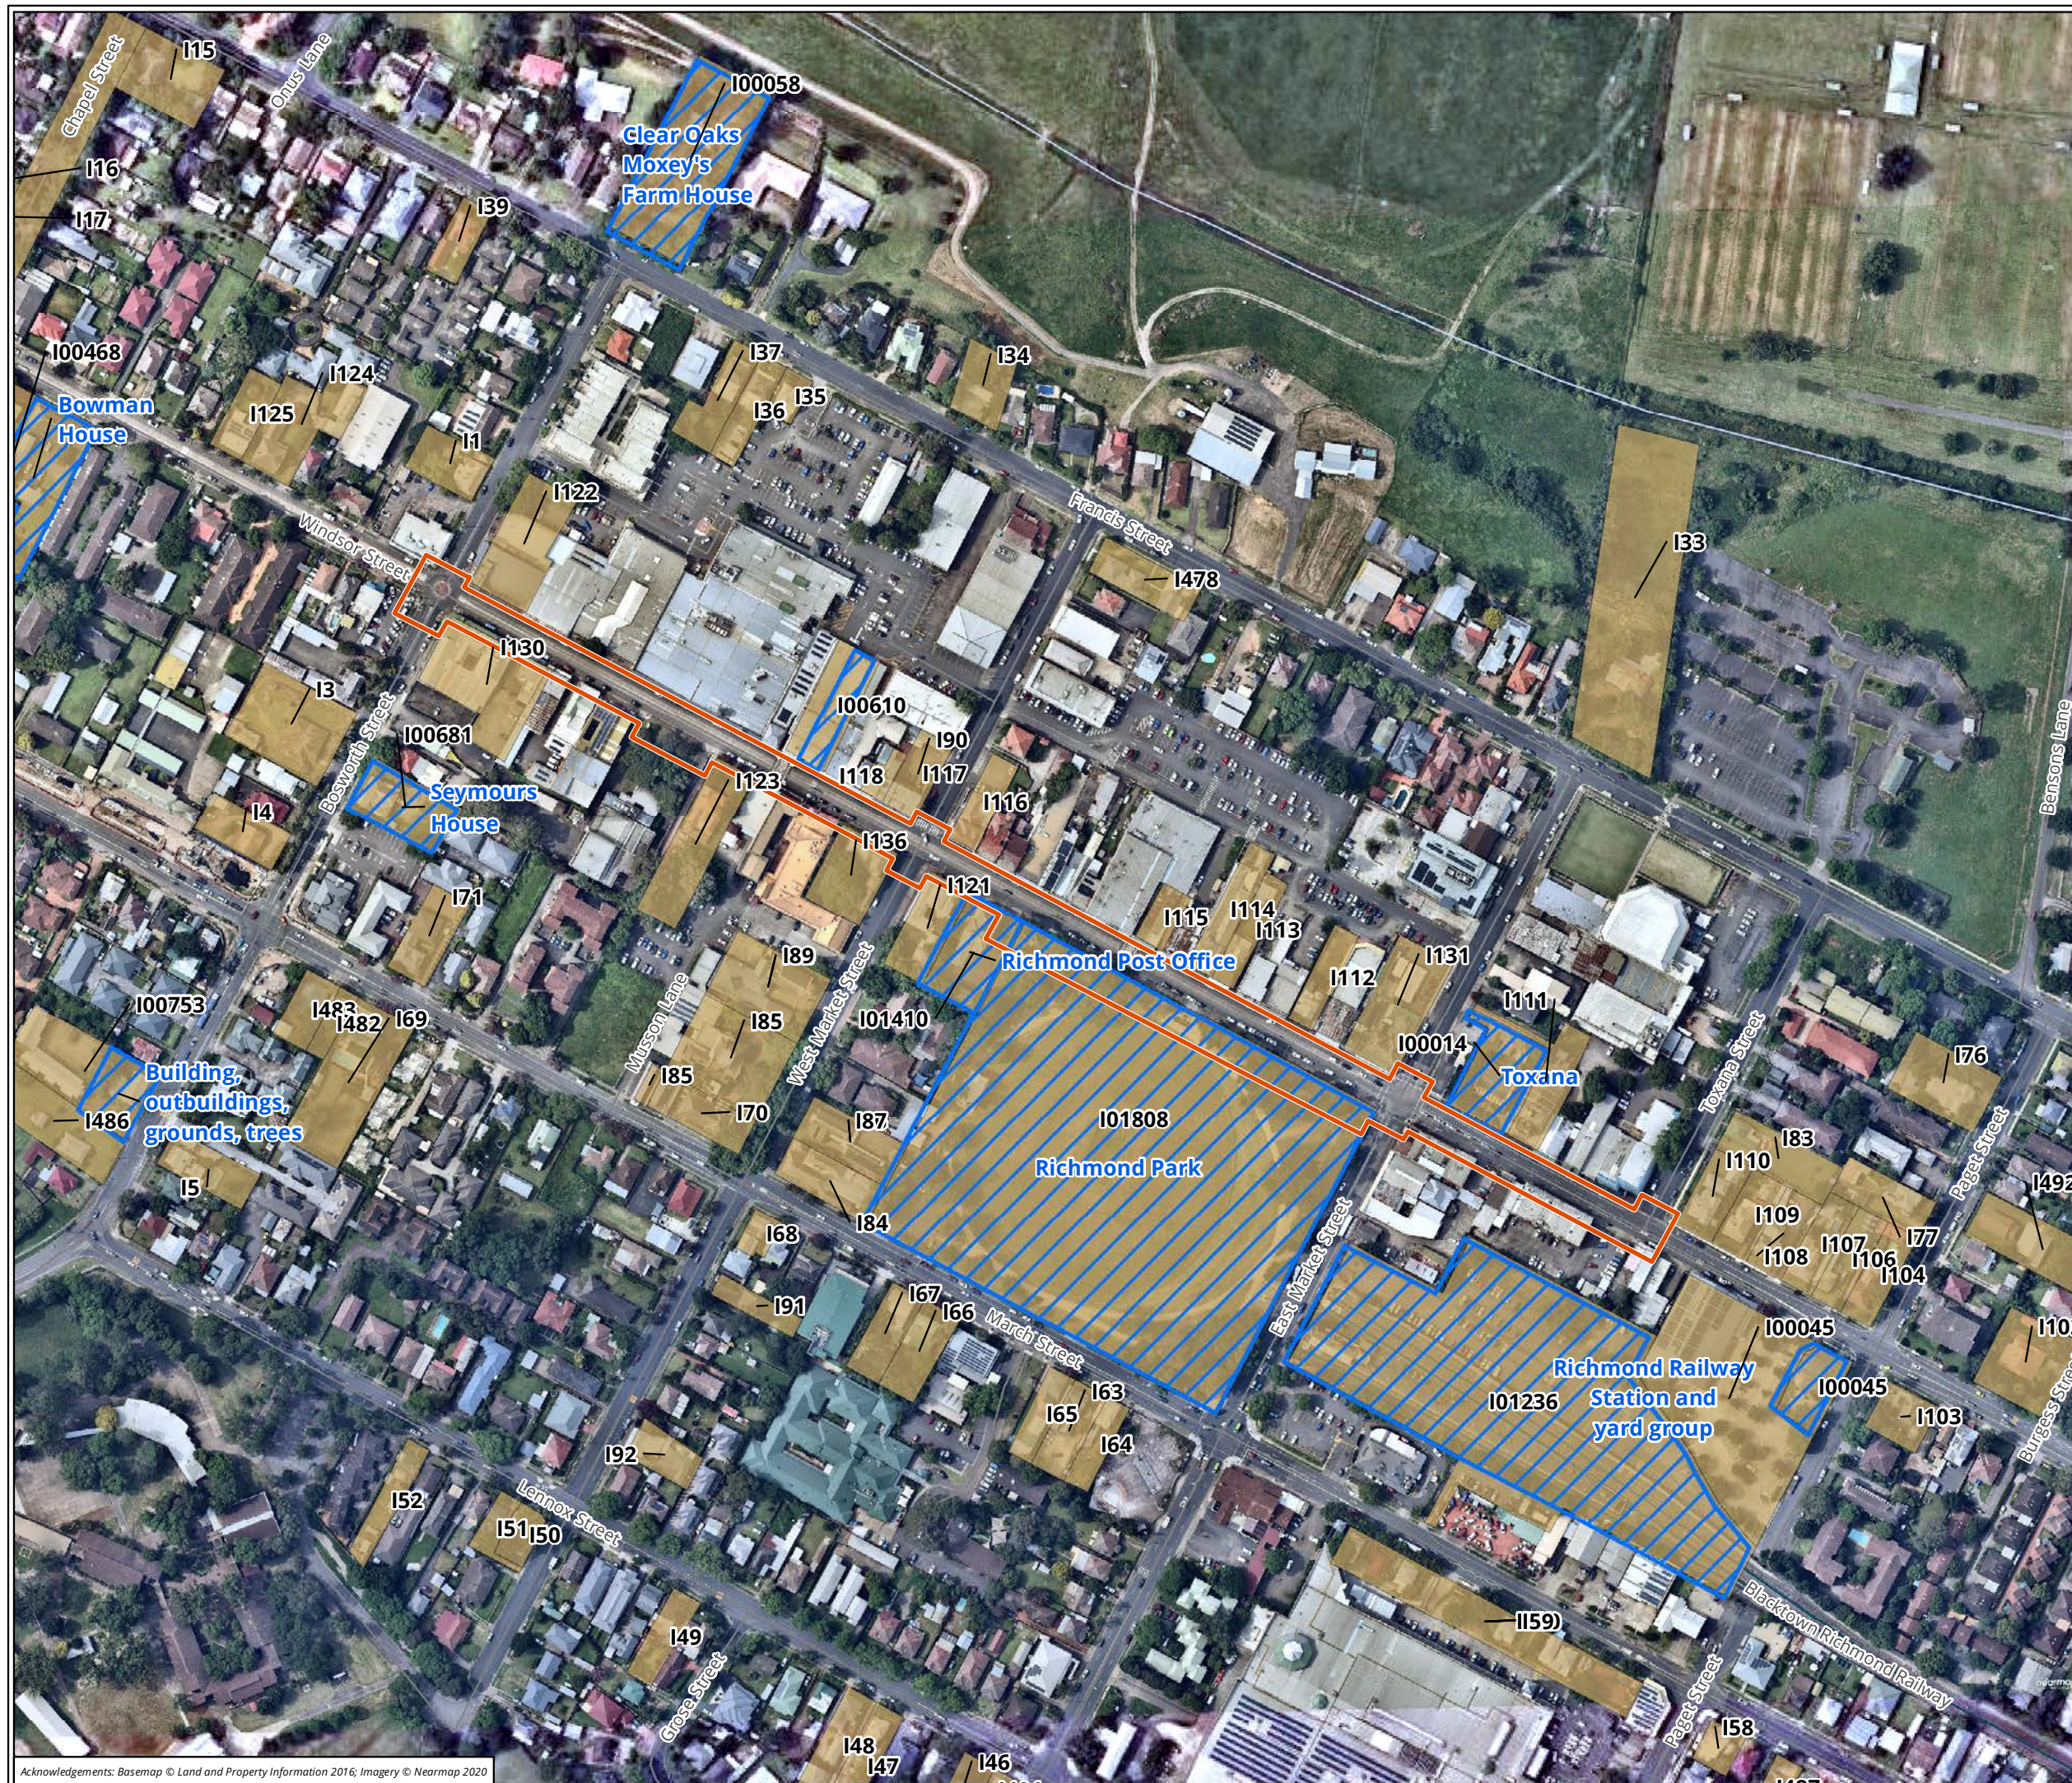
Figure 3 Heritage items in the vicinity of the study area

- Legend**
- Study area
 - Local heritage item**
 - Item - General
 - State heritage item

The Hawkesbury LEP 2012 contains schedules of heritage items that are managed by the controls in the instrument. Heritage items in the vicinity of the study area are identified in Figure 3.

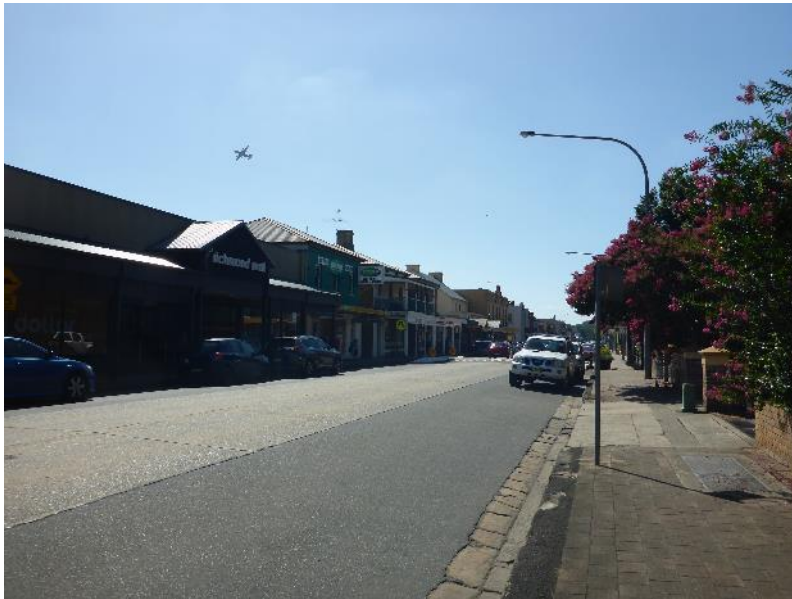
Photo 3 Area R01, Windsor Street showing a mixture of 19th century and modern development in the western portion of the study area

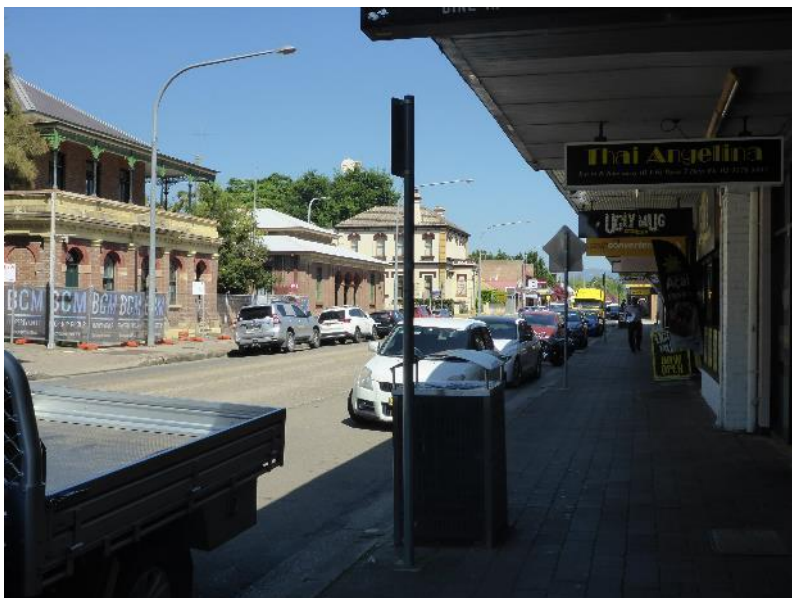
Photo 4 Area R01.1, Windsor Street showing heritage items Richmond Post Office (01410), Court House (I121) and Bank and stables (I136)

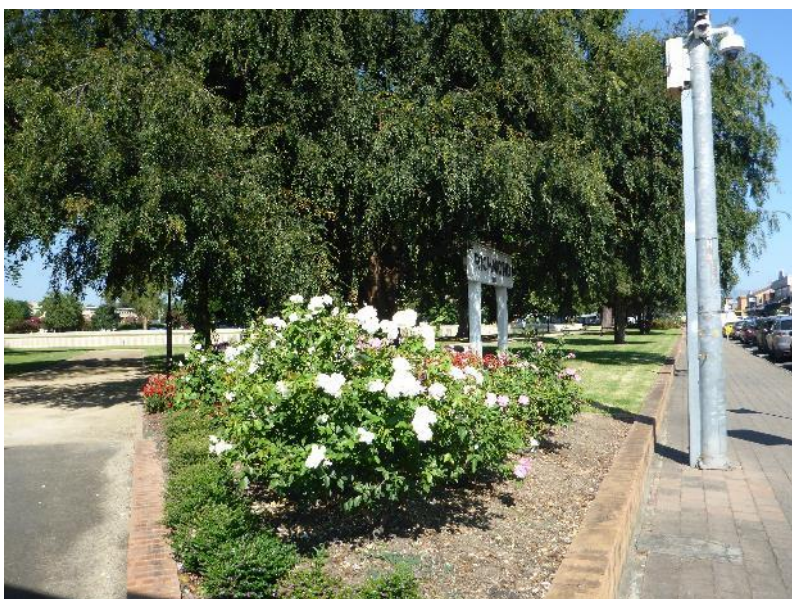
Photo 5 Area R02, Richmond Park Interface Richmond Park and Windsor Street in the eastern portion of the study area

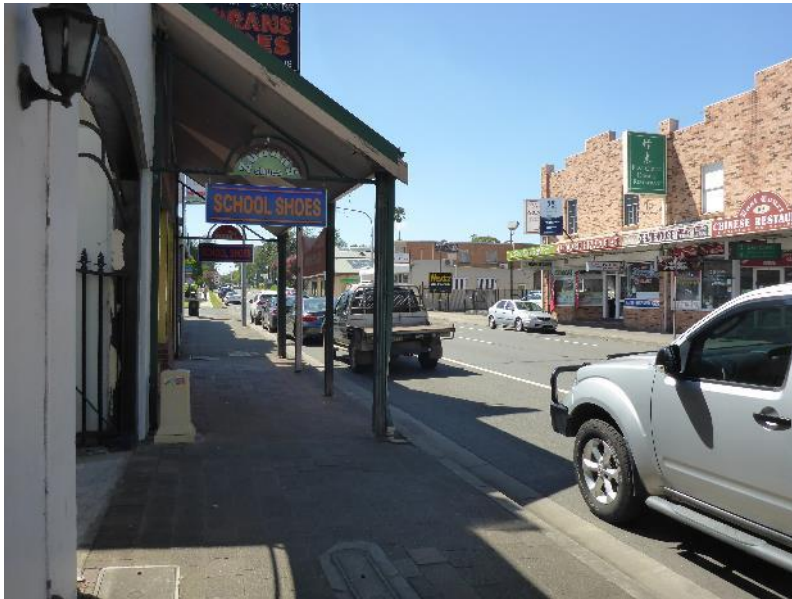
Photo 6 Area R01 Windsor Street showing a mixture of 20th century buildings in the eastern portion of the study area

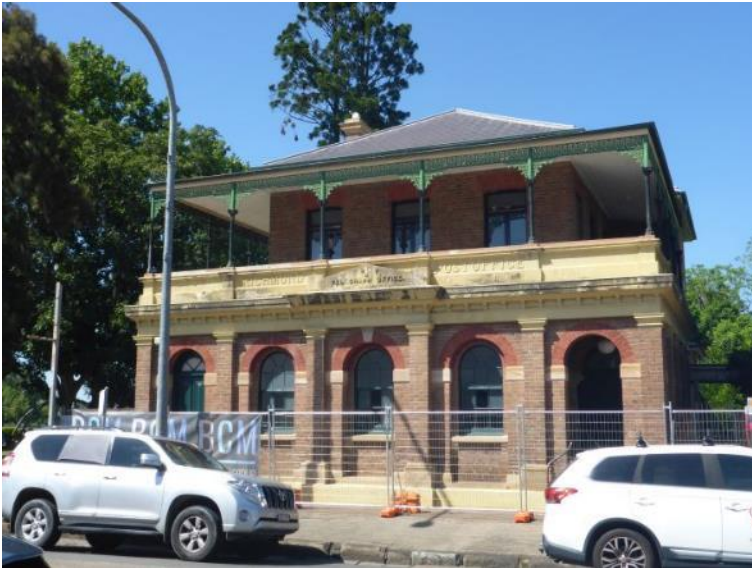
Photo 7 Post and telegraph office and stables, Richmond Post office (Item no. 1410 on the SHR and I01410 on the LEP), currently under renovations

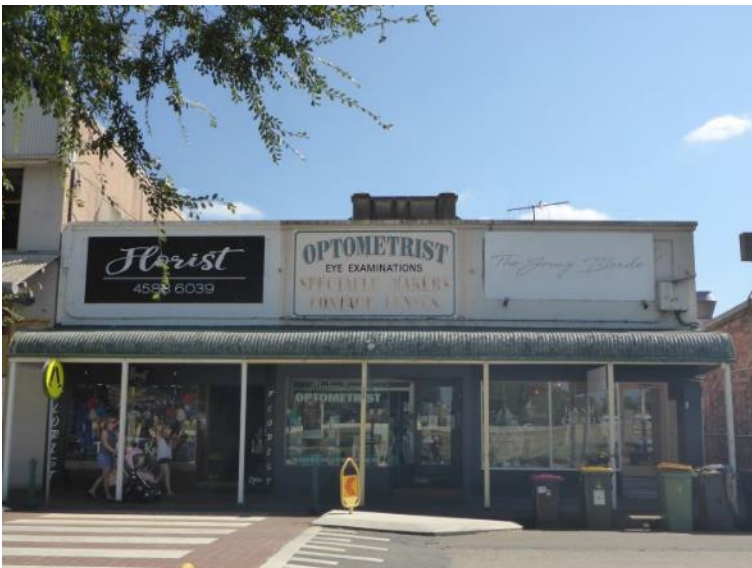
Photo 10 Example of a heritage item with an awning that extends into the street, Item no. 115 (LEP)

It should also be noted that while other listed items aren't necessarily within the study area, their awnings do encroach into the foot path/road reserve as seen in Photo 10. Some of these verandah awnings are attached to newer non-heritage buildings, or may not be original to / a historical component of the heritage item. A full photographic inventory of the heritage items directly adjacent to the study area is included as Appendix 2.

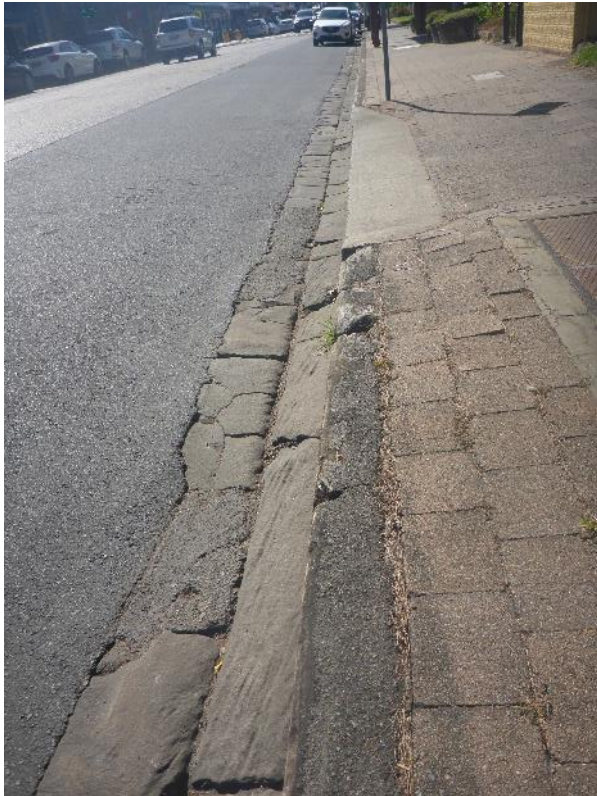
Photo 11 Example of sandstone kerbing and gutters which extended along most of Windsor Street within the study area

One item in the study area has been assessed as having heritage significance but is not listed on any heritage schedules. This is sandstone kerbing which is found throughout the study area. As per Recommendation 1 this kerbing should be retained and the design modified to avoid any impacts.

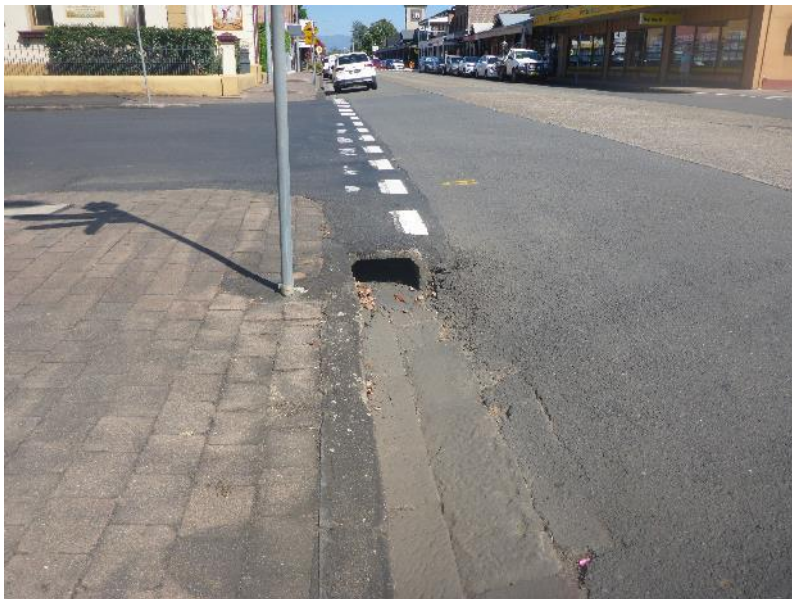
Photo 12 Example of sandstone kerbing and gutters at the corner of Windsor and West Market streets, modified by more recent infrastructure

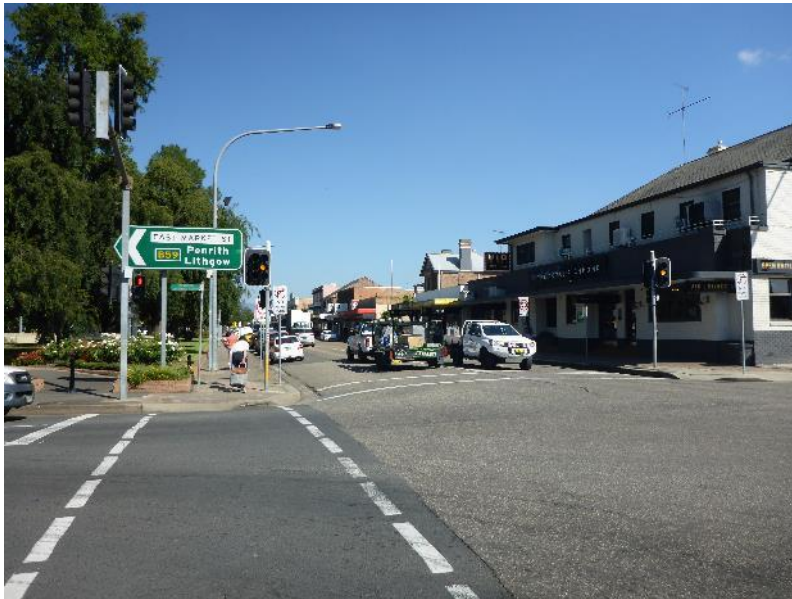
Non-historical built fabric includes brick pavers, poles for signage, lights and electricity, sealed roads, footpaths and driveways, concrete kerbs and gutters, modern infrastructure associated with traffic management, and street furniture including potted plantings, bollards and picnic tables (Photo 13, Photo 14, Photo 15).

Photo 13 Modern road surfaces, lighting, traffic management infrastructure and footpaths, located at the corner of Windsor and East Market streets

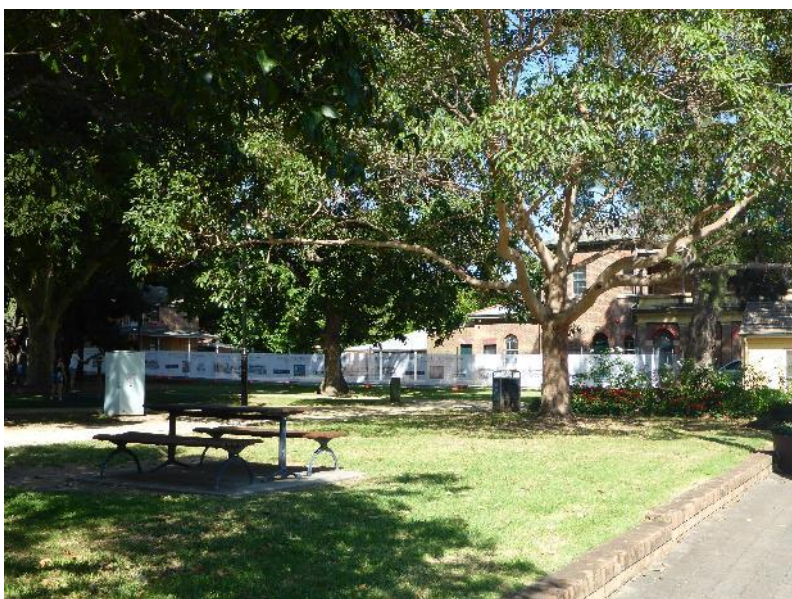
Photo 15 Modern footpaths, garden features and street furniture located at the western end of Richmond Park

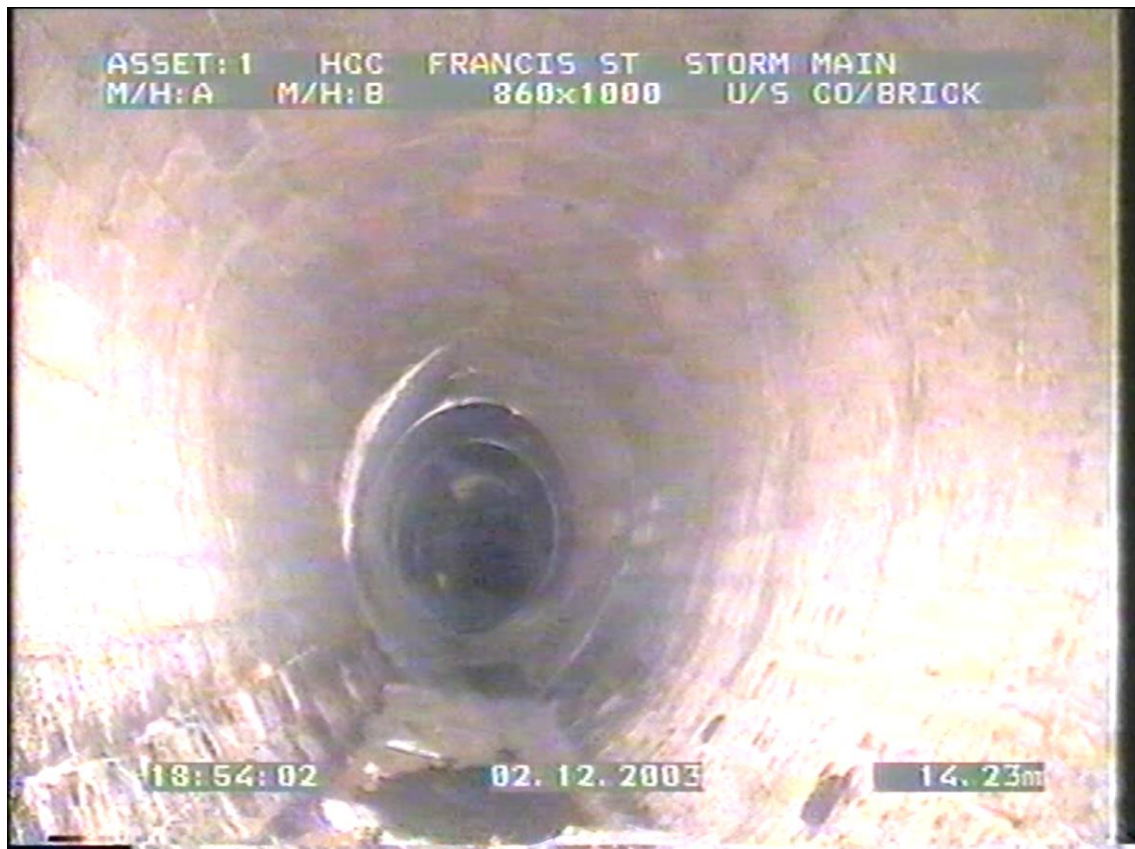
As with Windsor, Richmond contains a brick barrel drain. In contrast to Windsor however, it is unknown when this drain was constructed as it did not appear in any primary sources or histories of Richmond that Biosis uncovered at the time of writing the draft assessment. A meeting with Hawkesbury City Council revealed the presence of the drain as it runs under Francis Street, East Market Street and across Windsor Street adjacent to Richmond Park. CCTV footage was taken from inside the drain in 2003 which can be seen in Photo 18. The location can be seen in Photo 19 below provided to Biosis from Hawkesbury City Council.

Photo 18 Interior of the brick barrel drain (Source: Hawkesbury City Council)

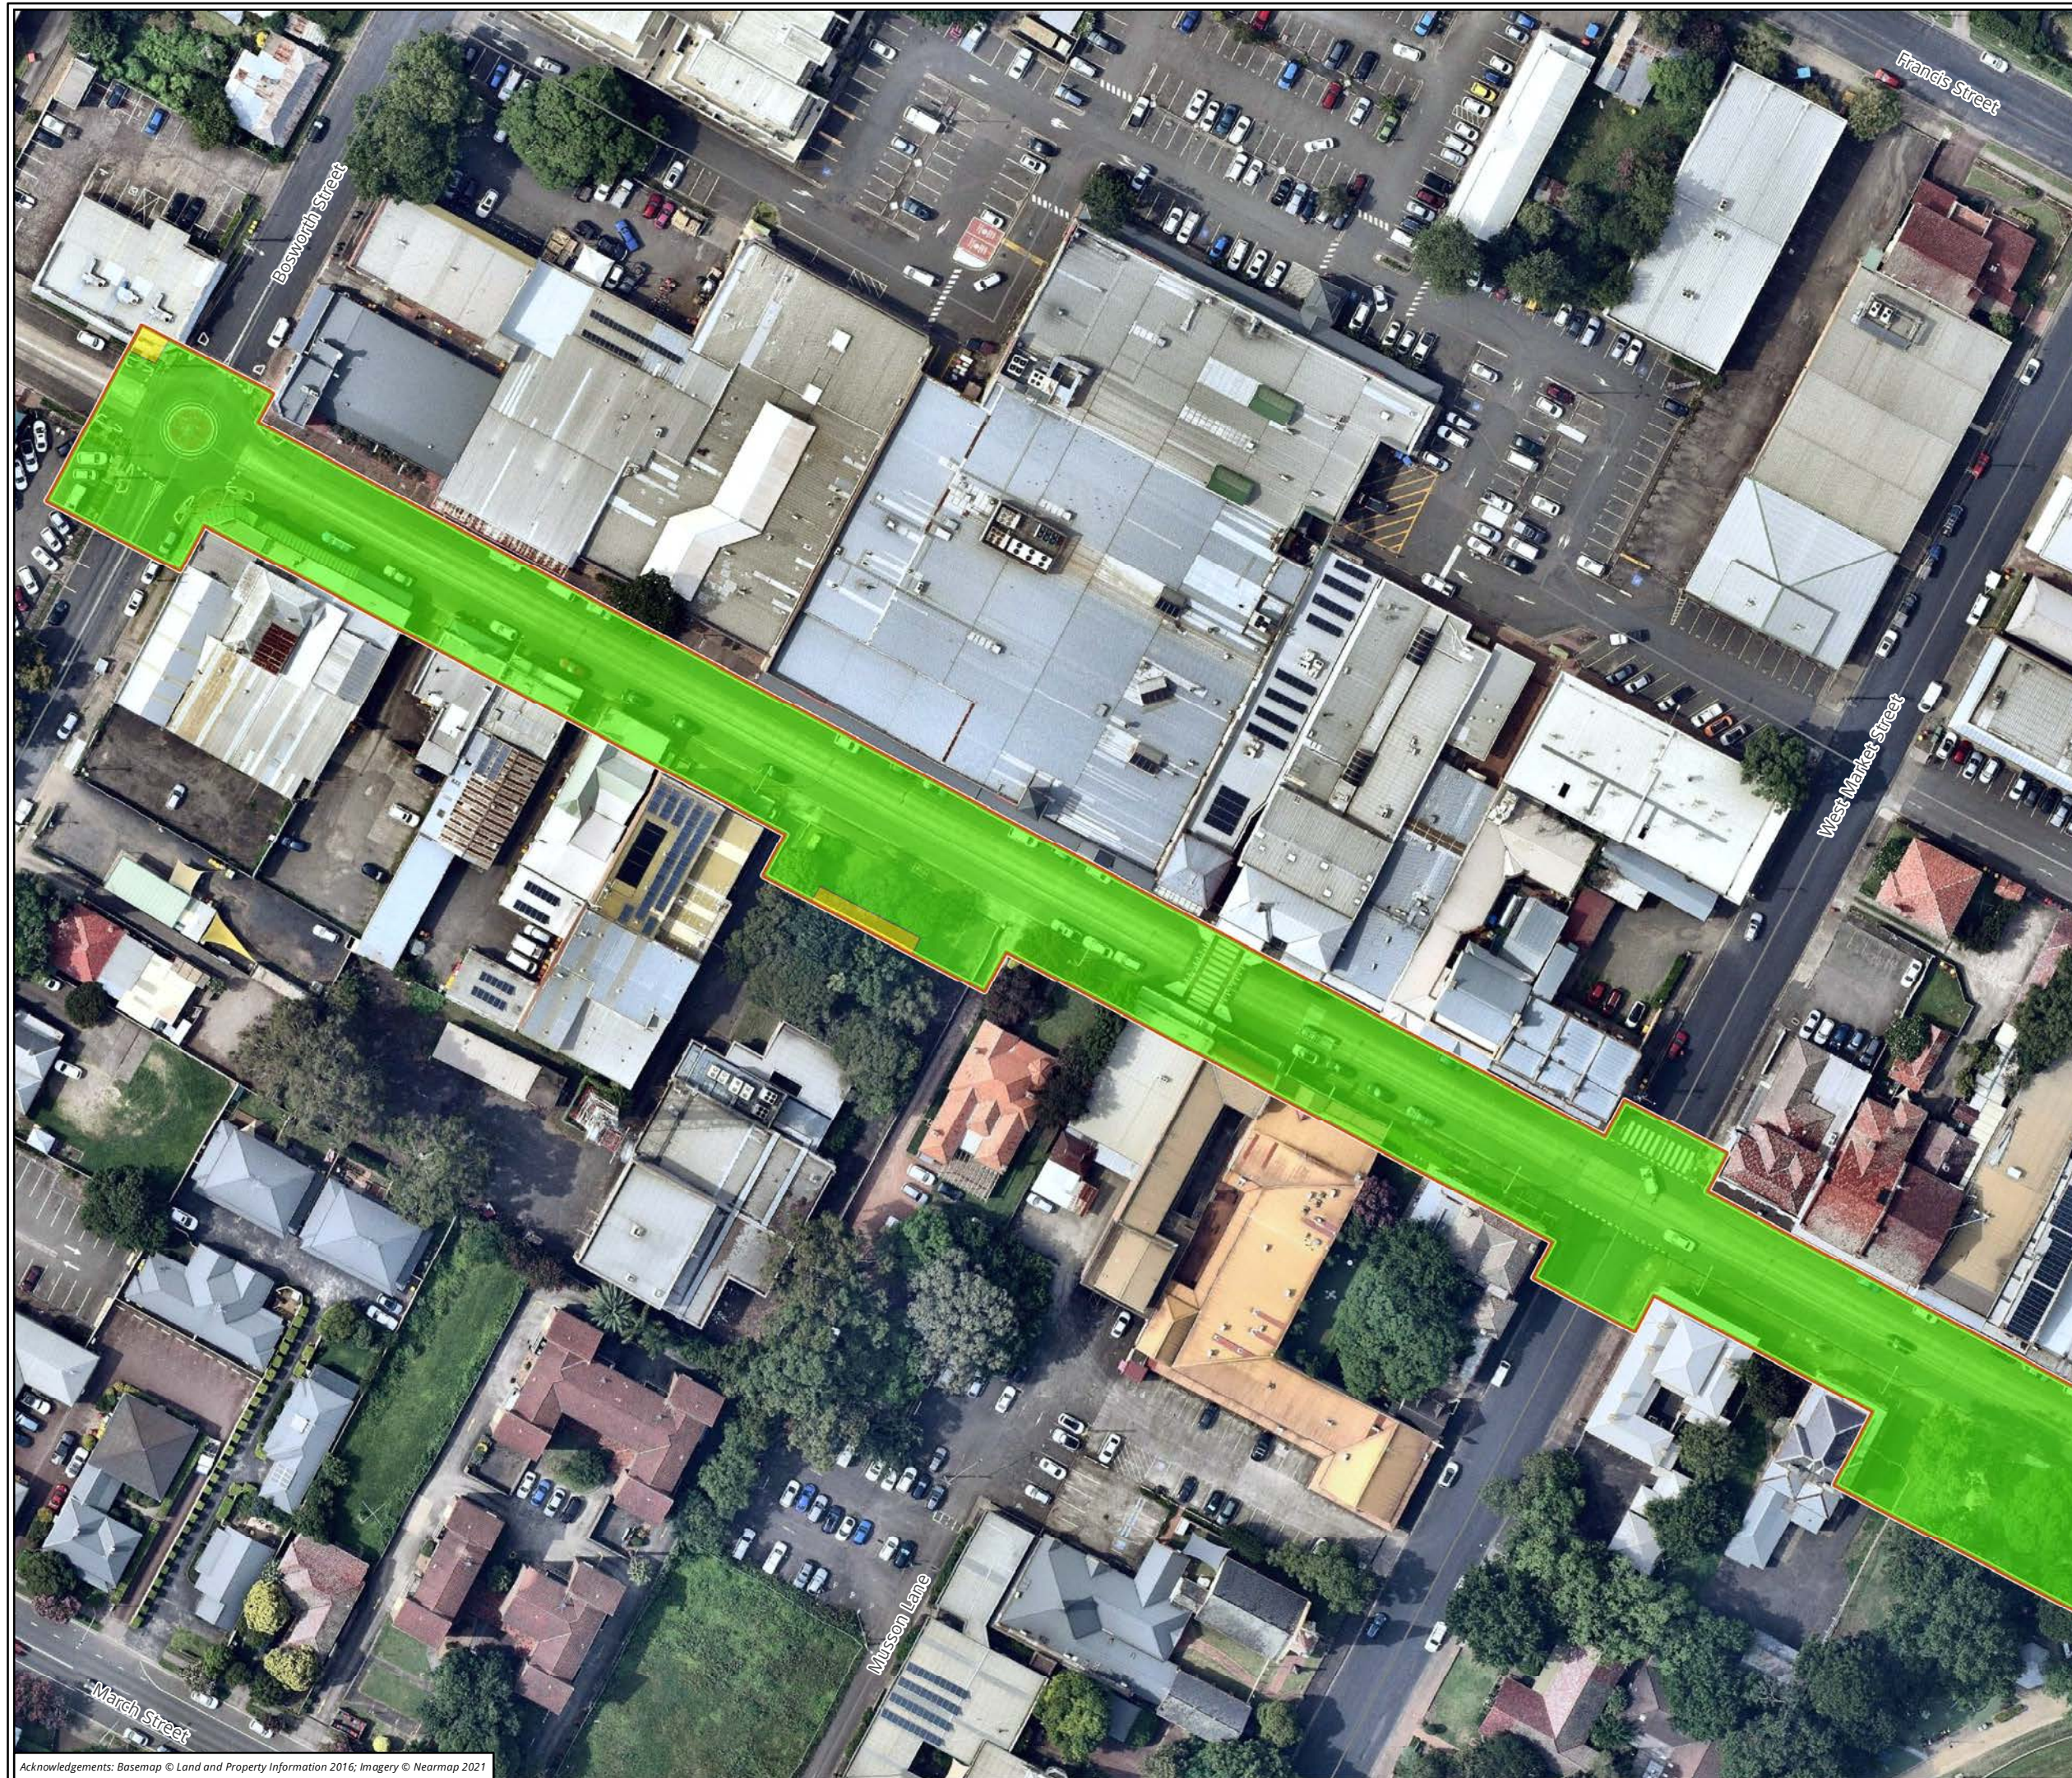
Figure 4.1 Assessment of archaeological potential

- Legend**
- Study area
 - Moderate archaeological potential
 - Low archaeological potential

Through an analysis of the above factors a number of assumptions have been made relating to the archaeological potential of the study area. These are presented in Table 11 and Figure 4.

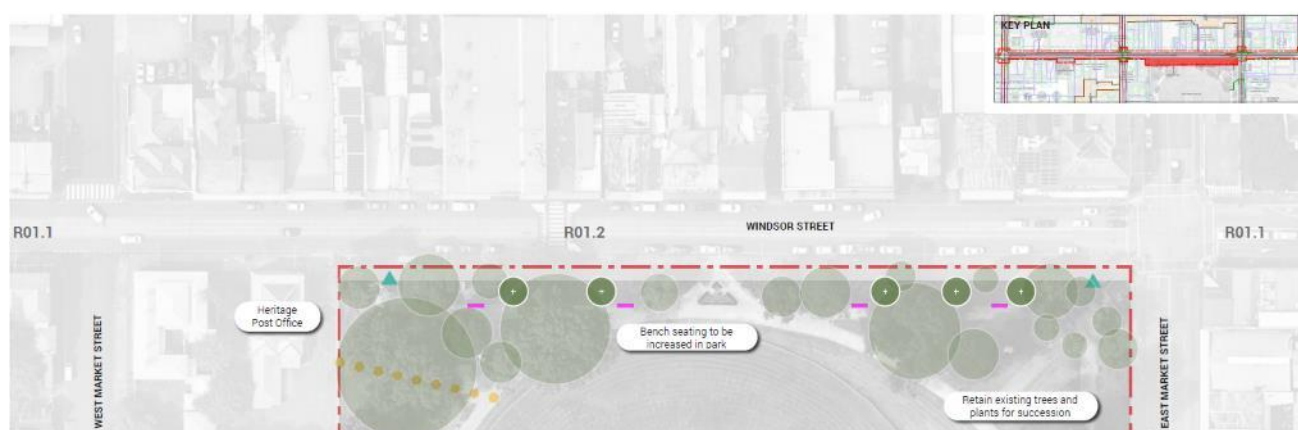
Photo 22 Proposed upgrades for R02 Richmond Park Interface

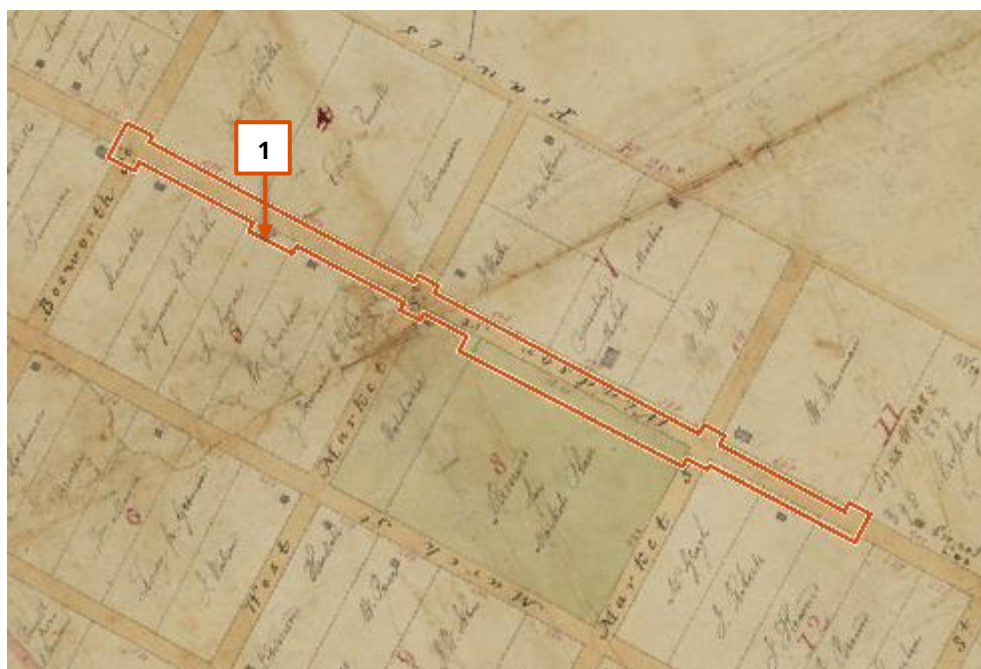
Photo 26 1811 plan of Richmond with the study area bounded in orange (Source: State Library of NSW, reference FL3779286)

above Pugh's Lagoon (outside of the study area) was consecrated, having already been in use since 1809.⁴⁷ Richmond parish was separated from Windsor and Castlereagh around 1813.⁴⁸ A town plan of Richmond dated to 1811 records eight structures in the vicinity of the study area on allotments including those named for Simmonds, Randall, Payne, Durham, the watchhouse, Watts, a chapel, Bowman and Roberts (Photo 26). The structure [1] on Payne's allotment is located in very close proximity to or on the boundary of the study area. It is possible that this plan has been annotated at a later date or has been incorrectly dated. At this date it, it is unlikely that any defined road features would have been constructed.

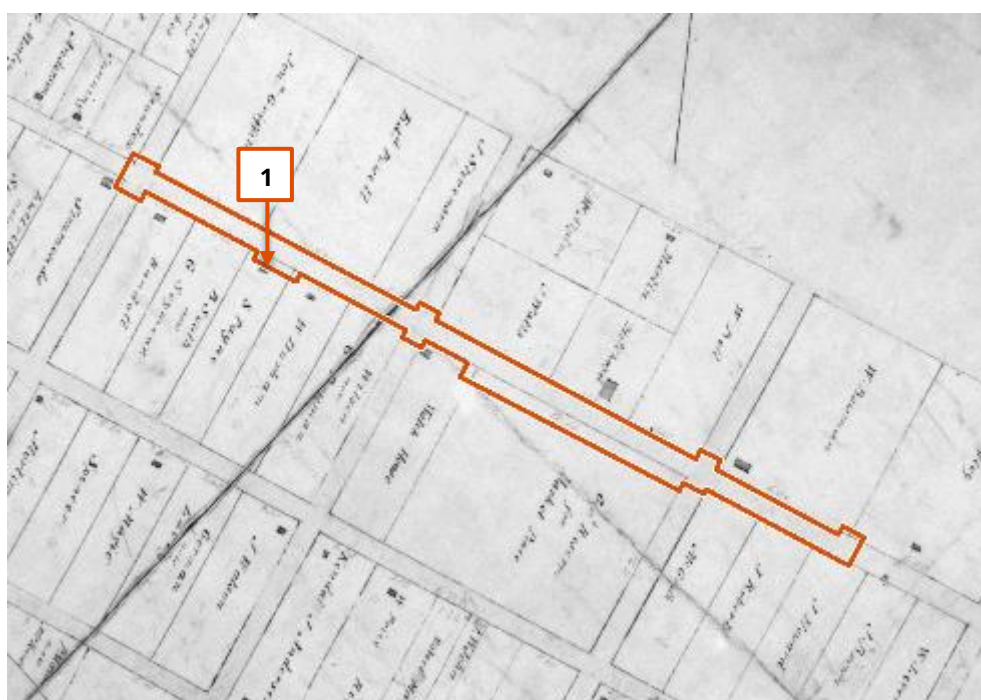
Photo 29 1827 plan of Richmond, with the study area outlined in orange, showing Payne's structure [1] on the study area boundary (Source: NSW State Archives and Records, plan reference 4985)

By the later 1820s more than 32,000 acres had been cleared in the Hawkesbury and half had been cultivated. This was the largest cultivated area in the colony at the time.⁶² An 1827 plan of Richmond shows approximately 40 dwellings, with the allotments generally being 1 acre (0.4 hectares) in size (Photo 29). This plan is very similar to the 1811 plan presented above (Photo 26), but there are two fewer structure in the vicinity of the study area on the allotments named for J. Walts and J. Roberts, and one new structure on S. Payne's allotment [1]; this new structure is located in very close proximity to the study area boundary. Reserves for a market place in the centre of town, a church, a school and a burial ground are also recorded. Many of the dwellings would have been the required two-roomed buildings required by the land grant conditions.⁶³ The building materials used were varied, often within the same dwelling due to shortages within the colony. Timber slabs and brick nogging (a technique where bricks are used to infill a timber frame) were often used, while some walls had rubble infill.⁶⁴ While there are no early descriptions of the activities within the market place (Richmond Park), it is presumed that stock and crops were bought and sold. However, a testimonial in the early 20th century noted that this location had never been used as a market, and instead had been used for recreation throughout its existence.⁶⁵

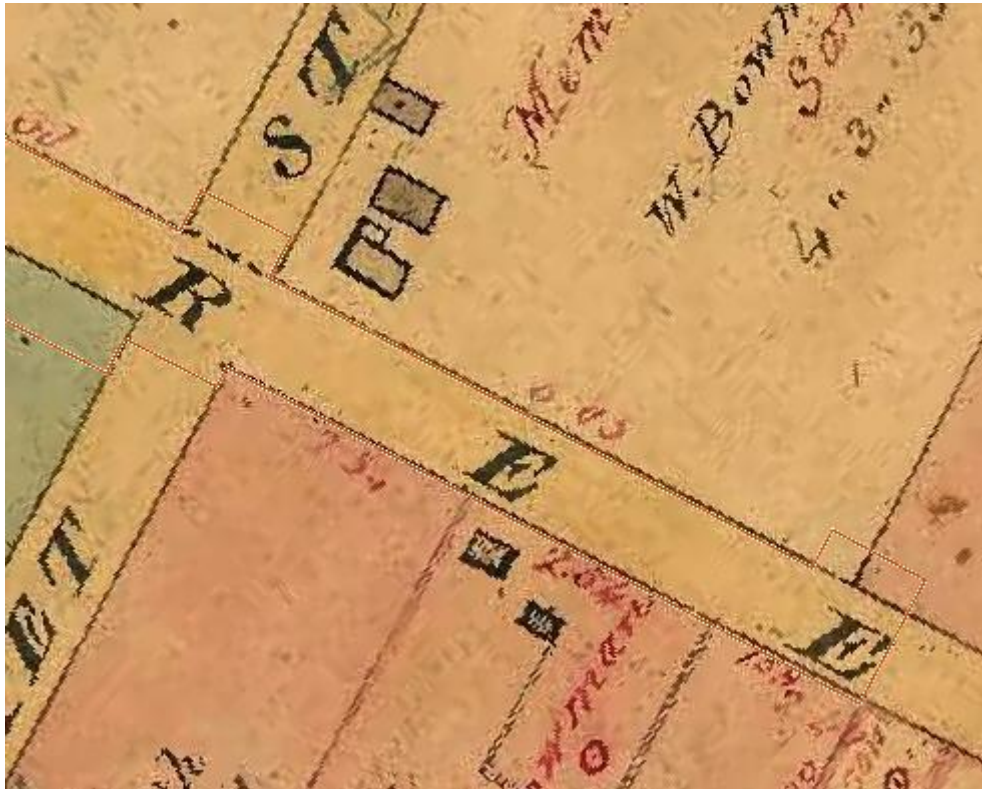
Photo 33 Detail from the 1831 plan of Richmond focused on the eastern portion of the study area, which is outlined in orange (Source: NSW Land Registry Services, Crown plan 1-469)

Two more structures are recorded on Bowman's allotment in Section 11 on the corner of Windsor and East Market streets (Photo 33). A second structure and fencelines are recorded on Roberts' allotment in Section 12 (Photo 33), which may have been acquired by either W. Mason or W. Bowman according to the annotations on the plan.

1838, W. Mason was granted Allotments 1-3 of Section 12, of which 2 and 3 appear to have been later obtained by W. Bowman (Photo 37). The two structures and fenceline previously identified in the 1831 plan (Photo 33) are recorded on this plan also, with an additional fenceline running along the road reserve boundary. Similarly, another Crown plan dating to that year also records the granting of Allotment 3 of Section 5 to Samuel Payne (Photo 38). The two structures recorded in the 1831 plan of Richmond, one of which [1] still appears to be on the boundary of the study area, are also recorded on this plan, with a fenceline [5] bounding Allotment 3 of Section 5 now recorded. Also, a Crown plan for Allotment 6 of Section 1 was also prepared in 1838, claimed by Isaac Cornwell (Photo 39). The structure [2] previously identified remains at the north-western corner of Windsor and Bosworth streets, as is the boundary fenceline within the study area [3] and the fencelines containing other buildings. It should be noted that georeferencing of these plans may not be completely aligned due to inaccuracies in the original plans.

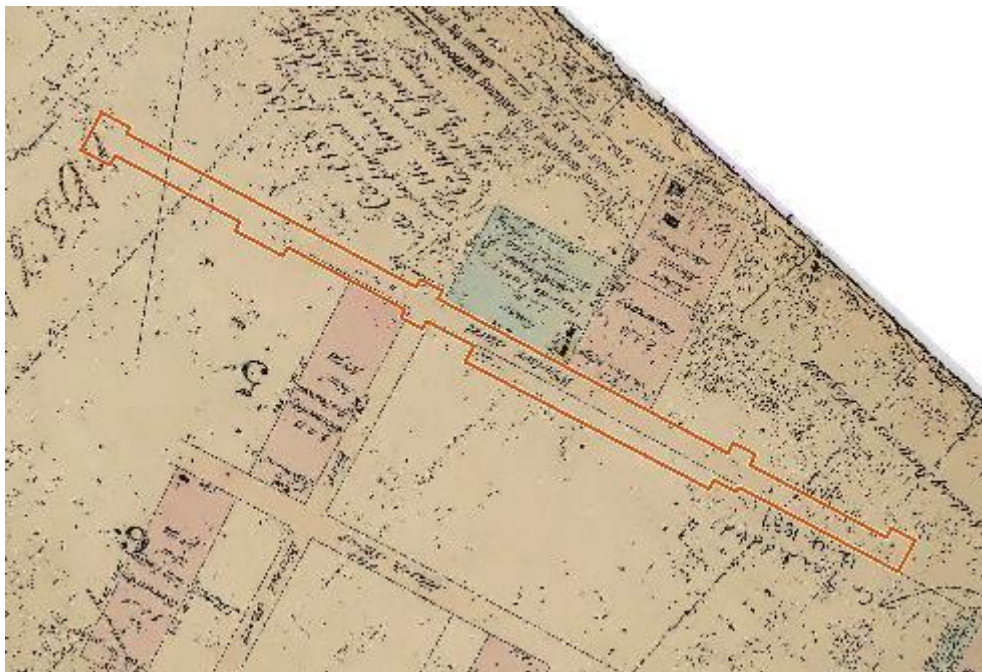
Photo 41 1843 Crown plan of several allotments in the central portion of the study area, which is outlined in orange (Source: NSW Land Registry Services, Crown plan 2-899)

It has been said that at the first elections in 1843, polling took place under a cedar tree at the corner of Windsor and West-Market Street, where the court house now stands.⁸³ A Crown plan dating to the same year provides some detail on several lots adjacent to the study area (Photo 41). G. Bowman has acquired the allotment at the south-western corner of Windsor and West Market Street, while Watts' Allotment 2 in Section 7 is noted to belong to both Thomas Eather and William Price, with R. Martin noted as the owner of Allotment 3, Section 7. The small fenced off portion previously annotated as a chapel remains, with another building established to its north. Another Crown plan dating to the same year provides more detail on structures within these allotments (Photo 42). This plan records the old Wesleyan chapel in its own small portion of land, taken from Allotment 2. Adjacent to the old chapel is the new chapel and a dwelling with a verandah, with a further dwelling in the south-eastern corner of Allotment 3. The plan also records a small dwelling and the Union Inn near the north-eastern corner of Windsor and West Market Street. The lines in this plan are likely fencelines as they appear to be smaller than the allotment boundaries and may relate to leaseholds or smaller subdivisions.

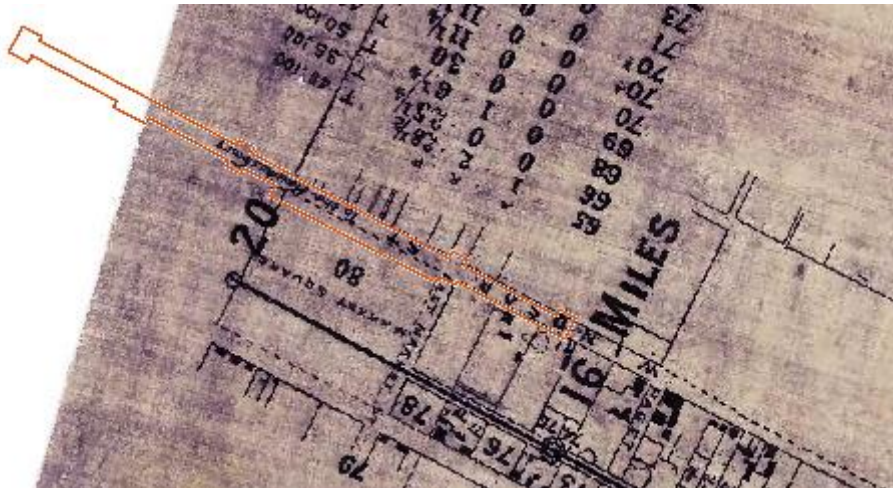
Photo 43 Undated Crown plan of the Blacktown to Richmond Railway, with the study area outlined in orange (Source: NSW Land Registry Services, Crown plan 4379.3000)

The Blacktown-Richmond Railway was completed in 1864, with Richmond acting as the terminating station. The Crown plan for the railway line records the proposed line itself extending into the market place / Richmond Park, as well as a third structure with Allotment 2 of Section 12, and possible a dam which is situated in Allotments 2 and 3 (Photo 43). The finished line did not extend into the market place / Richmond Park. The original intention was to have the trains drawn by horses, but during construction it was confirmed

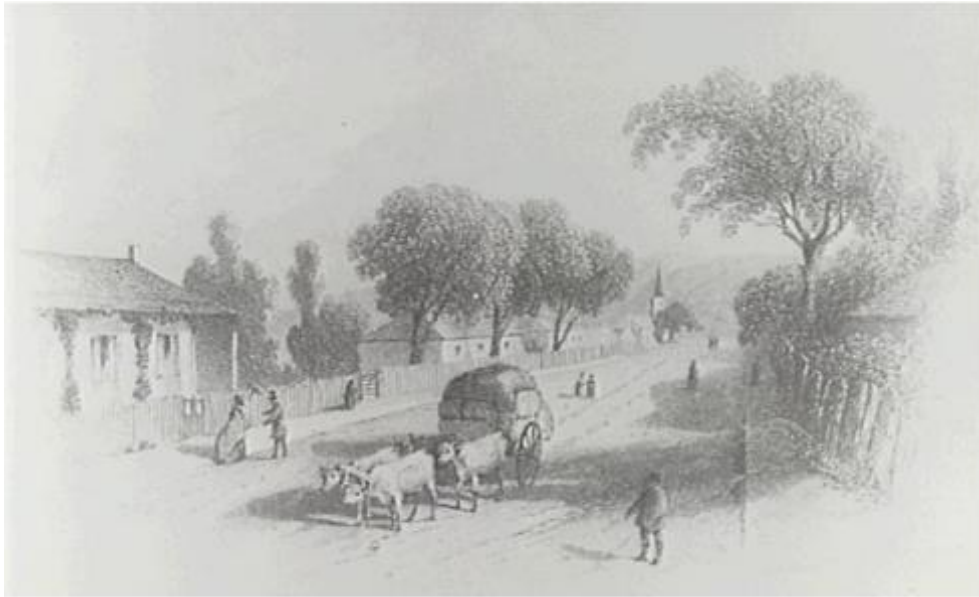
Photo 45 Undated sketch of Windsor Street, facing west (Source: Hawkesbury Museum)

An undated sketch of Windsor Street, estimated to be from the 1870s-1890s based on the dress of the subjects within the drawing, may provide some information regarding the western portion of the study area (Photo 45). While the exact location is not known, it is likely to be in the vicinity of Bosworth Street due to the presence of the church spire of St Peter's in the distance. There appears to be either stone or earth and grass kerbing, with the road surface being driven up by the ox and cart, suggesting it would have been metalled or gravelled.

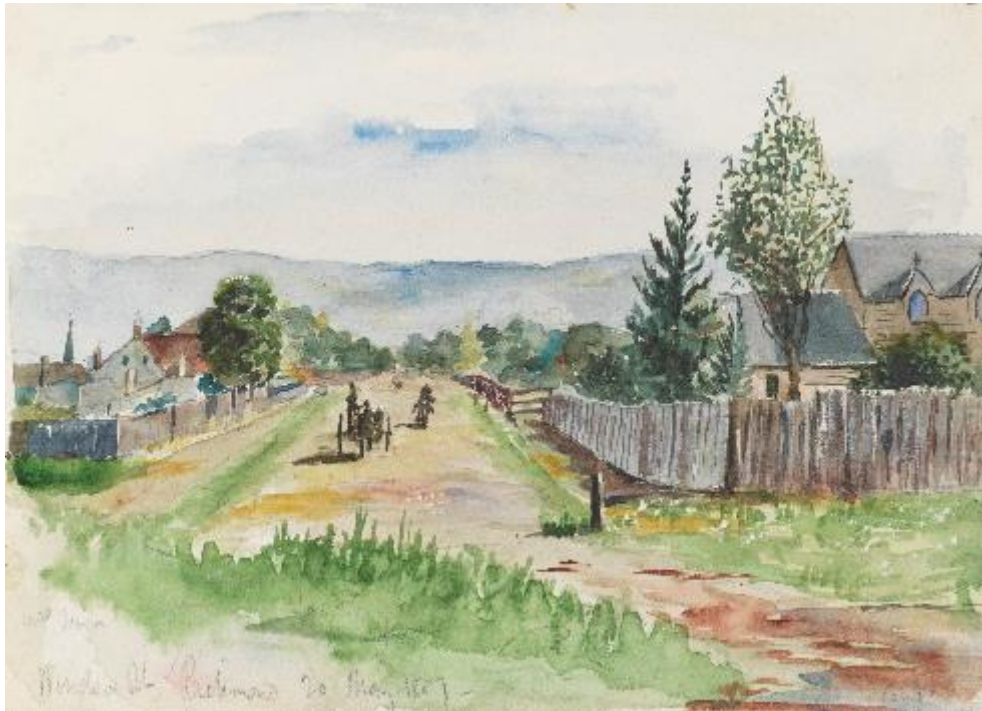
Photo 47 1887 watercolour of Windsor Street by Charles Conders (Source: State Library of NSW, c12028_0007_c)

An 1887 watercolour of Windsor Street by Charles Conders provides some information about the state of the study area at this date (Photo 47). It is likely that this view is from the far eastern point of Windsor Street where it meets Richmond Road, considering the angle of the road and the Blue Mountains positioned in the background; a milepost is present at this junction also. While outside of the study area, this image suggests that many of the roadways within the town had not been subject to formal construction of kerbs and guttering, or of the road itself. The edge of town retains a rural character.

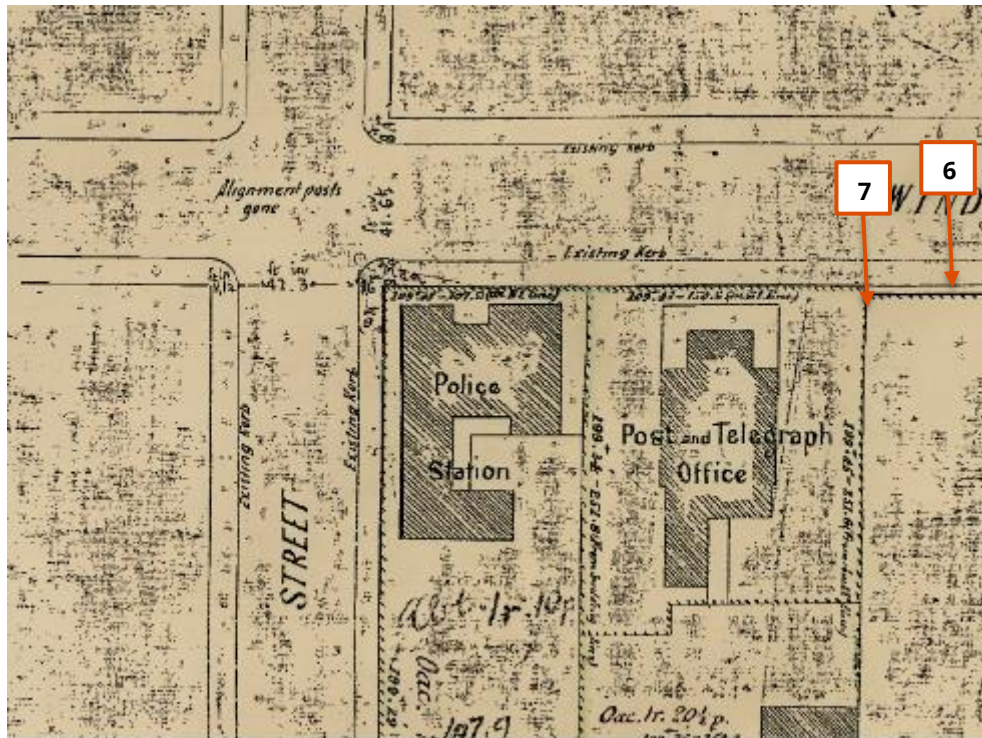
Photo 52 1891 Crown plan of the Police Station and Post Office, with detail of kerbing and roadways, showing the two-rail fence [6] and boundary fence [7] for Richmond Park and the Post Office (Source: NSW Land Registry Services, Crown plan 553.3000)

A Crown plan dating to 1891 provides some detail on the Courthouse and Police Station, Post Office, Richmond Park and the kerb and roadway within the study area (Photo 52, Photo 53). The plan shows the footprint of the two buildings, as well as verandahs and fencelines within and at the boundary of the properties. The fencelines [6] [7] for Richmond Park is also recorded, as are the widths of the roads and kerbs of Windsor, West Market and East Market streets.

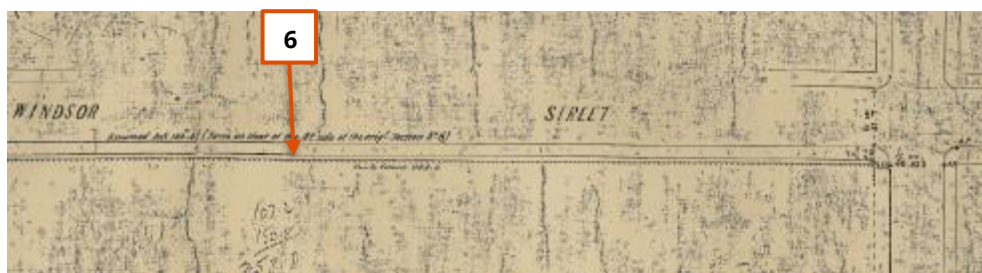
Photo 53 1891 Crown plan showing Richmond Park, with detail of kerbing and roadways, showing the two-rail fence [6] (Source: NSW Land Registry Services, Crown plan 553.3000)
