Hawkesbury Masterplan: Windsor
Historical Heritage Assessment and
Constraints Analysis Final Report

Hawkesbury Masterplan: Richmond Historical Heritage Assessment and Constraints Analysis

FINAL REPORT

Prepared for Place Group Design

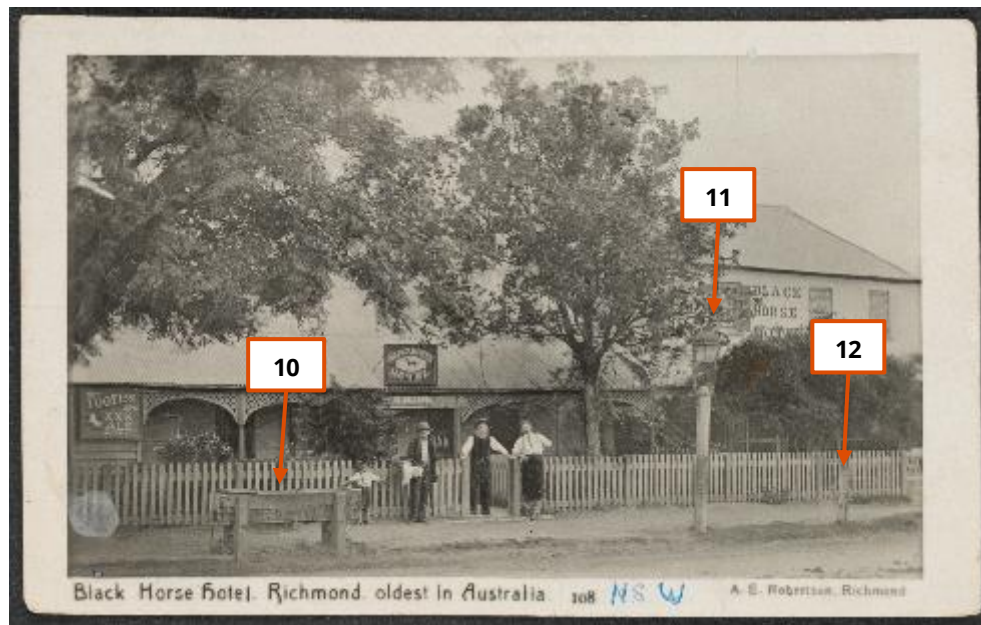
Photo 54 Undated photograph of the Black Horse Inn (Hotel), located at the corner of Bosworth and Windsor streets, showing a water trough [10], light pole [11] and short post [12] (Source: State Library of Victoria)

An undated photograph of the Black Horse Inn shows the two component buildings of the establishment, likely taken in the late-19th or early-20th centuries (Photo 54). There is a longer single storey brick structure with a verandah and porch which is similar in appearance to residential dwelling, as well as a two-storey brick building adjacent. The angle of photograph is unknown so it may have been taken on Bosworth or George streets. The photograph shows a paling fence and a water trough [10] for horses, as well as a short light post [11] and another post [12] at the interface of the dirt footpath and road, which appears to be compacted dirt or gravel/metal. A stone kerb is visible in the left foreground of the image before the horse trough, while past this point it is unformed with grass growing over.

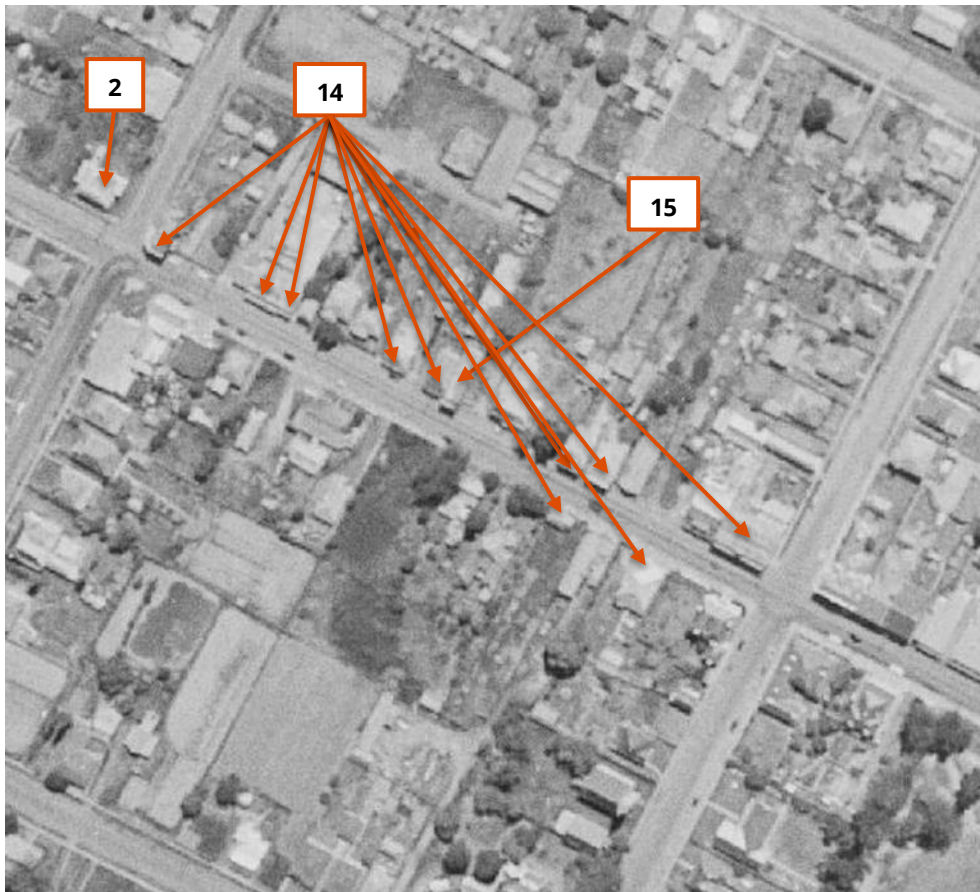
Photo 60 Detail of 1955 aerial between Bosworth and West Market Street (Source: NSW Spatial Services, Historical Imagery Viewer 2021)

Between Bosworth and West Market Street, ten structures identified within the 1937 aerial photograph [14] are present, in addition to another verandah extending into the study area [15] (Photo 60). This structure may have already existed but its view was obstructed in the previous aerial. The building located within Saunder's Allotment in Section 1 also remains within the western portion of the study area dating back to 1831. Between West Market and Toxana streets six structures dating to pre c.1890 remain, with seven additional verandahs between West Market and East Market Streets [16] and three between East Market at Toxana Streets [17] (Photo 61).

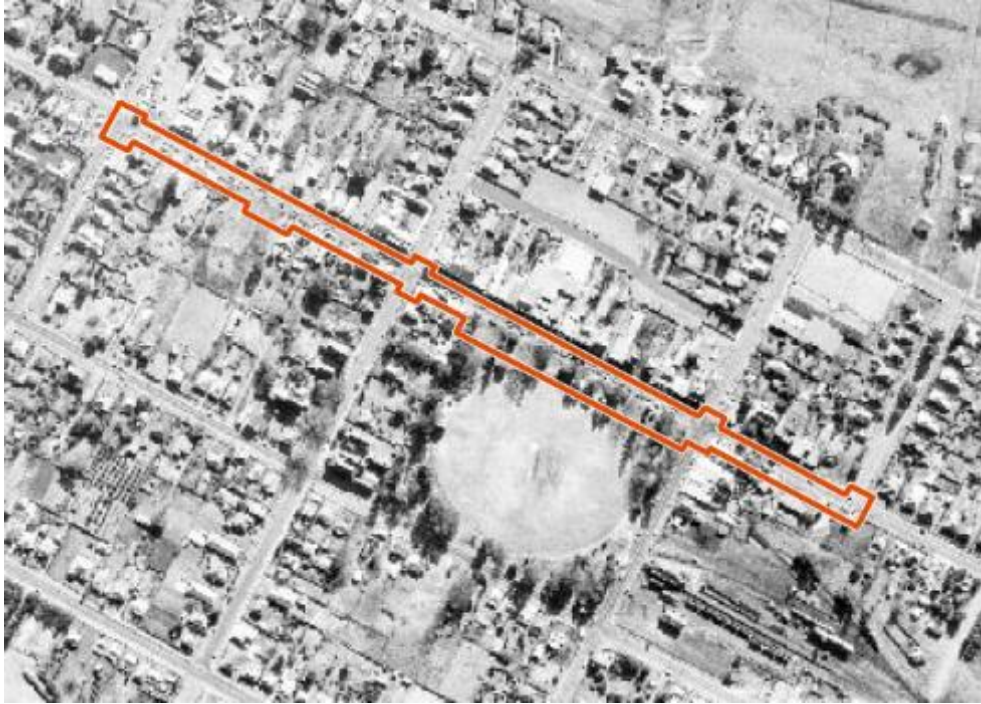
Photo 62 1970 aerial photograph of the study area (Source: NSW Spatial Services, 2021)

Further developments occurred in the 1960s and 1970s. A sewerage scheme was introduced to Richmond in 1962.¹⁴¹ An aerial photograph from 1970 demonstrates that Richmond continued to develop as an urban centre in the mid-20th century (Photo 62). While there appears to be little change within the study area, the surrounding area shows increasing density of housing. It is possible that a number of verandahs which previously extended over the footpath have been removed by this date.

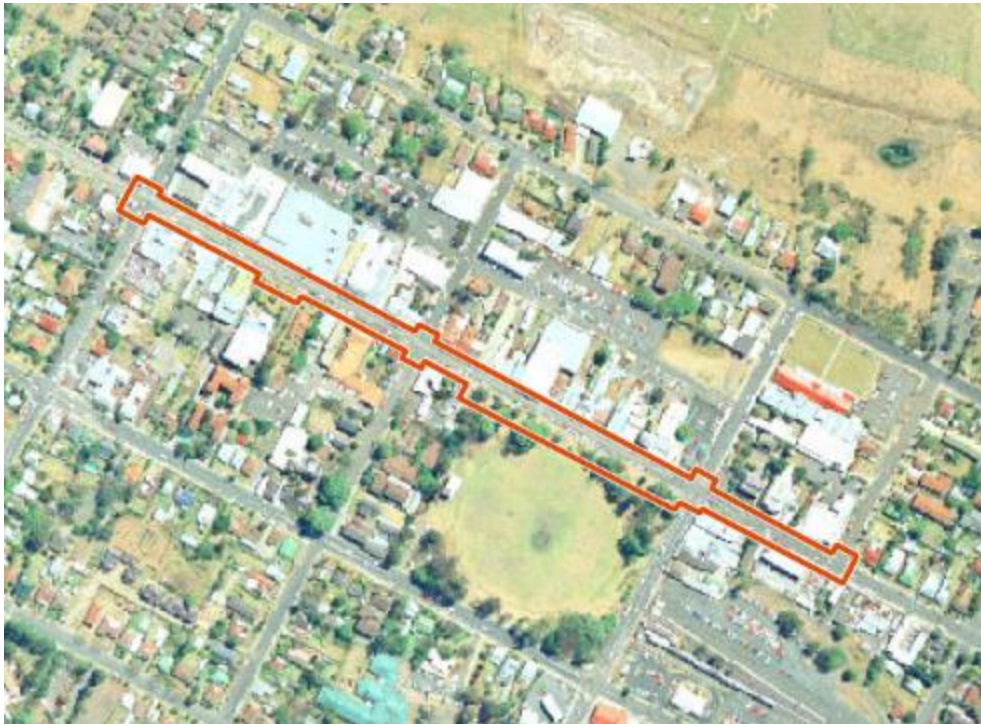
Photo 65 1994 aerial photograph of the study area (Source: NSW Spatial Services, 2021)

A 1994 aerial photograph again shows increasing urban development in Richmond (Photo 65). Within the immediate vicinity of the study area, many of the former residential and commercial properties have been demolished and lots consolidated, with larger modern buildings constructed, such as the Richmond Mall.

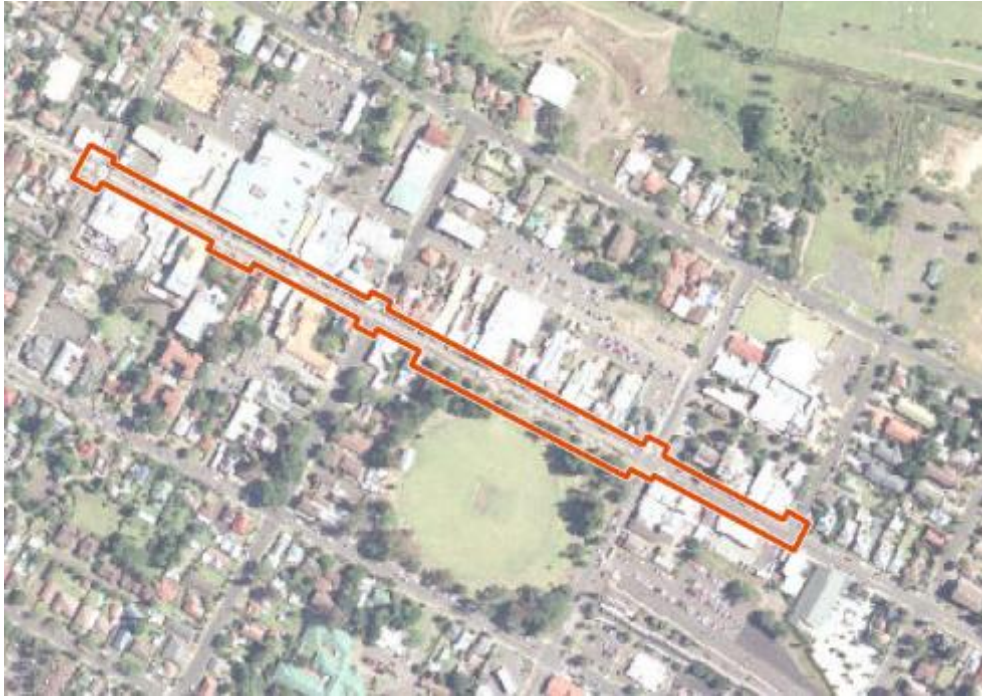
Photo 68 2005 aerial photograph of the study area (Source: NSW Spatial Services, 2021)

A 2005 aerial photograph shows much the same, with few changes observed when compared with the earlier photograph (Photo 68). It appears that the Black Horse Inn has had some additions made to it where it fronts Windsor Street, which is likely the current form of the item.
