Hawkesbury Masterplan: South  
Windsor Historical Heritage  
Assessment and Constraints Analysis  
Final Report

# Hawkesbury Masterplan: South Windsor Historical Heritage Assessment and Constraints Analysis

FINAL REPORT

Prepared for Place Group Design

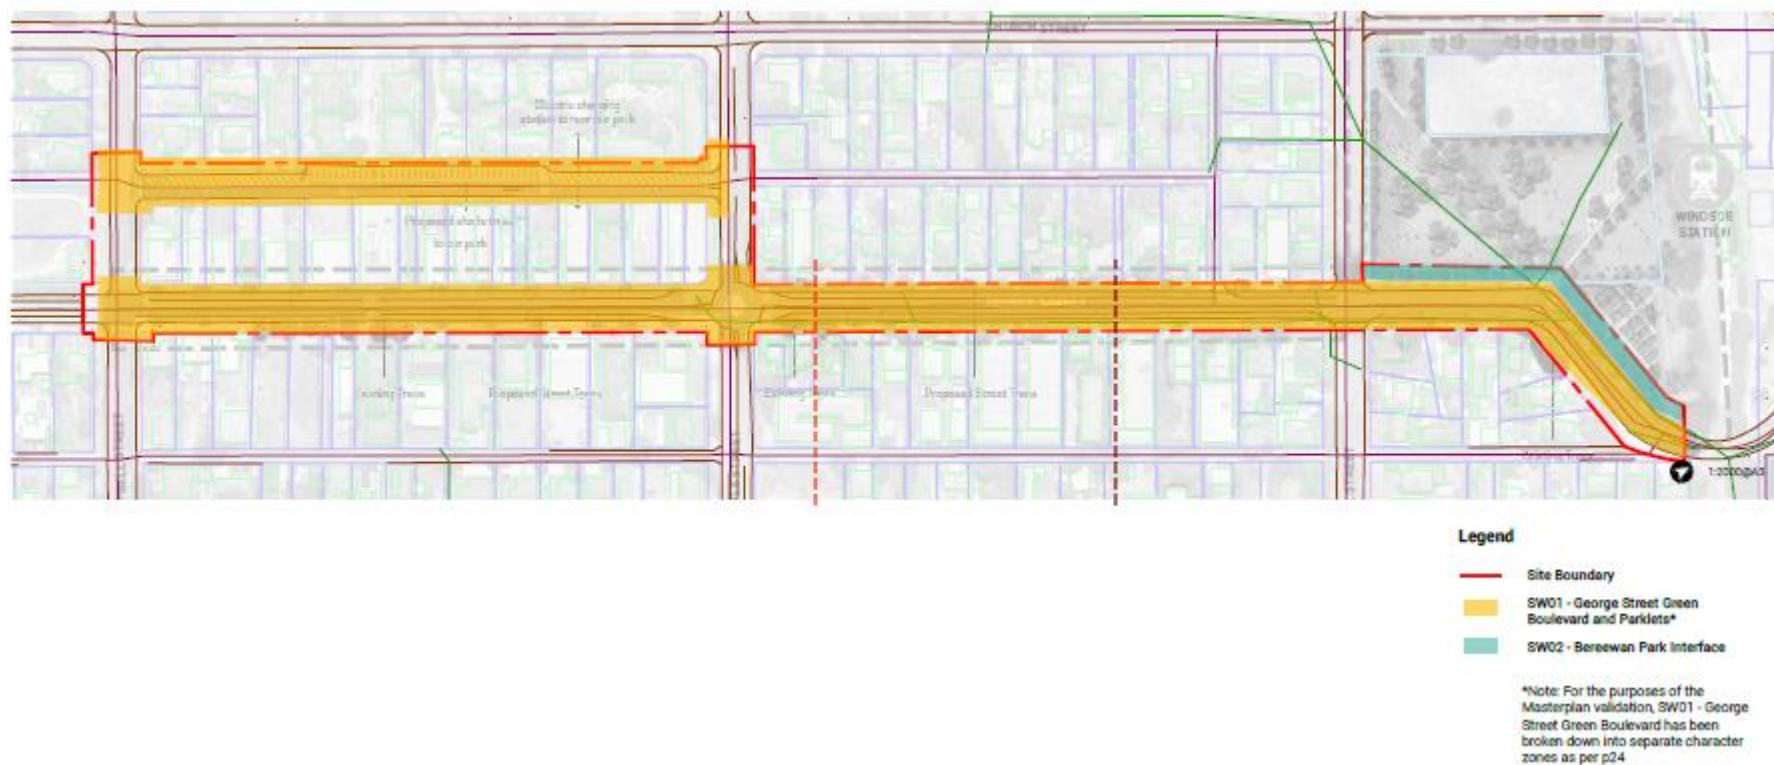
The Master Plan Analysis Report<sup>20</sup> has broken down the study area into two different scope areas, each of which have designated character zones. The scope areas, as shown in Figure 4 are: George Street Green Boulevard and Parklets (SW01); and Bereewan Park Interface (SW02). Within the George Street Green Boulevard and Parklets (SW01) scope area there are three character zones: Park (SW01.1); Retail (SW01.2); and Carpark (SW01.3).

**Figure 4 South Windsor scope areas (Source: Master Plan Analysis Report)**

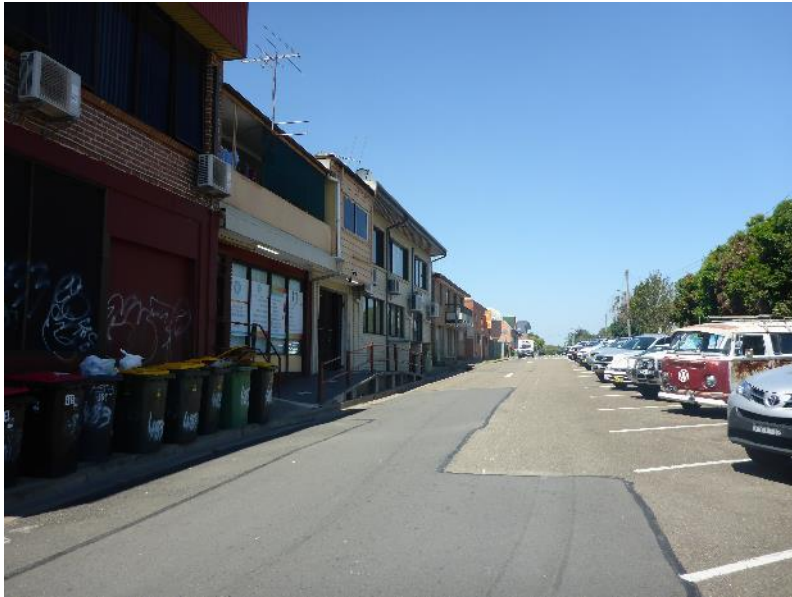
**Photo 1** Area SW01.3 from the northern end of Mullinger Lane, showing carparking and retail/commercial building rears

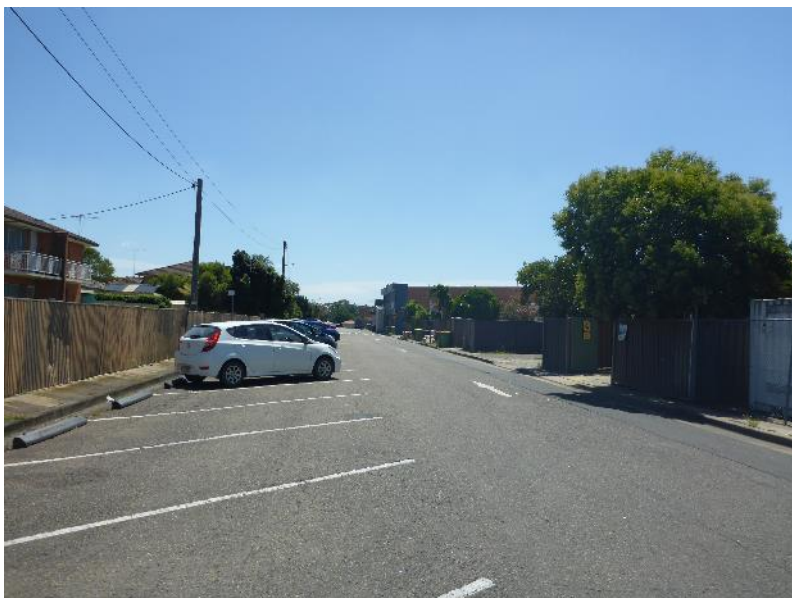
**Photo 2** Area SW01.3 from the southern end of Mullinger Lane, showing carparking and retail/commercial building rears

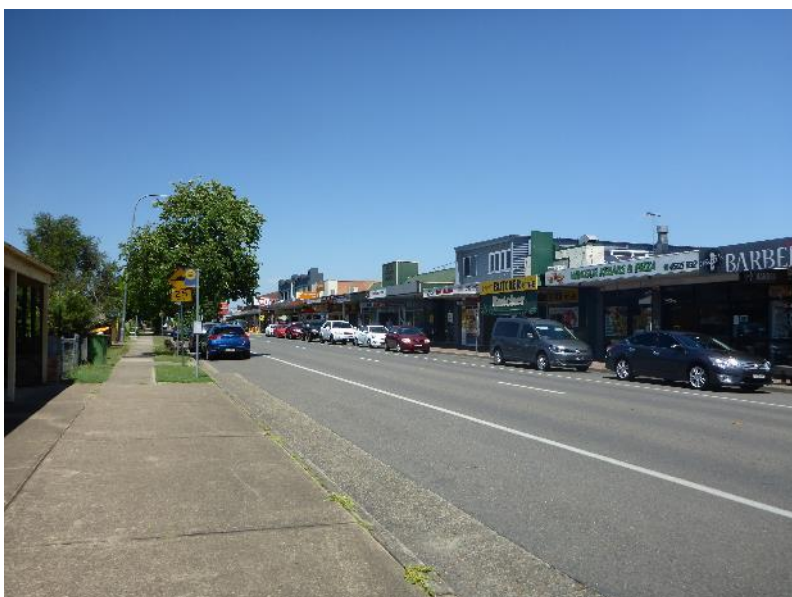
**Photo 3** Area SW01.2, showing the retail/commercial area on the western side of George Street

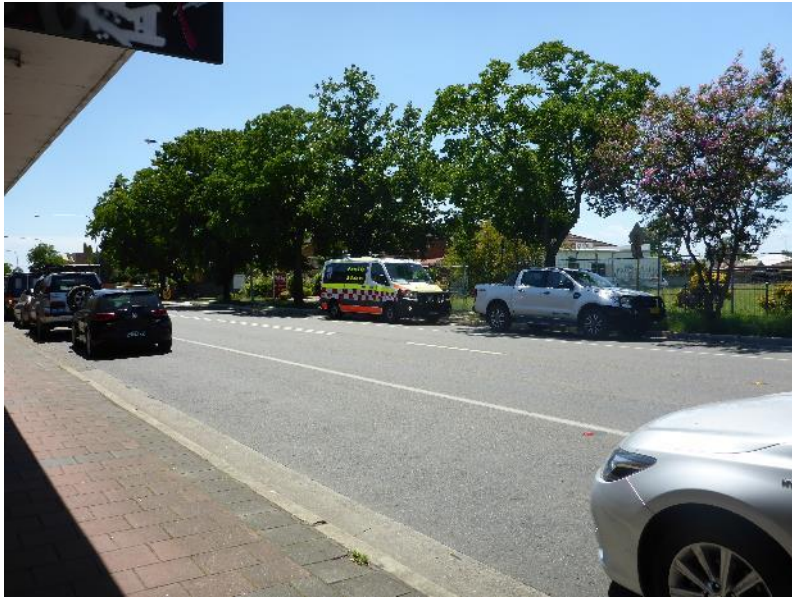
**Photo 4** Area SW01.2, showing vacant and residential lots opposite the retail/commercial area on the western side of George Street

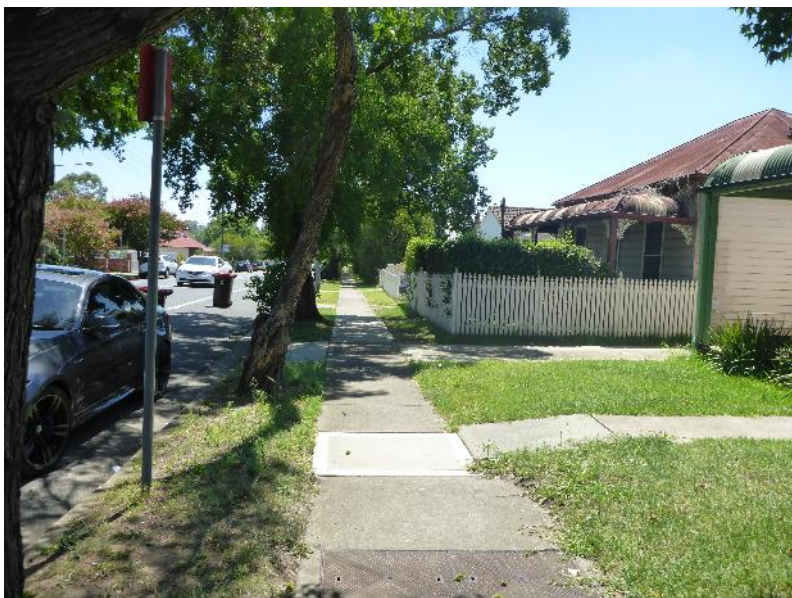
**Photo 5** Area SW01.1 near the intersection of George and Argyle streets, showing heritage and non-heritage dwellings with property fencing and street plantings

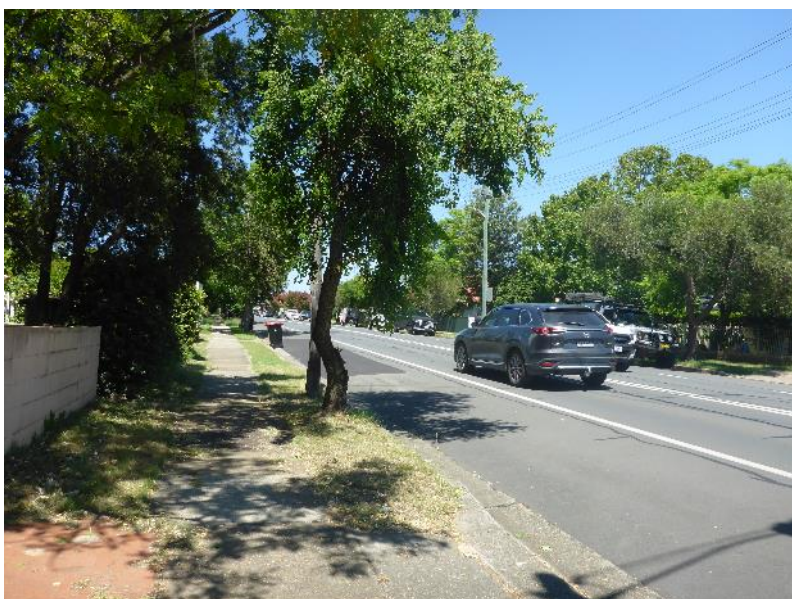
**Photo 6** Area SW01.1 near the intersection of George and Bell streets, showing heritage and non-heritage dwellings and street plantings

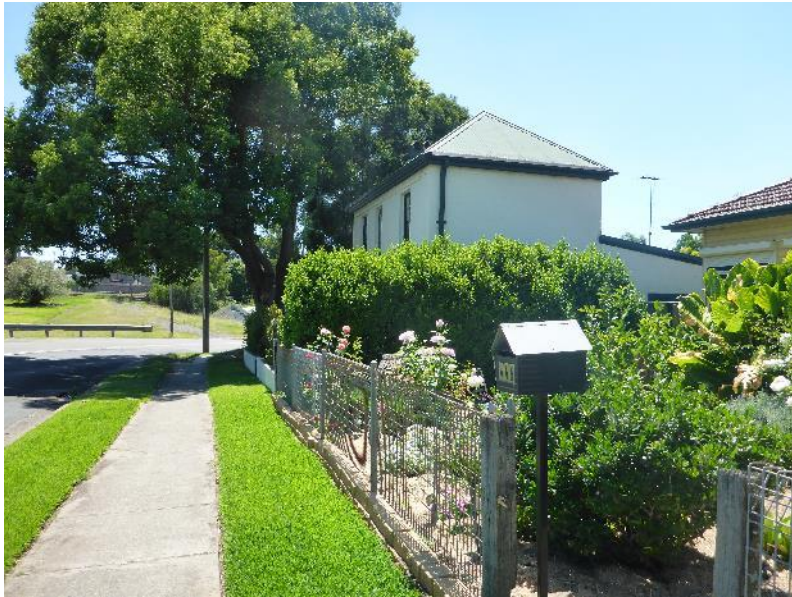
**Photo 7** Area SW01.1 near the deviation of George Street, showing heritage and non-heritage dwellings with property fencing and street plantings

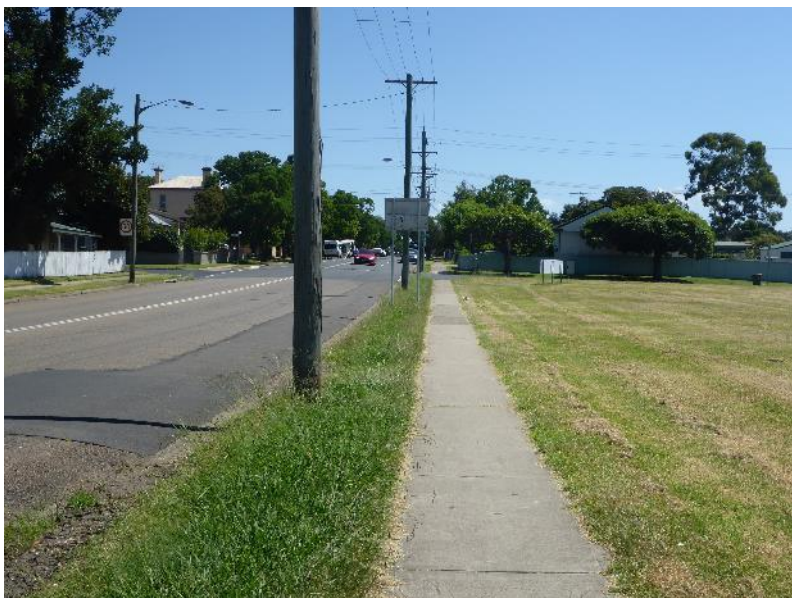
**Photo 8** Area SW02 near the deviation of George Street, showing the cleared parkland area of the Prebyterian burial ground and the streetscape beyond containing heritage and non-heritage dwellings and street plantings

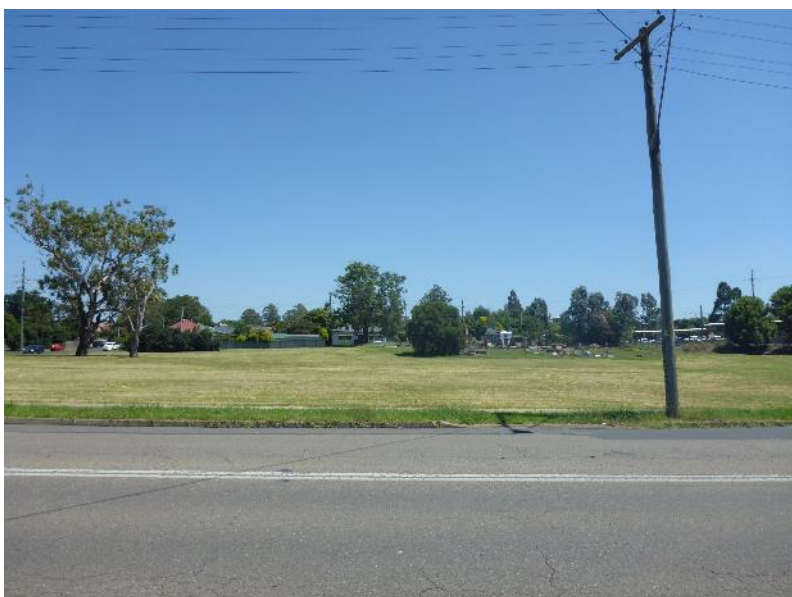
**Photo 9** Area SW02 near the deviation of George Street, showing the cleared parkland area of the Prebyterian burial ground

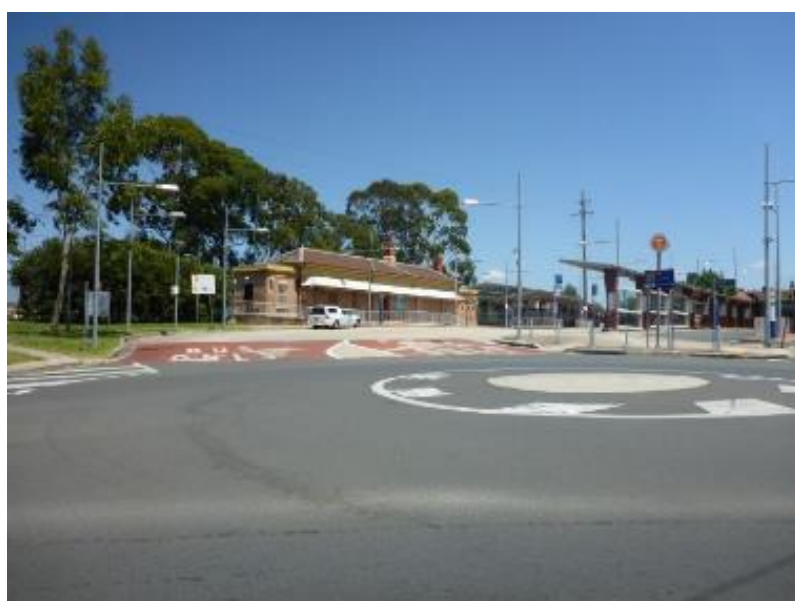
**Photo 10 Windsor Railway Station Group and Former Goods Yard, (Item No. 01287)**

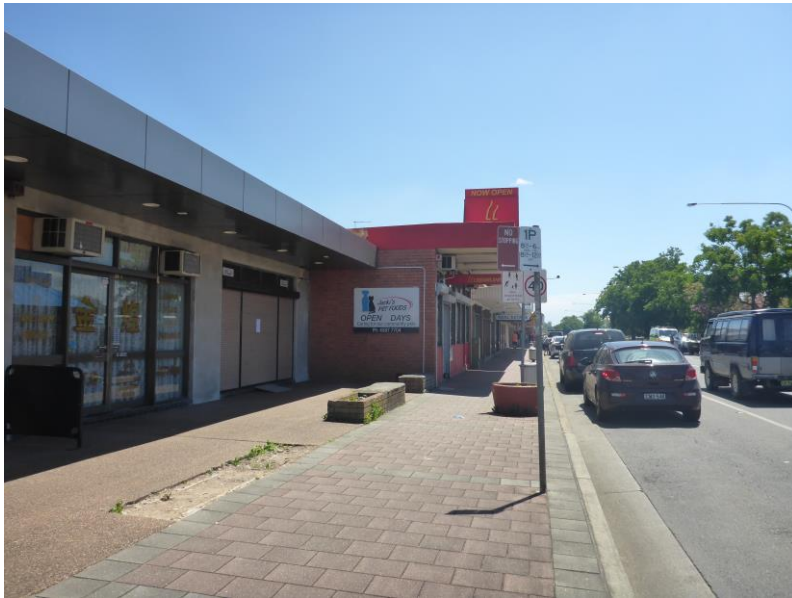
There is only one heritage item within the study area. No further heritage fabric or built heritage items were observed within the study area during the visual inspection. Non-historical built fabric includes: brick pavers, poles for signage, lights and electricity, sealed roads, footpaths and driveways, concrete kerbs, gutters and footpaths, and modern infrastructure associated with traffic management, as well as street furniture including potted plantings and rubbish bins (Photo 11, Photo 12, Photo 13).

**Photo 11** Example of paved footpaths, signage, concrete kerbs and gutters, sealed roads, and street furniture in the form of potted plantings and rubbish bins

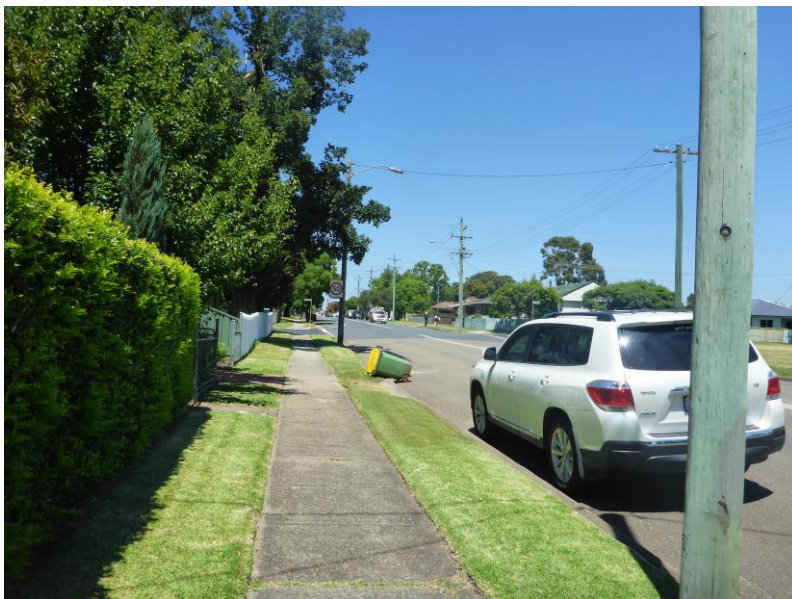
**Photo 12** Example electricity and lighting infrastructure concrete kerbs and gutters, sealed roads and driveways

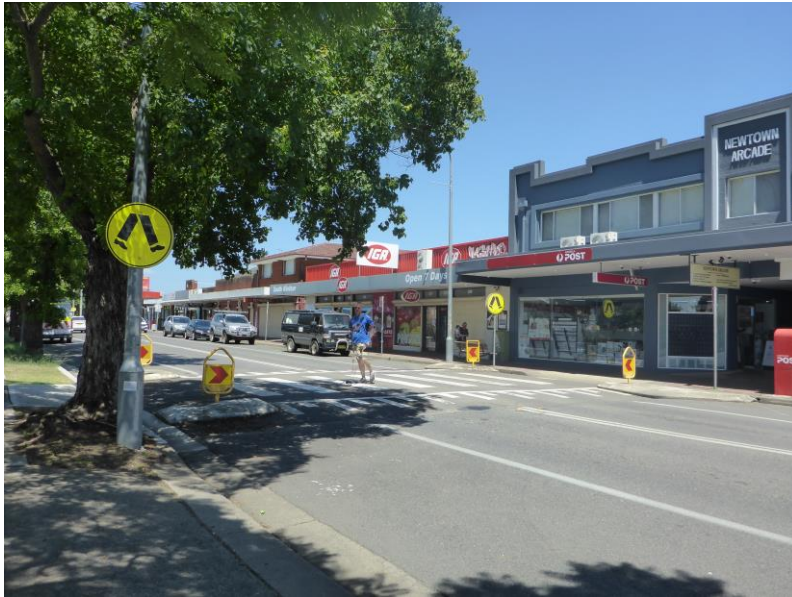
**Photo 13** Example of paved footpaths, signage, traffic management infrastructure, concrete kerbs and gutters and sealed roads

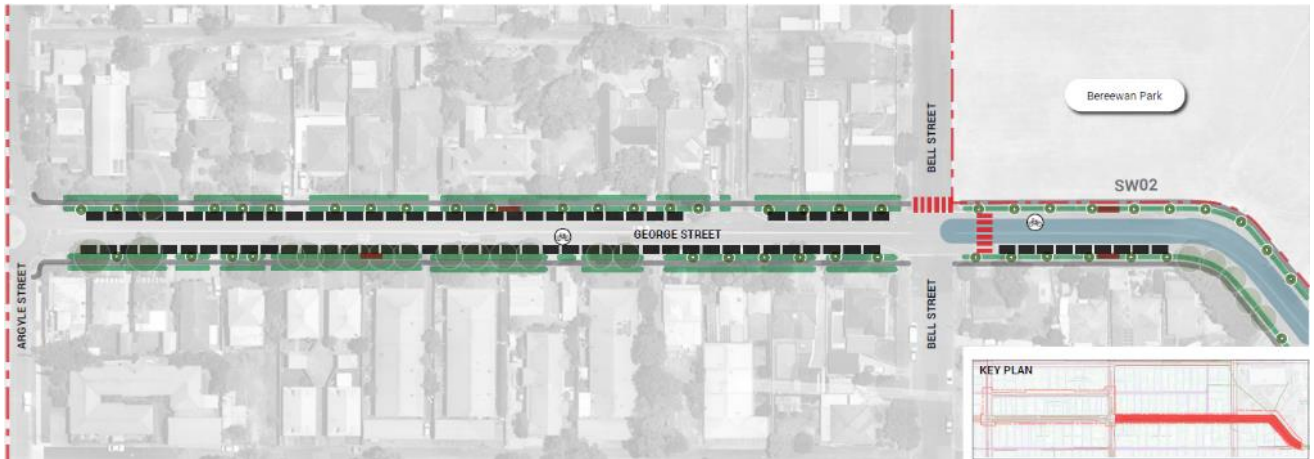
**Photo 14 Proposed upgrades for SW01.1 George Street Green Boulevard**

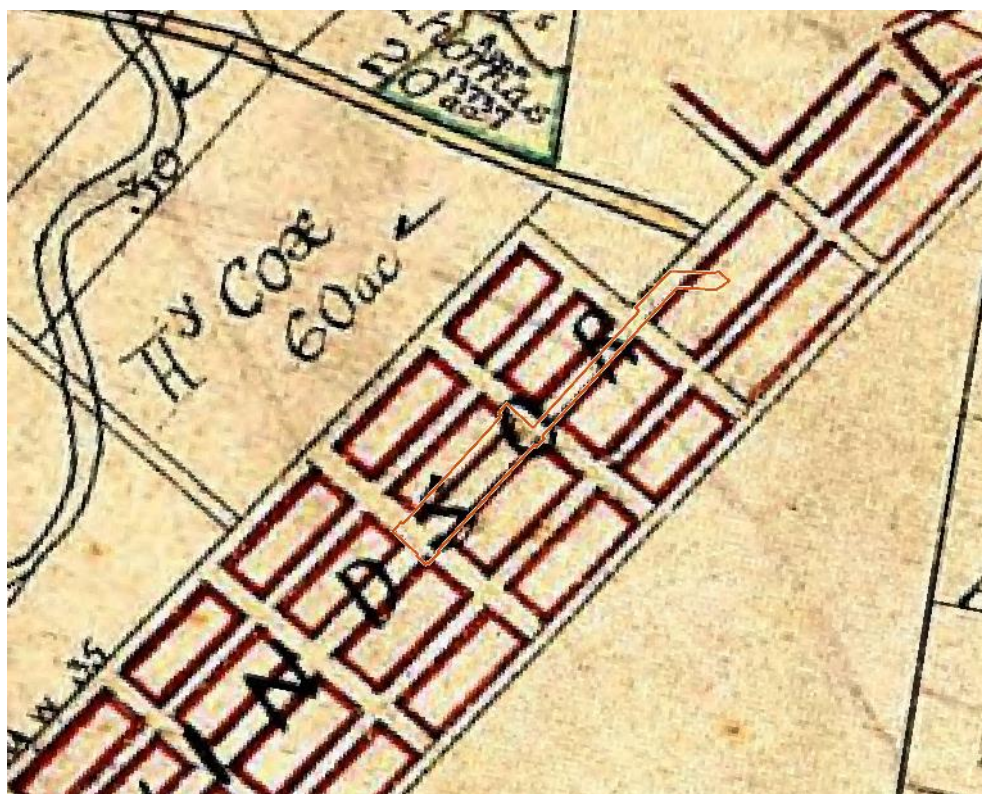
**Photo 19 Early undated St Matthews parish map, with the study area outlined in red (Source: NSW Land Registry Services)**

parcels of land had been granted along the Hawkesbury River and South Creek. The study area is located outside of early land grants, but is situated east of Henry Cox's 60 acre (24.3 hectares) (Photo 18, Photo 19).

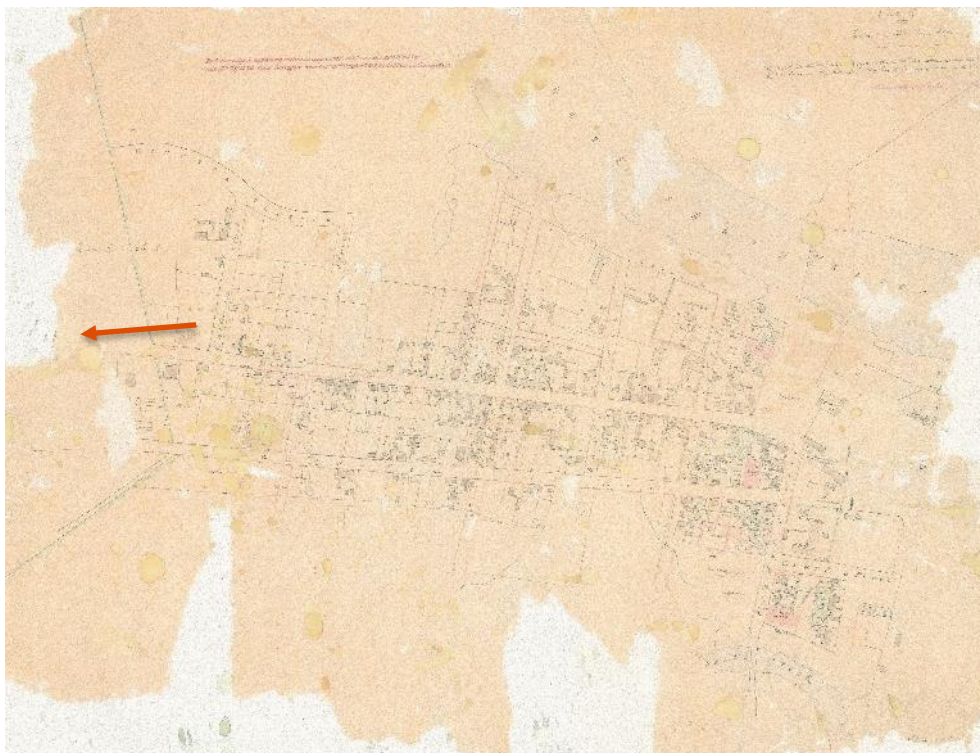
**Photo 26** 1835 plan of Windsor, which only records the area of the town north of the study area, the direction of which is indicated by the orange arrow (Source: NSW State Archives Records, plan reference 5968)

Despite allotments being granted, very little development occurred in South Windsor until the 1840s.<sup>54</sup> An 1835 plan of Windsor does not even extend south of St Matthew's church and the green associated with it (Photo 26). Similarly, an 1840 plan still does not show the town sections within and adjacent to the study area as being divided into allotments (Photo 27). This suggests that there was very little activity taking place in this part of the town, possibly some agricultural works. Many of the streets in Windsor had been named for early residents such as Baker, Kable and Fitzgerald, as well as Thompson Square.<sup>55</sup> One dwelling, which may date to around 1840 is located at 464 George Street (Hawkesbury LEP 2012, Item no. 1472) on its eastern side, between Bell and Argyle streets; the house comprises a double gable workman's cottage with a front verandah and a vertical timber slab rear wing.<sup>56</sup> However, by 1841 occupation of allotments and houses began spreading south towards the road to Richmond (Hawkesbury Valley Way). In the same year, Windsor was promoted as the third town of the colony in auction advertisements for allotments in George Street, Windsor Terrace, Church Street and New Street in what is described as the business part of the town, near the Church, Catholic Chapel and the Scotch Church, and also noting the current development of a steam communication with Sydney.<sup>57</sup> By 1848, the population of Windsor had grown to 1,679, which featured a daily stage coach and substantial and high quality inns.<sup>58</sup>

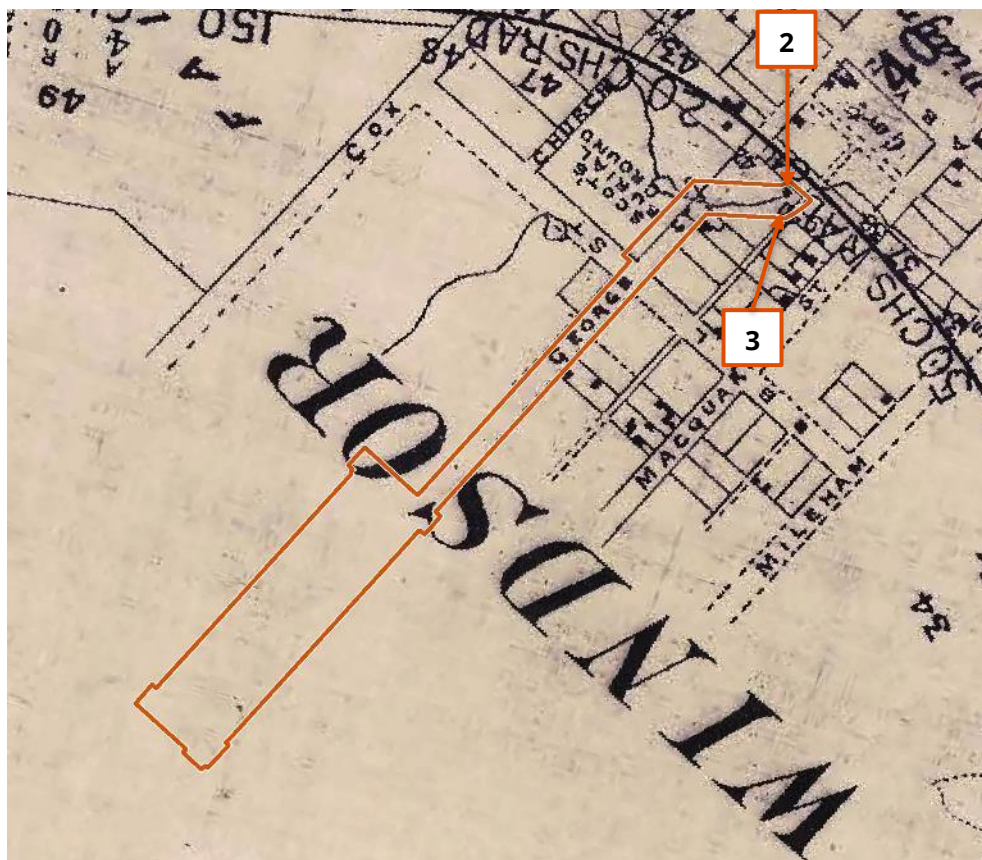
**Photo 30 Undated plan of the Blacktown-Richmond Railway, with the study area outlined in orange, with two structures [2] [3] south of the line (Source: NSW Land Registry Services, Crown plan 4379.3000)**

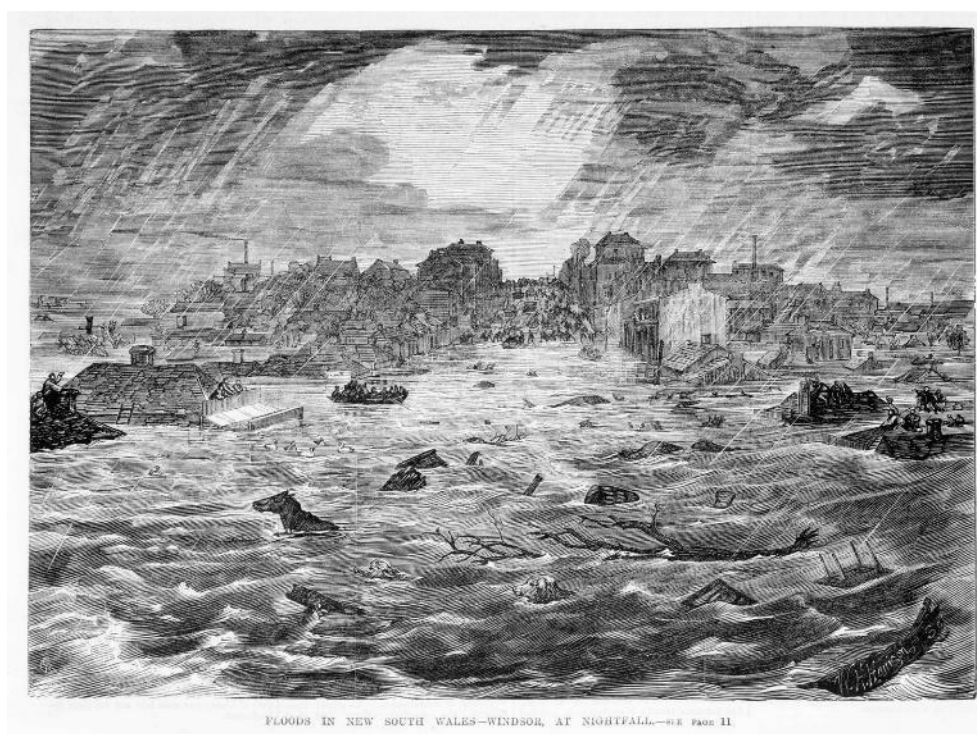
**Photo 31 Depiction of the 1867 floods at Windsor (Source: State Library of Victoria, reference FL15606869)**

Windsor (Photo 31). It is likely that the view is of George or Macquarie Streets, with the northern part of Windsor's town centre in the distance on the higher ground. Based on this, it is therefore likely that the study area experienced similar inundation levels, and damage to housing, businesses and produce.

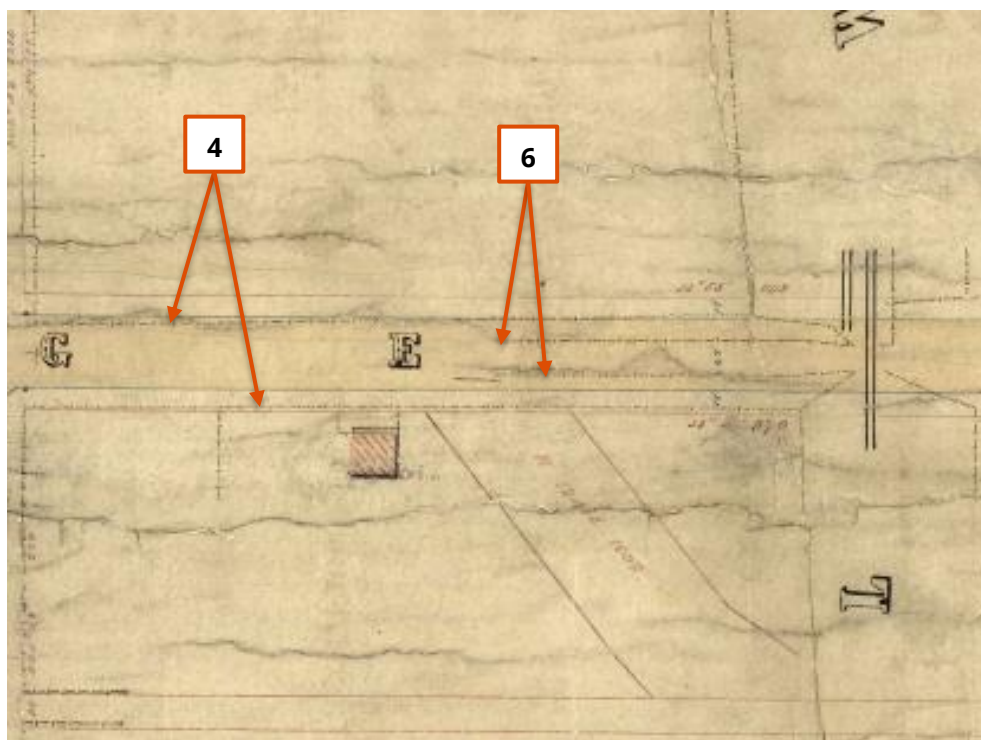
**Photo 33** Detail of 1871 plan of Windsor north of Bell Street, with the study area outlined in orange, showing property boundary fencelines [4] and fencelines [6] narrowing George Street for the railway crossing within the road reserve (Source: NSW Land Registry Services, Crown plan W1-1039)

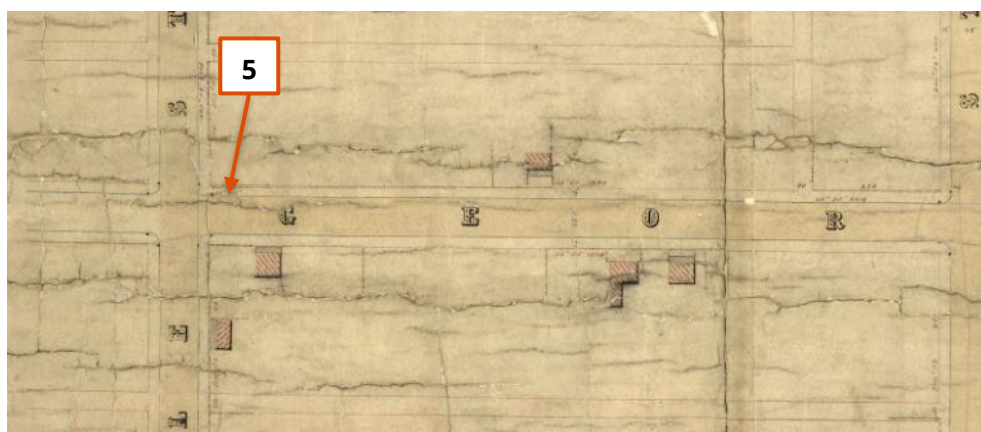
**Photo 34** Detail of 1871 plan of Windsor between Bell and Argyle streets, with the study area outlined in orange showing property boundary fencelines [5] within the road reserve (Source: NSW Land Registry Services, Crown plan W1-1039)

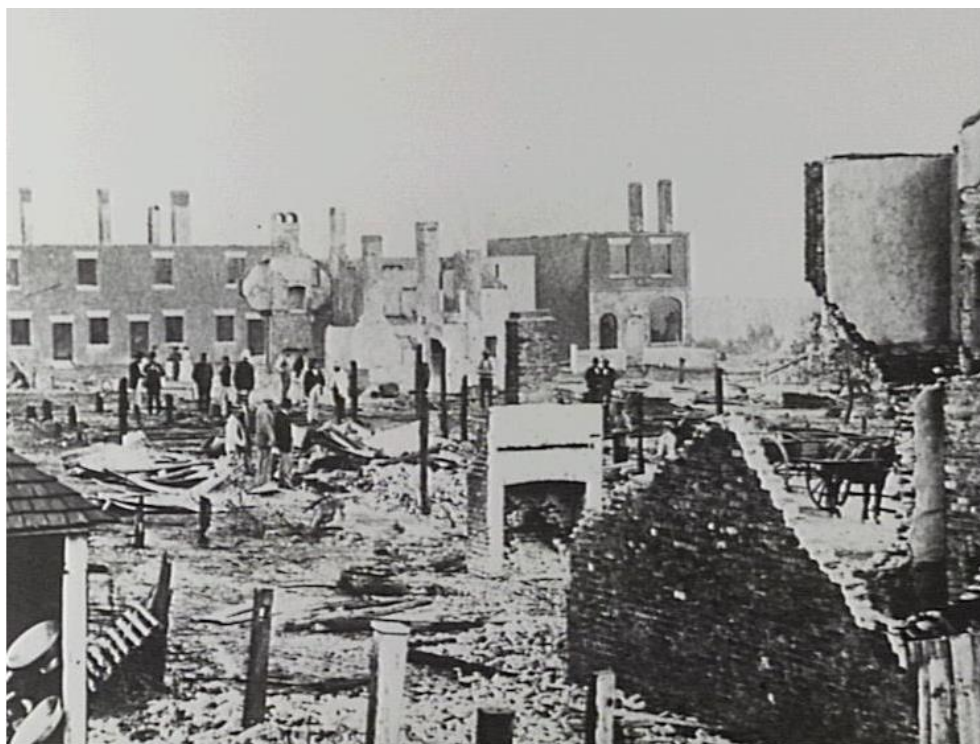
**Photo 35 Damage caused in George and Macquarie Streets by the 1874 fire in Windsor (Source: Hawkesbury City Library)**

In 1872, further works to George Street were to be undertaken. Council accepted the tender of D. Brown to undertake them.<sup>70</sup> Two years later in 1874, the bridge crossing the Hawkesbury at Windsor opened for public use.<sup>71</sup> In December of the same year, Windsor suffered a severe fire which reduced much of the northern part of town to rubble (Photo 35). More than 30 houses were destroyed in the fire, along with several major

buildings. The Sydney fire brigade was wired for and arrived late in the evening. Archaeological excavations for sites located along George Street have identified a layer of ash and charcoal which have been associated with this event.<sup>72</sup>

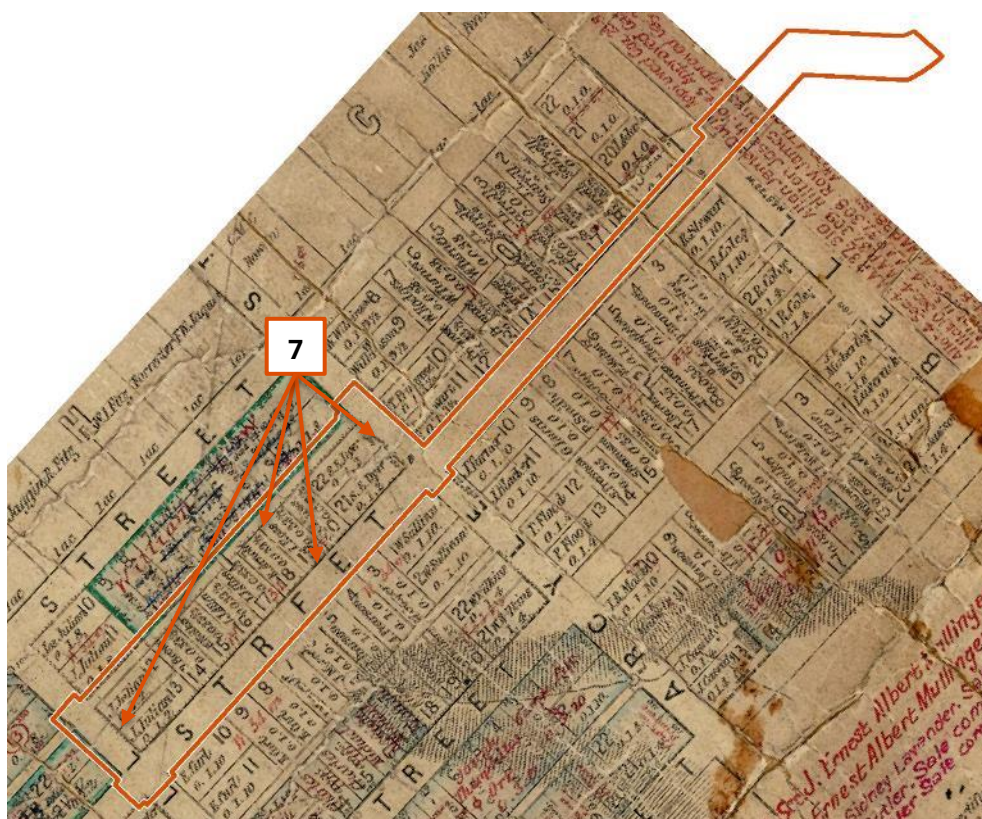
**Photo 36 1881 Crown plan of Allotments in Sections O, P, Q, S, T, J and V in the town of Windsor, with the study area outlined in orange, showing fencelines [7] surrounding allotments 12-22 in Section T (Source: NSW Land Registry Services, Crown plan W38.873)**

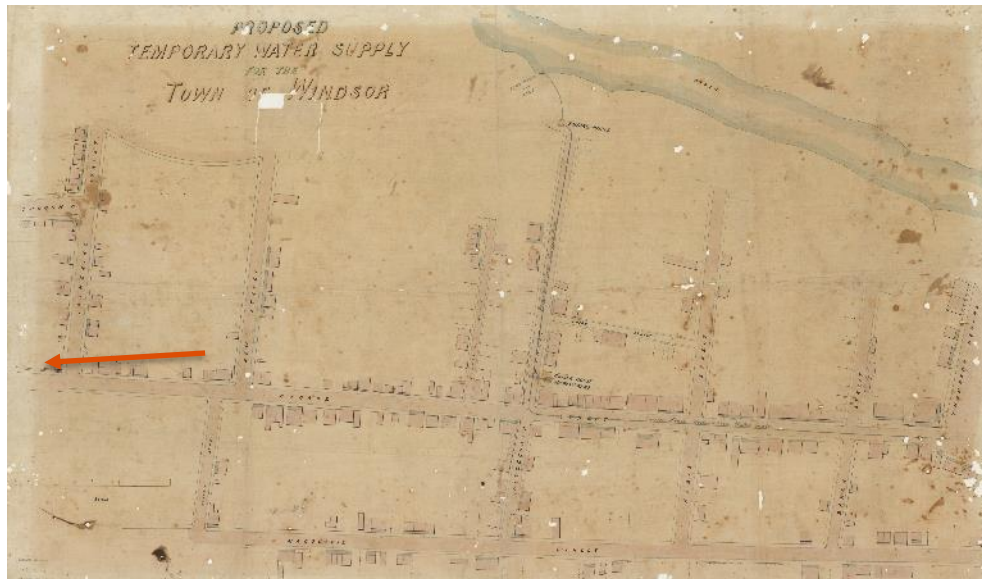
**Photo 37 c.1888 plan of the proposed temporary water supply for Windsor, with the orange arrow indicating the direction of the study area (Source: State Library of NSW, reference FL16810603)**

In 1889, Windsor commenced works to provide its own water supply, having previously had water carried from the wharf. Water from the river was pumped to an elevated tank in Fitzgerald Street. Reticulated pipes were laid down George Street from Railway Street to the end of Thompson Square, while footpaths were also being asphalted (Photo 37). By 1890, the town water supply was in operation.<sup>79</sup>

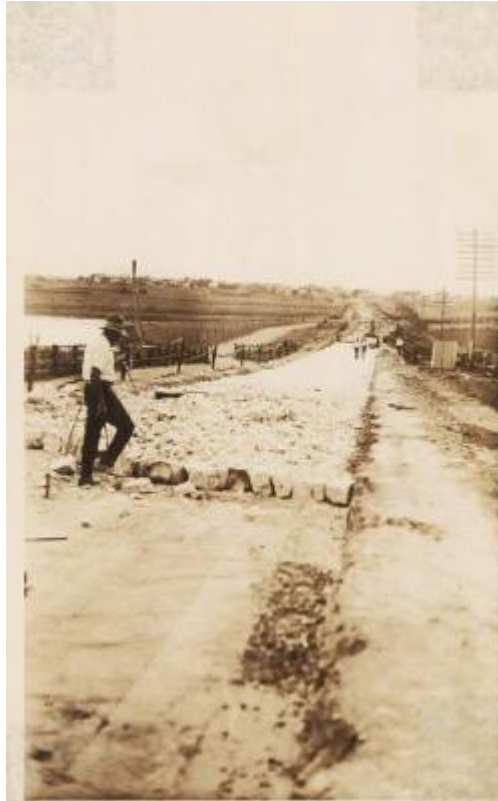
**Photo 38** 1924 photograph of reconstruction of the main road in Windsor (Source: (State Library of NSW, image no. 2024-a038-001670, cited in AAJV 2017)

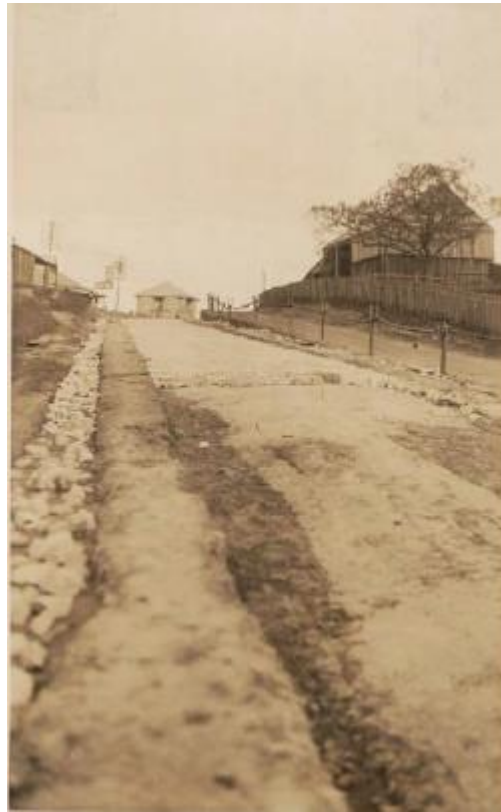
**Photo 39 1924 photograph of reconstruction of the main road in Windsor (Source: (State Library of NSW, image no. 2024-a038-001671, cited in AAJV 2017)**

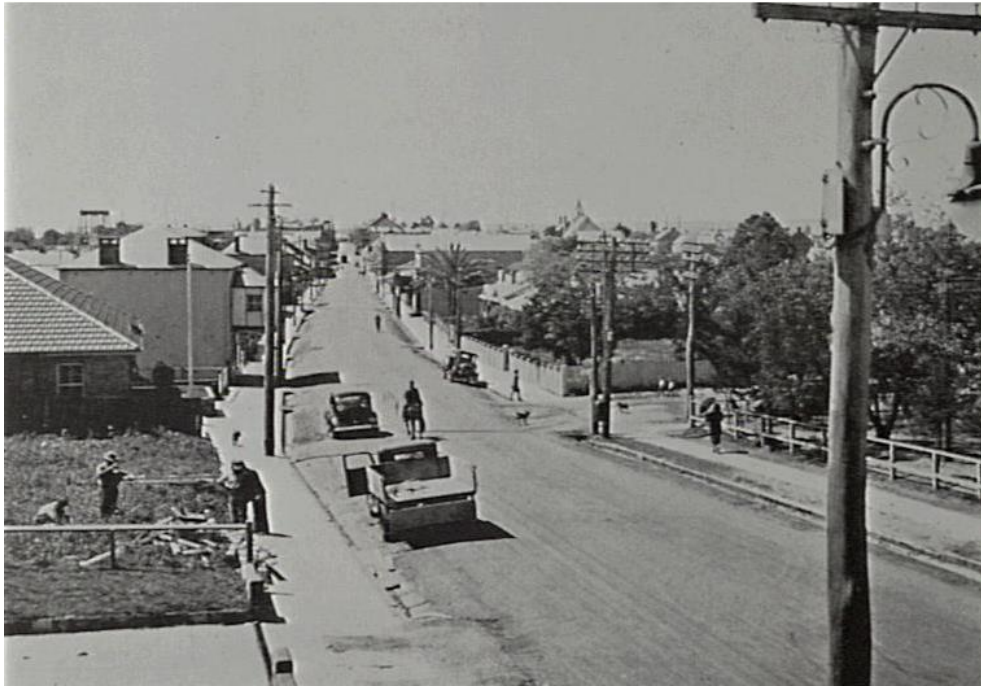
**Photo 41** 1939 photograph of George Street north of the study area prior to reconstruction in cement concrete (Source: Hawkesbury Museum)

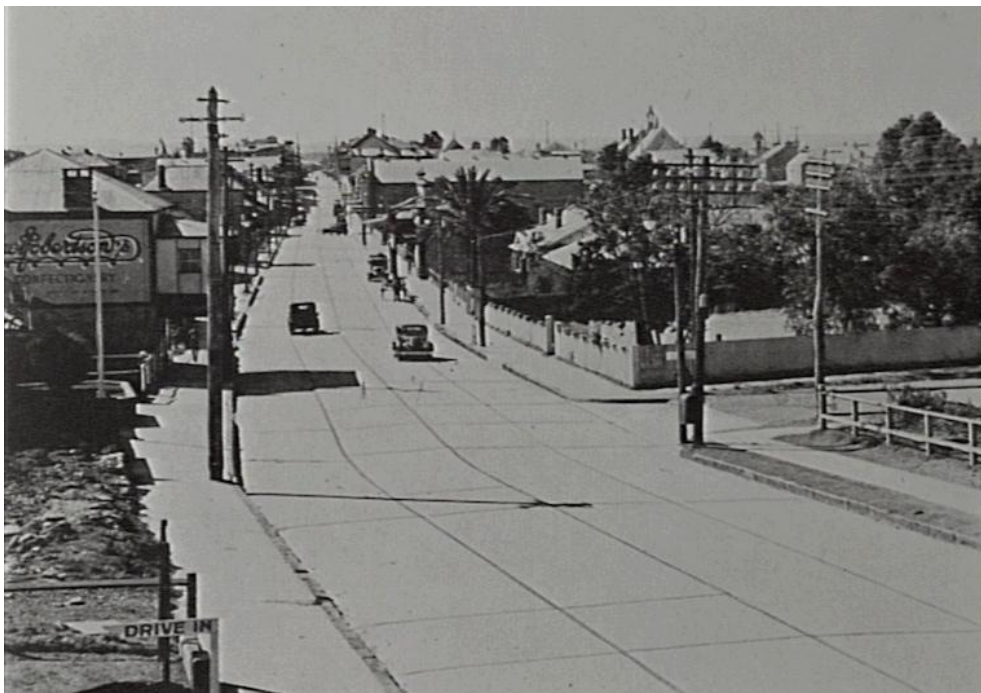
**Photo 42** 1939 photograph of George Street north of the study area following reconstruction in cement concrete (Source: Hawkesbury Museum)

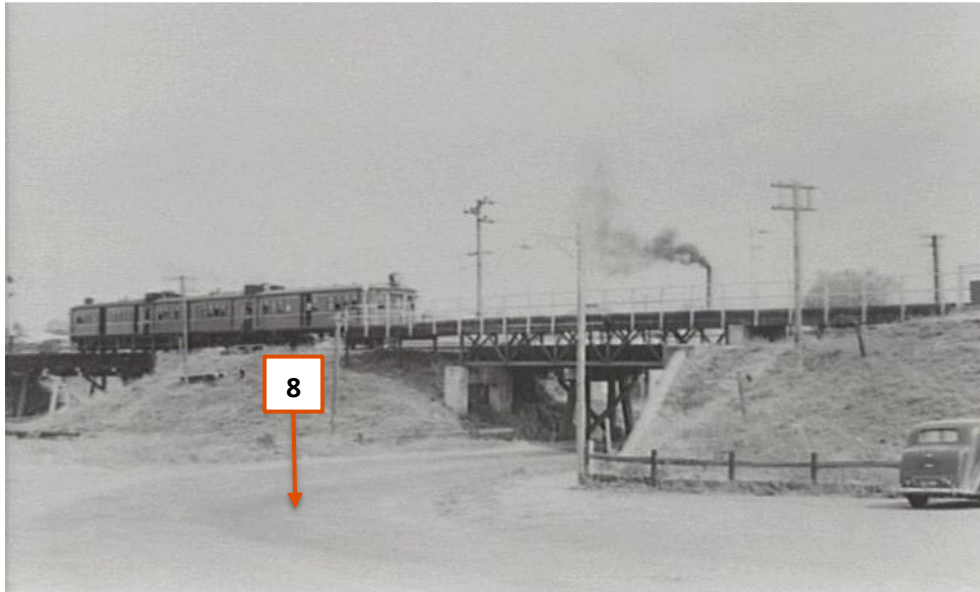
**Photo 43    Undated photograph of a train travelling over railway bridge at the deviated George Street [8] (Source: Hawkesbury City Library)**

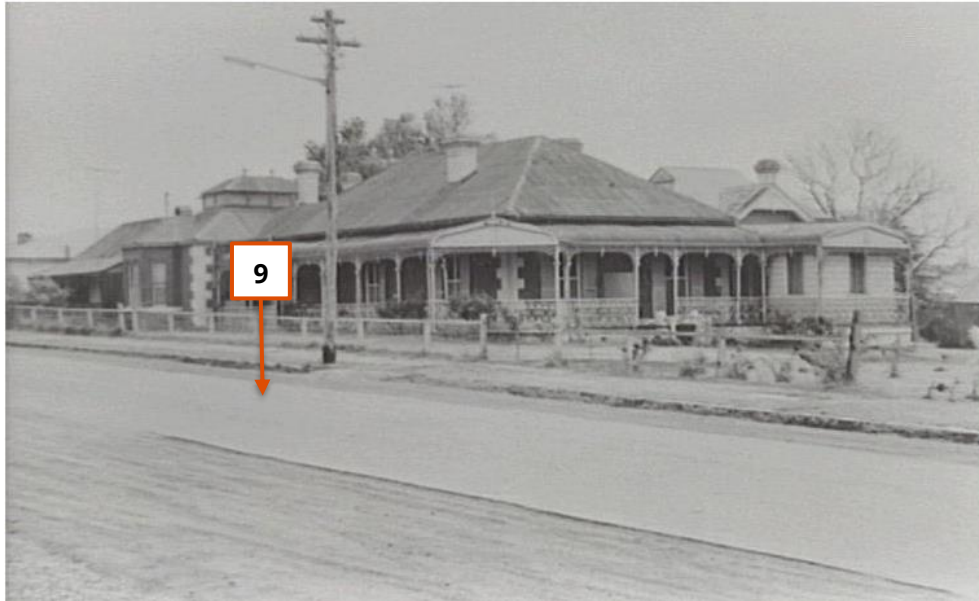
**Photo 44 Undated photograph of the substantial late Victorian suburban villa, known as Glenroy, on George Street, Windsor, showing a partially sealed road surface [9] on George Street (Source: Hawkesbury City Library)**

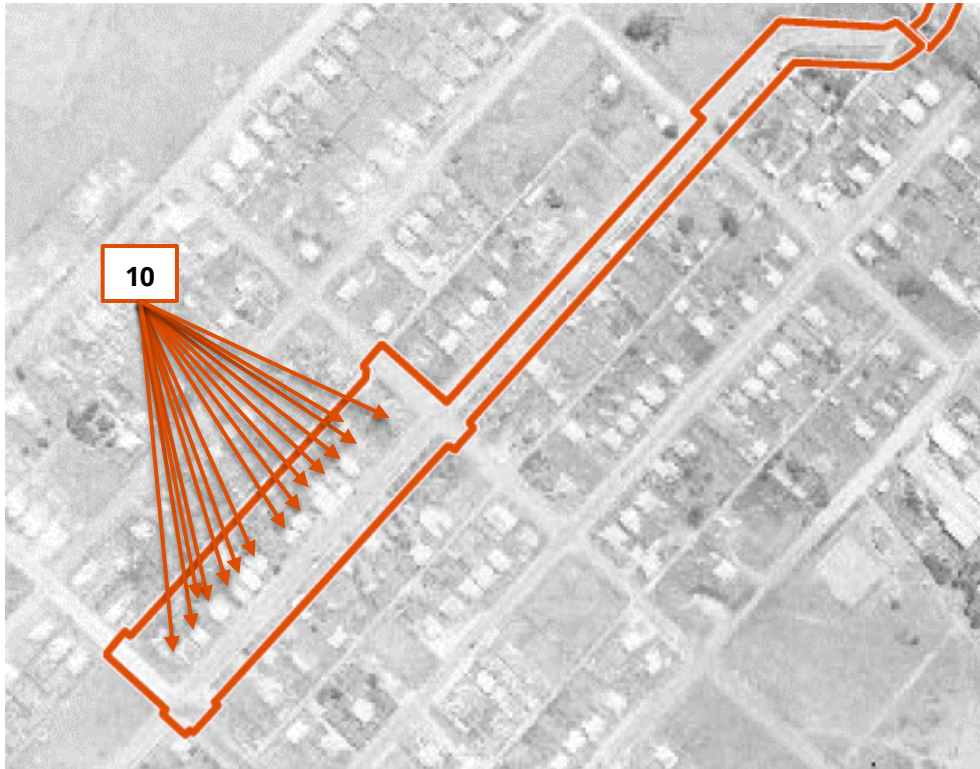
**Photo 45** 1955 aerial photograph of South Windsor, with the study area outlined in orange showing at least 14 structures [10] within Section T (Source: NSW Spatial Services, 2021)

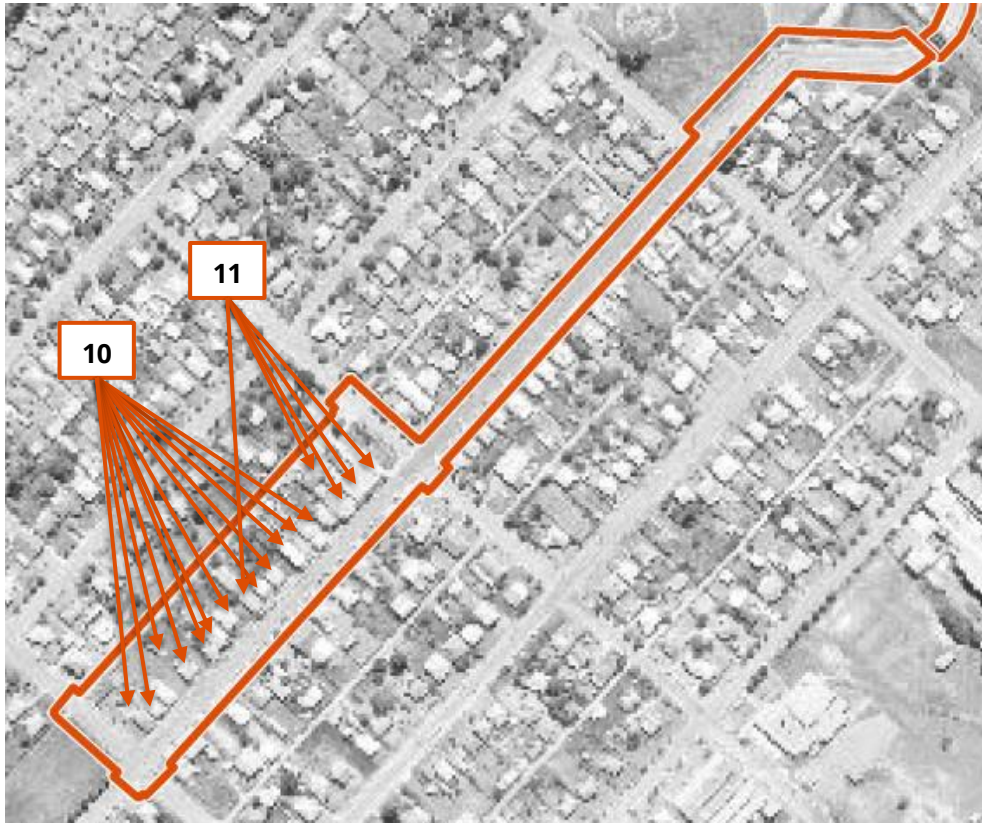
**Photo 46** 1978 aerial photograph of South Windsor showing a number of new and larger buildings between Argyle and Campbell streets and surrounding the study area, which is outlined in orange (Source: NSW Spatial Services, 2021)

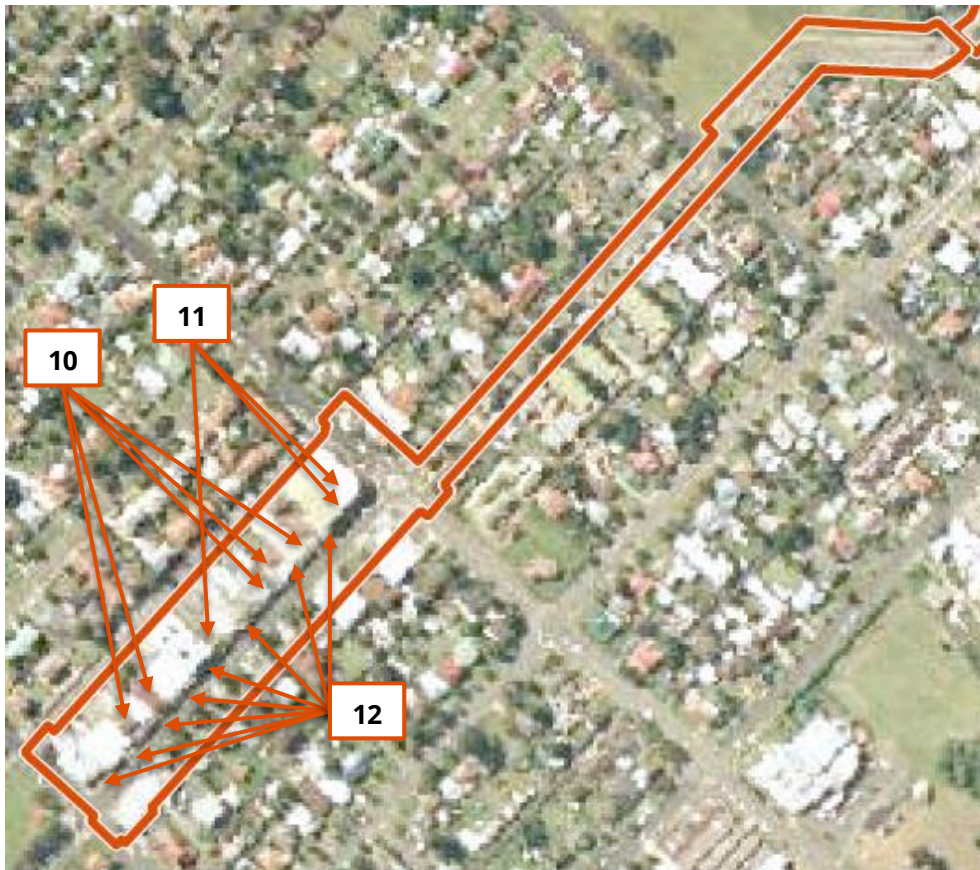
**Photo 48** 2004 aerial photograph of South Windsor showing further lot amalgamations and larger buildings between Argyle and Campbell streets, and increased dwelling density surrounding the study area, which is outlined in orange (Source: NSW Spatial Services, 2021)
