Hawkesbury Masterplan: Richmond
Historical Heritage Assessment and
Constraints Analysis Final Report

Hawkesbury Masterplan: Windsor Historical Heritage Assessment and Constraints Analysis

FINAL REPORT

Prepared for Place Group Design

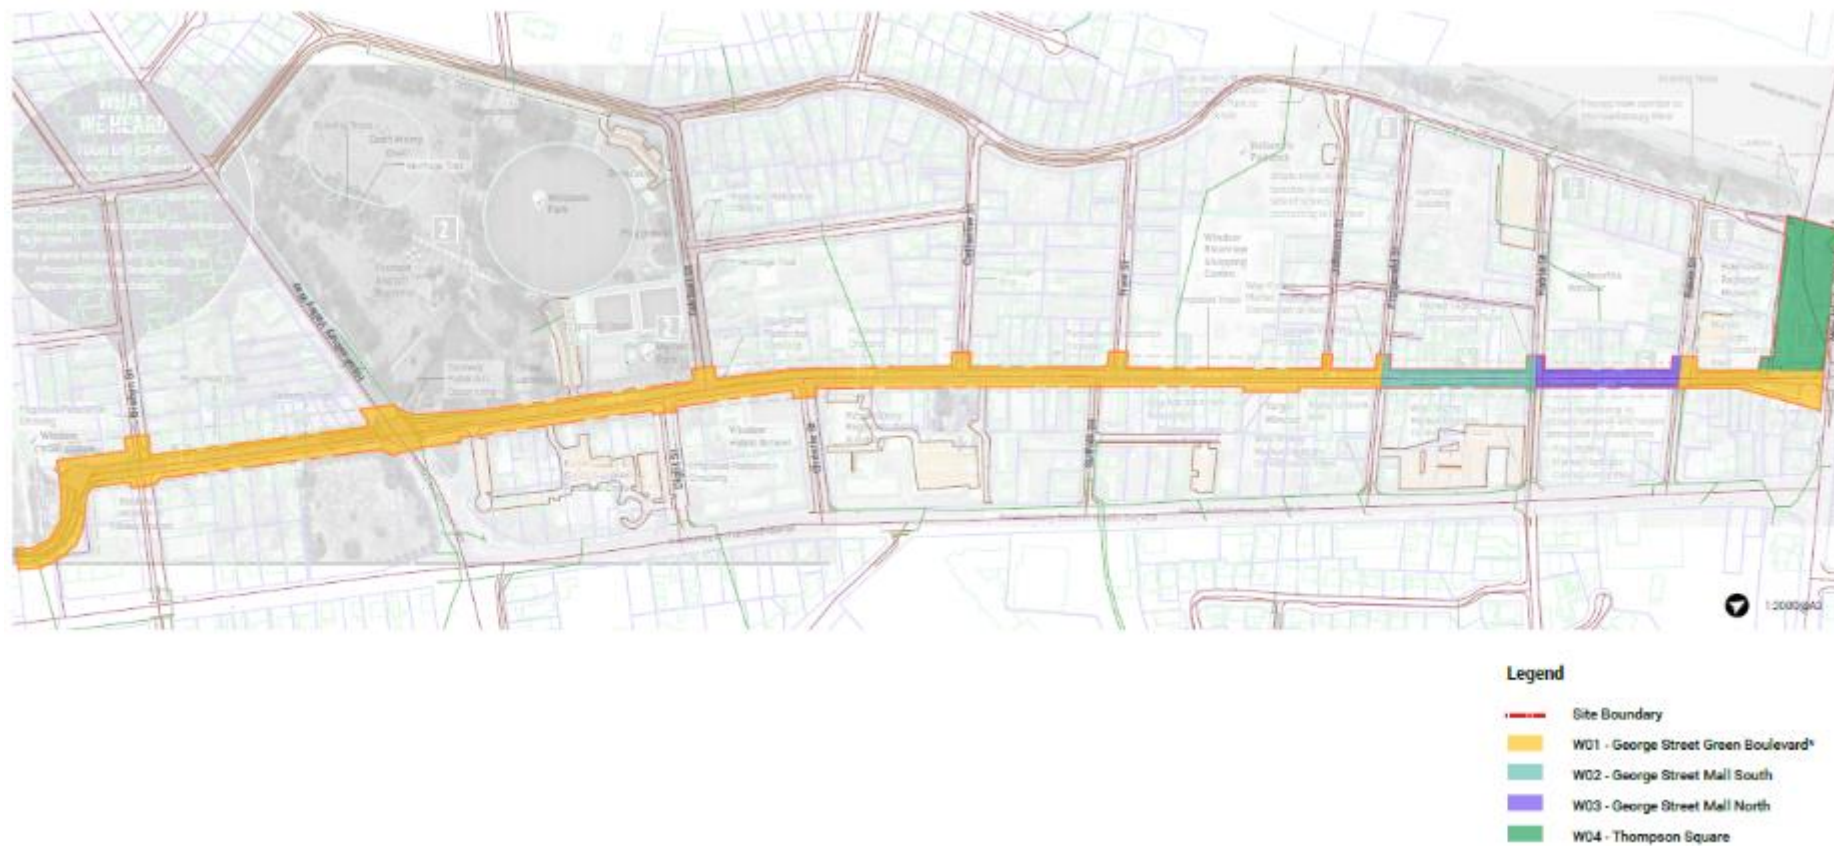
Figure 4 Windsor scope areas (Source: Master Plan Analysis Report)

The Master Plan Analysis Report¹⁹ has broken down the study area into several different scope areas, each of which have designated character zones. The scope areas, as shown in Figure 4 are: George Street Green Boulevard (W01), George Street Mall (W02, W03) and Thompson Square (W04). The character zones identified in the George Street scope area are shown in Figure 5.

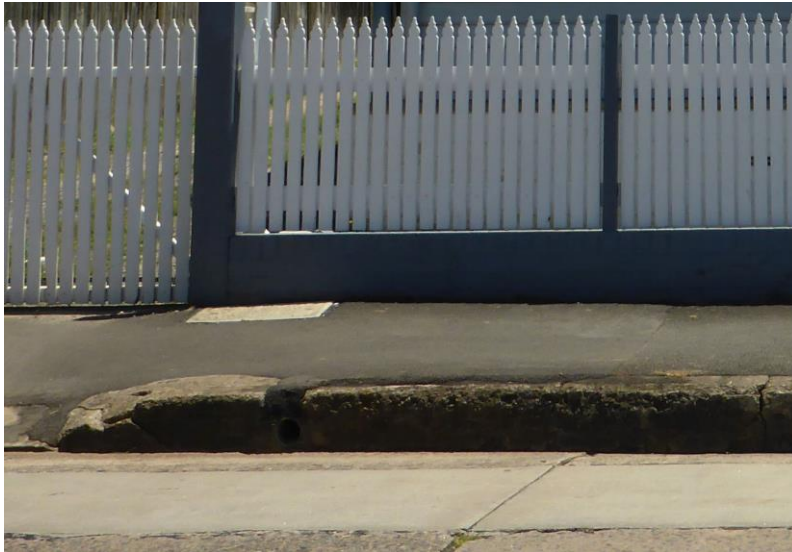
Photo 15 Example of simple stone kerbing and guttering within the study area, with modern concrete and sealed surface abutting

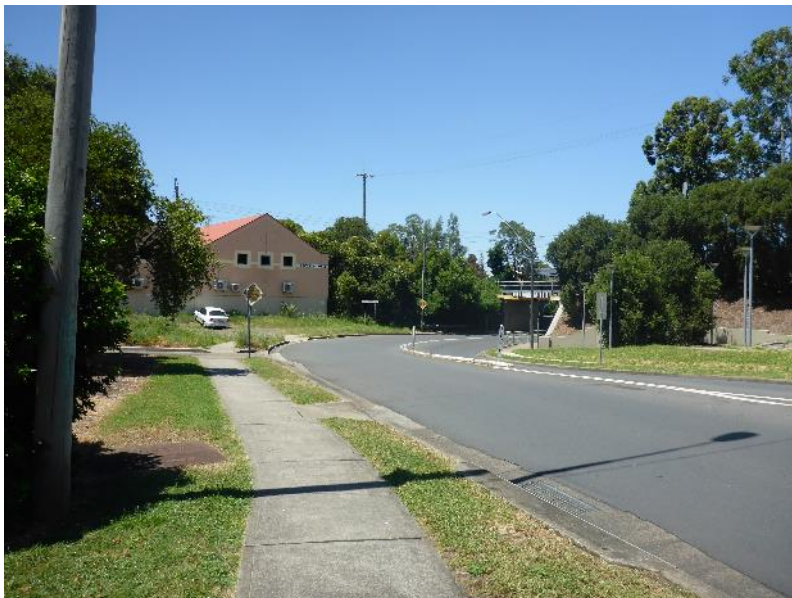
Photo 16 Example view of concrete footpaths, kerbing and gutters, sealed roads and modern infrastructure within the study area, north of Windsor Railway Station

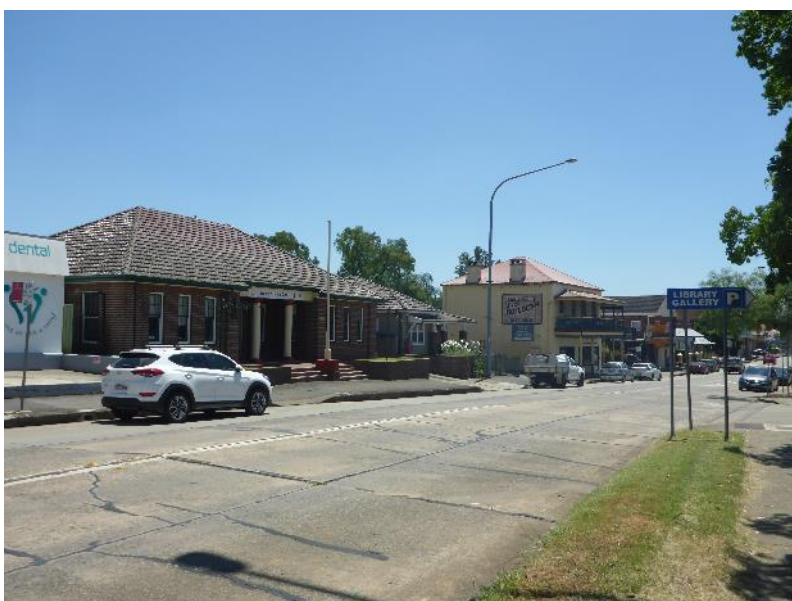
Photo 17 Example view of concrete footpaths, kerbing and gutters, sealed roads and modern infrastructure within the study area, near the former Windsor Council Chambers

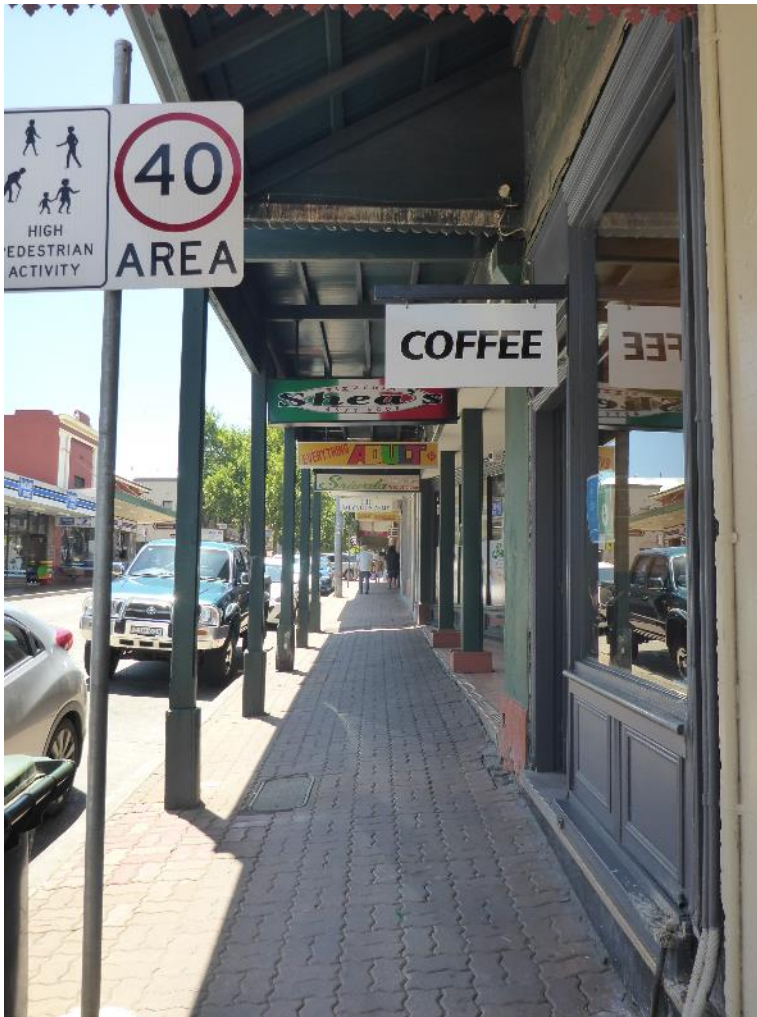
Photo 18 Example view of paved footpaths, concrete kerbing and gutters, concrete roads and modern infrastructure within the study area, in the vicinity of a series of heritage items

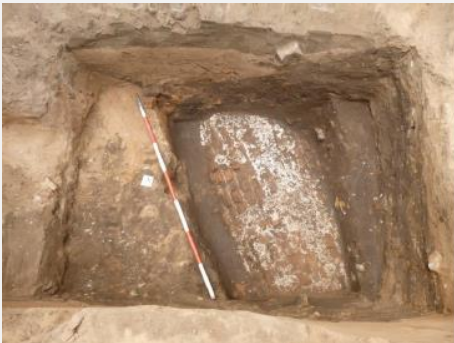
Archaeological item and location	Location and description
Brick drain, Thompson Square	<p>A brick barrel drain that crosses Thompson Square was identified during excavations associated with the Windsor Bridge redevelopment project.²³ The excavated drain includes barrel drain, headwall, feeder brick box drain for main drain alignment, brick shaft and later vitreous ceramic pipe dated to the late-19th or early-20th century. The item is constructed of sandstock bricks held together with mud and shell consistent with late-19th early-20th century date. The main drain structure consists of an inverted arch forming the base with straight battered walls topped by an arch. The drain has an internal height of 1.30m an invert width of 700mm. The remains of the brick drain exit were identified in 1986 at the river's edge behind the remains of the wharf.²⁴ It is likely that sections of the brick drain would have been truncated or destroyed as part of the 1947-1951 road cutting within Thompson Square. Part of the drain is contained within the study area in Thompson Square.</p> <div data-bbox="461 675 913 1018">

</div> <p data-bbox="423 1027 938 1093">View of exposed crown of brick drain with remnant lime render (AAJV 2018, p.46 Figure 31)</p> <div data-bbox="974 675 1424 978">

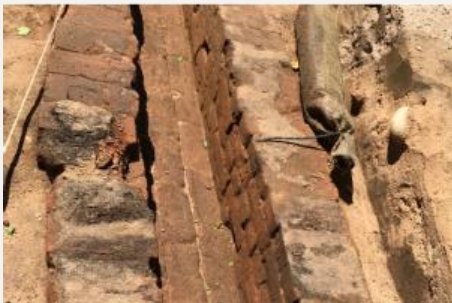
</div> <p data-bbox="974 986 1485 1093">Section of one of the box culverts with evidence of former timber coverings (AAJV 2018, p.59 Figure 50)</p> <div data-bbox="1520 675 1865 1133">

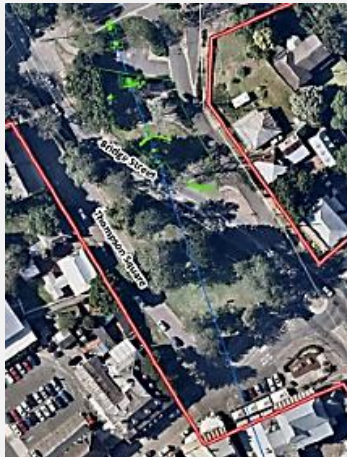
</div> <p data-bbox="1520 1141 2018 1323">Overlay of the brick drain alignment (blue) and excavation plan (green) (red outline is project area boundary from Windsor Bridge Replacement project) (AAJV 2018, p.41 Figure 28)</p>

Photo 40 Overlay of the brick drain [1] alignment (blue) and excavation plan (green) on a 2016 aerial of Thompson Square (red outline is project area boundary from Windsor Bridge Replacement project) (Source: (AAJV 2018, p.41 Figure 28)

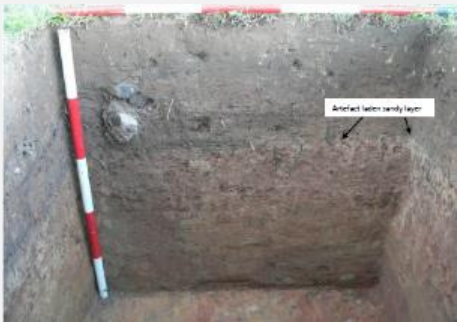
</div> <p>Shallow sandy layer featuring non-Aboriginal artefacts above the natural remnant sand dune (Biosis Research & Cultural Resource Management 2012, p.218 Plate 115)</p> <div data-bbox="1010 874 1464 1137">

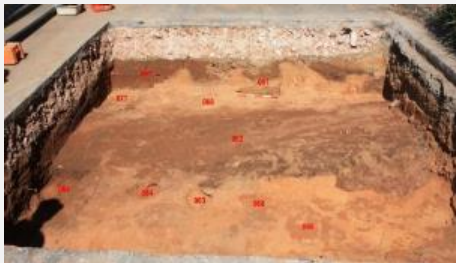
</div> <p>Test Trench 1 posthole (061), other pits and holes dug for plantings and stakes, and the dark soil of the remnant earl-19th century surface (Biosis Research & Cultural Resource Management 2012, p.216 Plate 113)</p> <div data-bbox="1547 874 2002 1101">

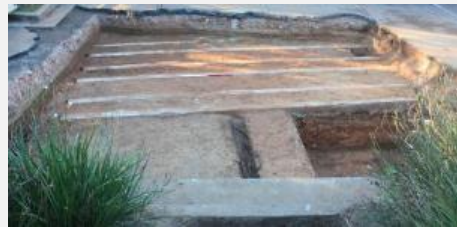
</div> <p>1897 levelling fills for road works and concrete cast beams for stabilisation (Biosis Research & Cultural Resource Management 2012, p.217 Plate 114)</p>

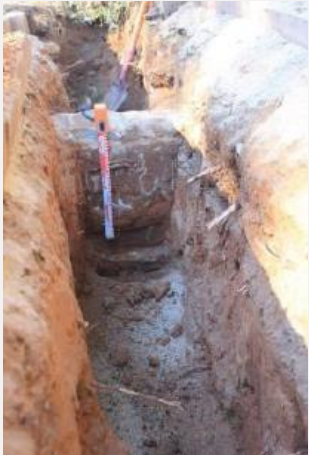
Archaeological item and location	Location and description
Remains of potential entry stairs to Macquarie Arms Inn and recent works, Thompson Square	<p>Archaeological monitoring in the road reserve adjacent to the Macquarie Arms Inn identified two sandstone walls (Feature 1 and Feature 2) within the road reserve on the northern side of the Macquarie Arms Inn, beneath the paved footpath and grass verge. The two features spanned the width of the trench, continuing into the unexcavated sections. Feature 1 had a concrete slurry on top with a concrete deposit abutting the stone. Feature 2 showed evidence of a second course. They were left in-situ and protected from the services works being undertaken. These features were interpreted as being the remains of former entry stairs to the inn from Thompson Square up the grass verge. Recent deposits 20th century deposits associated with landscaping and services were also found. Another deposit was interpreted as introduced fill material associated with pavement of landscaping works outside the inn.²⁶</p> <div style="display: flex; justify-content: space-around;"> <div style="text-align: center;">

<p>Feature 1, section of a sandstone wall interpreted as being associated with steps to the Macquarie Arms Inn (Biosis Pty Ltd 2015, p.20 Plate 5)</p> </div> <div style="text-align: center;">

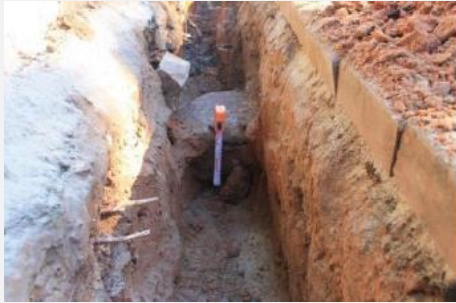
<p>Feature 2, section of a sandstone wall interpreted as being associated with steps to the Macquarie Arms Inn (Biosis Pty Ltd 2015, p.21 Plate 7)</p> </div> <div style="text-align: center;">

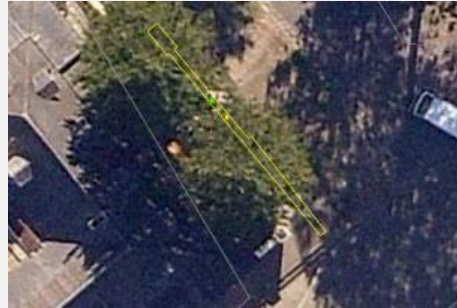
<p>Location of Feature 1 (yellow) and Feature 2 (green) adjacent to the Macquarie Arms Inn (Biosis Pty Ltd 2015 Figure 4)</p> </div> </div>

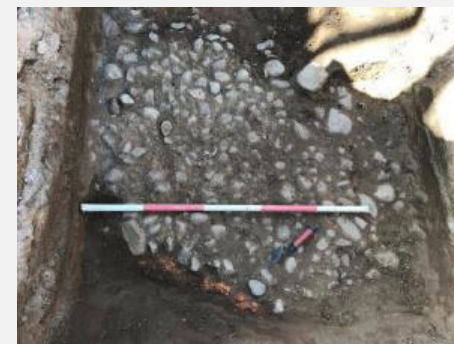
View of the late-19th century cobble surface with brick border in Test Pit SA32 (AAJV 2017, p.8 Figure 61)

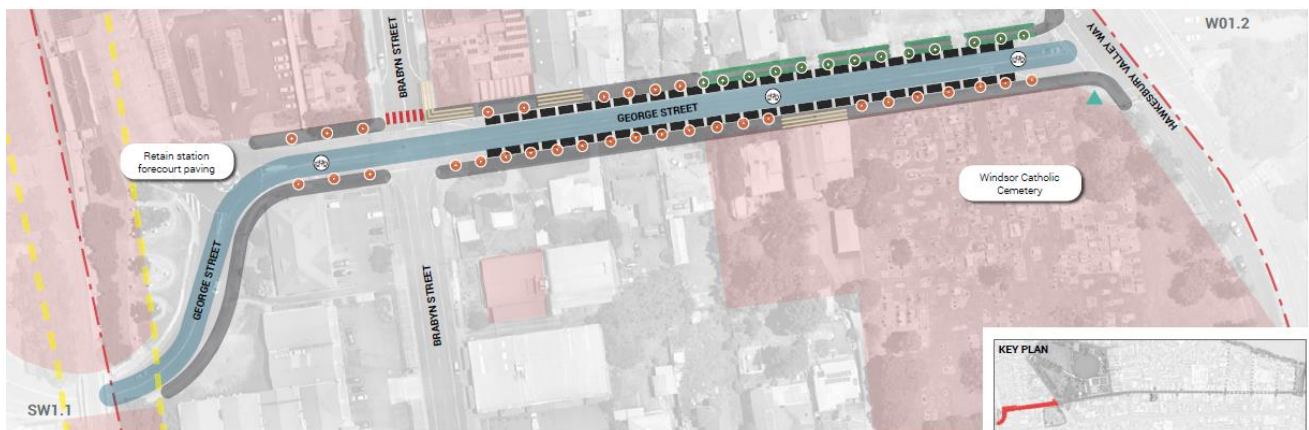
Photo 23 Proposed upgrades for W01.1 George Street Green Boulevard

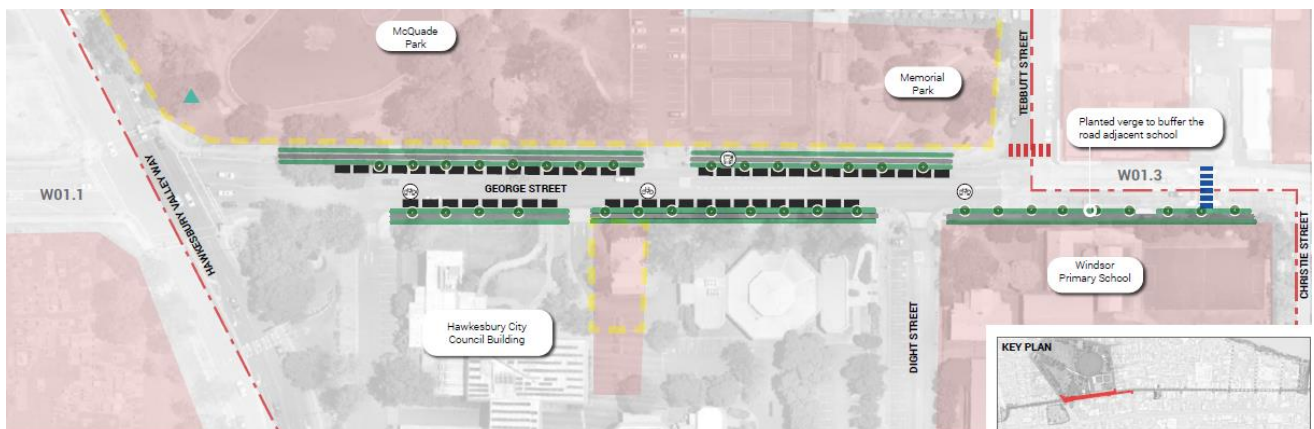
Photo 24 Proposed upgrades for W01.2 George Street Green Boulevard

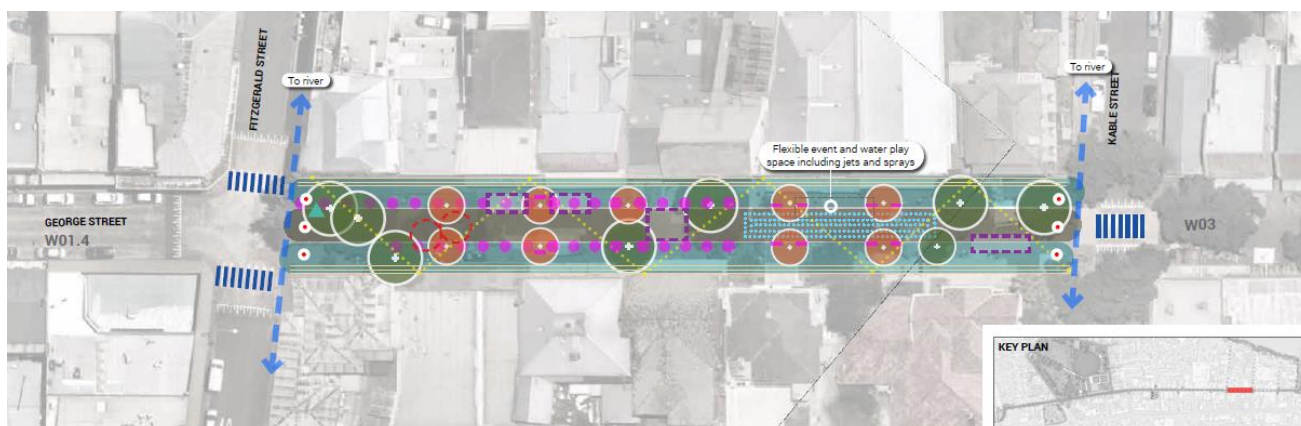
Photo 28 Proposed upgrades for W02 George Street Mall South

Works proposed in this zone can be seen in Photo 28. Heritage items can be seen in Figure 3 and areas of archaeological potential can be seen in Figure 6. Table 18 outlines the constraints and recommendations for works to take place in this area. It is assumed that mixed traffic bike lane, retaining on street parking and existing awnings will have no impacts and that the feature paving cannot be moved. It should be noted that all but three items along the alignment are on a heritage list, and therefore moving any of the works will not lessen the visual impacts to the streetscape or adjacent items.

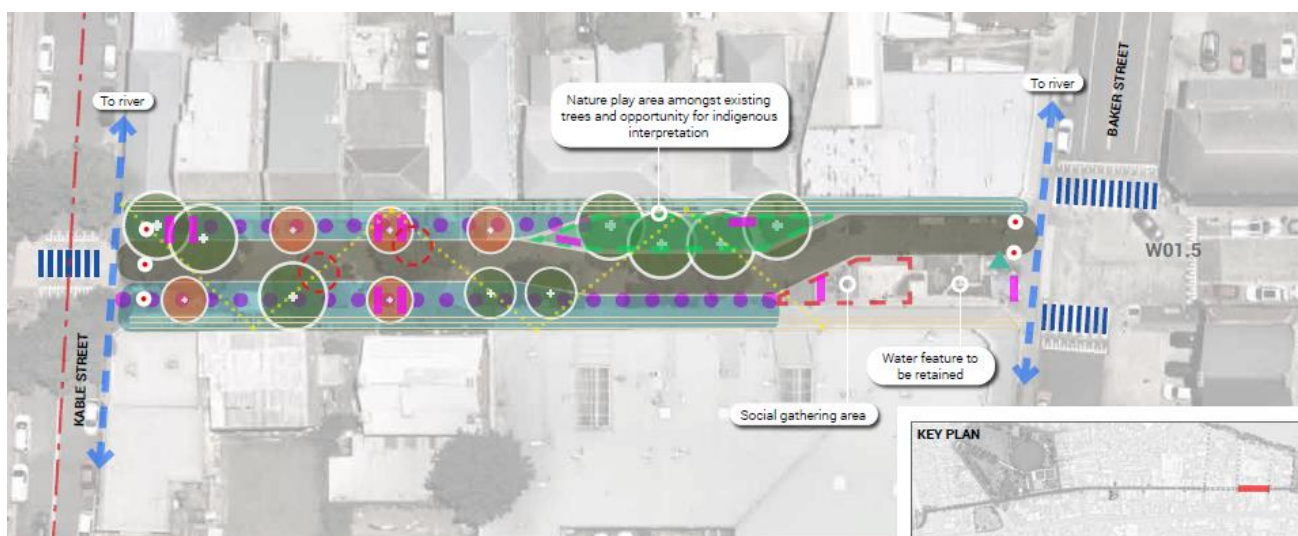
Photo 29 Proposed upgrades for W02 George Street Mall North

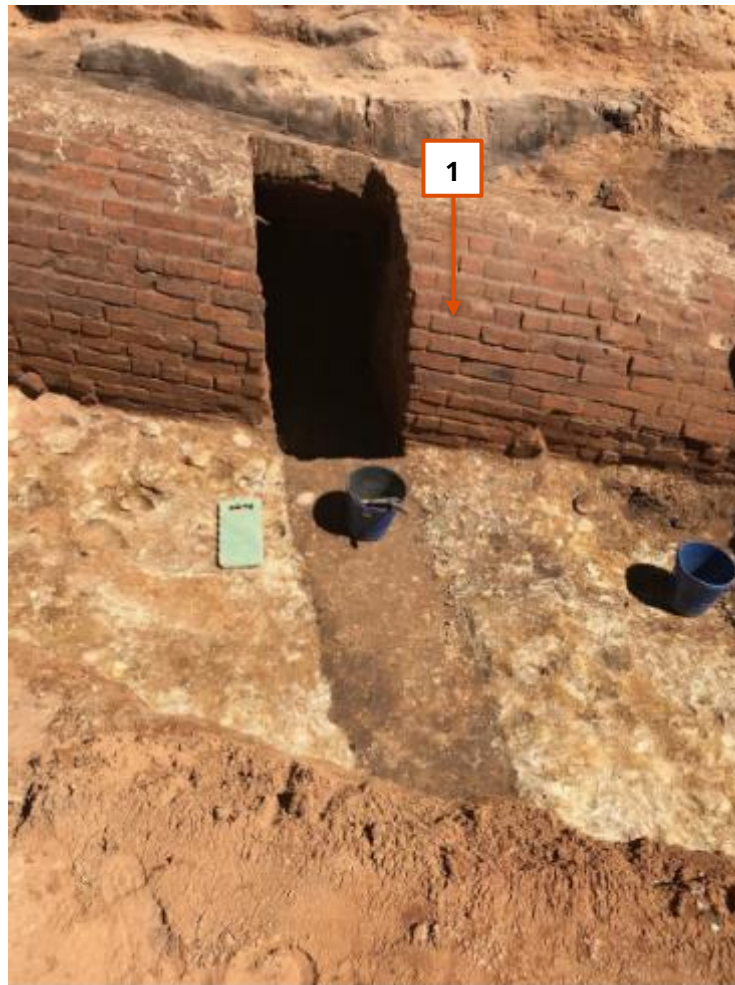
Photo 39 Partially excavated remains of the 1814-1816 brick drain [1] within Thompson Square, transected by a 1937 sewerage line (Source: (AAJV 2018, p.17 Figure 4)

the brick may have also been subject to inferior workmanship, but it is likely that the drain had been covered over before an inspection could be arranged.⁷³

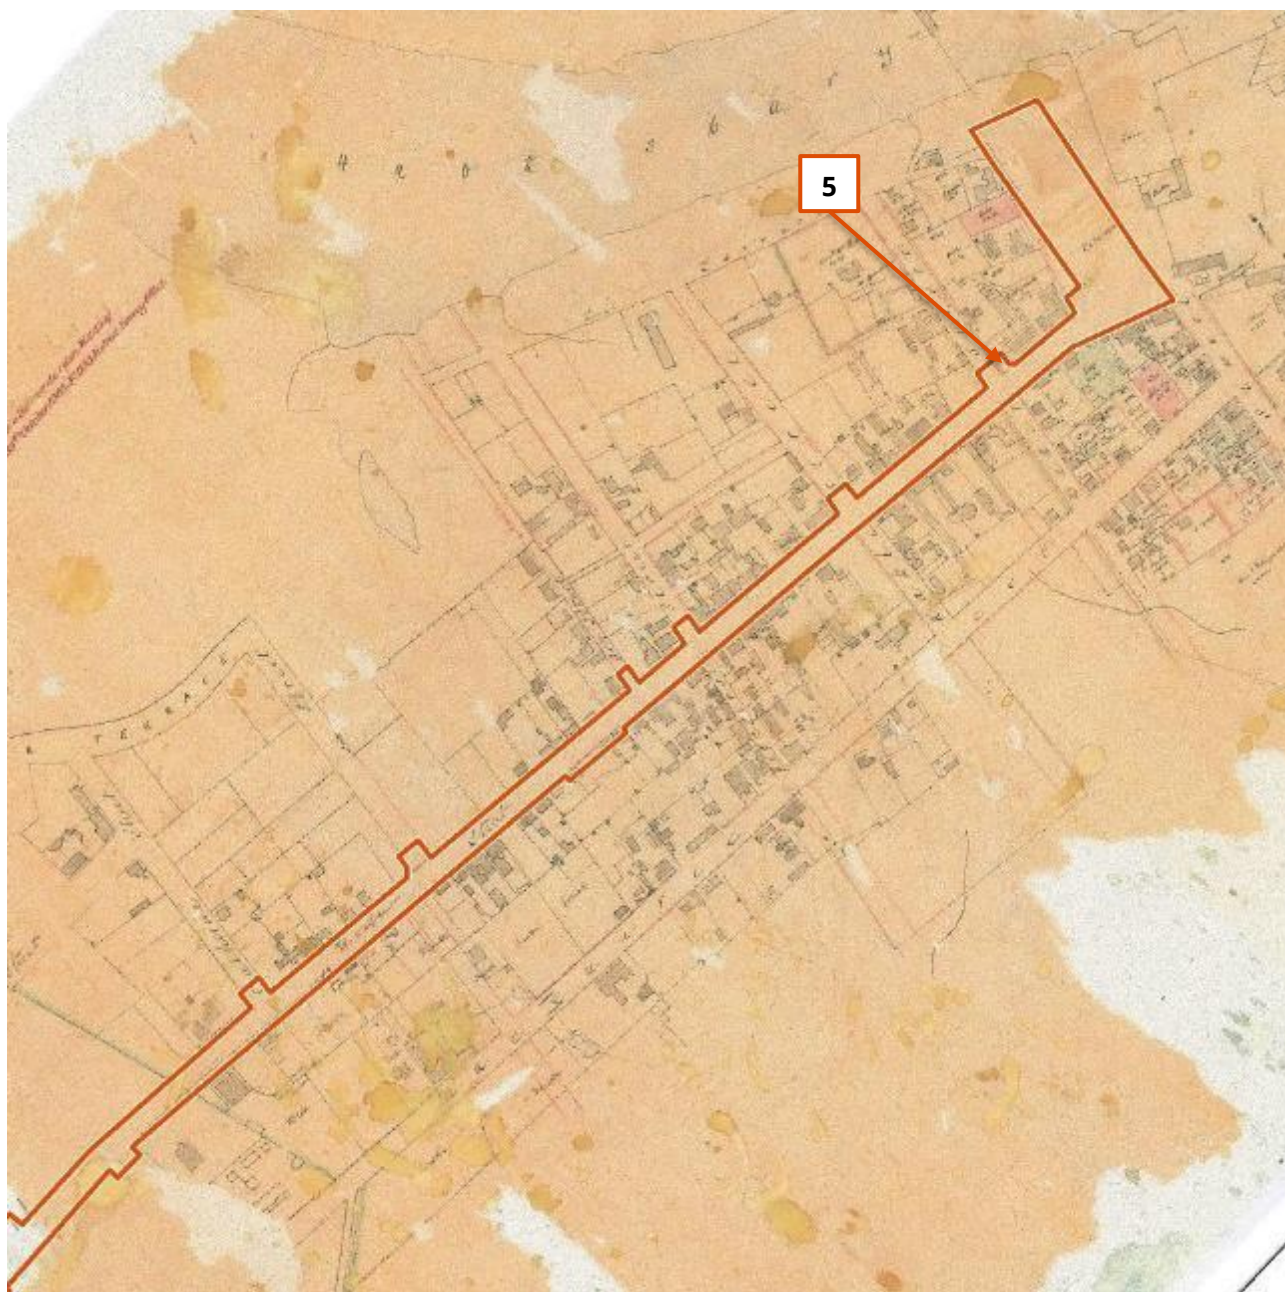
Photo 45 A plan of Windsor dated to 1835, with the study area outlined in orange, with possible early road features [5] indicate by the arrow (Source: NSW State Archives and Records, 5968)

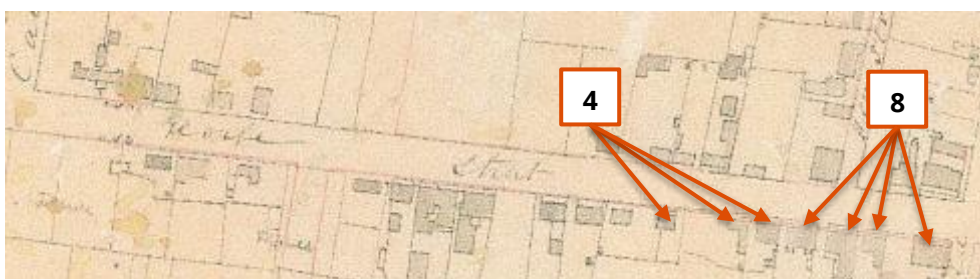
Photo 48 Detail of 1835 plan between Fitzgerald and Catherine streets showing three buildings [4] and the extension of four buildings/verandahs [8] extending into the road reserve (Source: NSW State Archives and Records, 5968)

From Fitzgerald to Suffolk streets (Photo 59), there are 12 buildings/verandahs [15] which enter the road reserve and study area. These all appear to be located on the eastern side of George Street. When compared with the 1835 Crown plan of the same area (Photo 48), all four [8] previously identified remain. A new building [16] is also present at 210 George Street in the vicinity of those three buildings [4] previously recorded in the 1835 plan (Photo 48).

From Suffolk to Christie streets (Photo 60), no buildings/verandas are recorded within the road reserve/study area, similar to what was previously recorded in the 1835 Crown plan (Photo 48). In general, there are fewer structures adjacent to the study area on the eastern side of George Street, but more structures adjacent to the study area on the western side of George Street.

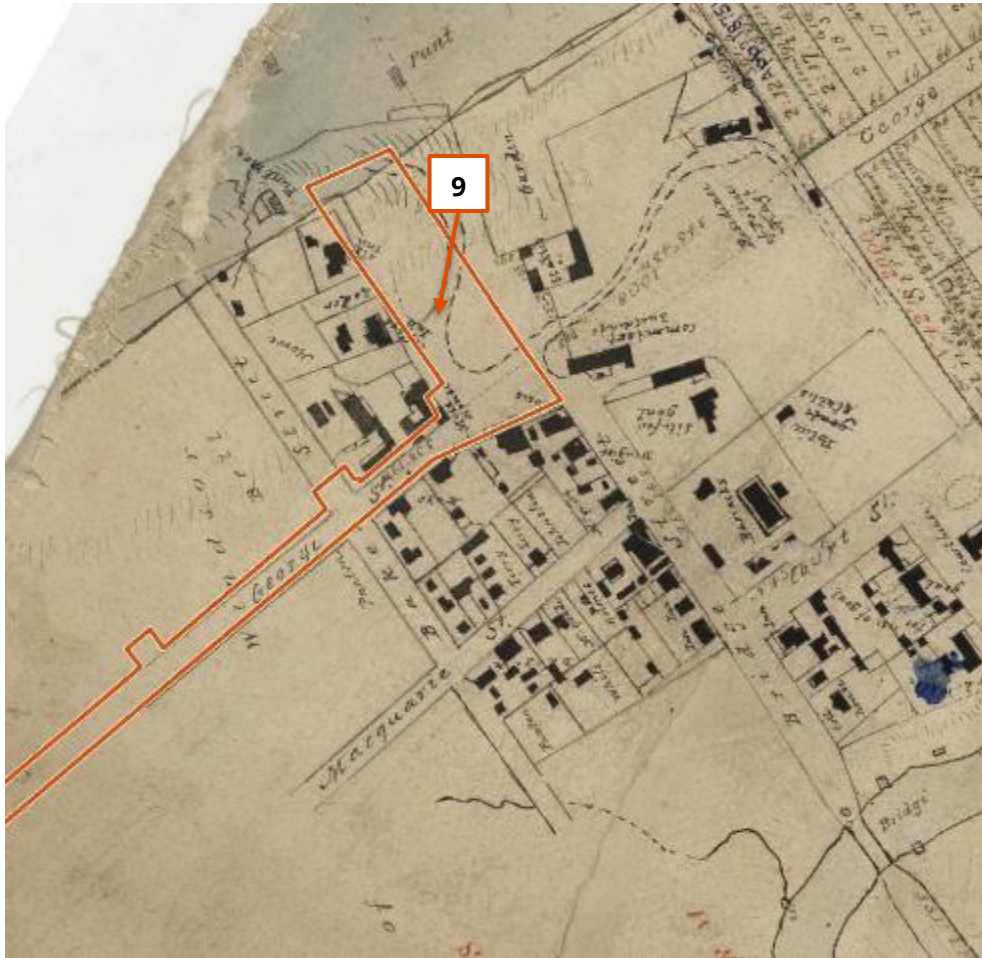
Photo 49 Crown plan dated to c1842 – 1844, with the study area outlined in orange (Source: State Library of NSW, reference FL3780275)

A Crown plan of Windsor dating between 1842 and 1844 shows a number of structures surrounding Thompson Square (Photo 49). Two structures are visible within the northern portion of the study area, within the southern corner of Thompson Square. However, this is likely due to issues with scale and the age of the map. The structure located on the corner of George Street and Thompson Square is labelled Mess House, which is also known as Macquarie Arms Inn. A roadway [9] within Thompson Square is also visible. The northern corner of the lot containing the structure labelled Old Inn can also be seen within the study area making up the corner of Thompson Square and The Terrace. The corner of Baker and George Street is again shown within the study area.

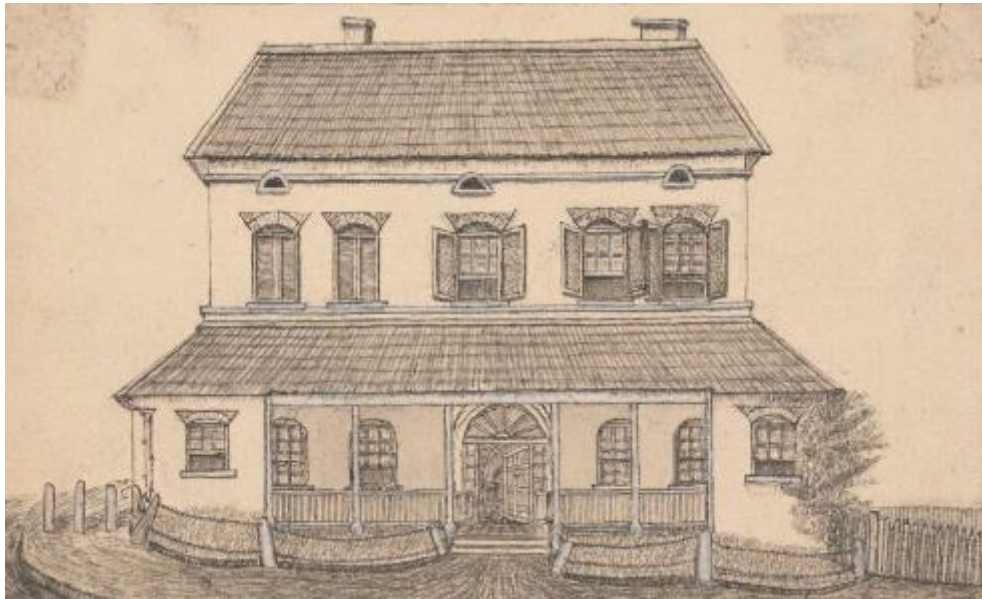
Photo 50 1842 sketch of the Macquarie Arms Inn by Elise Palmer when it was used as a military officer's quarters (Source: National Library of Australia, reference nla.obj-135213321)

An 1842 drawing of the Macquarie Arms Inn during its time as military officer's quarters provides an early depiction of the building (Photo 50). While the image may not be accurately to scale, it does indicate the structural form of the Inn at this time. It is likely that this view is taken from Thompson Square, as the corner of the road is on the left side of the building, suggesting that this corner is where George Street and Thompson Square meet. If this is the case, then three posts appear to be located within the footpath of George Street, and the with the stone boundary wall yet to be constructed on its north-western side.

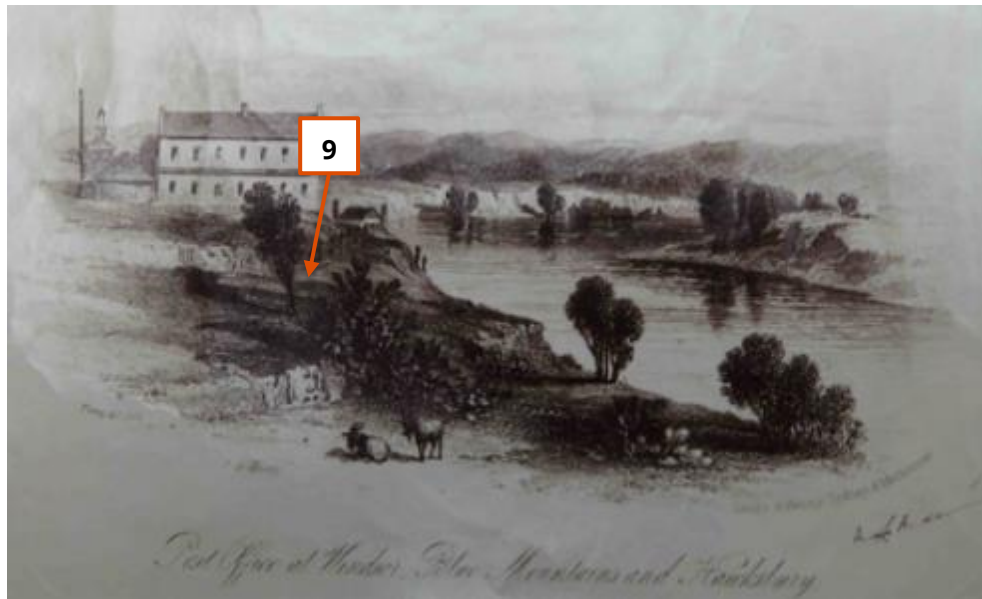
Photo 51 1853 sketch of the Doctor's House when it housed the post office, with Thompson Square and the roadway [9] leading to the riverbank (Source: (ML.SPF, PXA 2113, Box 374 , cited in Lucas Stapleton Johnson & Partners Pty Ltd 2018, p.77 Figure 2.52)

An 1853 sketch of the area containing Thompson Square and the banks of the Hawkesbury River provide an indication of the early formation of this area (Photo 51). The drawing features the Doctor's House when it contained the post office and a grassed reserve for Thompson Square with a cutting for a roadway [9] to the punt house and river.

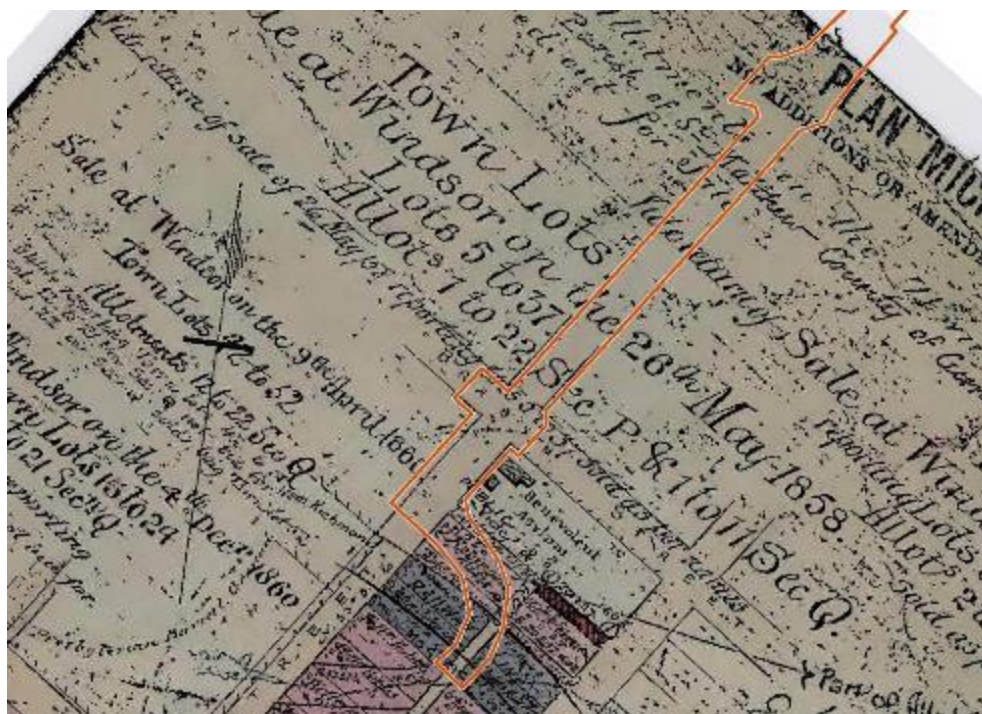
Photo 52 c.1858 Crown plan of Allotments for sale in George Street and Brabyn Street, with the study area outlined in orange (Source: NSW Land Registry Services, Crown plan W27.873)

An 1858 Crown plan of shows Allotments for sale in the vicinity of the southern portion of the study area (Photo 52). Allotment 2 is shown to be under the ownership of J. Robinson. A laneway between George and Macquarie Street can also be seen within this portion. Adjacent east of the study area are two structures

associated with the Benevolent Asylum. The Blacktown-Richmond Railway Line has been annotated onto the plan at a later date.

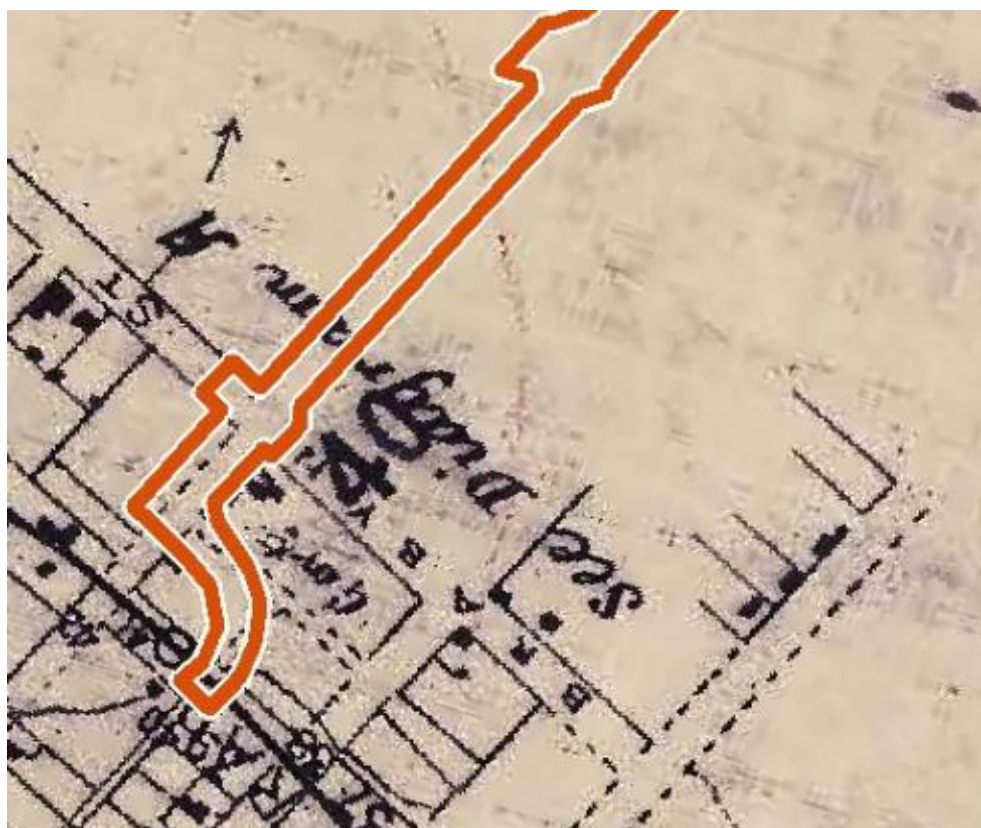
Photo 53 Undated Crown plan (likely around 1864) for the Blacktown-Richmond Railway Line. Study area in orange (Source: NSW Land Registry Services, Crown plan 4379.3000)

The Blacktown-Richmond Railway came through Windsor in 1864; the line hugged the built up section of the town on the southern cutting, in the vicinity of Fairfield house and intersecting a number of allotments (Photo 53). The Crown plan for the railway line does not record any structures within the study area. The station was constructed by W & A Elphinstone, with the original station building containing a residence and an office.¹⁵⁰ It was hoped that the railway would reinforce the idea of Windsor as a farm produce depot and distribution point. Small vessels transported grain, fruit, poultry and eggs to Windsor along the Hawkesbury, Colo and Macdonald rivers. However, while this did occur for a short time, the land west of the mountains became the dominant supplier to the Sydney market after the river silted up in the mid-1880s as a result of the flooding following clearing of the catchment area, and the shipping channel within Hawkesbury River was no longer navigable. Attempts were made to dredge silt from the river but these were not successful. The number of boats berthed at Windsor dropped from 468 in 1881 to 40 in 1888.¹⁵¹ The demise of river trade caused by the silting up of the channel resulted in the growth of the area slowing and the population in the town began to decline. However, the region was a focus for agriculture and Windsor was the centre for produce as far

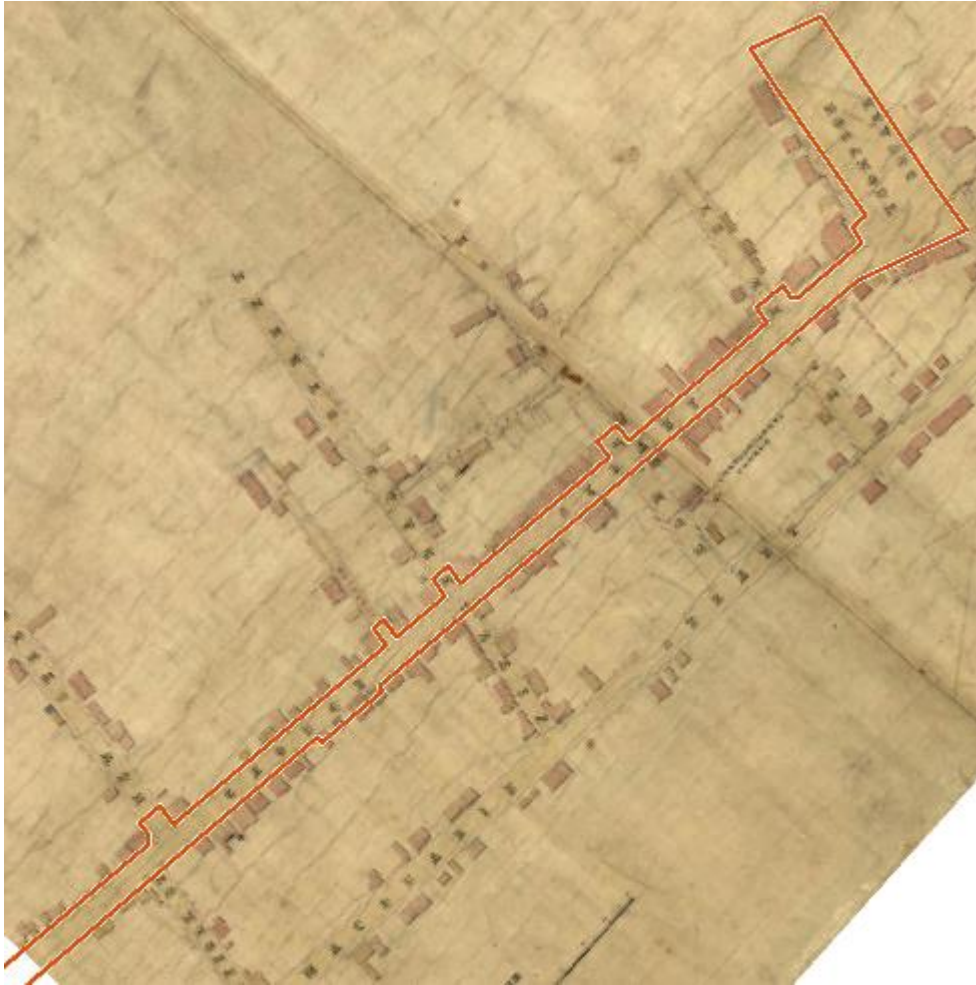
Photo 56 Northern part of 1871 Crown plan of the town of Windsor, with the study area outlined in orange (Source: NSW Land Registry Services, Crown plan W1-1039)

A detailed Crown plan was created in 1871 which provides information regarding the extant structures at this time and the wider development of Windsor as a township (Photo 56, Photo 57). It should be noted that georeferencing of these plans may not completely accurate; as such a structure has been noted where they enter the recorded road reserve in the plan or within the study area where it extends beyond the general road reserve. Fencelines along property boundaries regularly stray from the official road reserve boundary, and as such there are numerous property fences which enter into the road reserve/study area.

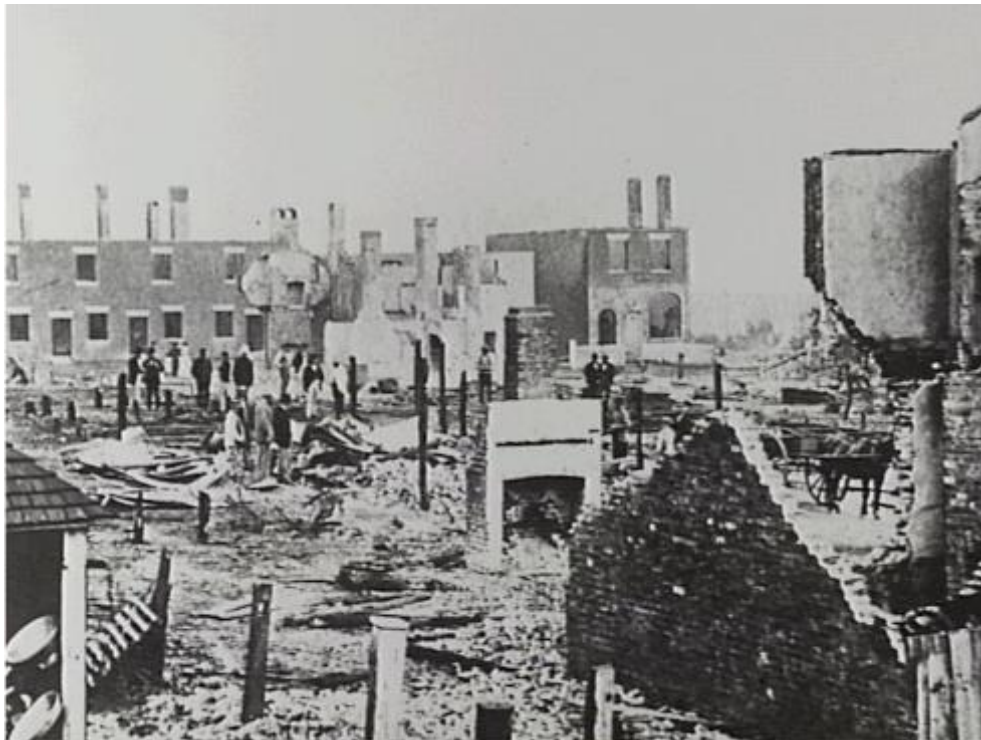
Photo 64 Damage caused in George and Macquarie Streets by the 1874 fire in Windsor (Source: Hawkesbury City Library)

In December of the same year, Windsor suffered a severe fire which reduced much of the northern part of town to rubble (Photo 64). More than 30 houses were destroyed in the fire, along with several major buildings. The block bounded by George, Suffolk, Windsor and Fitzgerald Street was particularly affected, in which only three shops and the Wesleyan Hall were not destroyed. The Barraba Hotel, which stood opposite

the post office, the Methodist Church and parsonage, two tanneries, the Oddfellow's Hall and numerous shops and dwellings were razed. The Sydney fire brigade was wired for and arrived late in the evening. Archaeological excavations for sites located along George Street have identified a layer of ash and charcoal which have been associated with this event.¹⁶³

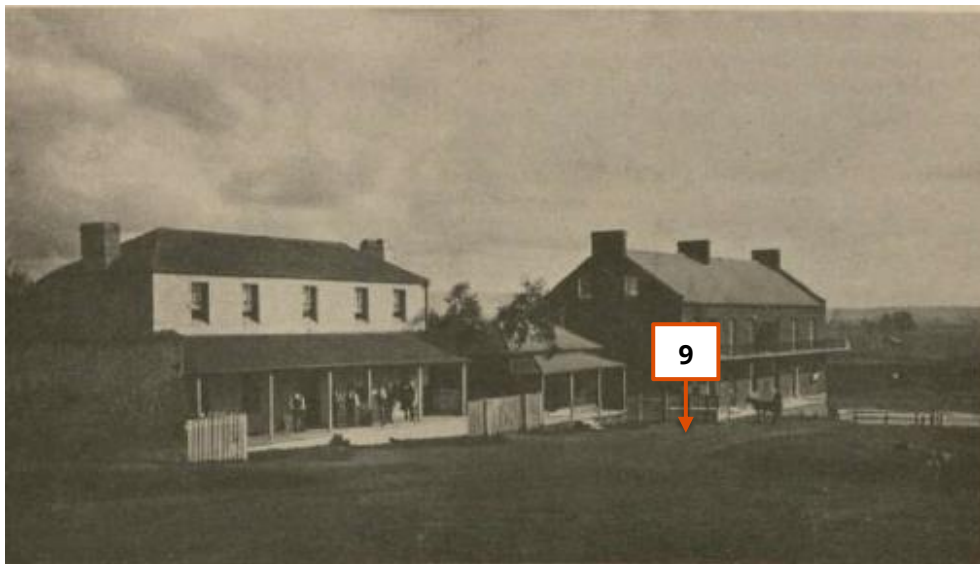
Photo 65 1879 photograph of Thompson Square, showing the roadway [9] to the riverbank
(Source: (Baker 1967, p.24)

A series of photographs taken in 1879 provide an indication of the development of Windsor at this time. A photograph of Thompson Square and the houses adjacent (Photo 65) indicate the road surface [9] as being gravel or dirt, and stone kerbing does not appear to be present. A subsequent view of the Windsor Bridge and Thompson Square from the opposite side of the Hawkesbury River provides further detail (Photo 66). The roadway [9] leading to the new bridge meanders through the square, which has been cut into the side of the slope. A view from the junction of George and Fitzgerald streets towards the railway station also indicates that George Street was a bustling centre of the town, with hotels, shops and dwellings located in this area (Photo 67). As has been noted in historical plans, some of the building verandahs extend over the public footpath area within the road reserve. The road surface appears to be metal with stone kerbing also present. Another photograph shows the new Windsor Public School with teachers and students (Photo 68). Similar to the previous photograph, the road is likely a metalled surface with stone kerbing, as well as what might be an electricity pole within the footpath.

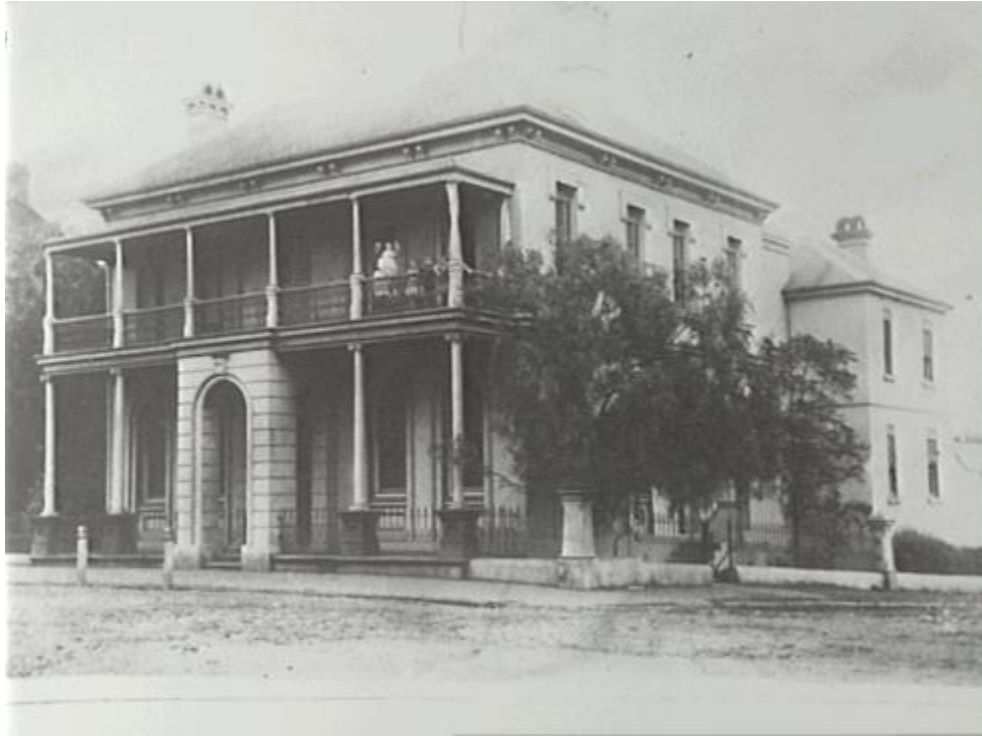
Photo 70 c.1880s photograph of the Commercial Bank (Hawkesbury LEP 2012, Item no. I185) at the corner of George and Kable streets (Source: Hawkesbury City Library)

A c.1880s photograph of the Commercial Bank (Hawkesbury LEP 2012, Item no. I185) at the corner of Kable and George streets shows the scale of the building but also the condition of the study area (Photo 70). The building features masonry boundary walls with metal fencing, while the road appears to be metalled with stone kerbing and guttering; two small posts are located at kerb at the front of the building entrance.

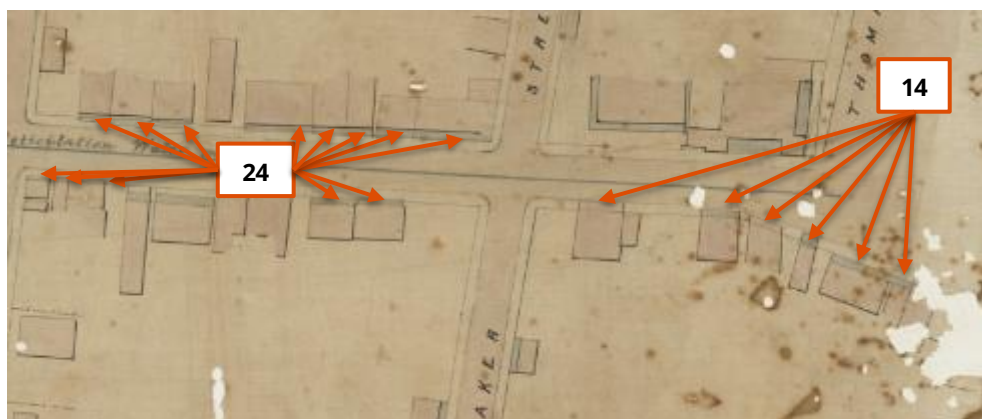
Photo 72 Detail of c.1889 plan of the proposed temporary water supply for Windsor between Thompson Square and Kable streets, showing buildings/verandahs [14] [24] extending into the study area (Source: State Library of NSW, reference FL16810603)

Between Thompson Square and Kable streets (Photo 72), there are five buildings/verandahs [14] that enter the road reserve/study area previously identified in the 1871 plan (Photo 58), and 13 buildings/verandahs [24] which previously were not recorded as being within the road reserve/study area.

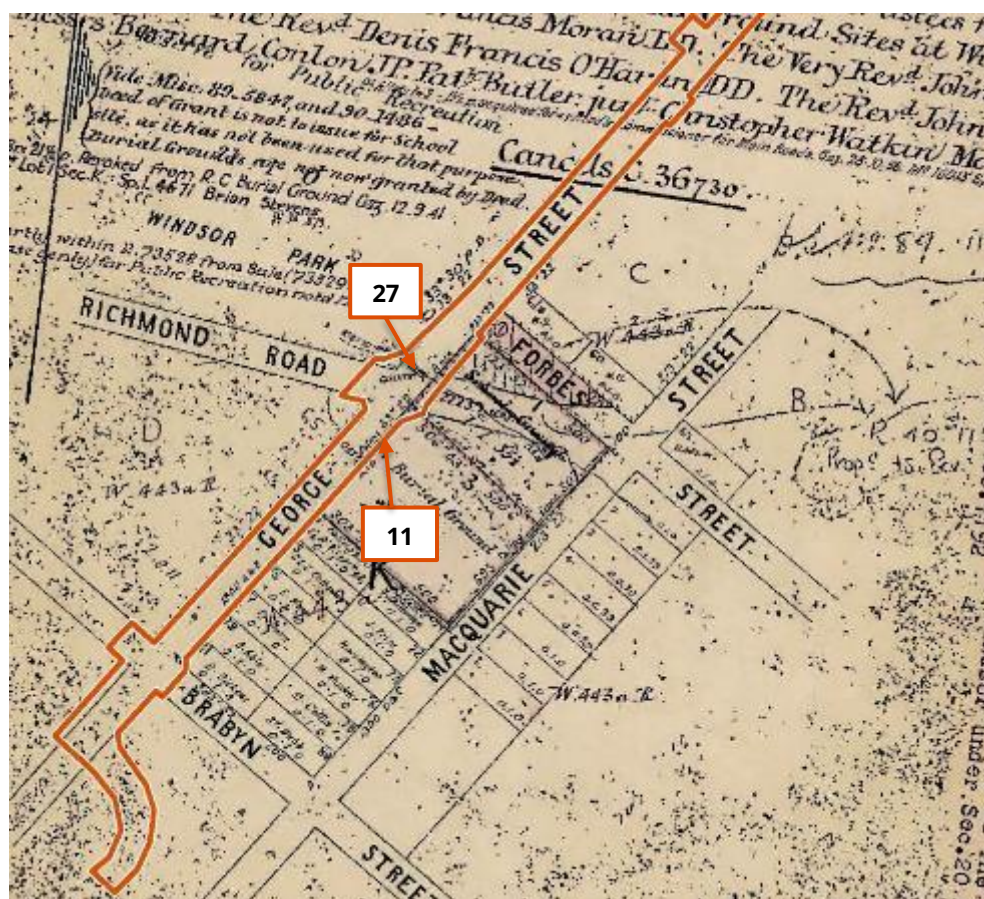
Photo 76 1889 Crown plan of the Roman Catholic Burial Ground, with the study area outlined in orange, showing the fenceline [11] and culvert[27] within the study area (Source: NSW Land Registry Services, Crown plan 41.873)
