Hawkesbury Masterplan: Richmond
Historical Heritage Assessment and
Constraints Analysis Final Report

Hawkesbury Masterplan: Windsor Historical Heritage Assessment and Constraints Analysis

FINAL REPORT

Prepared for Place Group Design

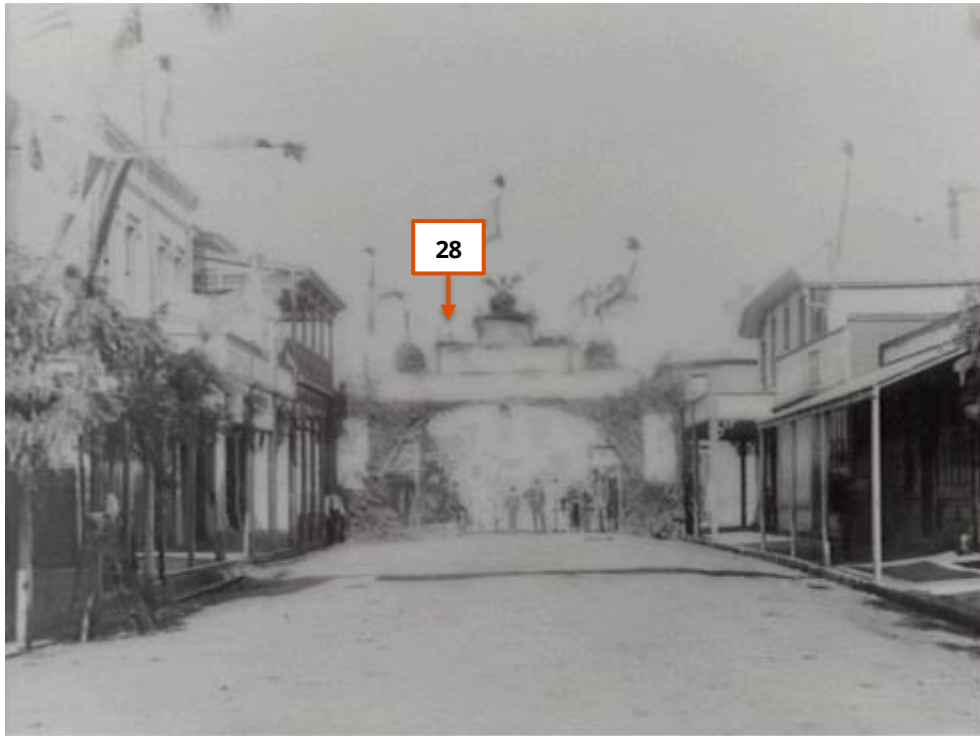
Photo 78 c.1890s photograph of the arch [28] constructed over George Street at the intersection with Fitzgerald Street (Source: Hawkesbury City Library)

A series of photographs attributed to the 1890s-1900s provide information regarding the development of Windsor and the study area at this time. An arch [28] was constructed over George Street at the intersection with Fitzgerald Street (Photo 78). The study area features numerous verandahs and awnings over the footpath, with stone kerbing and guttering and a metalled road; some tree plantings and flag poles are also present. Another photograph from c.1890s-1900s shows melons being carted to Windsor Station, taken from the corner of Tebutt and George streets (Photo 79). The roadway is metalled and features stone gutters. Similarly, a c.1890s-1900s photograph of George Street taken near the junction with Christie Street (Photo 80), featuring the Presbyterian church on the right, shows verandahs overlying the footpaths, with stone kerbing and gutters and paling fences along property boundaries. A c.1890s-1900s photograph of George Street from Kable Street towards Windsor Station provides similar information, with light poles also present within the footpath (Photo 81).

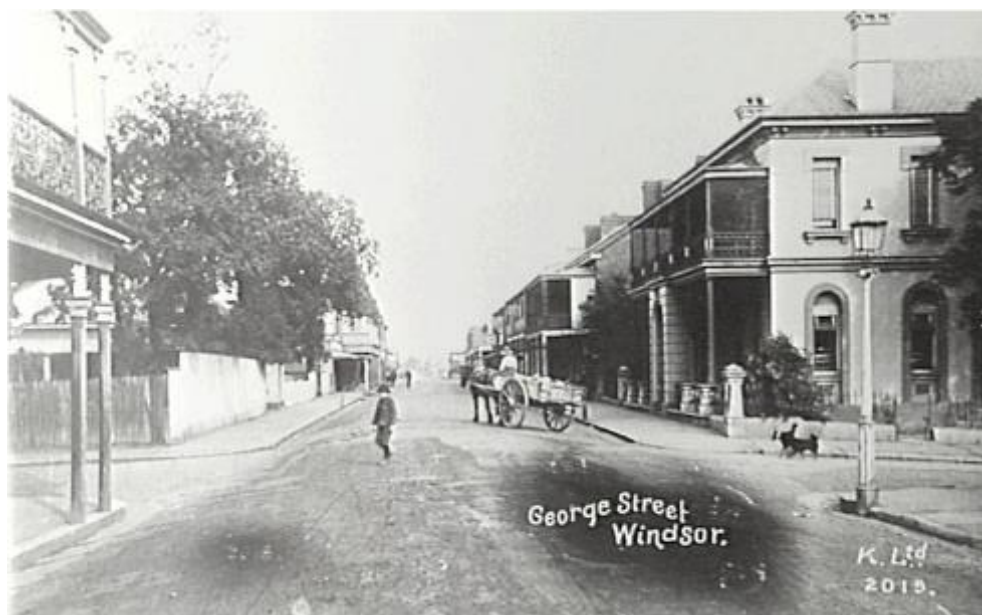
Photo 81 c.1890s-1900s photograph of George Street from Kable Street towards Windsor Station
(Source: Hawkesbury City Library)

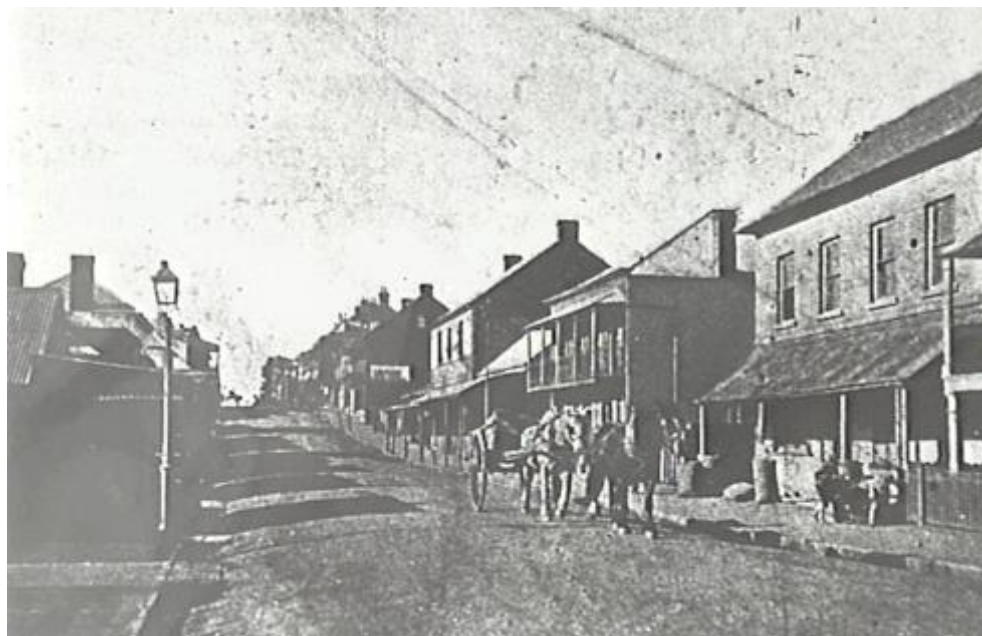
Photo 82 1905 photograph of George Street, taking near New Street looking towards Fitzgerald Street (Source: Hawkesbury City Library)

A 1905 photograph of George Street provides some information regarding the study area at this time (Photo 82). The street is crowded with buildings which appear to be of both a residential and commercial nature with a variety of sizes and forms. The roadway itself still appears to be metalled, with stone kerbing and guttering on either side. A light pole is also present. As has been noted in historical plans, some of the building verandahs extend over the public footpath area within the road reserve.

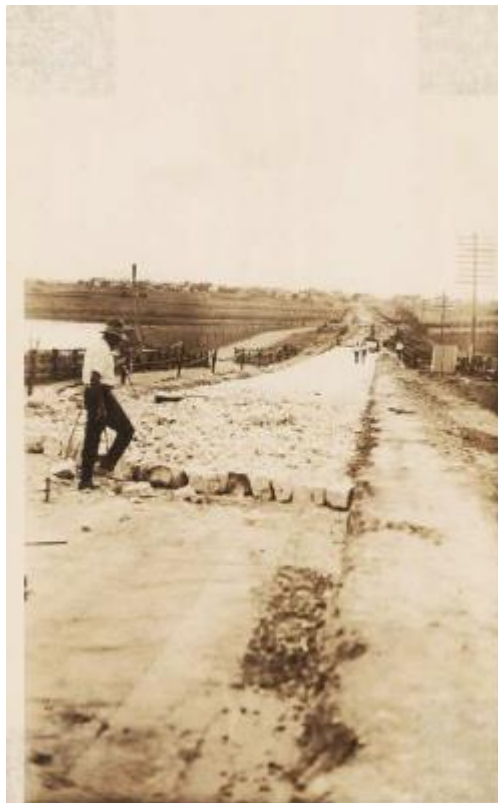
Photo 85 1924 photograph of reconstruction of the main road in Windsor (Source: (State Library of NSW, image no. 2024-a038-001670, cited in AAJV 2017)

Following a trial of tar paving the gravel in Fitzgerald Street (outside of the study area), in 1923 Council approved the tarring of George Street in sections. Keen to reduce the dust of the existing road surface, many local businesses fronting George Street had offered to contribute to the cost of the works. It was also suggested that an alternative material from Tarans be used as a top dressing instead of metal screening.²⁰⁶ Photographs from the following year show road construction works to 'the main road in Windsor' (Photo 85, Photo 86); it appears that the Macadam or Telford methods are being used in these works. A location for the photographs is not provided, but these images provide an indication of the road construction methods that may have been used within the study area at this time.

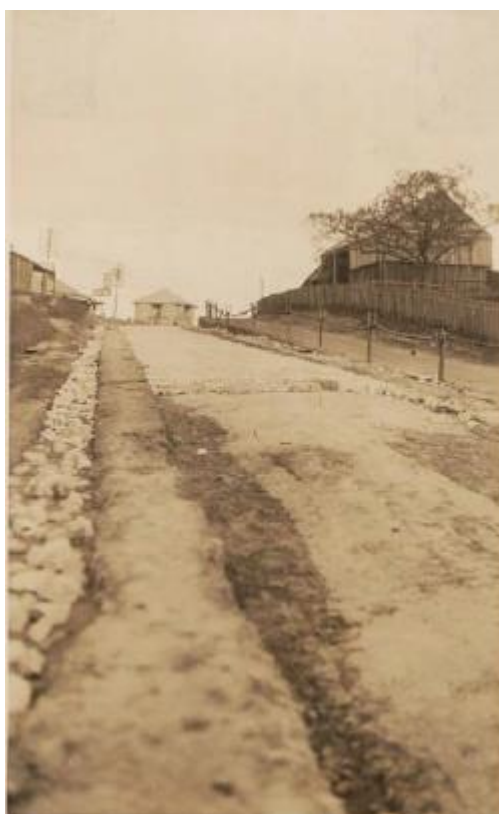
Photo 86 1924 photograph of reconstruction of the main road in Windsor (Source: (State Library of NSW, image no. 2024-a038-001671, cited in AAJV 2017)

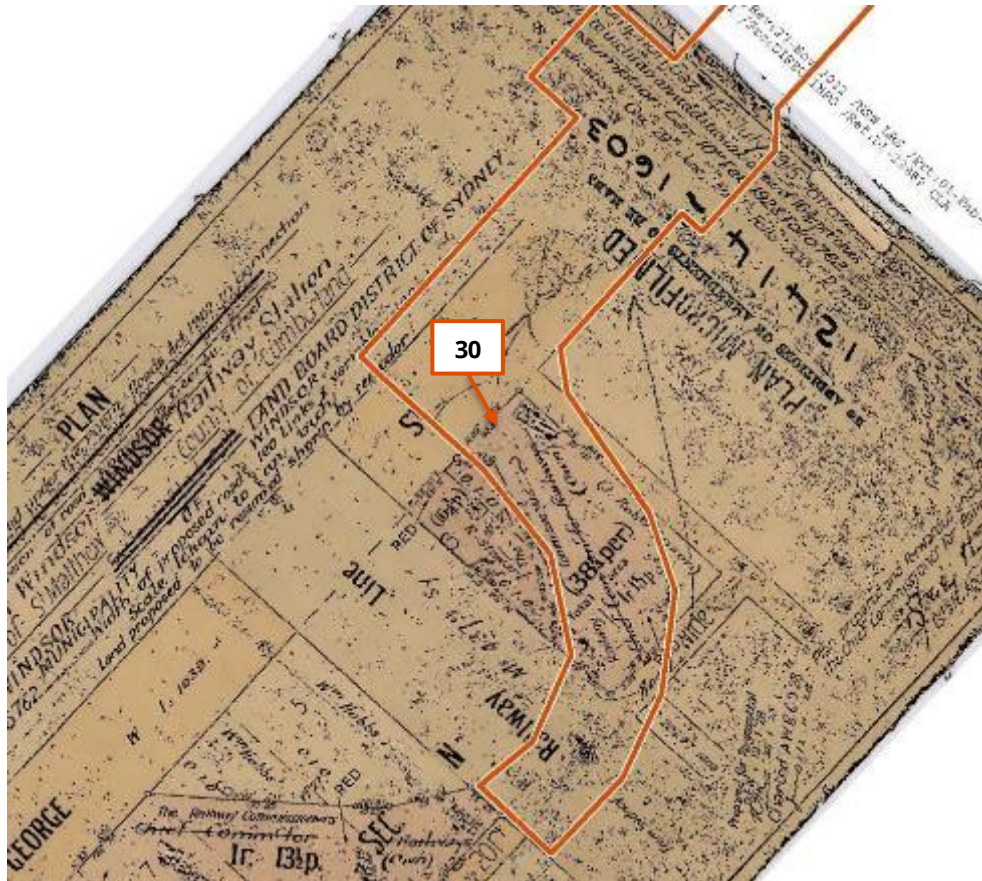
Photo 87 1928 Crown plan of the deviation of George Street [30] under the Blacktown-Richmond Railway, with the study area outlined in orange (Source: NSW Land Registry Services, Crown plan 12414.1603)

30	George Street deviation	Road cutting, stone kerbs and guttering, metal surface over macadam or telford base.	c.1928 to present
32	Concrete road surface, George Street	Concrete road surface, footpaths and kerbs and guttering	1939 to present
33	One verandah or building frontage at north-western corner of George and Brabyn streets	Building footings or foundations and associated cuts and deposits, walls, compacted underfloor deposits, structural postholes and footings including associated cuts and deposits	Pre-1937 to unknown

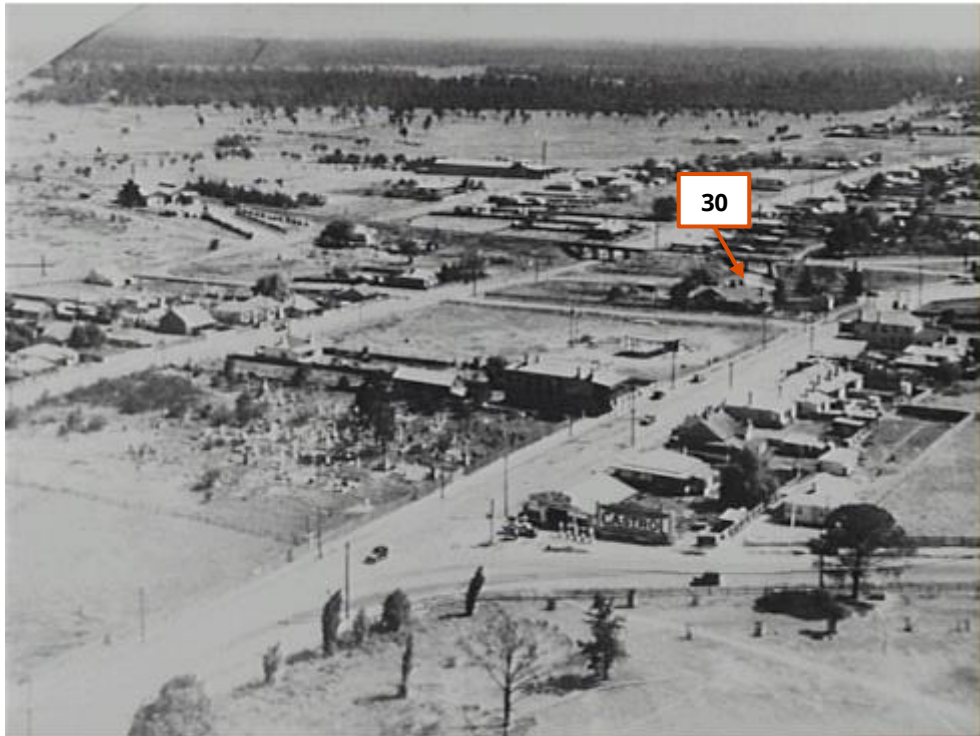
Photo 89 Undated aerial photograph of the junction of George Street and Richmond Road, showing the Roman Catholic Cemetery and deviated George Street [30] (Source: Hawkesbury City Library)

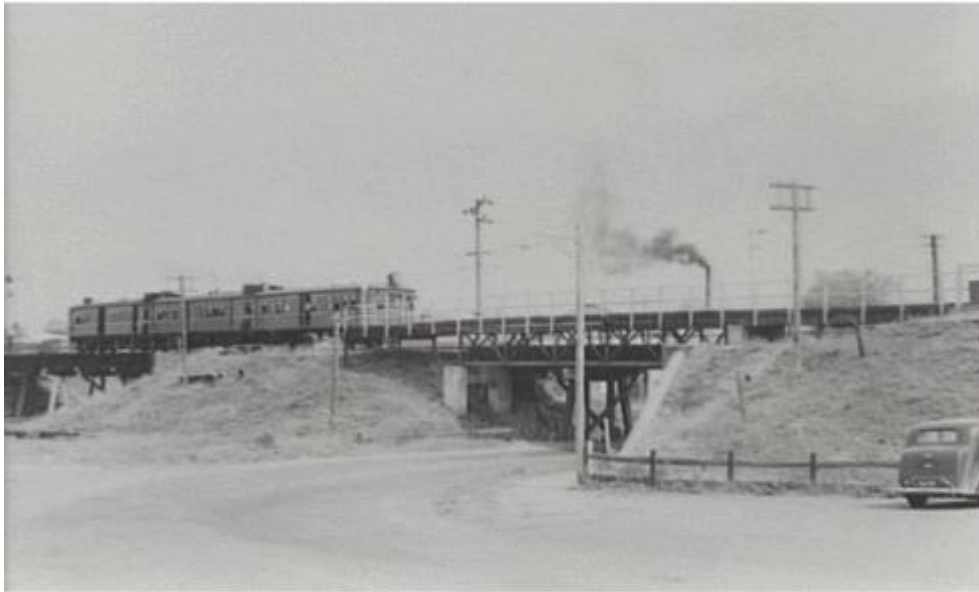
An undated photograph, but likely attributable to the 1930s or 1940s, of a train travelling over the railway bridge at George Street provides an indication of the study area at this time (Photo 90). It is not known whether this photograph is taken from the northern or southern side of the railway line, but it does show that the road is unsealed at this time, with no defined kerbing at the road edge and a post and rail fence on the boundary of the rail line to the road reserve.

Photo 90 Undated photograph of a train travelling over railway bridge at George Street (Source: Hawkesbury City Library)

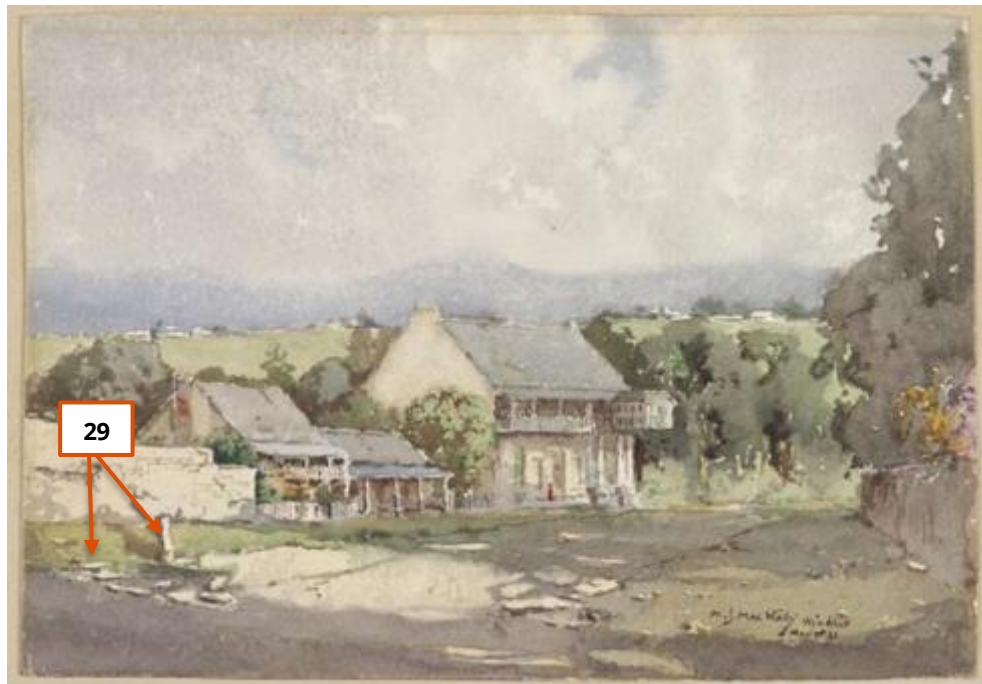
A depiction of Thompson Square in 1931 also shows the stone steps and post leading from the Macquarie Arms Inn into Thompson Square adjacent to the boundary wall (Photo 91). However, the accuracy of this image should be treated with caution; for example the scale of the closest house is incorrect as this building has the same bulk size as that as the Doctor's House at the end of the street.

Photo 91 1931 depiction of Thompson Square, featuring the steps and post [29] (Source: (M/VIB/Wind/2, cited in Biosis Research & Cultural Resource Management 2012, p.111 Plate 60)

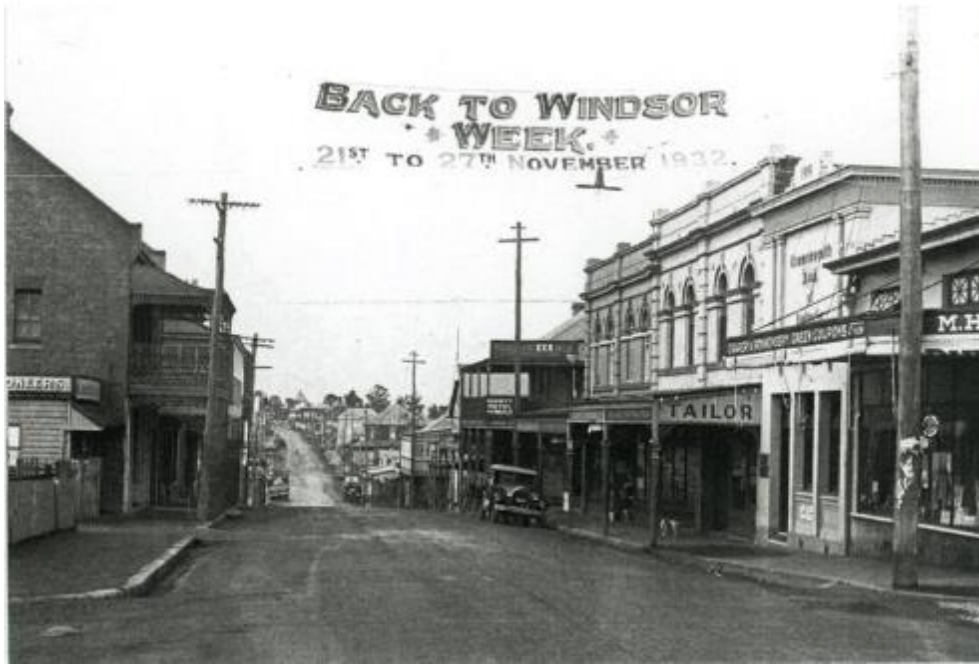
Photo 92 1932 photograph of George Street looking towards the railway station (Source: Hawkesbury City Library)

In 1932, the heritage listed Bussell Bros Building (Hawkesbury LEP 2012, Item no. I192) was constructed at 153 George Street.²¹⁶ A 1932 photograph of George Street near the corner of Fitzgerald Street looking towards the railway station (Photo 92) shows little change since 1915 (Photo 83). Considerable works were undertaken within Thompson Square during the mid-1930s as part of a new approach to Windsor Bridge. This created deep cuttings through the reserve with retaining walls [31] constructed (Photo 93).²¹⁷ Several years later, after 1934, Sydney City Council supplied both Richmond and Windsor with electricity.²¹⁸

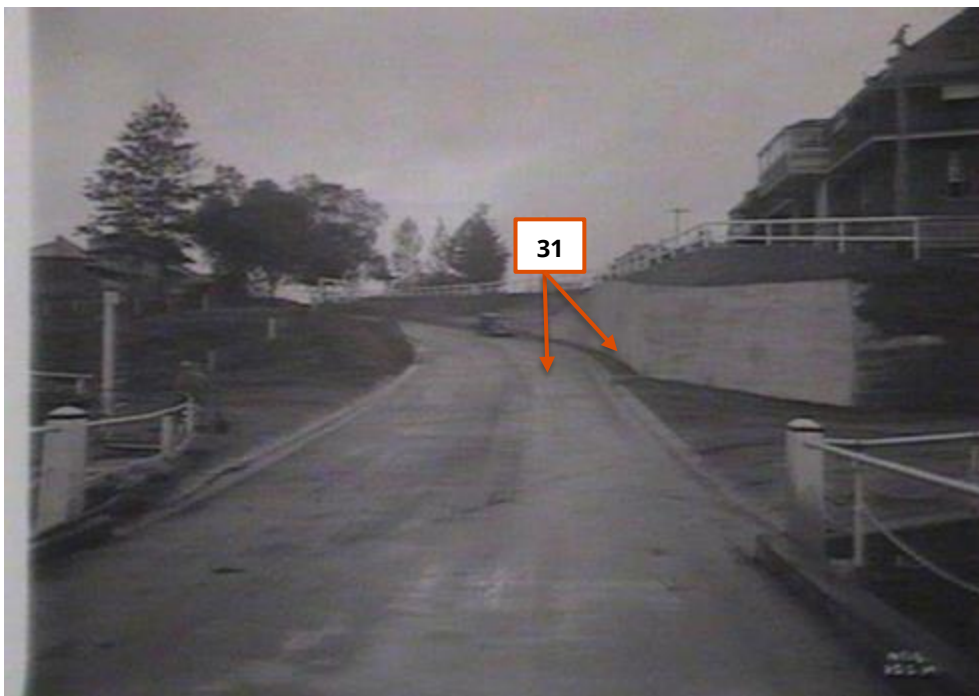
Photo 93 Mid-1930s view of completed works to realign the approach to Windsor Bridge [31] through Thompson Square (Source:(ML GPO I-01880 cited in Biosis Research & Cultural Resource Management 2012, p.106 Plate 58)

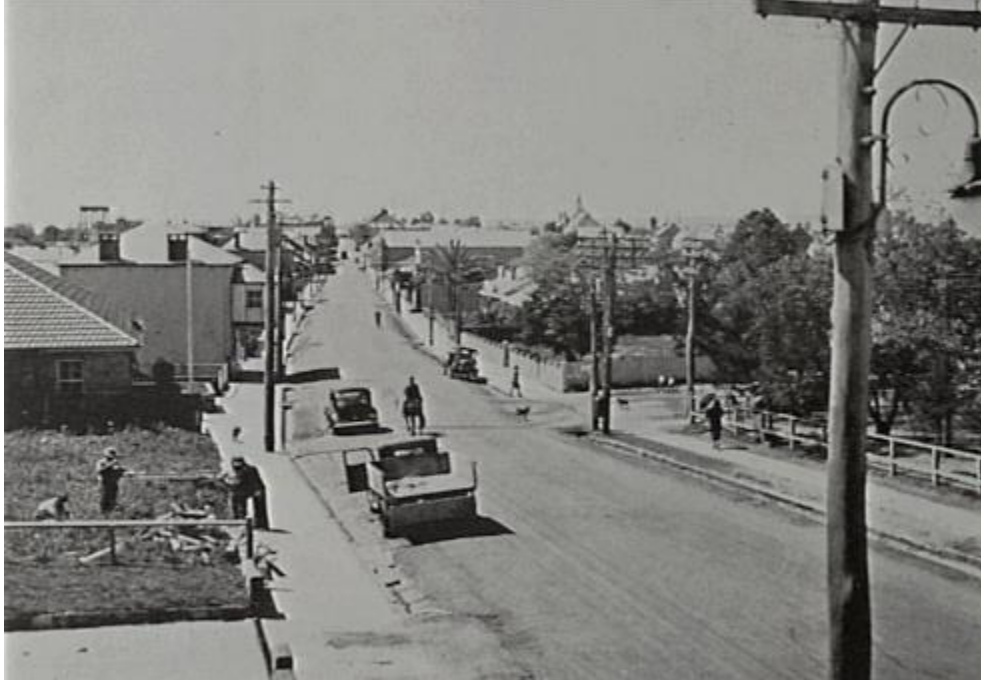
Photo 94 1939 photograph of George Street prior to reconstruction in cement concrete (Source: Hawkesbury Museum)

In 1935, Windsor Council agreed to apply for the concreting of George Street [32] through the main business centre of town from Bridge Street to the picture theatre. As part of this, it was anticipated that the water mains [23] would need to be removed from the centre of the roadway and replaced with 6 inch mains on each side. George Street is described as unusually narrow, which handicaps the convexity of the surface, particularly for heavily and high loaded vehicles which had to keep towards the centre of the road to remain

stable but endangering other traffic while doing so. The following year, the Department of Main Roads stipulated that all water mains within the roadway had to be re-laid beneath the footpaths. Some concrete footpath areas had already been laid at this point, but the Department would not agree to any water mains being laid beneath the gutter of the new road so as to avoid disturbing the recently concreted footpaths.²¹⁹ The works took place in 1939, with before and after photographs taken (Photo 94, Photo 95).

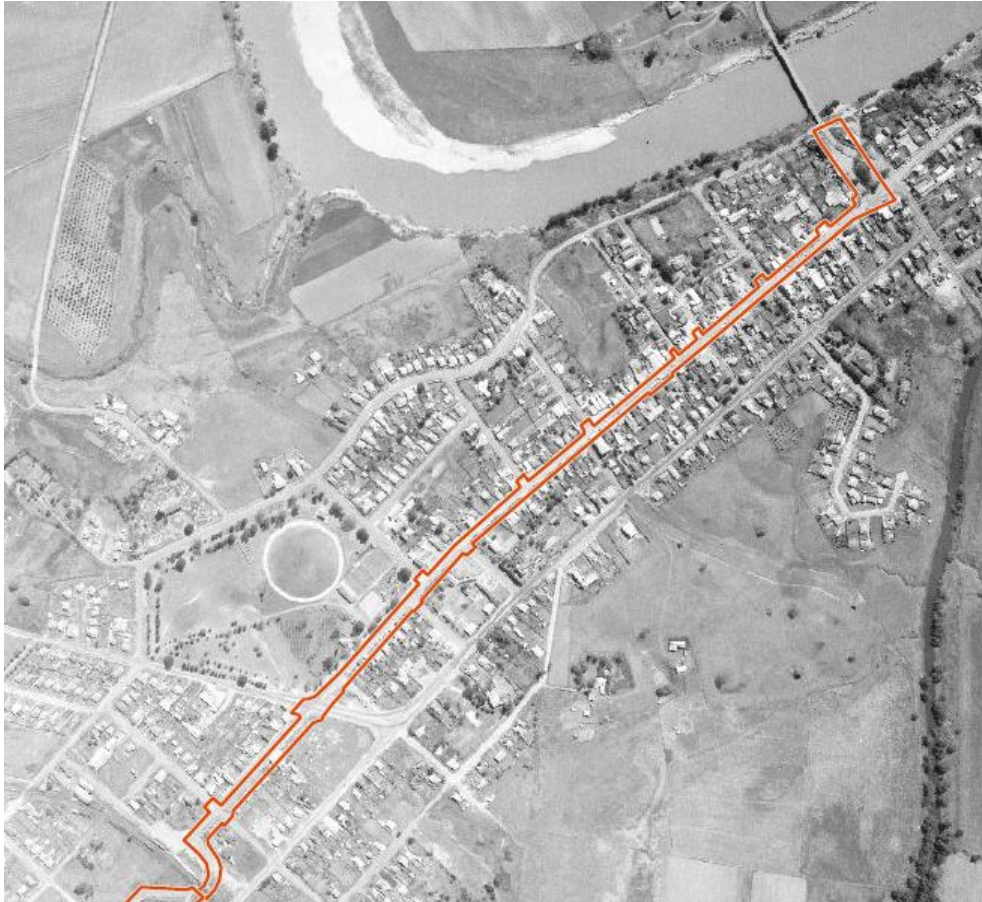
Photo 100 Aerial photograph dated to 1955, with the study area outlined in orange (Source: NSW Spatial Services, Historical Imagery Viewer 2021)

An aerial photograph dated to 1955 shows a number of remaining structures within the study area in addition to a number of new structures (Photo 100, Photo 101, Photo 102, Photo 103, Photo 104, Photo 105). Within Thompson Square a potentially updated pavilion [35] and the deviated road to Windsor Bridge [35] is visible (Photo 101). Due to the angle of the photograph, the streetscape surrounding Thompson Square cannot be seen. Along George Street, between Thompson Square and Kable Streets four buildings/verandahs identified within the 1871 plan [14], nine within the 1889 plan remain [24] and five new verandahs [36] can be seen on both the eastern and western sides of George Street.

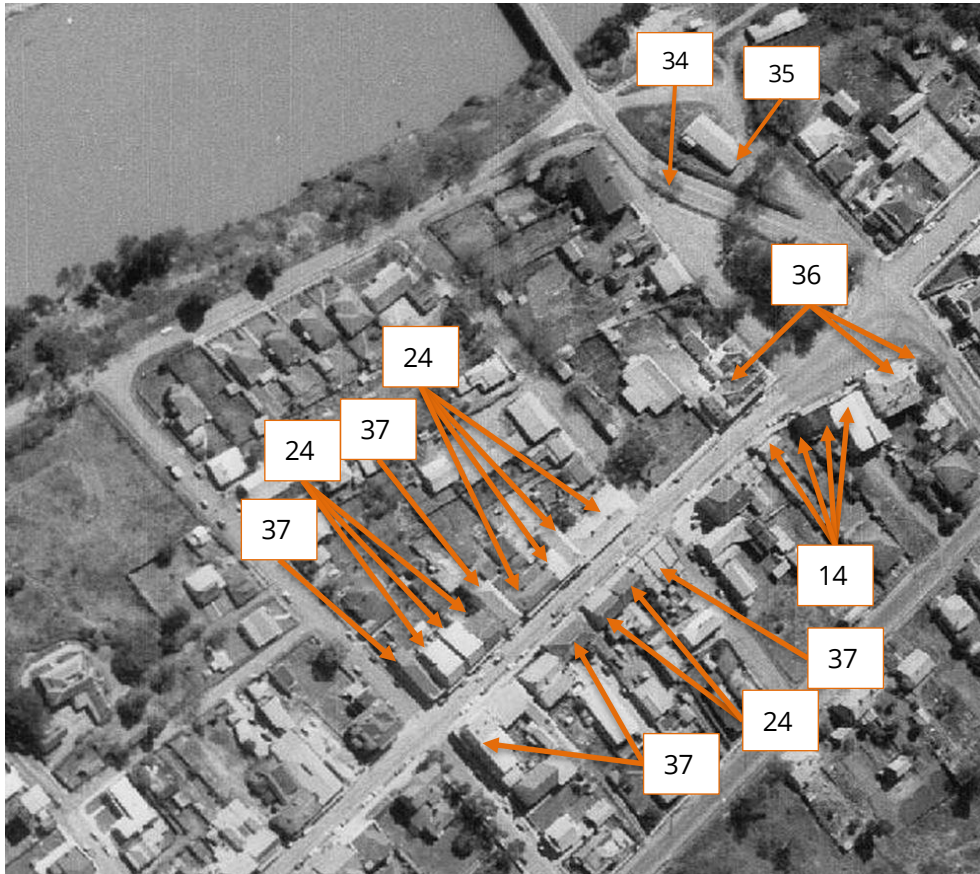
Photo 101 Detail of the 1955 aerial photograph between Thompson Square and Kable Streets, showing buildings/verandahs extending into the study area (Source: NSW Spatial Services, Historical Imagery Viewer 2021)

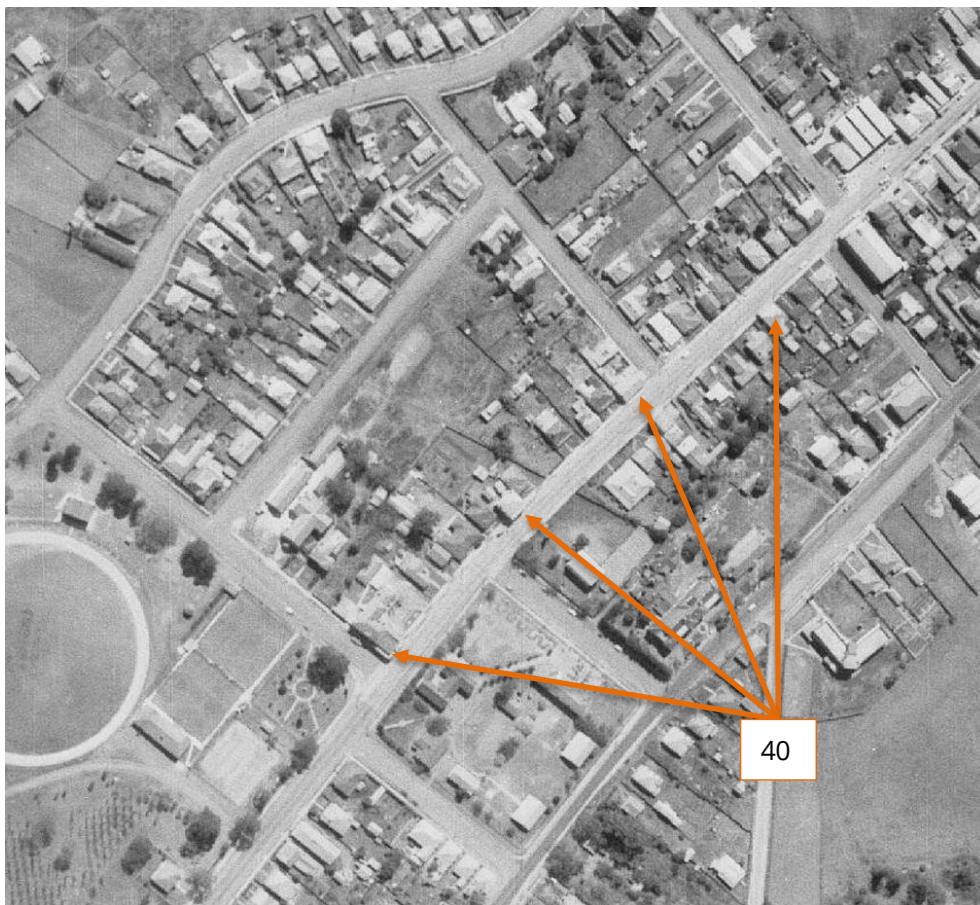
Photo 104 Detail of the 1955 aerial photograph between Suffolk and Dight streets, showing buildings/verandahs extending into the study area (Source: NSW Spatial Services, Historical Imagery Viewer 2021)

Between Kable and Fitzgerald streets, two structures identified in the 1835 [7] plan remain, five structures identified in the 1889 plan [25] and five additional structures [38] on both sides of George Street (Photo 102). Between Fitzgerald and Suffolk Streets two structures could be identified that were present within the 1835 plan [8], one from the 1888 Crown Plan [26], and thirteen additional verandahs constructed pre 1955 [39] (Photo 103). It should be noted that there is potential for some of these thirteen structures to be identified in earlier maps and plans, however due to the quality of the aerial and the significant development seen within this area of George Street, it is difficult to determine. The 1955 aerial also showed four verandahs extending within the road reserve/ study area between Suffolk and Dight Streets [40], and three between Dight Street and the Blacktown-Richmond Railway [41] (Photo 104).

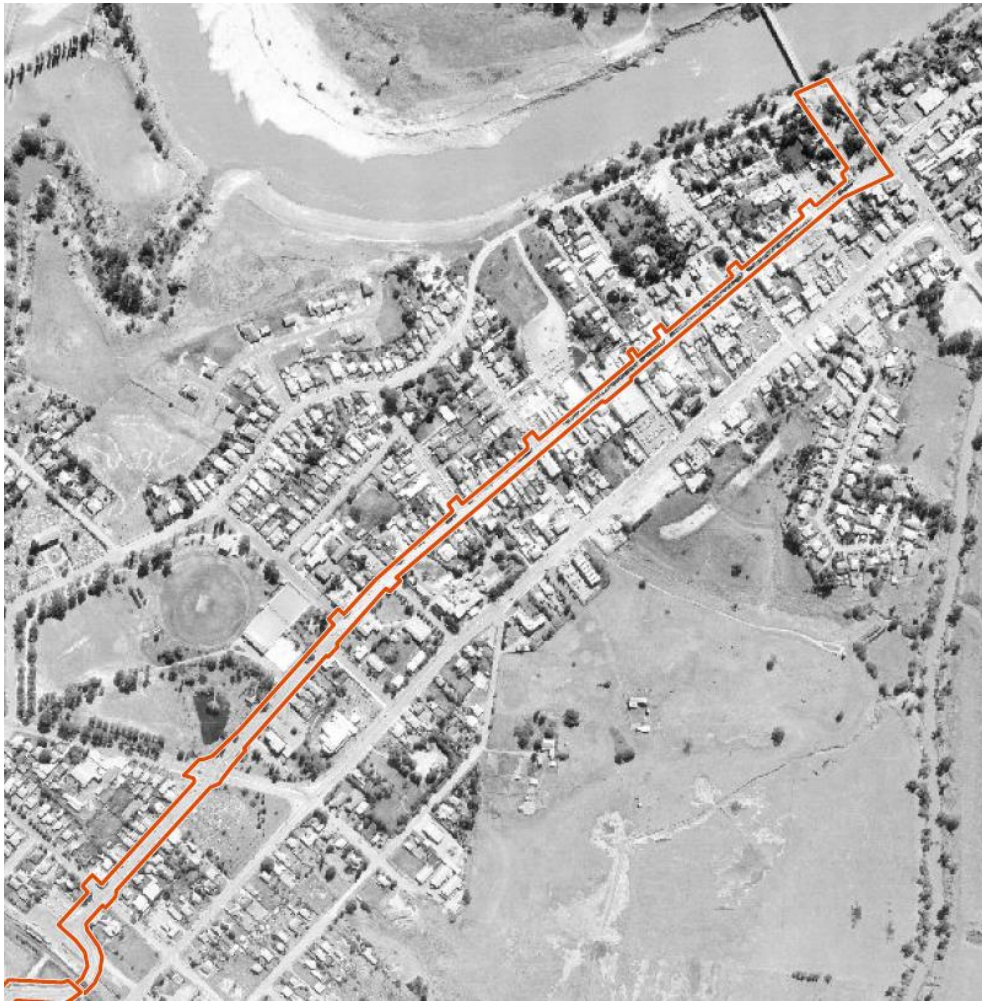
Photo 106 Aerial photograph dated to 1978, with the study area outlined in orange (Source: NSW Spatial Services, Historical Imagery Viewer 2021)

An aerial photograph dated to 1978 between Thompson Square and Kable Street show a number of structures demolished since 1955 (Photo 106, Photo 107, Photo 108, Photo 109, Photo 110, Photo 111). Between Thompson Square and Kable Street four structures identified on the eastern side of George Street, with seven remaining from the 1889 Plan [24] and two from the 1871 plan [14] (Photo 107). Two structures identified along the eastern side of George Street in the 1955 aerial have also been demolished [37]. Structures in and around Thompson Square remain [34] [35] [36]. No new structures are present within the study area.

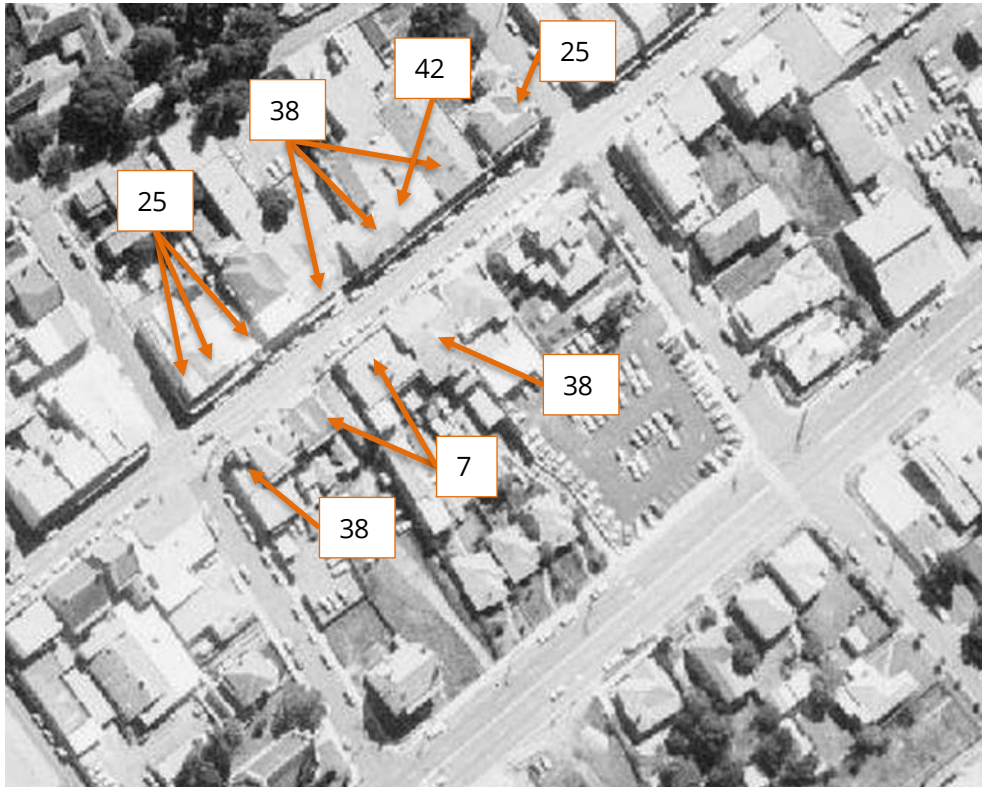
Between Kable and Fitzgerald Streets some development has also occurred however this is primarily adjacent to the study area rather than within (Photo 108). A number of previously identified structures remain, including two from the 1835 plan [7], four from the 1889 plan [25] and five from the 1955 aerial [38]. One structure from the 1889 plan [25] appears to be demolished on the western side of George Street, while an additional structure [42] on the western side has been constructed which extends into the study area.

Photo 108 Detail of the 1978 aerial photograph between Kable and Fitzgerald Streets, showing buildings/verandahs extending into the study area (Source: NSW Spatial Services, Historical Imagery Viewer 2021)

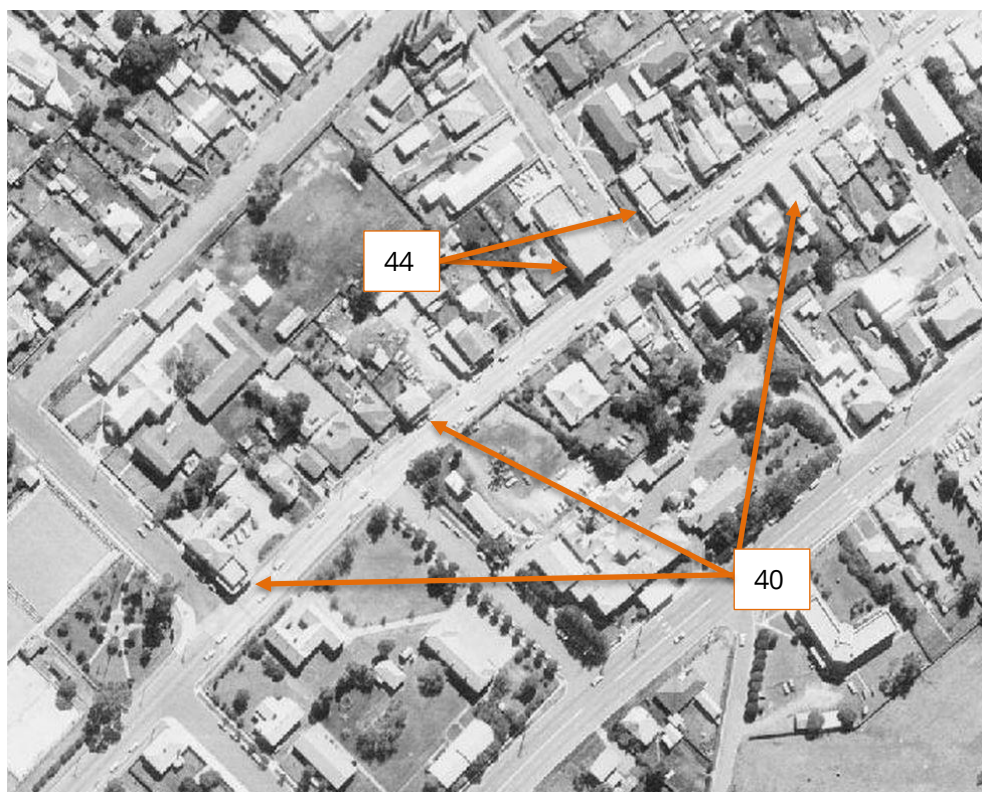
Between Suffolk and Dight Streets three structures identified within the 1955 aerial [40] to be within the study area remain, with one demolished on the western side of George Street (Photo 110). A new structure replaces this building that also encroaches on the road reserve and a verandah has been added to a previously existing structure also located on the western side [44]. No changes had occurred within the study area between Dight and the Blacktown-Richmond Railway, with the three previously identified in the 1955 aerial remaining (Photo 111). The manmade lake located within McQuade Park is also visible to the west.

Photo 110 Detail of the 1978 aerial photograph between Suffolk and Dight Streets, showing buildings/verandahs extending into the study area (Source: NSW Spatial Services, Historical Imagery Viewer 2021)

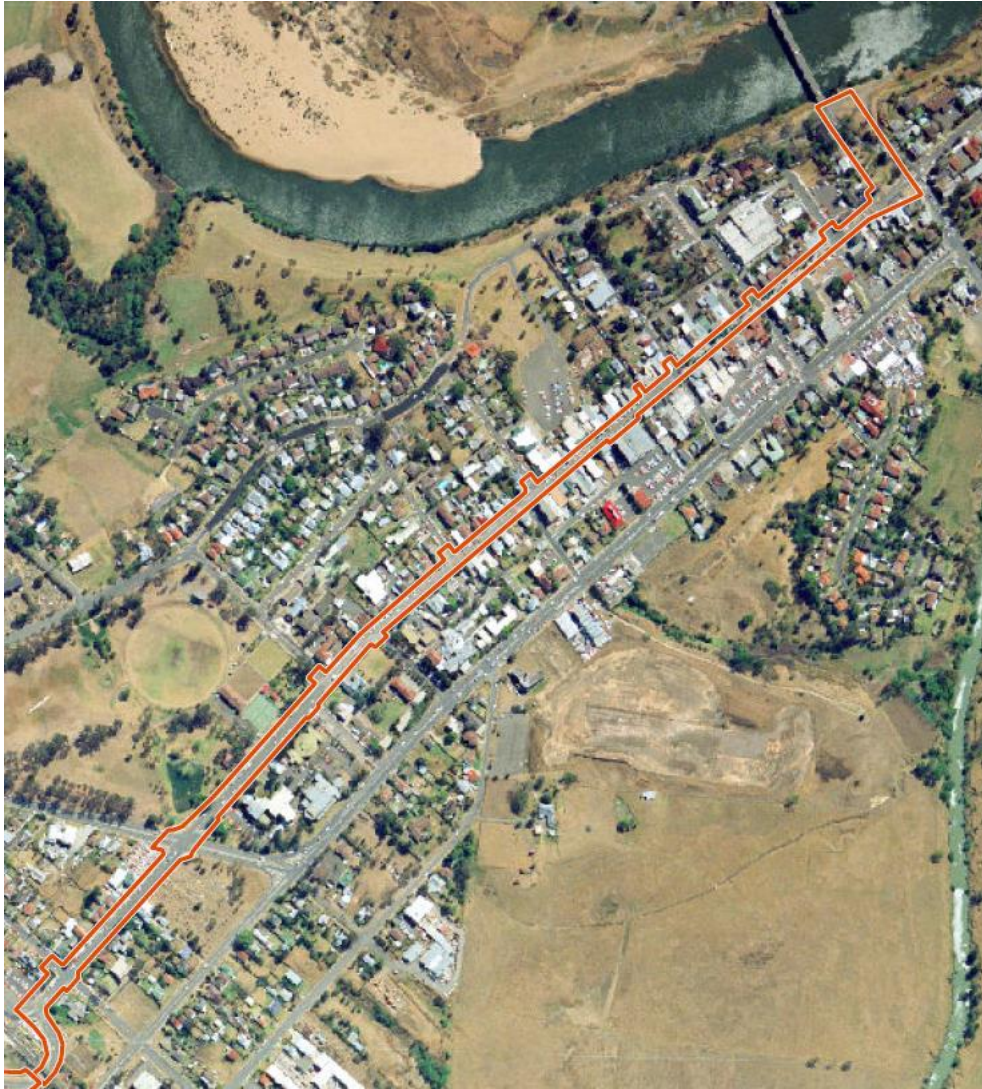
Photo 112 Aerial photograph dated to 1994, with the study area outlined in orange (Source: NSW Spatial Services, Historical Imagery Viewer 2021)

An historical aerial dated to 1994 shows further development that has occurred within the study area (Photo 112, Photo 113, Photo 114, Photo 115, Photo 116, Photo 117). Due to the quality of the aerial it is difficult to identify which structures extend within the study area however a number of previously identified structures remain. Between Thompson Square and Kable Street, the pavilion structures within the east of Thompson Square has been demolished [35] (Photo 113). Structures surrounding Thompson square identified within 1955 remain [36] in addition to those within the 1871 plan [14] and the 1889 plan [24]. The development of George Street into a shared pedestrian [47] access area can be seen, in addition to a roundabout [45] at the junction of George and Bridge Streets.

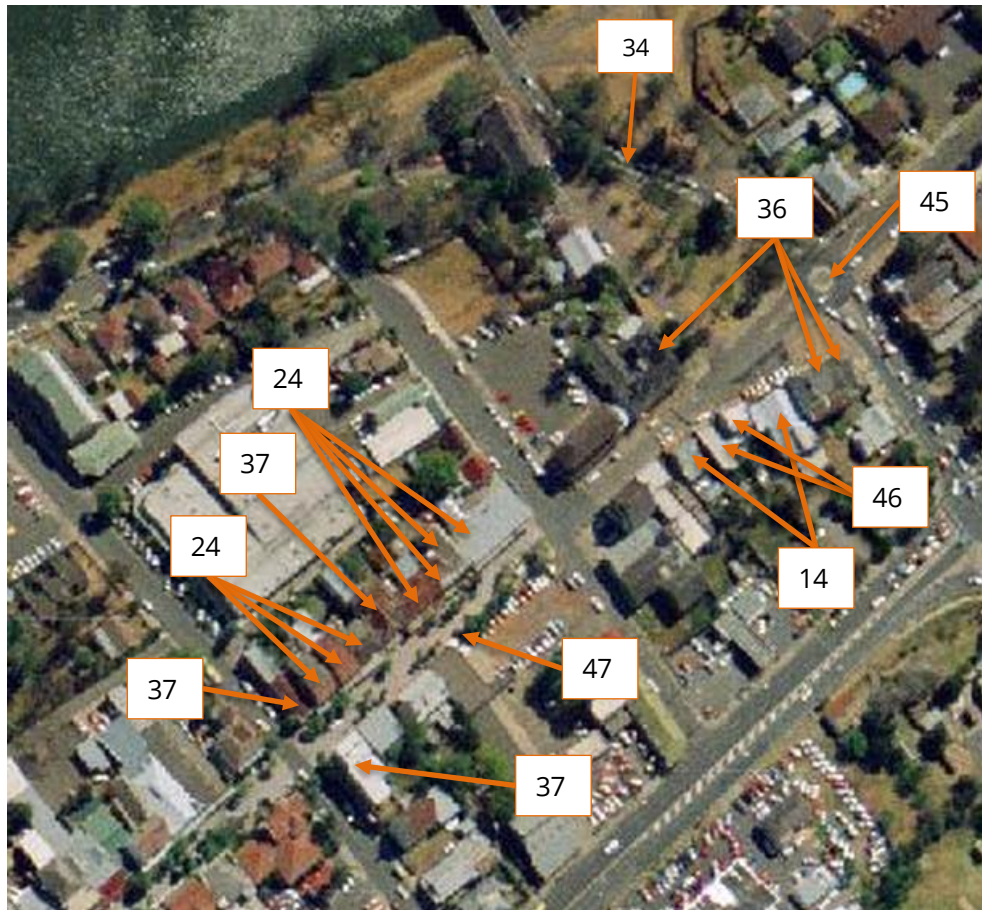
Photo 113 Detail of the 1994 aerial photograph between Thomson Square and Kable Street, showing buildings/verandahs extending into the study area (Source: NSW Spatial Services, Historical Imagery Viewer 2021)

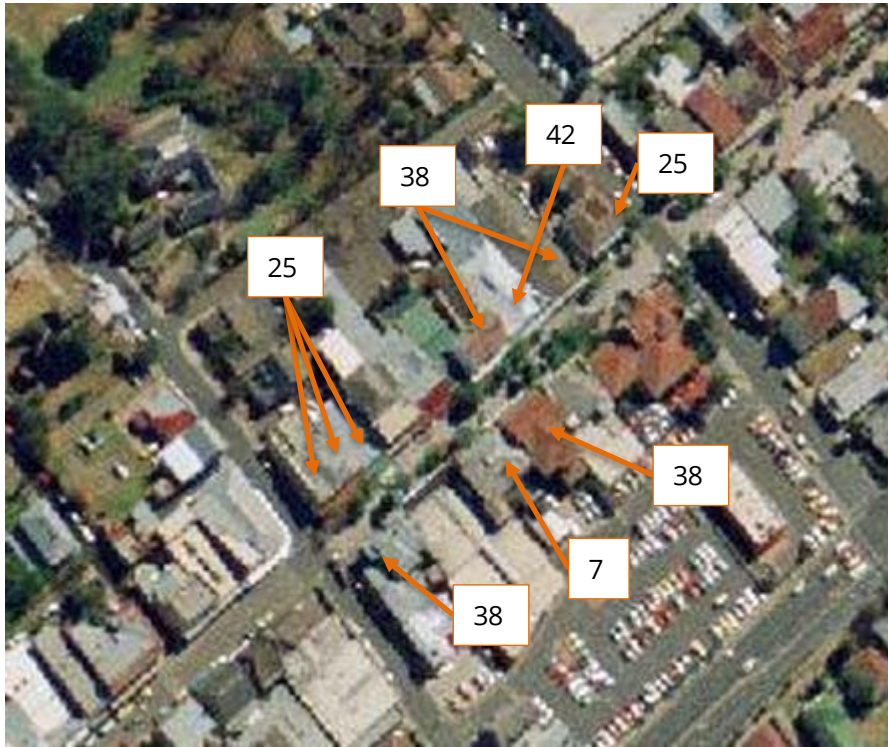
Between Kable and Fitzgerald no additional structures are visible within the study area (Photo 114). Between Fitzgerald and Suffolk streets a number of previously recorded structures remain, including two identified within the 1835 plan [8], one within the 1889 plan [26], six within the 1955 aerial [39], five within the 1978 aerial, and three additional verandahs on previously existing buildings [48] (Photo 115). Between Suffolk Street and the Blacktown-Richmond Railway 1955 [40] [41] and the 1978 aerial [44] remain with no additional structures visible (Photo 117).

Photo 114 Detail of the 1994 aerial photograph between Kable and Fitzgerald Street, showing buildings/verandahs extending into the study area (Source: NSW Spatial Services, Historical Imagery Viewer 2021)

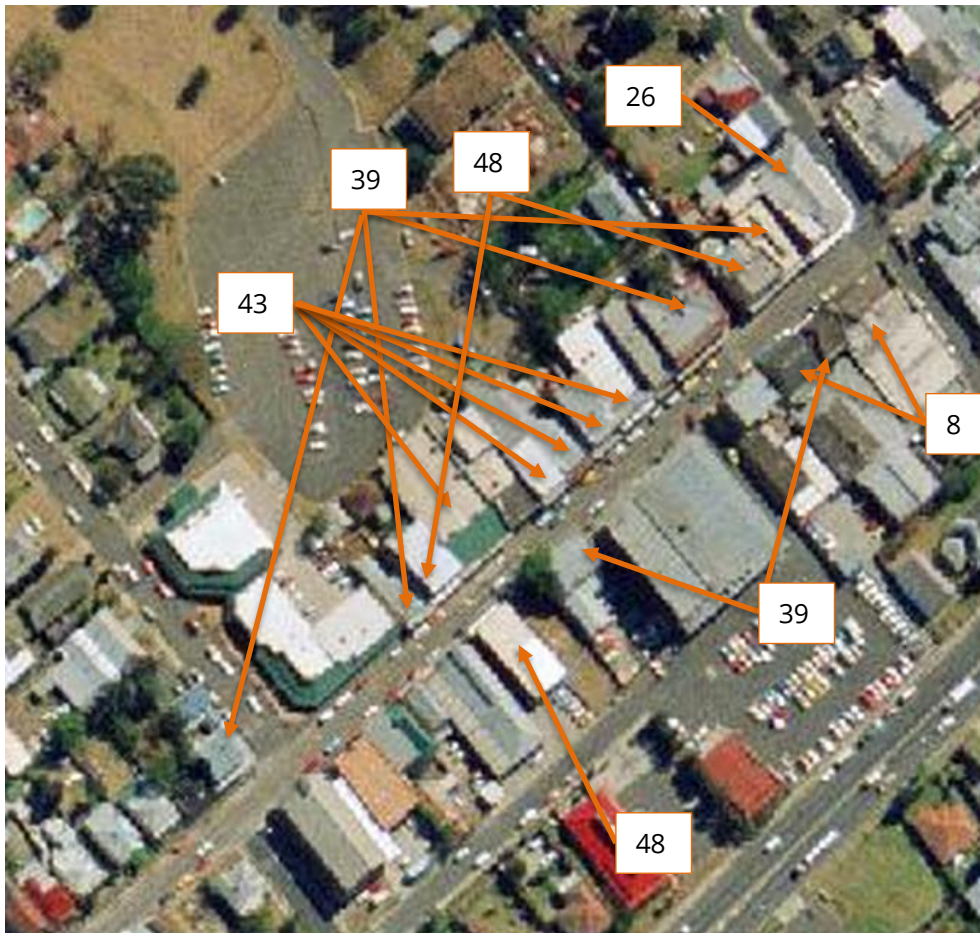
Photo 115 Detail of the 1994 aerial photograph between Fitzgerald and Suffolk Streets, showing buildings/verandahs extending into the study area (Source: NSW Spatial Services, Historical Imagery Viewer 2021)

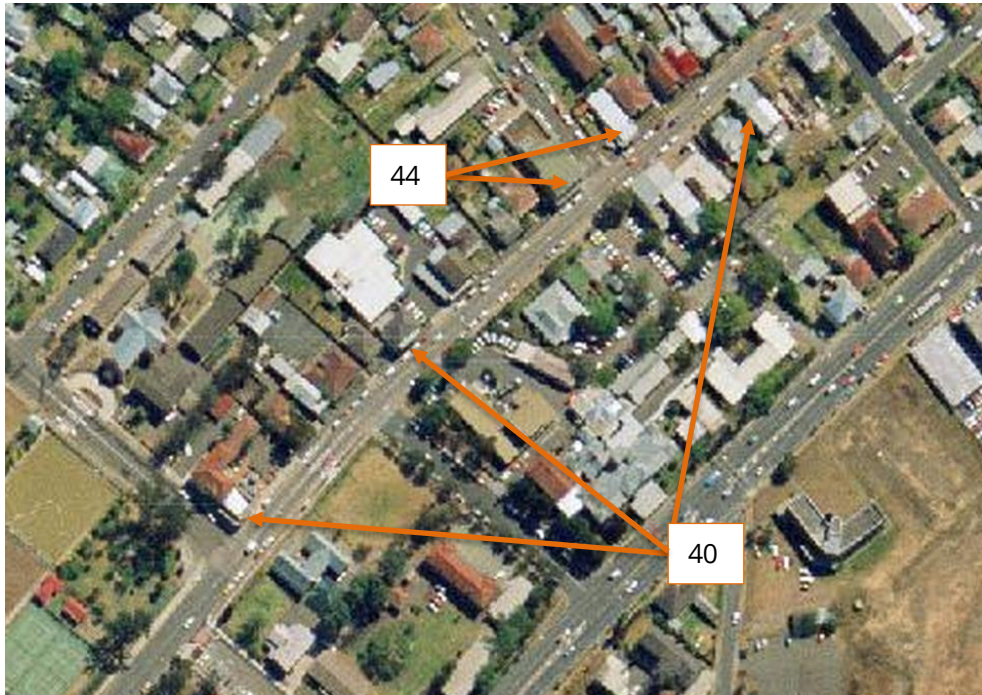
Photo 116 Detail of the 1994 aerial photograph between Suffolk and Dight Streets, showing buildings/verandahs extending into the study area (Source: NSW Spatial Services, Historical Imagery Viewer 2021)

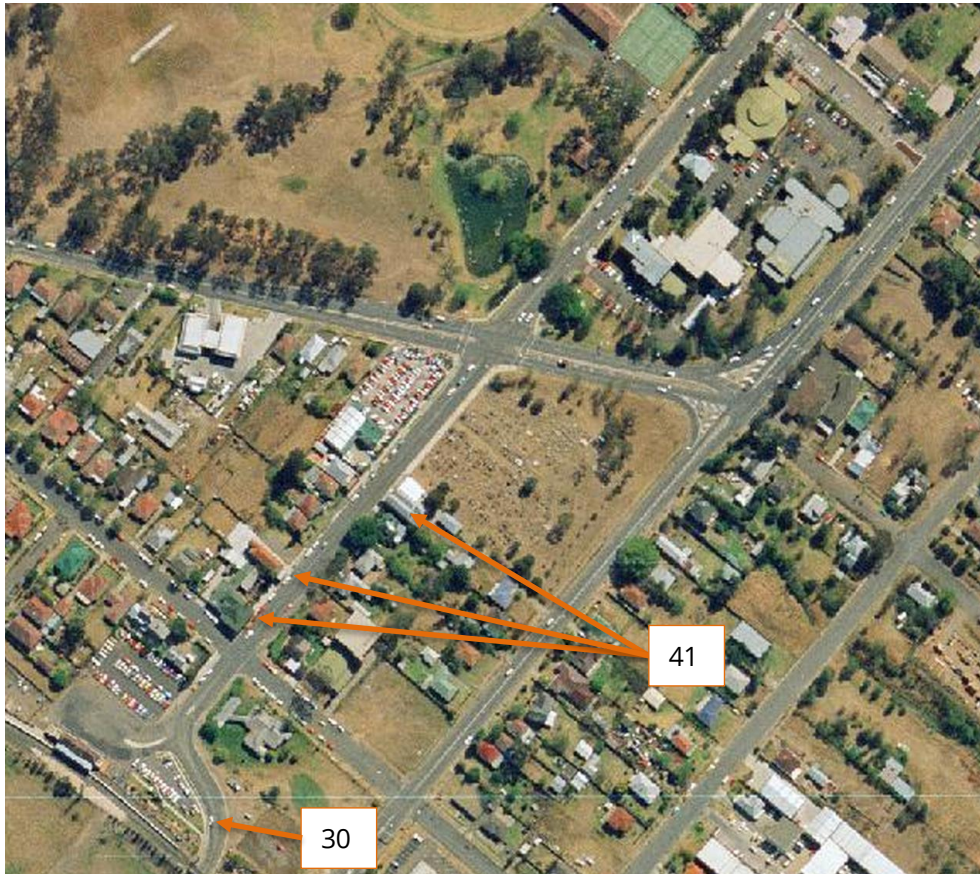
Photo 117 Detail of the 1994 aerial photograph between Dight Street and Blacktown-Richmond Railway, showing buildings/verandahs extending into the study area (Source: NSW Spatial Services, Historical Imagery Viewer 2021)
