Hawkesbury Masterplan: Richmond
Historical Heritage Assessment and
Constraints Analysis Final Report

Hawkesbury Masterplan: Windsor Historical Heritage Assessment and Constraints Analysis

FINAL REPORT

Prepared for Place Group Design

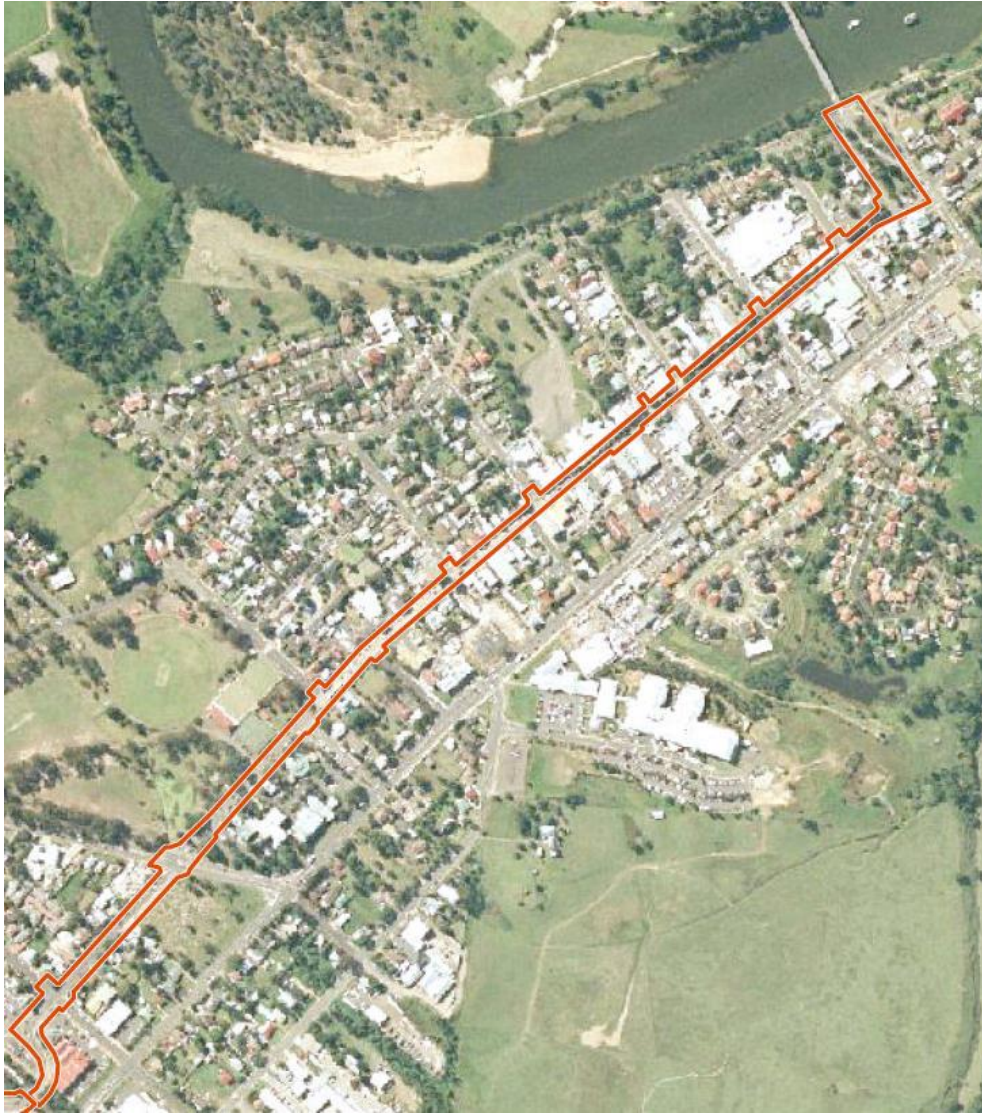
Photo 118 Aerial photograph dated to 2004, with the study area outlined in orange (NSW Spatial Services, Historical Imagery Viewer 2021)

An aerial photograph dated to 2004 can provide further insight into developments within and surrounding the study area (Photo 118, Photo 119, Photo 120). However, due to the quality of the aerial additional verandahs extending into the study area cannot be determined. Within both the northern and southern portion of the study area it appears that the majority of the previously identified structures remain. Development surrounding these structures can be seen however it is unclear if the new structures extend within the road reserve.

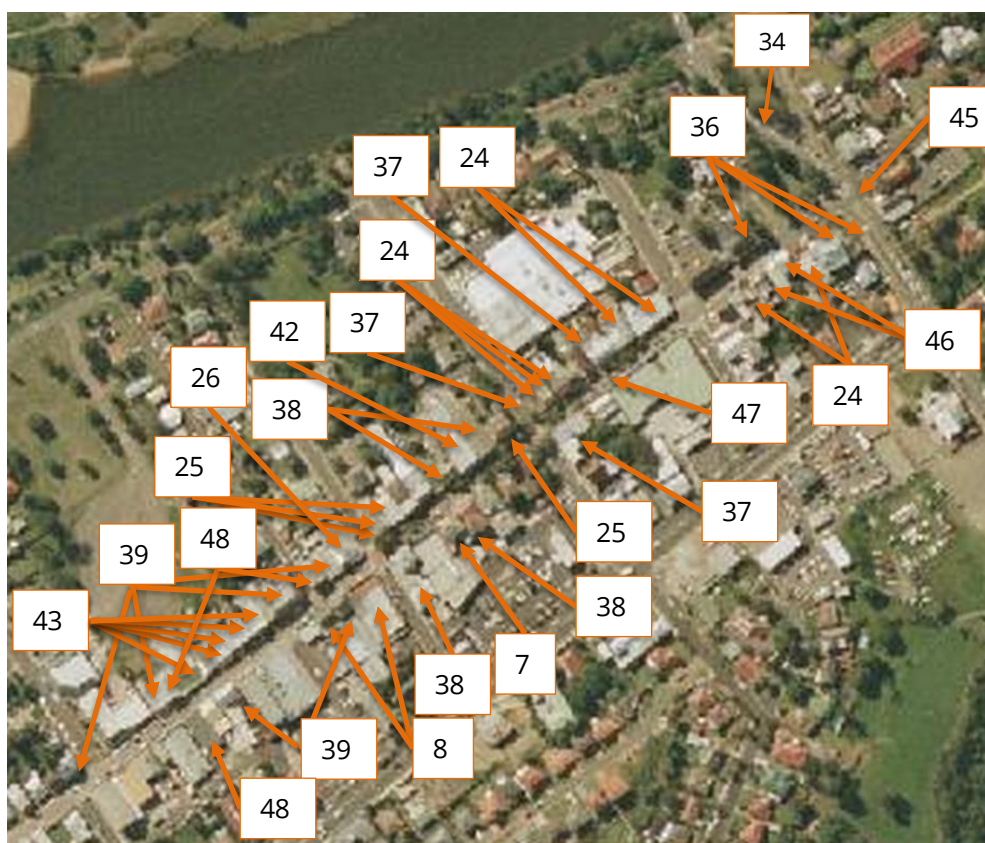
Photo 119 Detail of the 2004 aerial photograph between Thompson Square and Suffolk Streets, showing buildings/verandahs extending into the study area (Source: NSW Spatial Services, Historical Imagery Viewer 2021)

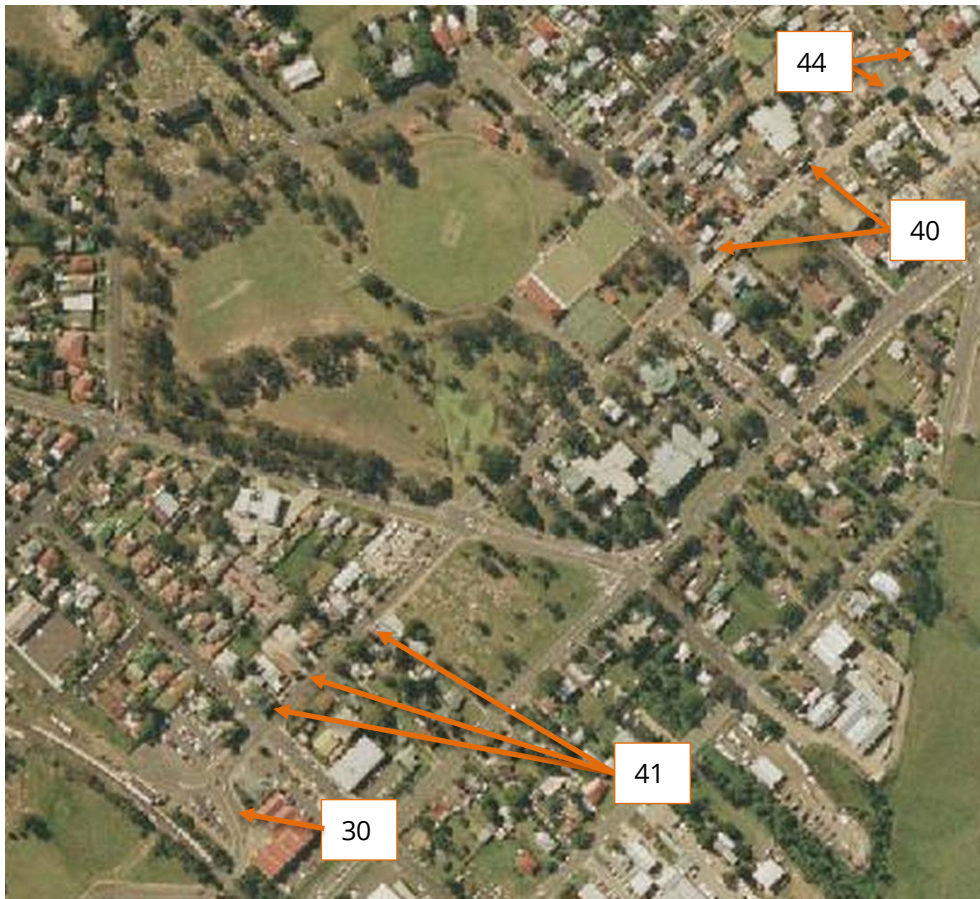
Photo 120 Detail of the 2004 aerial photograph between Suffolk Street and Blacktown-Richmond Railway, showing buildings/verandahs extending into the study area (Source: NSW Spatial Services, Historical Imagery Viewer 2021)

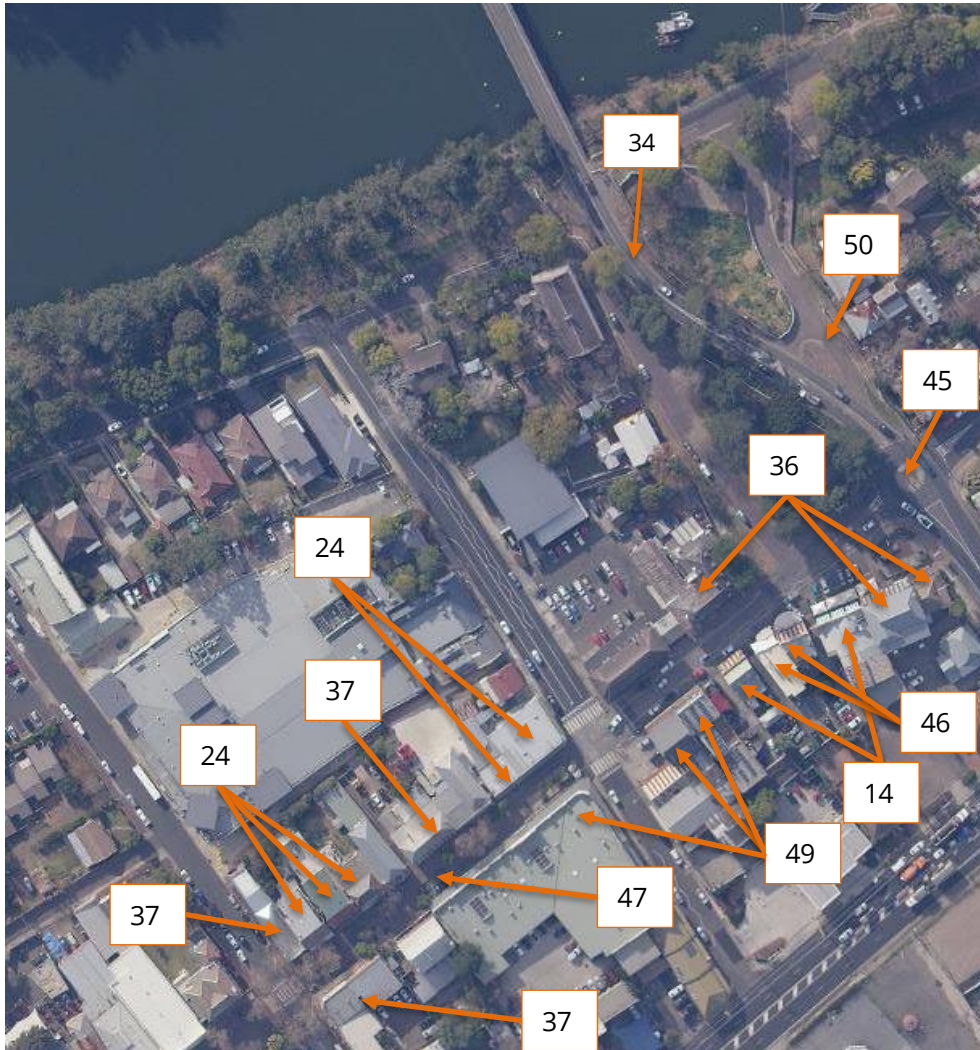
Between Thompson Square and Kable Streets, two structures surrounding Thompson Square date back to a 1871 plan [14], while five within George Street to a 1888 plan [24], six date to pre 1955 [36] [37] and four date to pre 1994 [46] [46] [47] (Photo 121). New features within this portion include three additional verandahs [49] constructed within the study area in additional road infrastructure within Thompson Square [50].

Photo 121 Detail of a current aerial photograph between Thompson Square and Kable Street, showing buildings/verandahs extending into the study area (Source: NSW Spatial Services, Historical Imagery Viewer 2021)

A current aerial photograph shows a number of already recorded structures remaining within the study area in addition to a number of new structures (Photo 121, Photo 122, Photo 123, Photo 124, Photo 125). Some previously identified structures have also potentially undergone repairs showing the same shape however different roofing material. It should also be noted that due to visibility issues within previous aerals, a number of structures may have been removed or constructed at an earlier date.

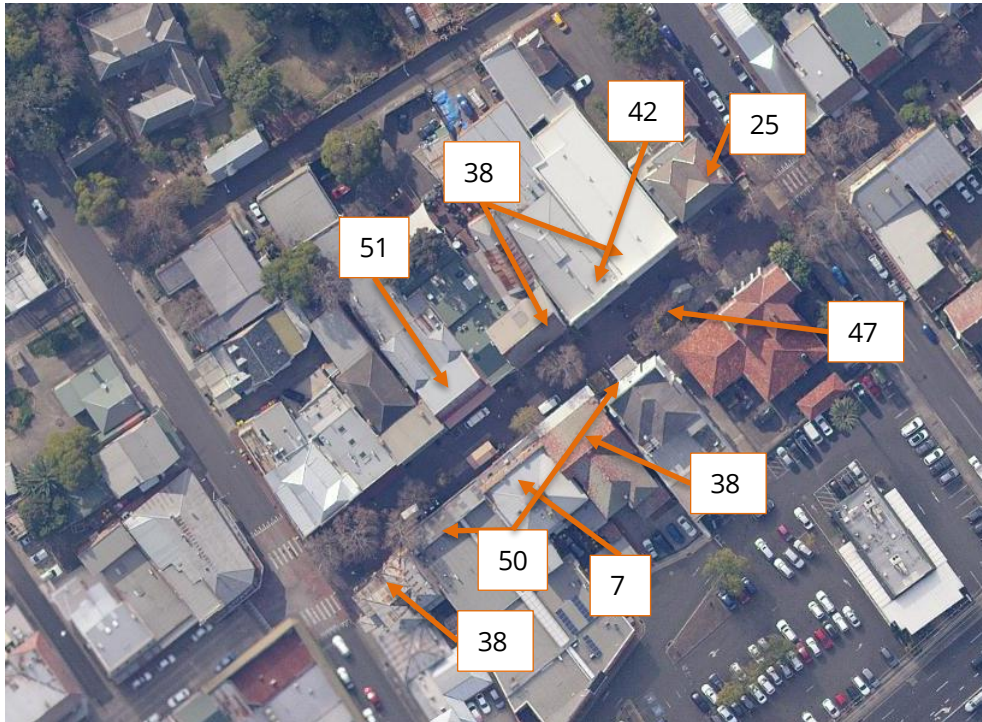
Between Kable and Fitzgerald Street a number of historical structures remain within the study area, including one dating to an 1835 plan [7] and one to an 1888 plan [25] (Photo 122). Three also remain dating to pre 1955, in addition to one pre 1978 and three new structures are visible within the study area [51].

Photo 122 Detail of a current aerial photograph between Kable Street and Fitzgerald streets, showing buildings/verandahs extending into the study area (Source: NSW Spatial Services, Historical Imagery Viewer 2021)

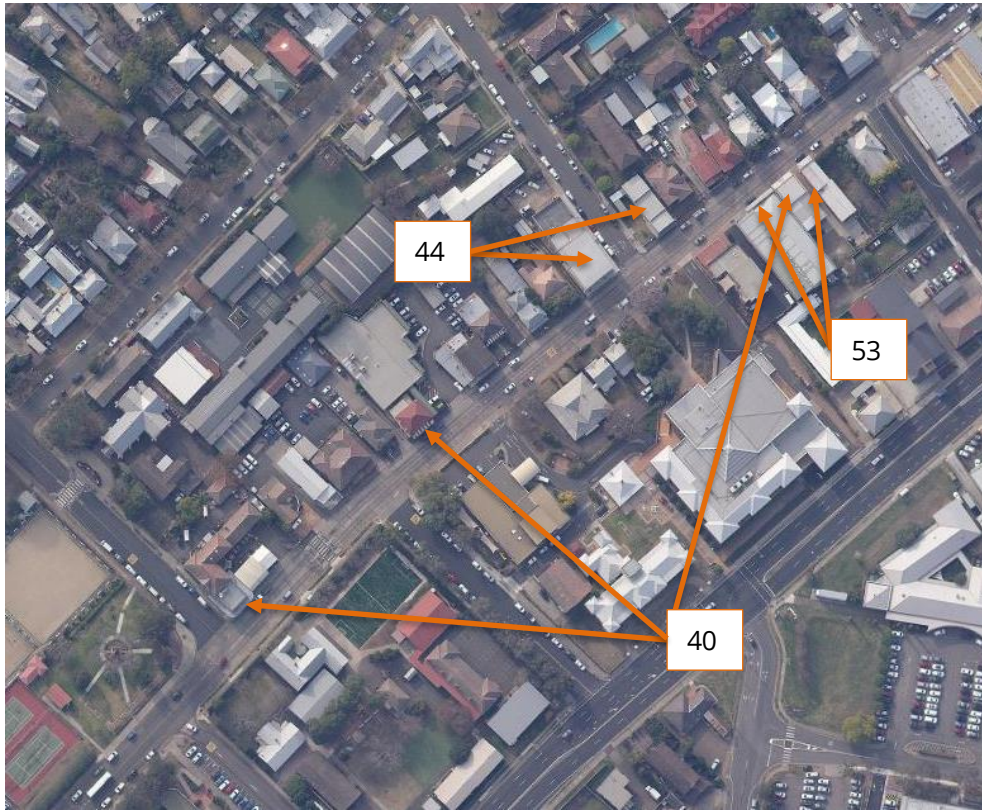
Photo 124 Detail of a current aerial photograph between Suffolk and Dight streets, showing buildings/verandahs extending into the study area (Source: NSW Spatial Services, Historical Imagery Viewer 2021)

Between Suffolk and Dight Streets, three buildings date to pre 1955 [40], two buildings to 1978 [44] and two pre 2021 [53] (Photo 124). Between Dight Street and the Blacktown-Richmond Railway two structures date to pre 1955 [41] and one to pre 2021 [54] (Photo 125). A roundabout and island has also been constructed within George Street prior to 2021 [55].

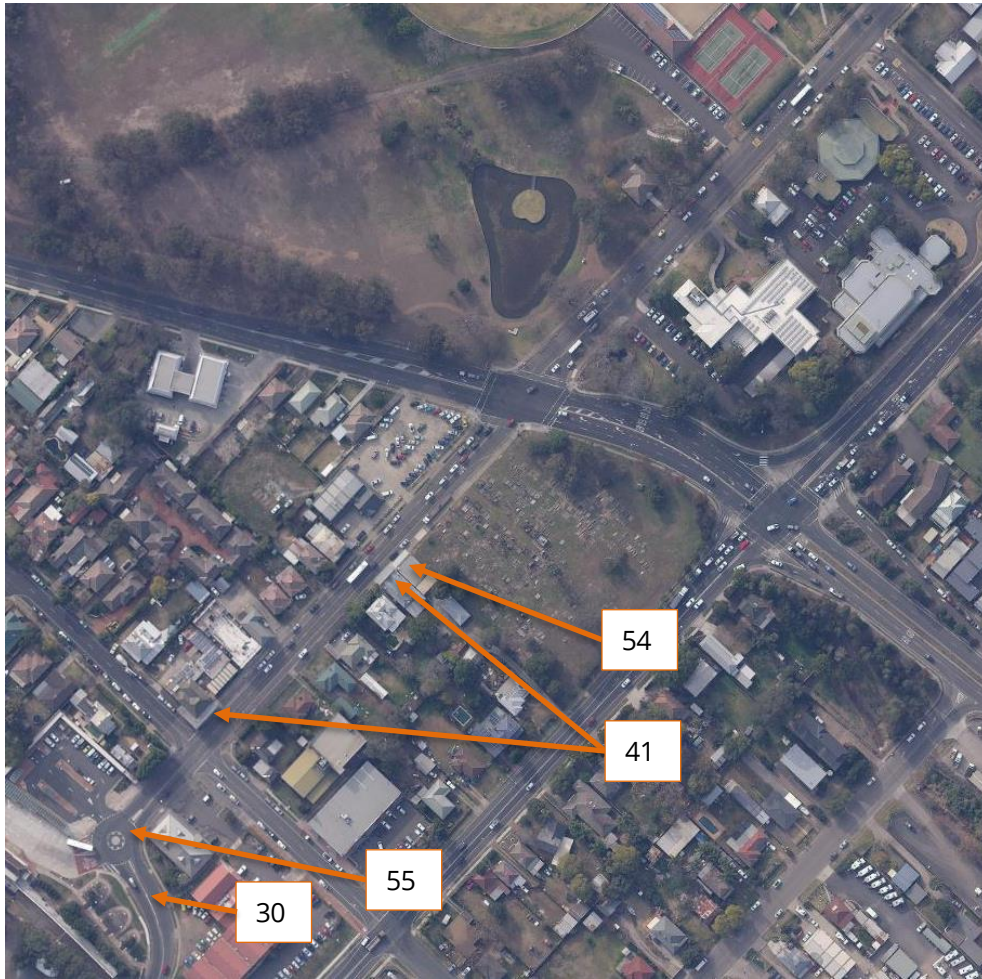
Photo 125 Detail of a current aerial photograph between Dight Street and the Blacktown-Richmond railway, showing buildings/verandahs extending into the study area (Source: NSW Spatial Services, Historical Imagery Viewer 2021)

Photo 125	Detail of a current aerial photograph between Dight Street and the Blacktown-Richmond railway, showing buildings/verandahs extending into the study area (Source: NSW Spatial Services, Historical Imagery Viewer 2021)	221

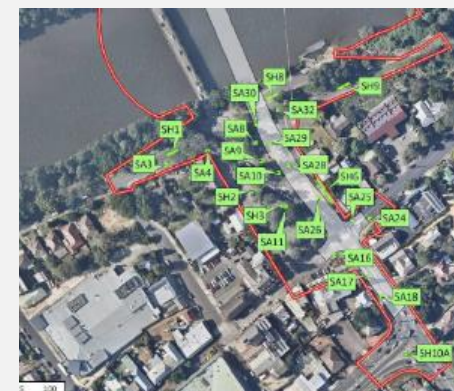
Locations of test trenches and pits where historical archaeological evidence was identified (AAJV 2017, p.40 Figure 21)

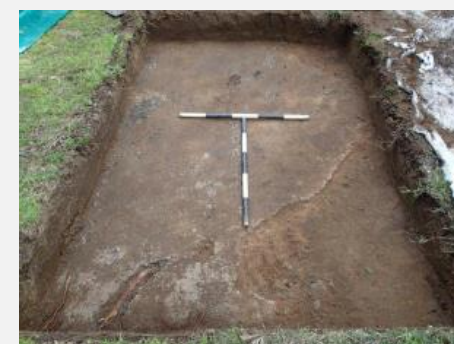
West-facing view of Test Trench SH2, showing the degraded bitumen road surface (AAJV 2017, p.46 Figure 23)

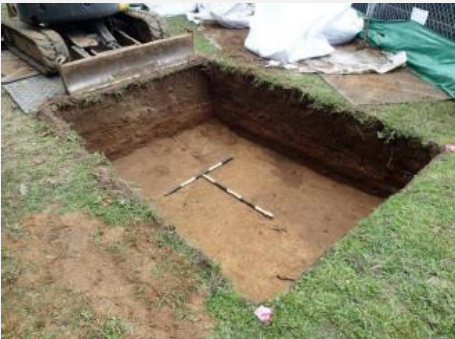
<p>South-eastern view of Test Trench SH3, showing historical modified natural sands (AAJV 2017, p.47 Figure 24)</p> <ul style="list-style-type: none"> • Test Trench SH4 within Thompson Square contained a series of fill deposits laid down over the 19th and early-20th centuries over truncated natural soils, with no historical artefacts identified. The results have been interpreted as levelling or turf preparation deposits as part of ongoing occupation and maintenance of Thompson Square.

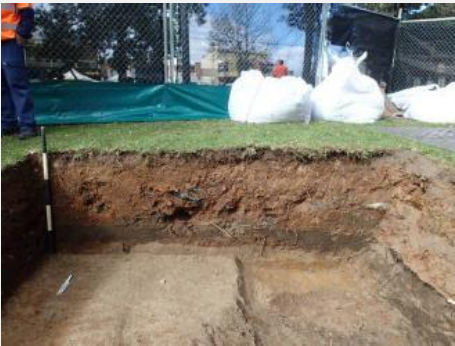
<p>Southern view of Test Trench SH4, showing the different depositional layers and truncated natural soils (AAJV 2017, p.48 Figure 25)</p>

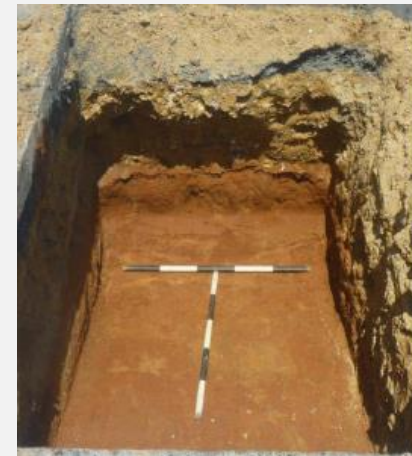
Archaeological item and location	Location and description
	<ul style="list-style-type: none"> Test Trench SH5 within the alignment of Bridge Street encountered a mixed sandy clay fill material under modern road surfacing and finely crushed rock. Beneath these was a truncated natural reddish clay. <div data-bbox="1435 325 1845 783" data-label="Image">

</div> <div data-bbox="1254 786 1998 893" data-label="Caption"> <p>Western view of Test Trench SH5 showing modern road surface and bedding, the shallow mixed sandy clay fill and natural silty clay (AAJV 2017, p.49 Figure 26)</p> </div> Test Trench SH6, located within the footpath at the junction of Old Bridge and Bridge streets, was excavated in separate pits within the originally planned trench area due to active services and private driveways. <ul style="list-style-type: none"> Two areas of heavily disturbed sandstock bricks indicating former structures or demolition scatters were exposed in test pit 2 and 3, both of which were upper 30 centimetres of the profile and pressed directly into modified clays; the feature had been truncated in several locations by services. Deposits overlying the brick feature in test pit 2 contained artefacts with an adjusted date of 1890-present, which has been interpreted as disturbance to historical deposits during laying of services, as the assemblage mostly comprises earlier items with dates ranging between 1794 and 1846, including forged and horseshow nails, engraved coursed earthenware, dark blue <div data-bbox="1413 949 1868 1294" data-label="Image">

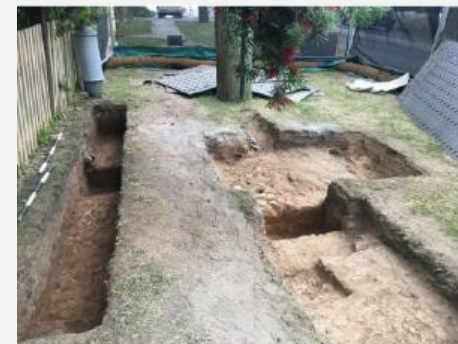
</div> <div data-bbox="1254 1297 2016 1406" data-label="Caption"> <p>Southern view of Test Trench SH6 with test pit 4 to the right (brick and pebble surface) and test pit 2 to the left (disturbed brick feature) (AAJV 2017, p.52 Figure 28)</p> </div>

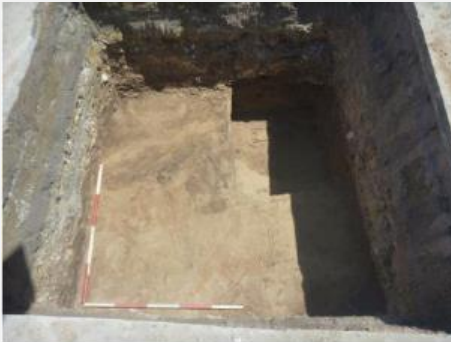
Archaeological item and location	Location and description
	<ul style="list-style-type: none"> Test Trench SH10 is situated in the road reserve at the corner of Macquarie and Bridge streets in the location of a traffic island. Underlying concrete and a series of clay fills was a sandy silt which contained artefacts with an adjusted date range of 1900-1930. Beneath this was a course sand, at the base of which was a semi-circular cut with a deposit of the sandy silt which was investigated further, with a similar mottled silt exposed. Natural soils were not reached as excavation ceased at the extent of impact. The deposits were interpreted as being redeposited soils associated with works at the turn of the 20th century which extend to 1.5 metre below the current level of Macquarie Street. It is possible that further historical deposits are located beyond the extent of excavation, with natural soils likely being natural clay or alluvial material associated with South Creek.

<p>Western view of Test Trench SH10A showing 20th century sandy fills to the base of the trench (AAJV 2017, p.63 Figure 39)</p> <ul style="list-style-type: none"> Test Pit SA4, situated at the western end of Thompson Square within the road reserve. In addition to more recent fill deposits, an aggregate road surface was encountered, followed by a section of vitrified clay stormwater or sewer pipe and associated fill, overlying a humic sand which contained fragments of late-18th century to early 19th century ceramics, under which was another sand layer which featured artefacts with an adjusted date range of 1820-1905, which sat on natural alluvial sand. These were interpreted as remains associated with levelling activities in Thompson Square as well as road construction likely dating to the 1870s.

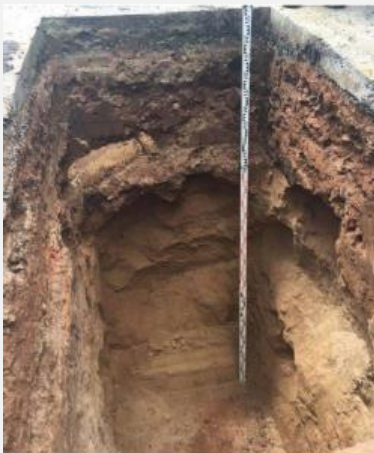
<p>Eastern view of Test Pit SA4 showing road and fill deposits over natural sand (AAJV 2017, p.68 Figure 42)</p>

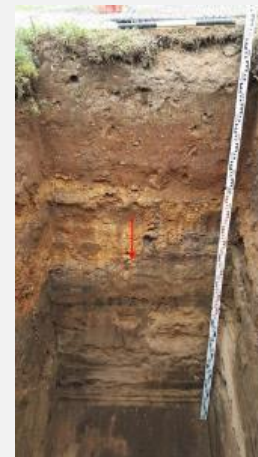
Archaeological item and location	Location and description
	<ul style="list-style-type: none"> Test Pit SA8 was located in the north-western portion of Thompson Square. A series of historical fill deposits were encountered with those of note including a sandy clay featuring artefacts dating to 1885 to 1910, under which was a silt deposit with few artefacts but with a date range of 1835-1850 but also those which indicate earlier use (i.e. 1794-c.1830 and 1802-1830). This overlaid an upper disturbed natural soil profile which featured few artefacts but with a date range of 837-1859, but also Aboriginal artefacts made from European bottle glass, followed by natural undisturbed sand. <div data-bbox="1512 325 1769 783" data-label="Image">

</div> <p data-bbox="1272 794 2022 895">Eastern view of Test Pit SA8 showing historical fill deposits over natural sand; the dark material at the base has been scaped into the base a later deposit (AAJV 2017, p.69 Figure 43)</p> <ul style="list-style-type: none"> Test Pit SA9, Test Pit SA10 and Test Pit SA28, located in the central-western, south-western and south-eastern portions of Lower Thompson Square near the former Bridge Street cutting (respectively), produced similar results to Test Pit SA8.

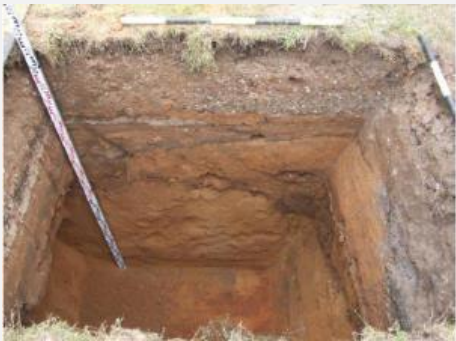
</div> <div data-bbox="416 673 981 778"> <p>Northern view of Test Pit SA28 showing an irregular dark brown band of modified historical topsoil halfway down the section (AAJV 2017, p.83 Figure 56)</p> </div> <div data-bbox="1032 325 1487 778">

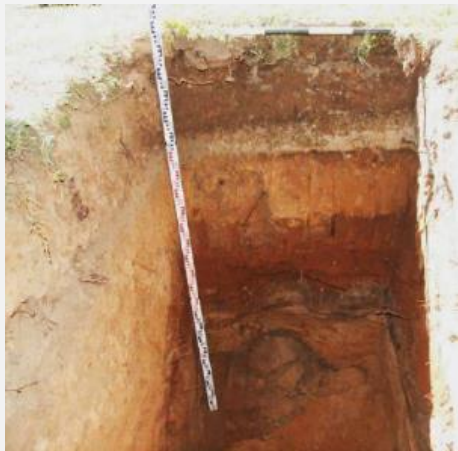
</div> <div data-bbox="1003 785 1473 967"> <p>Northern view of Test Pit SA10 showing marbled historical topsoil overlying subsoil below layers of historical fill, with slumped historical topsoil at the base of the pit (AAJV 2017, p.72 Figure 45)</p> </div> <div data-bbox="1554 325 2009 671">

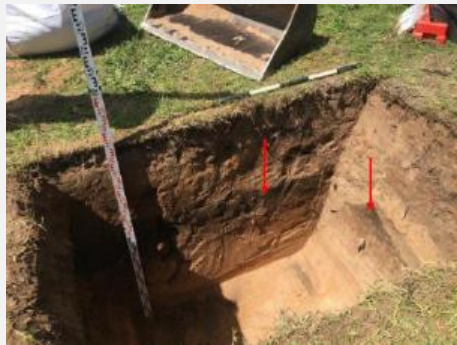
</div> <div data-bbox="1523 678 2024 860"> <p>Eastern view of Test Pit SA9 showing modified historical topsoil (indicated by the red arrow) which overlies an artefact-bearing sandy subsoil followed by natural sand (AAJV 2017, p.71 Figure 44)</p> </div> <div data-bbox="416 991 1245 1417"> <ul style="list-style-type: none"> Test Pit SA16 was located within the kerb and footpath on the southern side of George Street at the junction with Bridge Street. Underlying modern road bitumen with a sandy and clay bedding was a degraded sandstone block and rubble surface, overlying a natural silty clay. The stones had been laid vertically and set on a 45 degree angle to George Street. No artefacts were encountered. This surface was interpreted as the base layer of a Telford road type in light of the method of construction (narrow side of sandstone placed down) which would have provided a durable foundation of interlocked stone rather than the Macadam method of packed broken stone or maximum surface coverage by a basic pavement surface. This method of road building was in use from the early-20th century to early-20th century in some places, and as there were no artefacts the road could have been constructed at </div> <div data-bbox="1420 981 1874 1313">

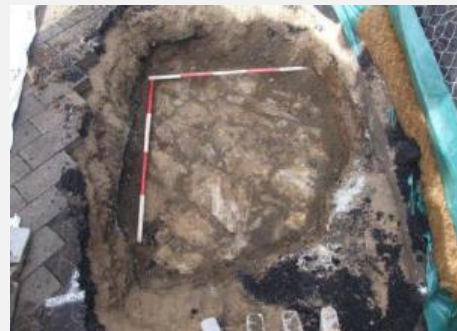
</div> <div data-bbox="1263 1319 1993 1390"> <p>North-facing view of the sandstone base of the Telford-style road in Test Pit SA16 (AAJV 2017, p.73 Figure 46)</p> </div>

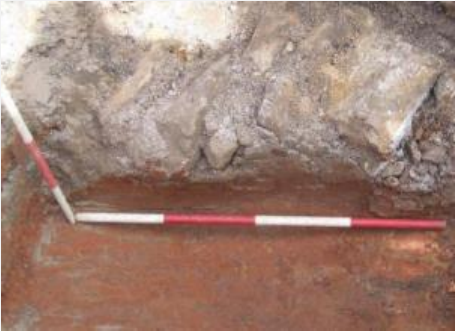
<p>North-facing section view in Test Pit SA16 of the sandstone base of the Telford road laid vertically onto natural clay (AAJV 2017, p.74 Figure 47)</p> <ul style="list-style-type: none"> • Test Pit SA17 was located within the left parking lane of Bridge Street below the roundabout. A sandstone block and rubble surface were encountered under modern road bitumen and FCR bedding. The edge of the structure was contained within the western side of the trench represented by a straight row of neatly cut and stretcher laid stone. This surface was not removed but it was strongly suspected to be laid directly on a natural clay similar to the Telford road base in Test Pit SA16. This feature was interpreted to be a sandstone road.

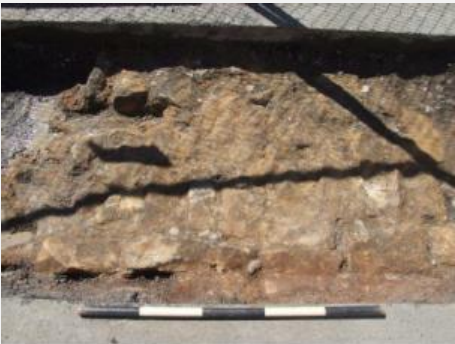
<p>East-facing view of the sandstone road in Test Pit SA17 (AAJV 2017, p.75 Figure 48)</p>

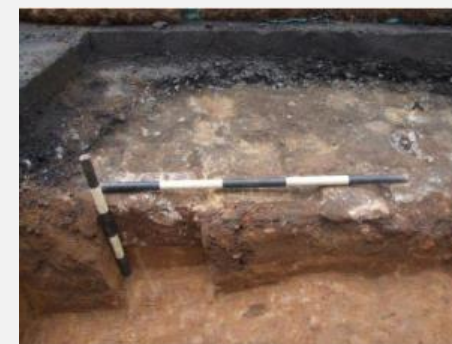
West-facing section view in Test Pit SA18 of the Telford type road base layer overlying the bedding material, followed by natural clay (AAJV 2017, p.76 Figure 50)

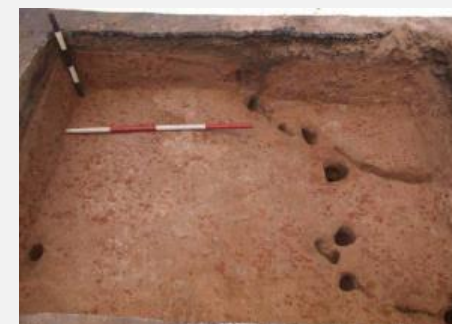
North-facing view of the natural silty sand in Test Pit SA24 with evidence of the sandy clay road surface being compacted into the former tree root (AAJV 2017, p.77 Figure 51)

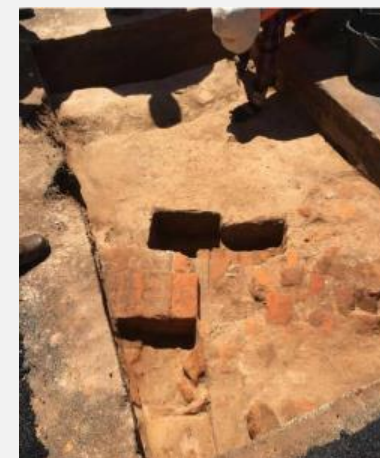
East-facing view of the sandstock brick wall footing in Test Pit SA25
(Source: (AAJV 2017, p.79 Figure 52)

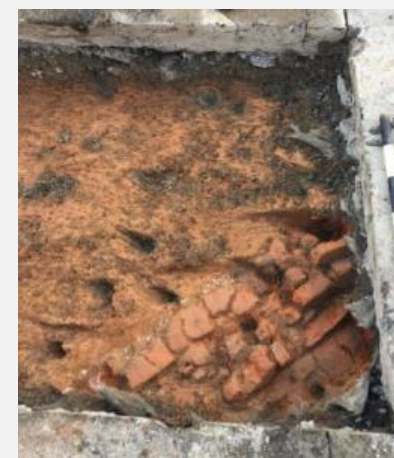
East-facing view of the sandstock brick box drain Test Pit SA26 (AAJV

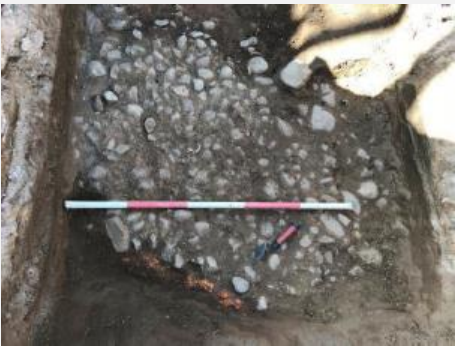
</div> <p data-bbox="1272 735 2038 799">View of the late-19th century cobble surface with brick border in Test Pit SA32 (AAJV 2017, p.8 Figure 61)</p>
