Draft Thompson Square Conservation
Management Plan
Part 1

Thompson Square Conservation Area Windsor, NSW

Conservation Management Plan

Date:
7th August 2018

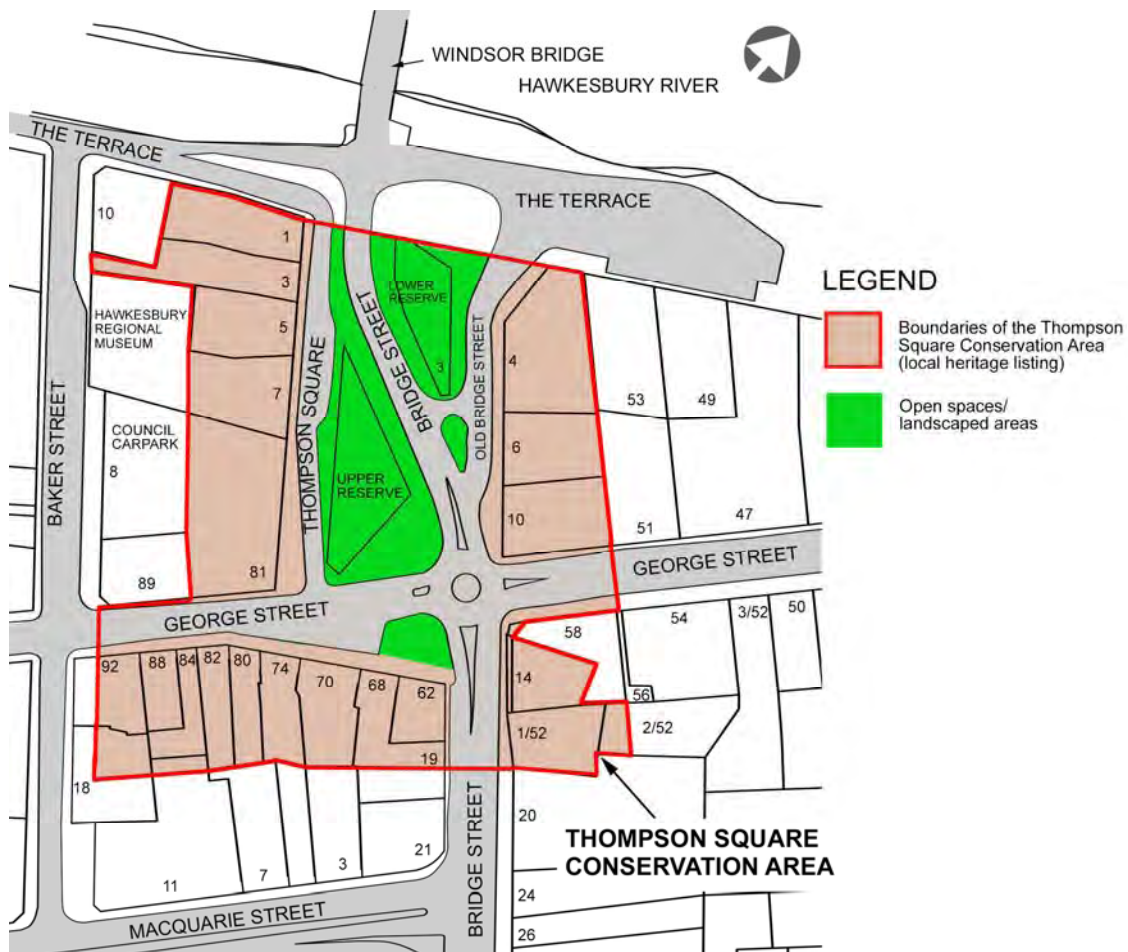
Figure 1. 1: The study area: Thompson Square Conservation Area (outlined in red).

The TSCA is identified as both a State heritage item and a local conservation area, however, the defined boundaries of each listing are slightly different (refer to Section 4 for Heritage Listings). For the purposes of this report, the study area consists of the Thompson Square Conservation Area (C4) as defined on Heritage Map- Sheet HER_008DB of the *Hawkesbury Local Environmental Plan 2012*, which is the larger of the two conservation areas. See Figure 1.1.

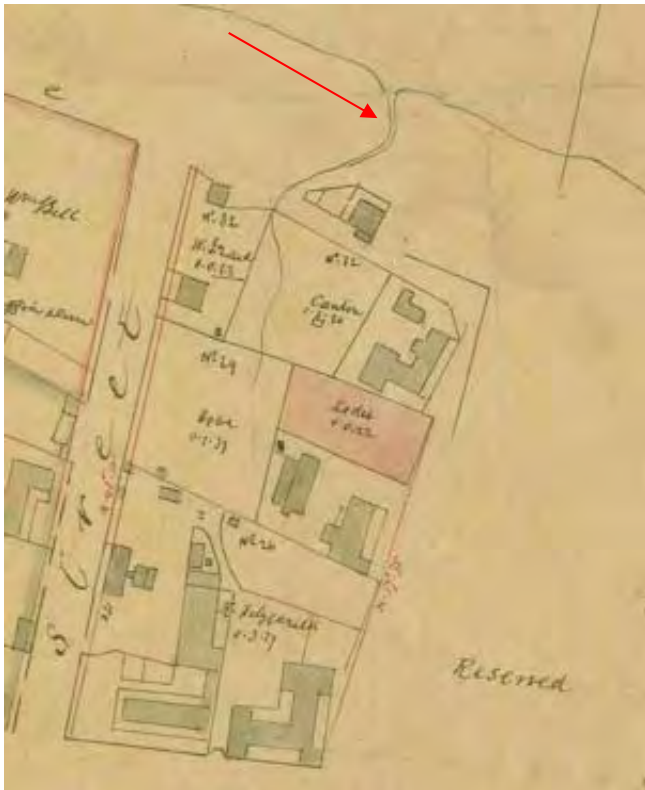
Figure 2. 13: The small creek running to the river between Baker Street and Thompson Square that may have been the original water source (indicated with an arrow). Source: SA Map 5968

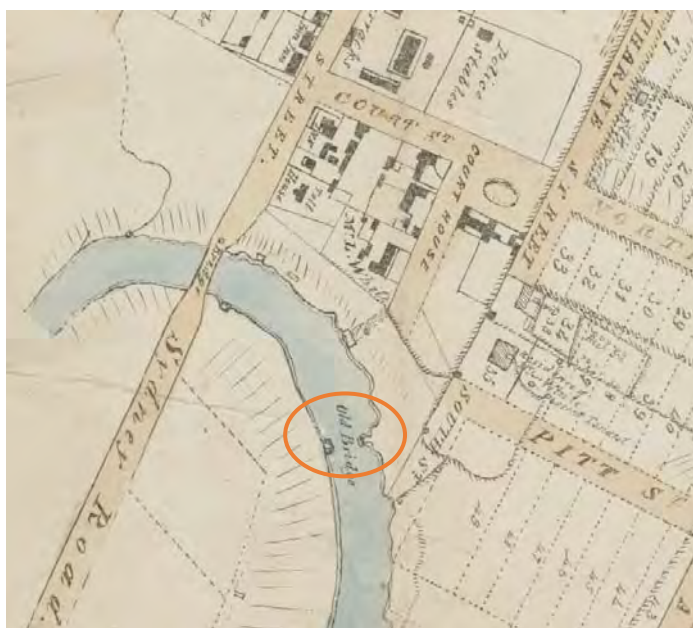
Figure 2. 15: Detail from 1842 plan of Windsor entitled "CXXIII building and 24 cultivation allotments comprising the Peninsular Farm adjoining the town of Windsor to be sold at auction on 5th. Feby. 1842 by Mr Laban White at Windsor". The location of Thompson's floating bridge is noted as "Old Bridge" (circled) to the south of the Courthouse and to the east of the South Creek bridge. Source: SLNSW M2 811.11222

Another part of the government precinct was leased to Andrew Thompson on 9 May 1809. It consisted of 1 acre 43¼ rods bounded on the north-east by Wilcox's land 7 chains, on the north-west by 1 chain 60 links, on the south west and on the south east by South Creek.¹¹¹ It was on this land that Thompson had established his floating bridge and toll gate across South Creek in c1802.

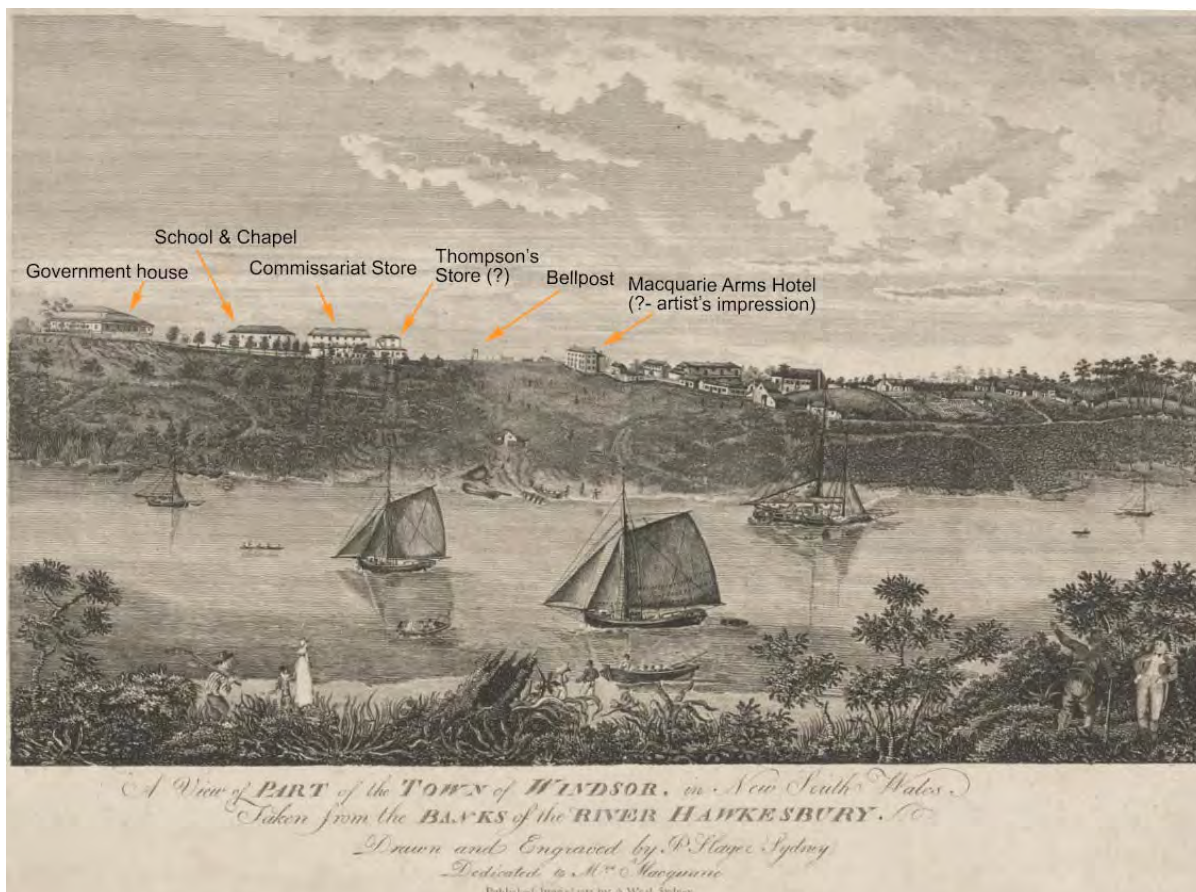
Figure 2. 21: Slaeger's published view of Windsor is significant not only for its detail but for the fact that it has a precise date of publication. Annotated to show the principal elements of the precinct. Source: P Slaeger, A view of part of the town of Windsor in New South Wales, taken from the banks of the River Hawkesbury, 1813, NLA

The etching published in 1813 by Slaeger can be precisely dated. It confirmed some of the detail of the painting apparently completed by Evans in 1812 (Figure 2.21). The three storey storehouses remained as did Government House. Thompson's garden had been absorbed into the Government Domain. The small inlet and beach on the riverbank that may have inspired the establishment of a landing place and subsequently, the Government Domain at this spot, was also visible. A notable addition compared to the earlier painting was a three storey building to the right of the image. It is almost exactly in the position where the Macquarie Arms Hotel was built. There is no other contender comparable to that building. Problematically, the Macquarie Arms Hotel is not a three storey building. If it is the Macquarie Arms Hotel, it suggests that it was already under construction by 1813, even though it was not finished until 1815.¹³²

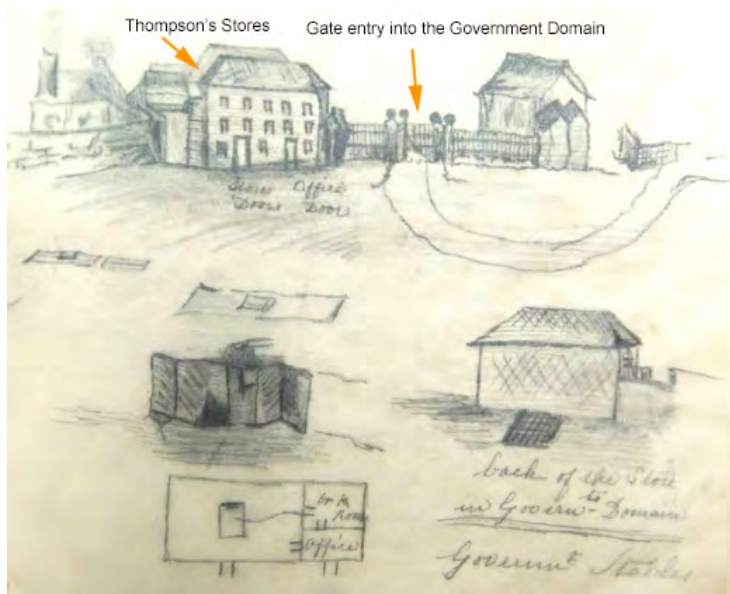
Figure 2. 22: This sketch of Thompson's stores was completed in 1820. Source: Bonwick Transcripts, BT 10, p 4259, ML

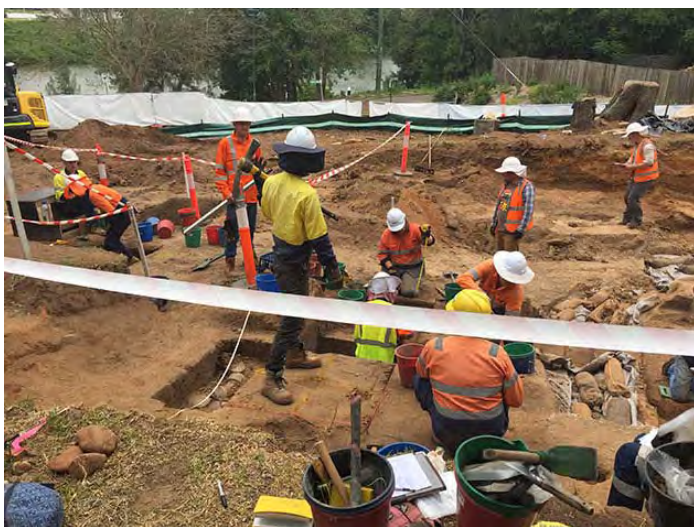
Figure 2. 31: Archaeological investigations being conducted in the Lower Reserve of Thompson Square. Source: <http://www.rms.nsw.gov.au/projects/sydney-west/windsor-bridge-replacement/index.html>

In 2018, as part of the RMS Windsor Bridge Replacement Project, archaeological investigations were undertaken in the Lower Reserve of Thompson Square. As a result of this work several items of colonial and Aboriginal significance were uncovered including Aboriginal stone tools and other artefacts (including ceramics, bottles, bricks, etc.) and a brick barrel drain and box drains, dating back to 1814.

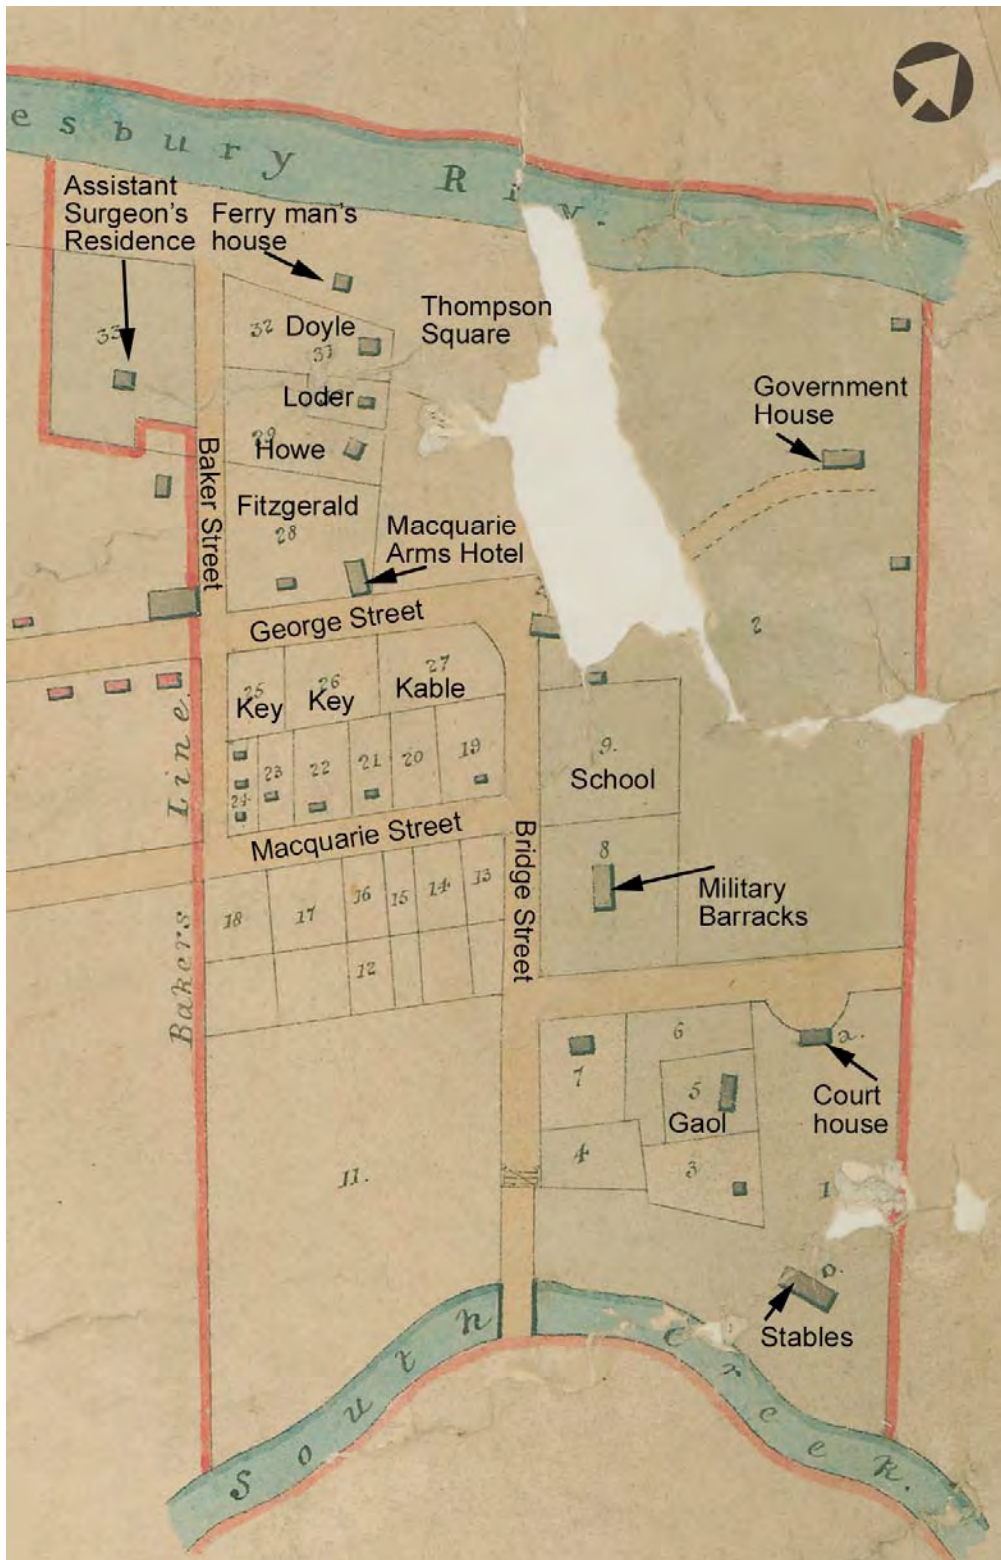
Figure 2. 37: The other 1827 survey by Assistant Surveyor George Boyle White. Source: SA Map SZ 524

1827: Another survey plan of 1827 also by Assistant Surveyor George Boyle White showed buildings on Fitzgerald's, Loder's, Howe's and Doyle's [1-3 Thompson Square] land.¹⁶⁶

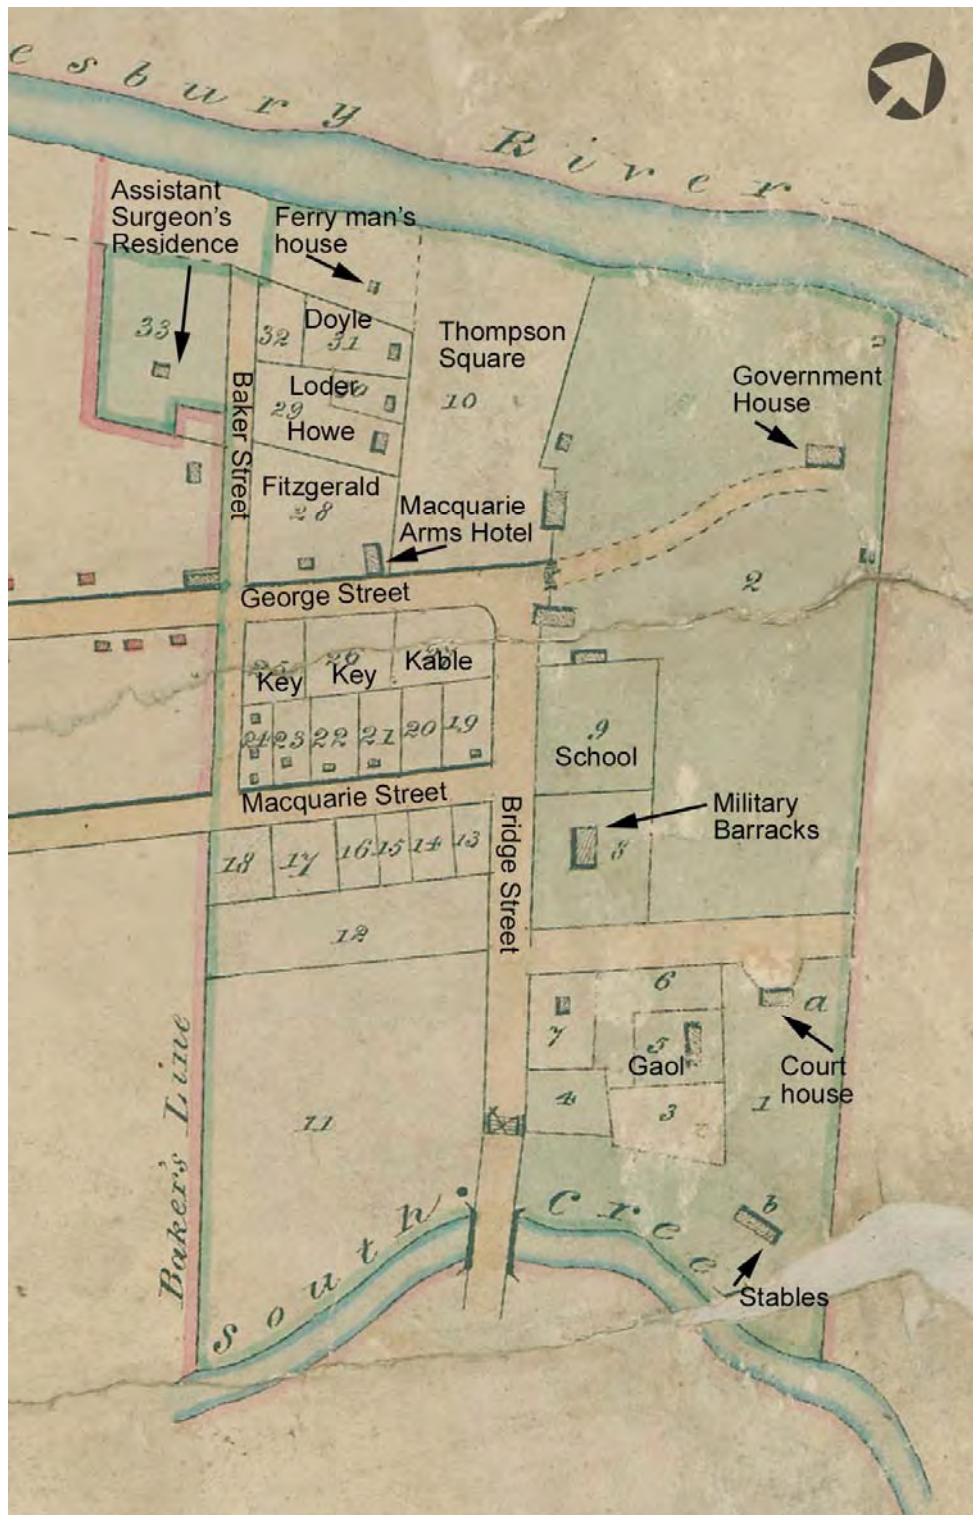
Figure 2. 38: The 1827 plan by John Thompson. Source: SA Map SZ 526

1827: A survey by Assistant Surveyor John Thompson also dated as 1827 appears to be a copy with almost identical detail to White's survey except that the position and alignment of the buildings on Numbers 29, 30 and 31 differ.¹⁶⁷

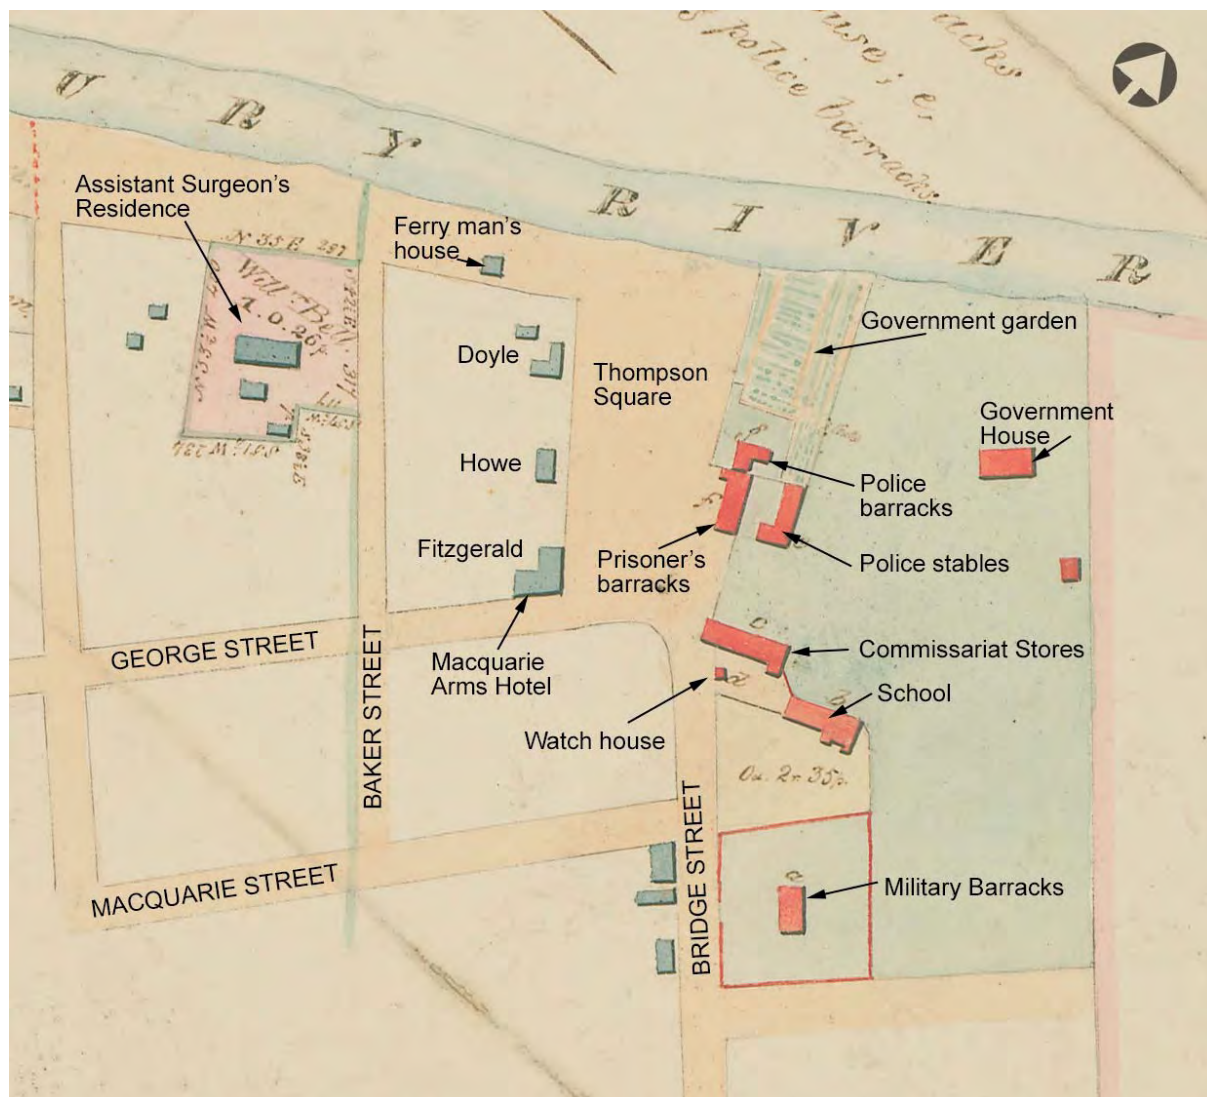
Figure 2. 39: Assistant Surveyor John Abbott's survey of September 1831. Source: SA Map 1816

1831: A plan by Assistant Surveyor John Abbott dated as 24 September 1831 showing land for a School showed details of government buildings on the plan. It may have been copied from one of the earlier 1827 maps. It also showed the layout and plantings of the garden on Thompson's former lease.¹⁶⁸

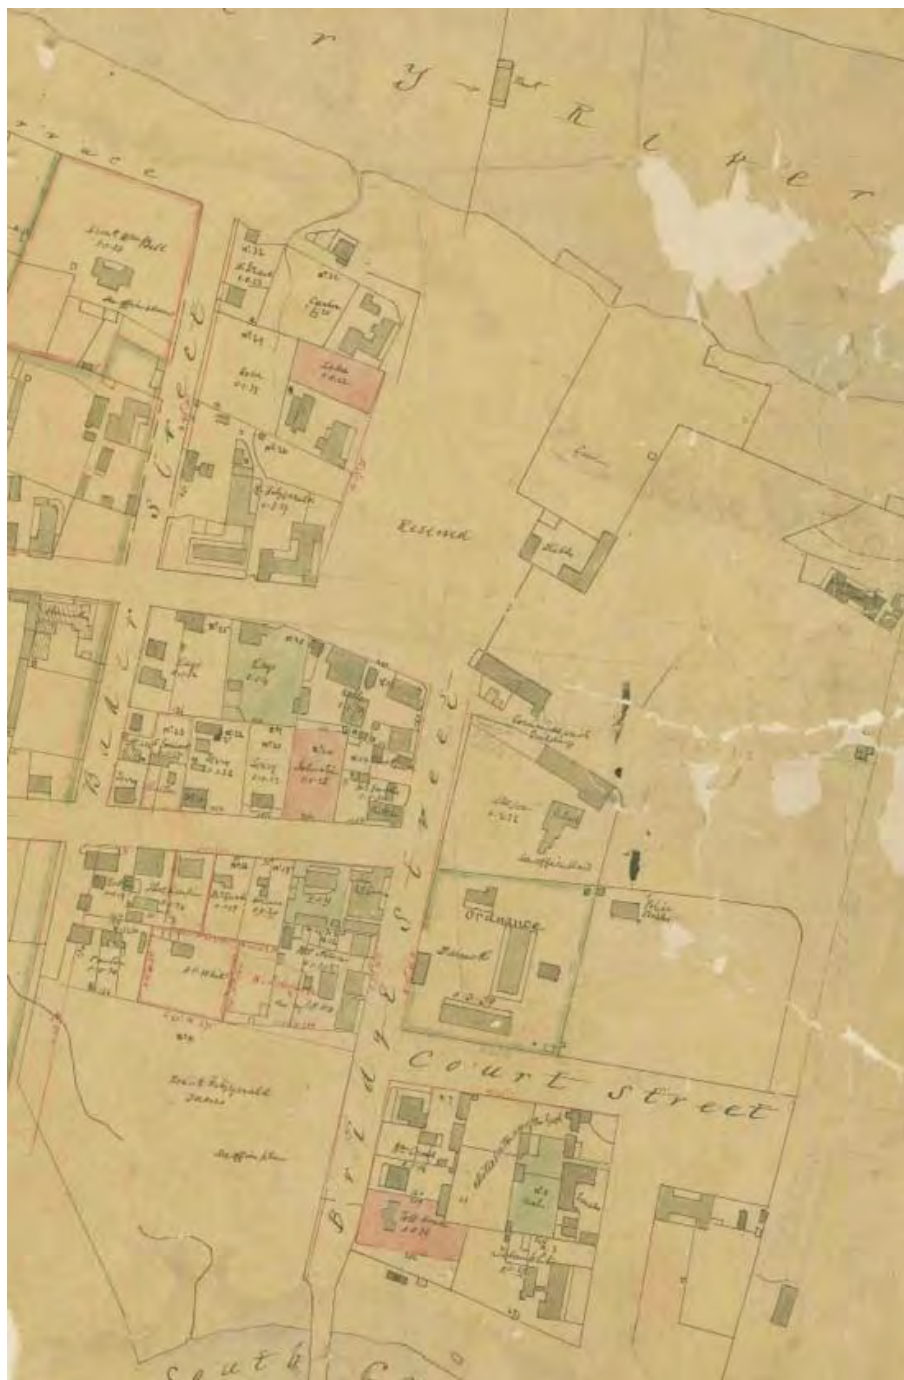
Figure 2. 40: The 1835 survey plan by Assistant Surveyor G B White provided the first plan with accurate details of building footprints around Thompson Square. Most of the lots on the western and southern sides of the Square had been built upon, whilst government buildings dominated the eastern side. Source: SA Map 5968

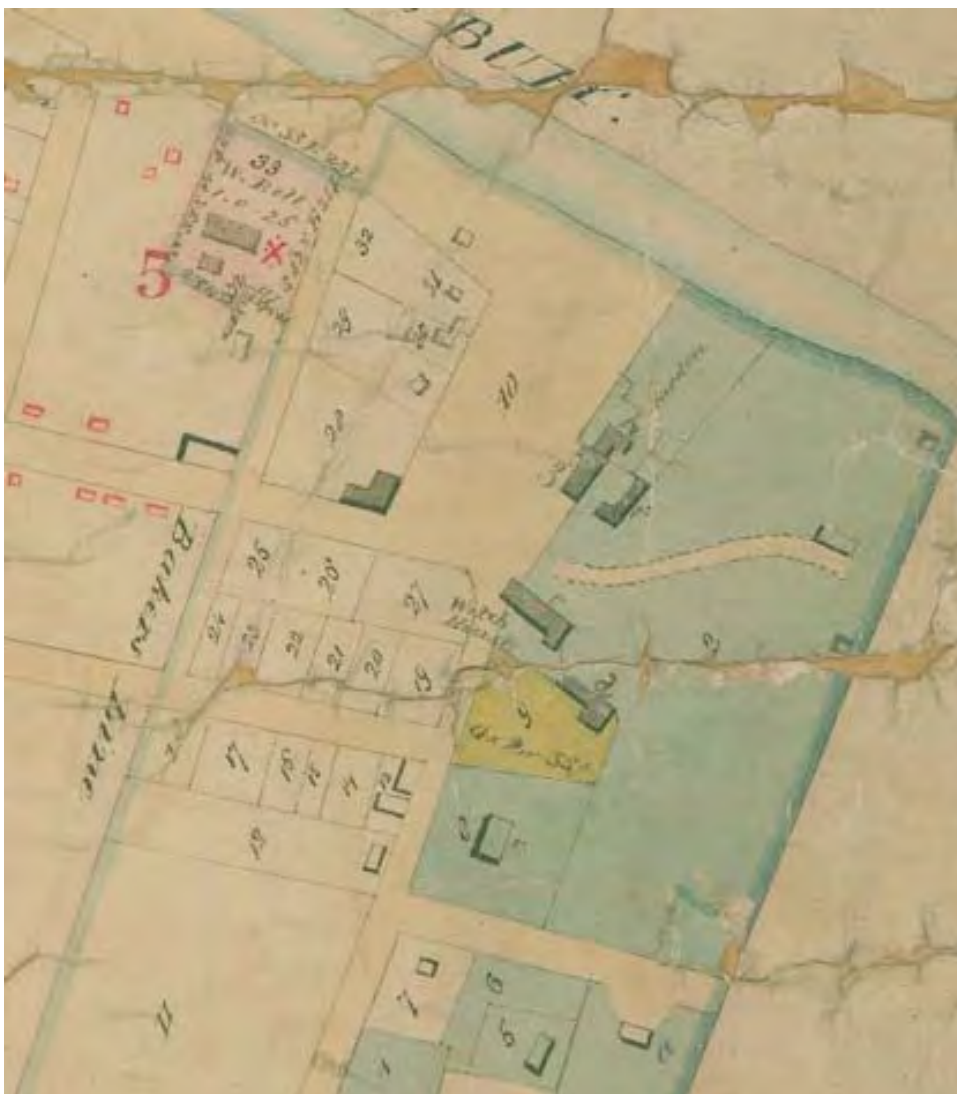
Figure 2. 41: This partially completed map compiled before 1847 by J J Galloway showed some building detail but it appears incomplete. Source: SA Map 5966

Pre 1847: A survey of the town of Windsor by Assistant Surveyor J J Galloway was partially completed 'before his departure for squatting districts'. He left for the squatting districts after the Deputy Surveyor General S.A. Perry instructed him to proceed to the Districts of New England and Gwydir on 3 November 1847.¹⁷⁰ The condition of the map suggests it may be an earlier version of the plan he eventually completed as the town design.¹⁷¹

This undated map showed Baker's line (boundary) on the western side of Baker Street. It sketched in the building on Howe's land as well as showing a building on what is now 5 Thompson Square, though this may be the hotel on the site later occupied by the Doctor's House (1-3 Thompson Square), plus a small building on the Doctor's House site. Government buildings shown included the Commissariat store also labelled as watchhouse (e); police barracks (f and h); prisoner's barracks (g); Gaol near Court Street (5); Military Barracks (8 and building c); School allotment (with an area of 2 roods 35 perches) and the School (9 and d).¹⁷²

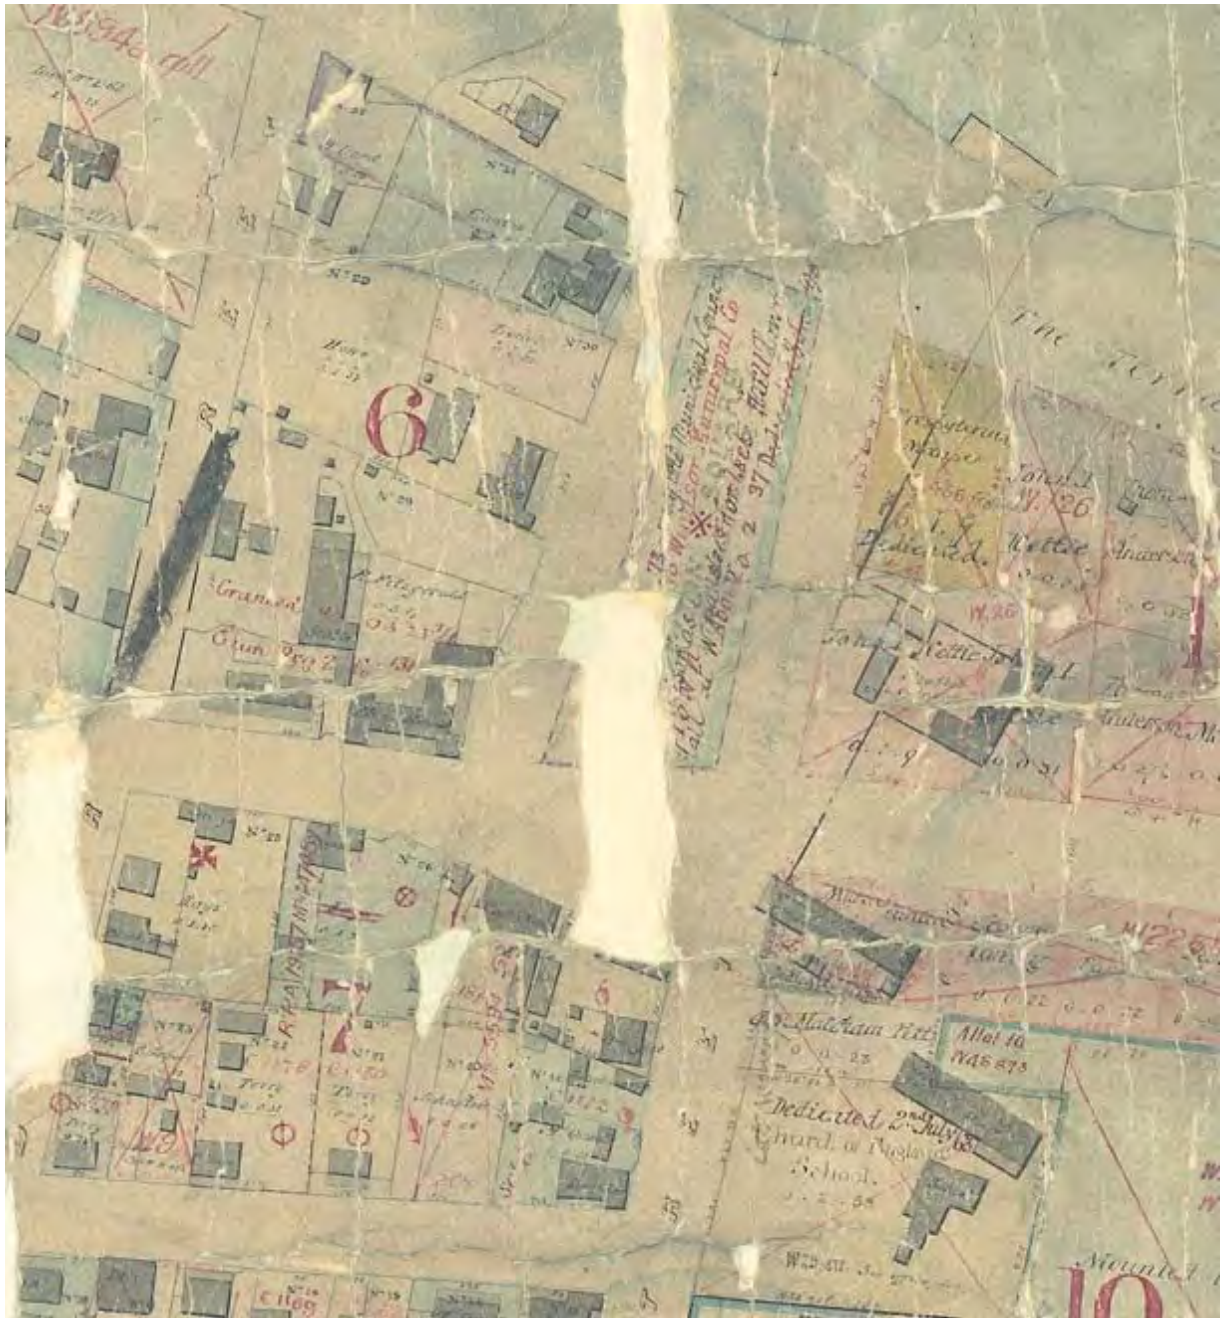
Figure 2. 42: J J Galloway's Town Design of Windsor dated December 1841 provided significant detail of buildings and their relationship to the cadastre. Source: W.443.a, Crown Plan

A comparison of the two versions of Armstrong's sale map with Assistant Surveyor Galloway's 1841 town design reveals some differences. The following buildings have differing footprints in Galloway's and Armstrong's maps – Fitzgerald's buildings at the corner of George and Baker Streets behind the Macquarie Arms; buildings on Howe's lot; buildings on the site of the Doctor's House; and the buildings on Kable's allotment facing George Street and the government stables. Galloway also showed a small building towards the river in the Government 'Garden'.

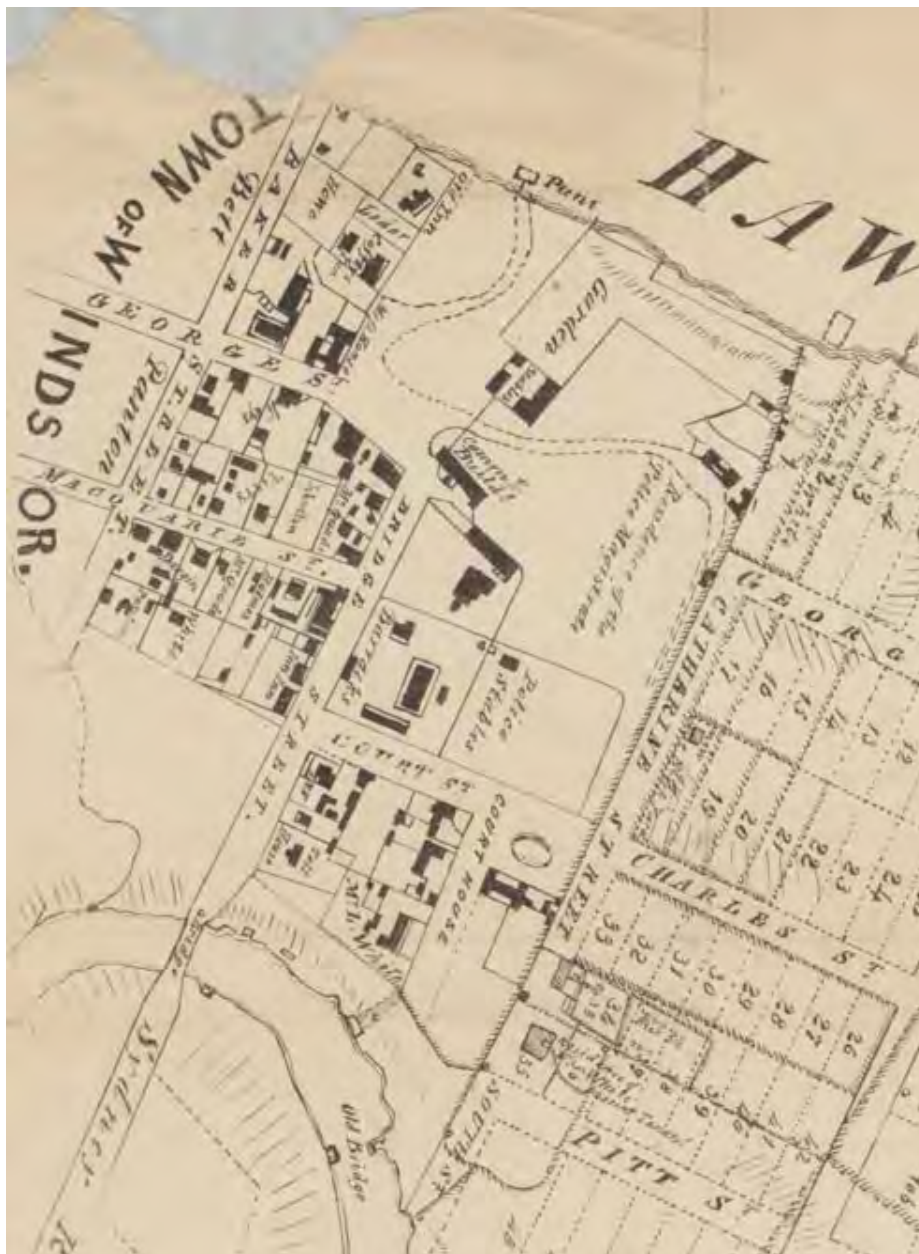
Figure 2. 43: Armstrong's sale plan of 1842 provides a useful comparison to Galloway's plan. Source: ML Map M2 811.11222/1842/1

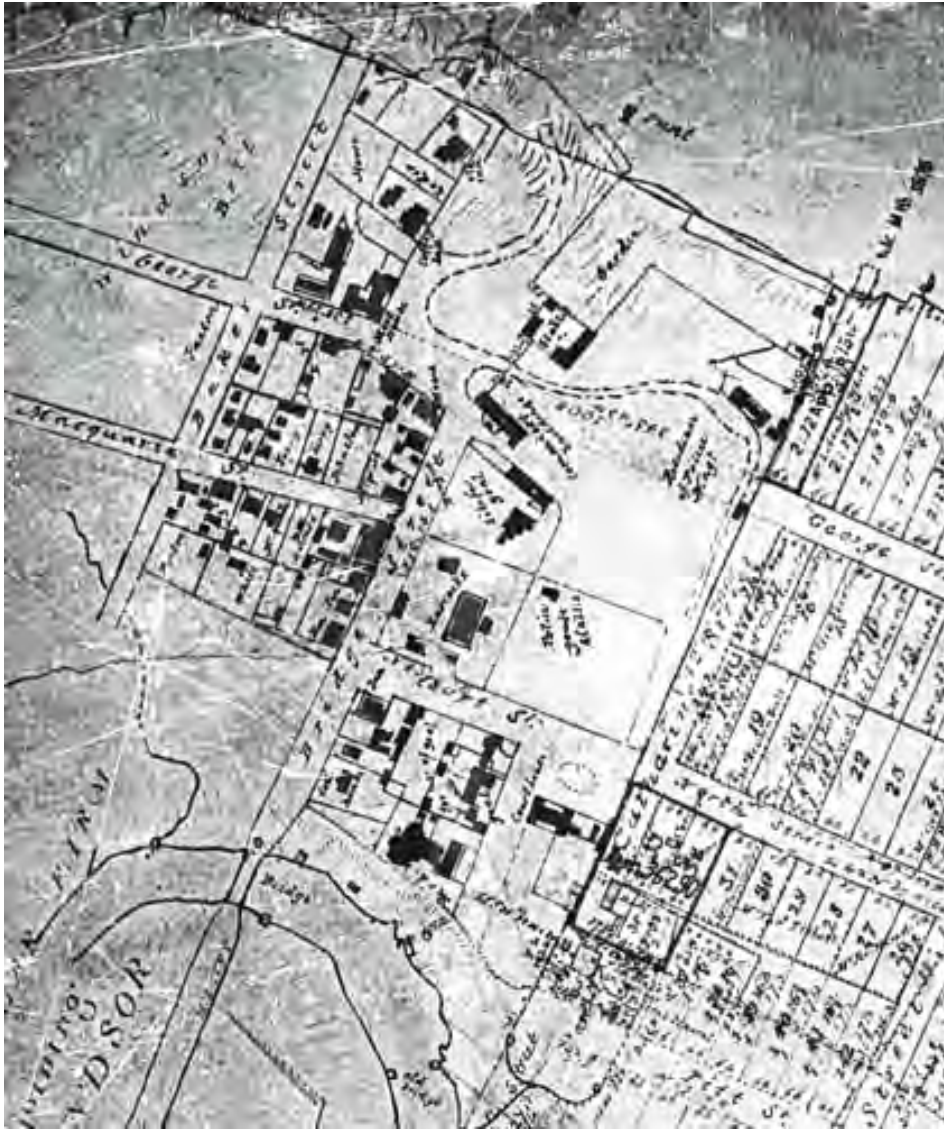
Figure 2. 44: The version of Armstrong's sale plan held by LRS. Source: 411 (A), LRS, NSW

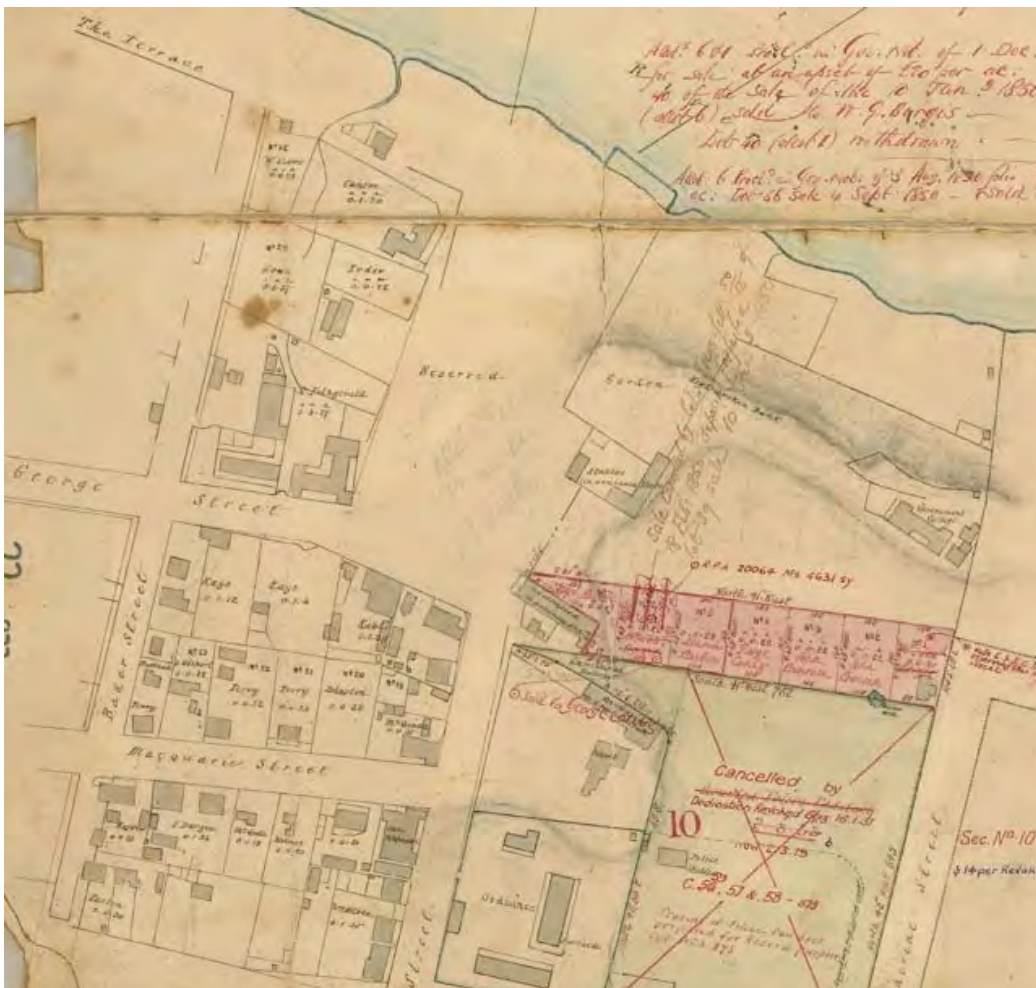
Figure 2. 45: Detail from Shone's 1848 plan showing Thompson Square. Source: W.22.873, Crown Plan

1848: Licensed Surveyor William Shone surveyed some of the government land on the eastern side for auction in December 1848. Though sales were slow and some sales were cancelled, the land was gradually alienated. This significantly reduced the government presence in Windsor. Shone's survey showed the various buildings around Thompson Square and the surviving government buildings. Buildings shown included the hotel on the site of 1-3 Thompson Square, Howe's cottage at 7 Thompson Square, the Macquarie Arms Hotel, Fitzgerald's cottage facing George Street, and the buildings constructed by Uriah Moses at the corner of George and Bridge Streets.¹⁷⁸

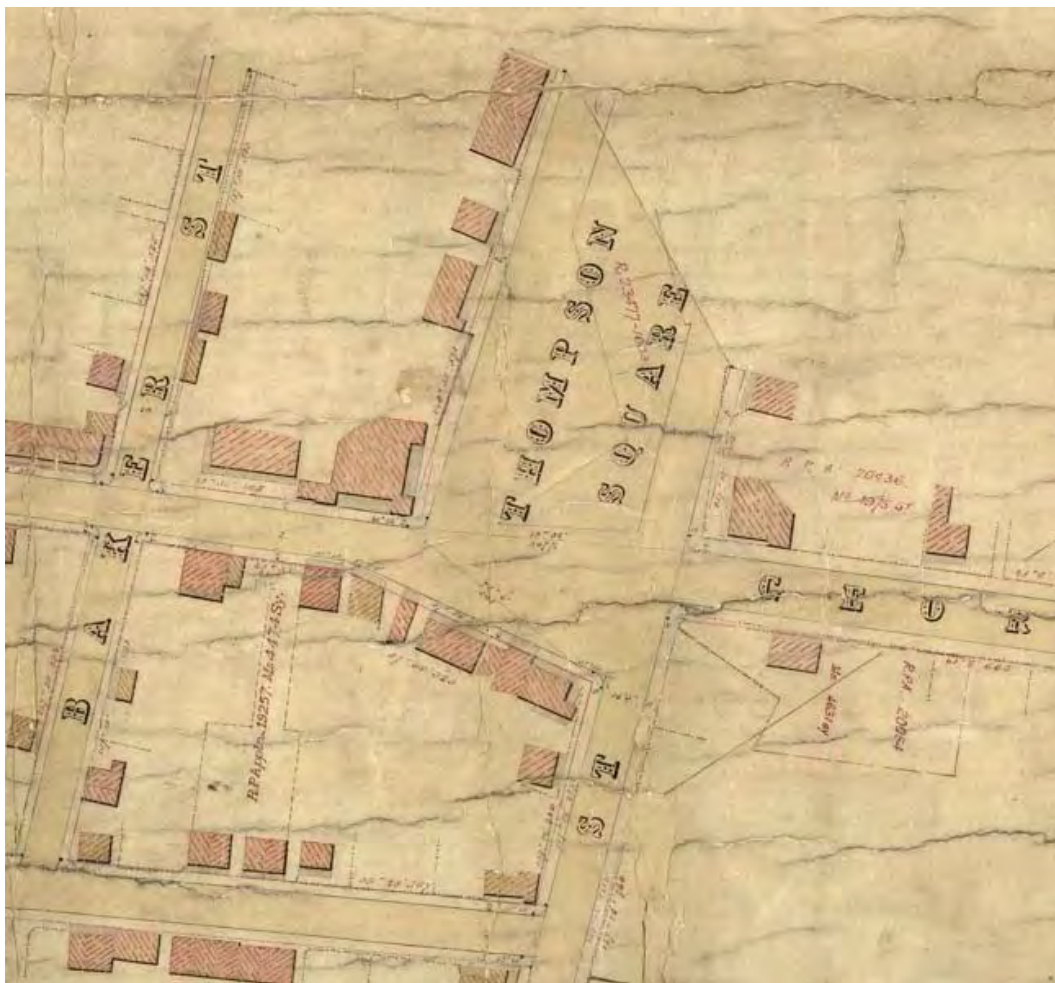
Figure 2. 46: Licensed Surveyor Robert Handcock's street alignment survey of June 1871 included footprints of buildings close to Thompson Square. Source: W.1.1039, Crown Plan

1871: Robert Handcock, licensed surveyor and civil engineer, dispatched his street alignment survey of Windsor to the Surveyor General on 23 June 1871. It showed the buildings around Thompson Square including 1-3 Thompson Square (Doctor's House), 5 Thompson Square, 7 Thompson Square (Howe's cottage now Museum), the Macquarie Arms Hotel, Fitzgerald's house facing George Street, 6 Bridge Street, 10 Bridge Street and the dwellings at the corner of George and Bridge Streets constructed by Uriah Moses.

Other buildings on the south side of George Street facing the square were also shown. Though it was apparently in existence, the School of Arts building was not shown nor were any Government buildings such as the watchhouse, even though they were extant. However, buildings on the western side of Bridge Street were included in the alignment survey. To further complicate the issue, Court and Catherine streets to the east of Bridge Street were aligned and existing buildings facing them were shown.¹⁷⁹

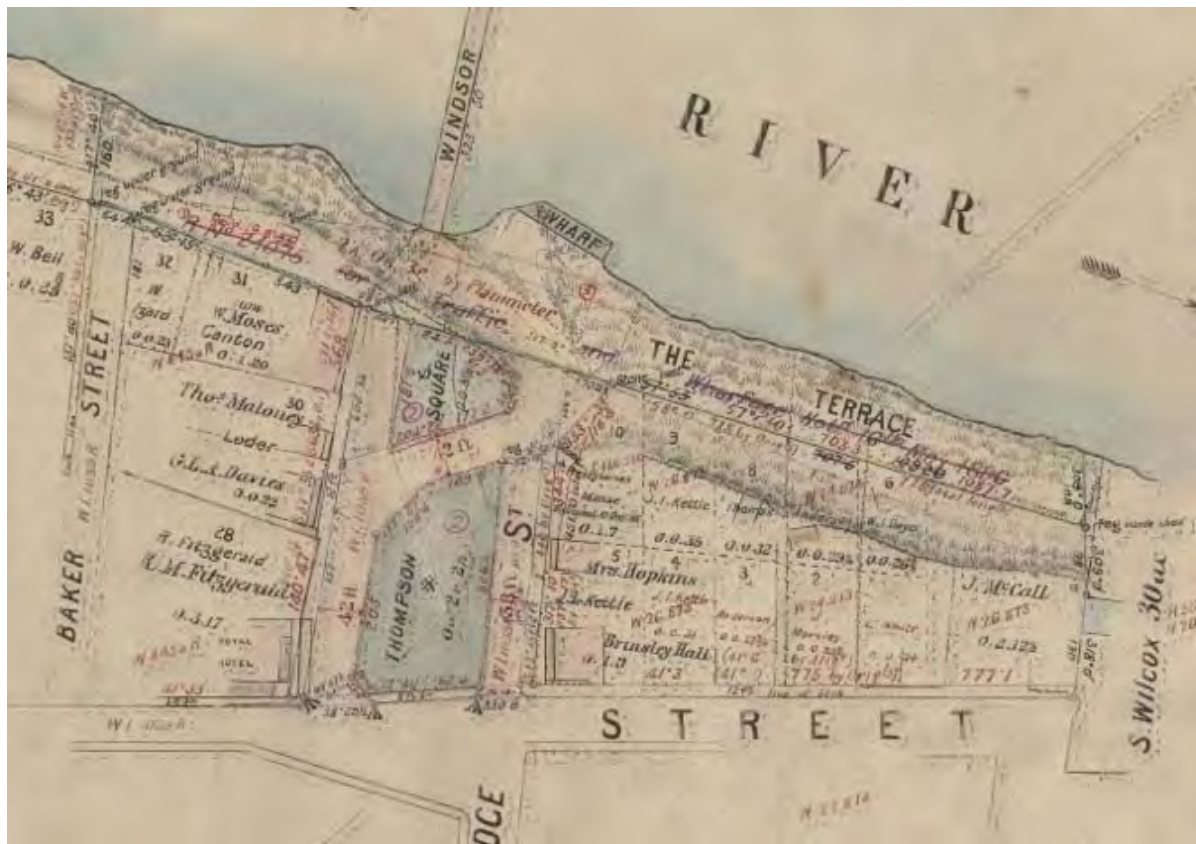
Figure 2. 48: Charles Robert Scrivener's survey of Thompson Square in December 1894 showing the adjacent landholders and some details of buildings. Source: Ms.1009.3000, Crown Plan

1894: On the other hand, Charles Robert Scrivener's survey of Thompson Square in December 1894 showed buildings around its perimeter. He also showed the two reserves created when the new road was cut through in 1874.¹⁸¹

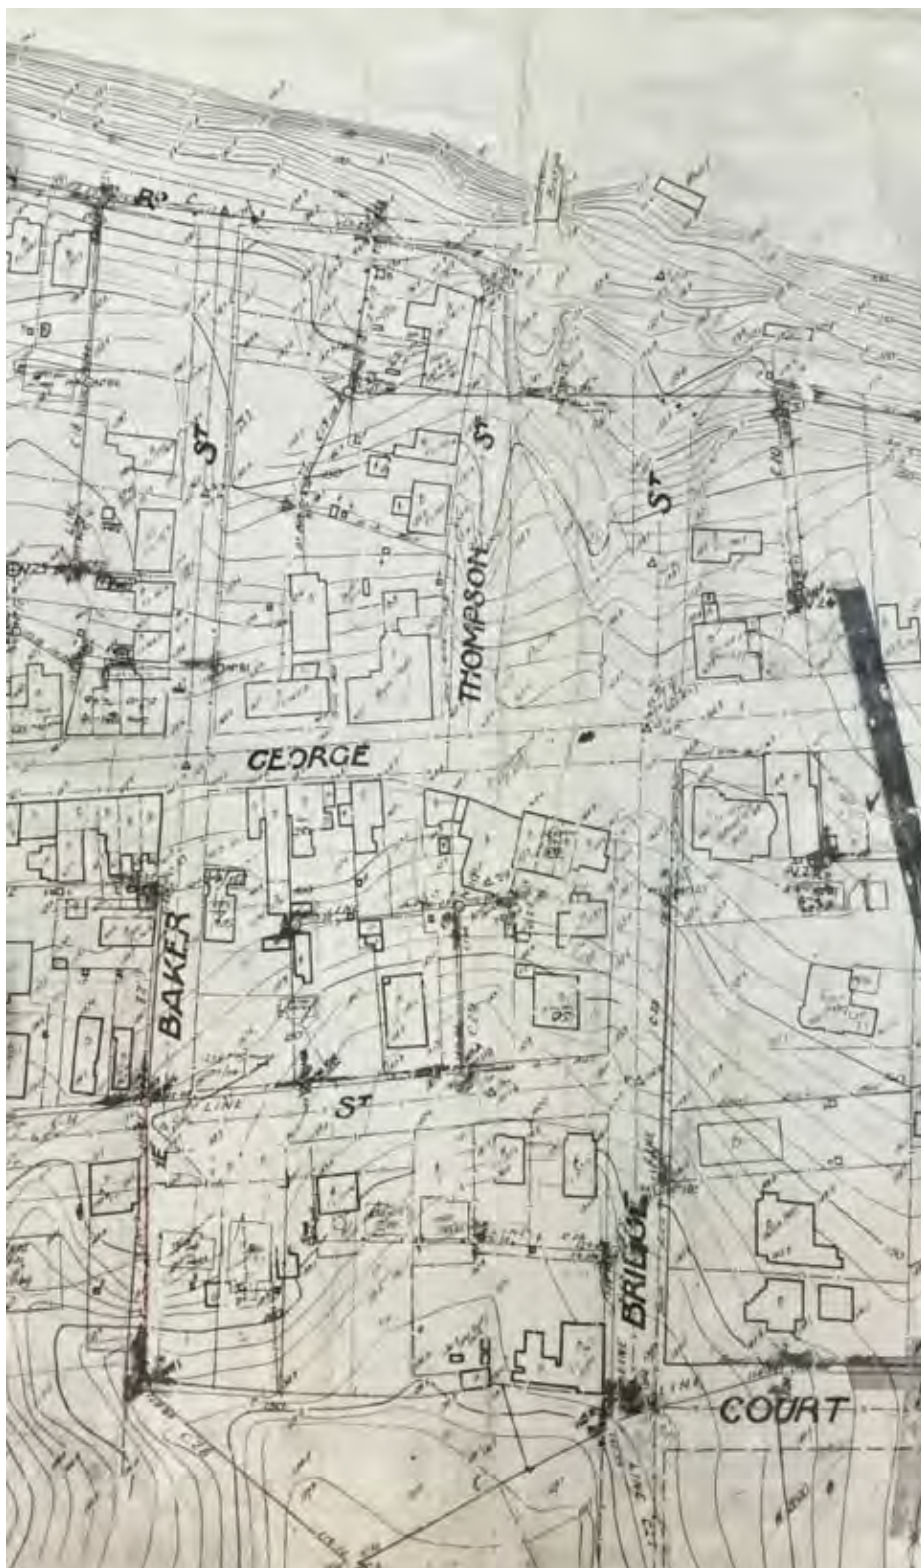
Figure 2. 49: The November 1936 sewerage survey that provides footprints of buildings around Thompson Square. Source: Windsor Sewerage, 3 November 1936, Hawkesbury City Council

1936: A sewerage scheme plan dated as 3 November 1936 provides a Detail Survey of the buildings around Thompson Square.

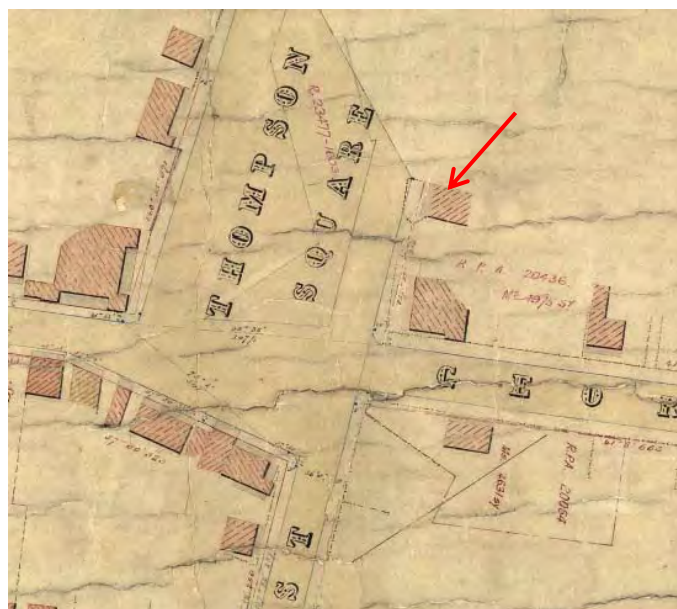
Figure 2. 60: Detail from Licensed Surveyor Robert Handcock's Street alignment survey of 23 June 1871. No. 6 Bridge Street is indicated with an arrow. Source: Crown Plan W 1 1039

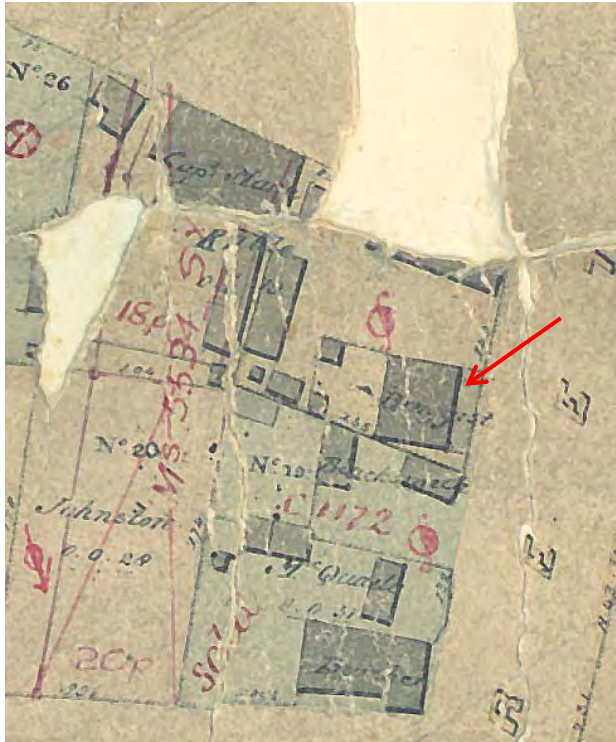
Figure 2. 65: J J Galloway's Town Design of Windsor dated December 1841 showing No. 19 Bridge Street (indicated with an arrow) noted as being the location of a "Druggist". Source: W.443.a, # Crown Plan

Occupying the southern portion of the allotment also containing Nos. 62 and 64-66 George Street, the Hawkesbury Stores, the single storey cottage fronting Bridge Street first appears on Galloway's town plan of 1841. Although difficult to read, the plan appears to note that the property was occupied by a druggist at this time. The 1840s cottage survives today.
