Draft Thompson Square Conservation
Management Plan
Part 1

Thompson Square Conservation Area Windsor, NSW

Conservation Management Plan

Date:
7th August 2018

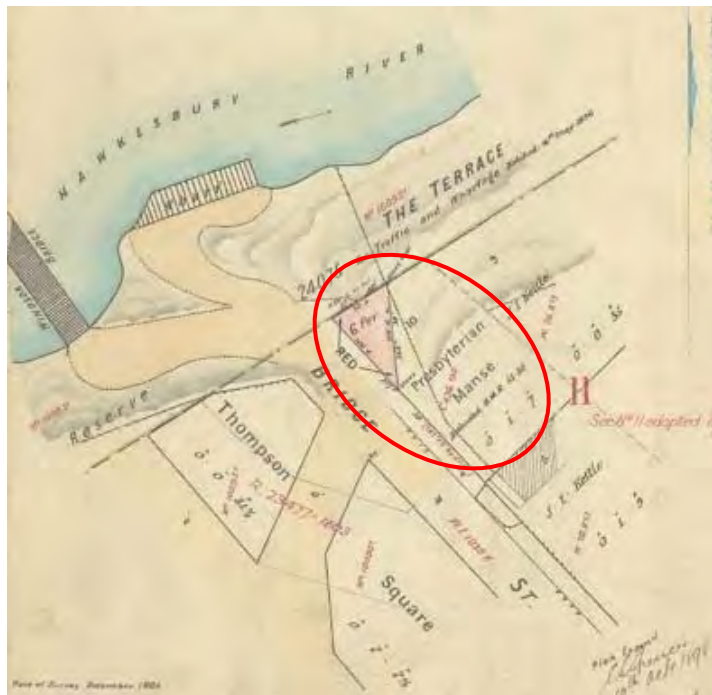
Figure 2. 68: This survey of the land taken from the Presbyterian manse lot (circled) for road access in Thompson Square appears to have been copied from Scrivener's survey of December 1894. Source: R.6026.1603, Crown Plan

A plan of the resumption of part of the lot granted for a Presbyterian manse, was prepared in the Lands Office based on Scrivener's survey, copying most of the details from Scrivener's survey of December 1894 and was dated as December 1894.²⁴⁵

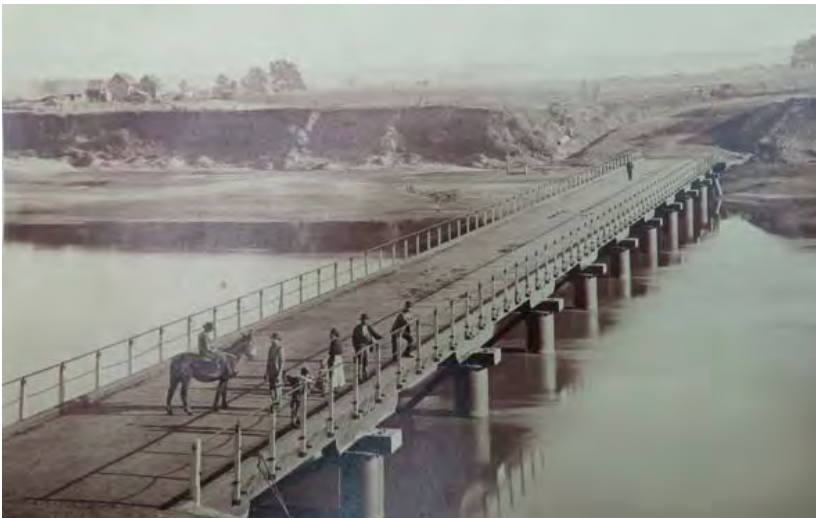
Figure 2. 75: The original low level bridge in the 1870s. Source: ML.SPF, PXA 2113, Box 74

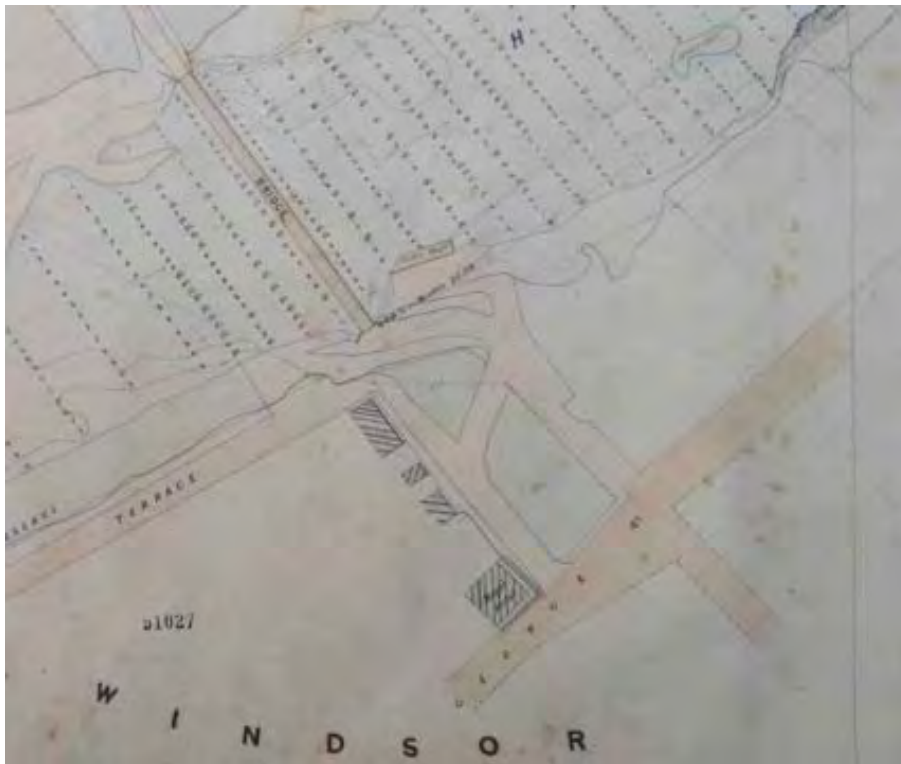
Figure 2. 78: Licensed Surveyor Joshua Josephson's survey of the river near Thompson Square. Source: SA Map X1080

Instead, the bridge grew in importance as produce was carted across the river and Thompson Square to the railway station. In October 1890, Licensed Surveyor Joshua Josephson surveyed the Hawkesbury River around the bridge taking soundings of the river.²⁶⁶

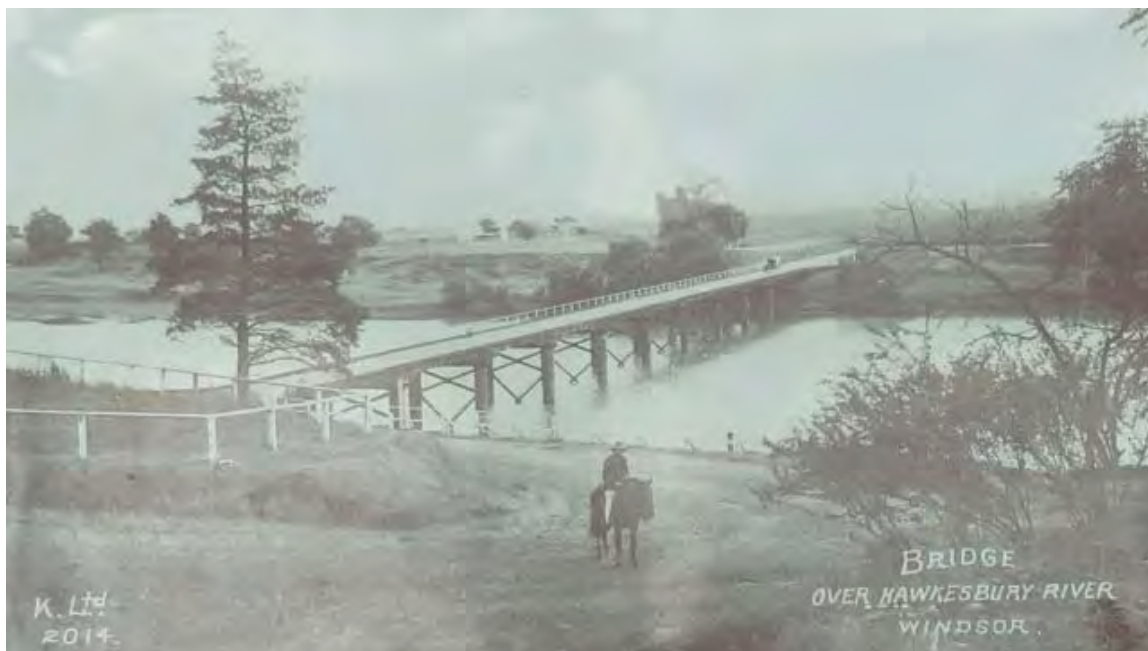
Figure 2. 79: The bridge in 1911 showing its new form after being raised. Source: ML.SPF, PXA 2113, Box 74

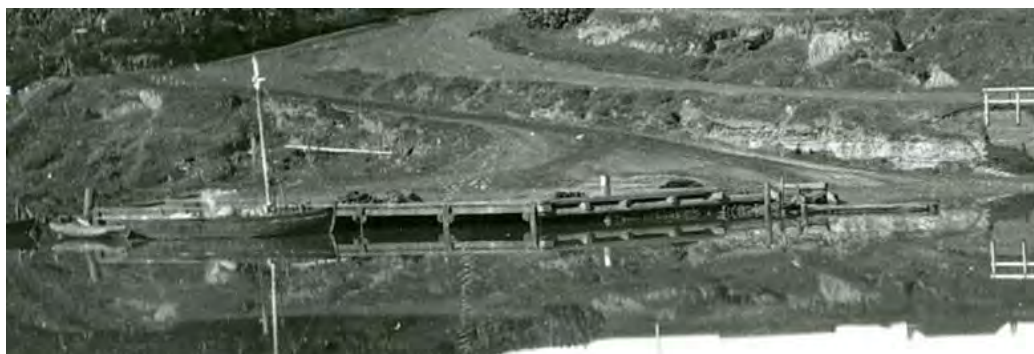
Figure 2. 80: Detail from c1879 photograph showing the Windsor Wharf to the east of the Bridge which at this time was quite a substantial structure. Source: GPO SH1658

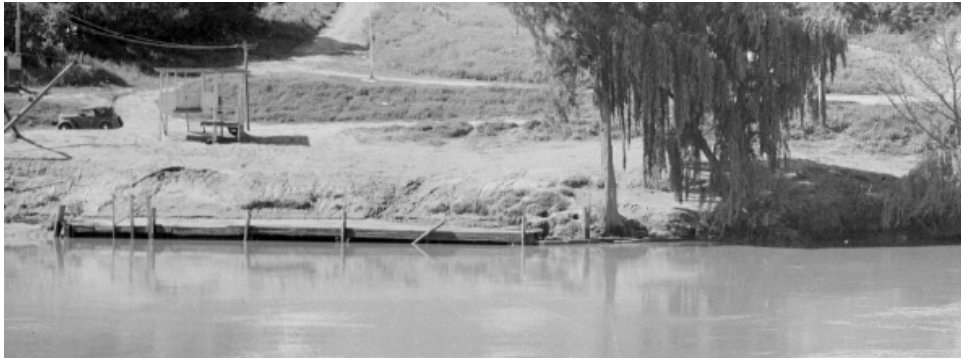
Figure 2. 81: Detail from c1935 photograph by E.W. Searle showing the Windsor Wharf to the east of the Bridge, much reduced in size. Source: NLA, PIC P838_1419 LOC Cold store SEA Box 11

During the late 1940s or maybe during the 1950s, the wharf appears to have fallen into disrepair and may have either been demolished or left to collapse.²⁶⁹ It appears to be visible in the 1947-51 aerial photograph (see Figure 2.83) but was not there on the 1966 aerial photograph (see Figure 2.84). Certainly, during the 1920s, newspaper articles in the *Windsor and Richmond Gazette* complained of the dilapidated condition of the wharf²⁷⁰ and any discussion of its refurbishment did not eventuate until the 1930s.²⁷¹

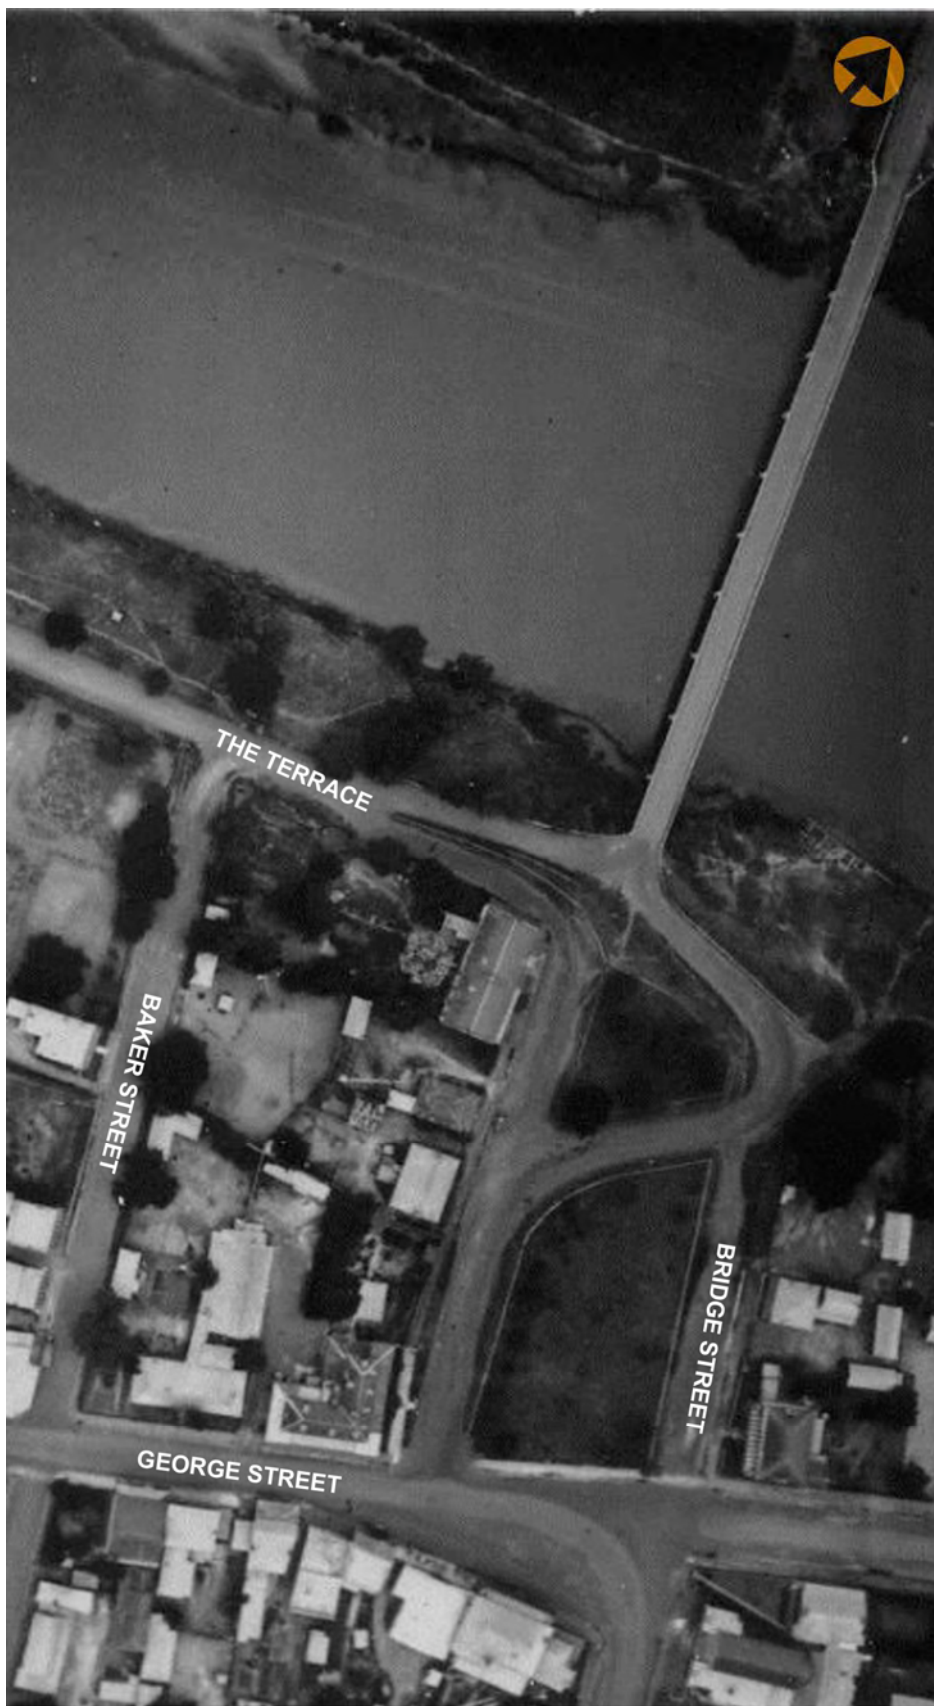
Figure 2. 82: 1929 aerial photograph of Thompson Square Conservation Area. Source: Carol Roberts, Windsor, from the collection of her mother, the late Iris Cammack. Photographer Frederick Halpin Willson, RAAF, 1929.

It should also be noted that landscaping along the river bank remains sparse from the 1920s through to the 1990s, with only the occasional tree appearing in the photographs. It has been assumed that clear views of Thompson Square from the northern side of the river would have been readily available as per the earliest paintings of the place throughout the 20th century.

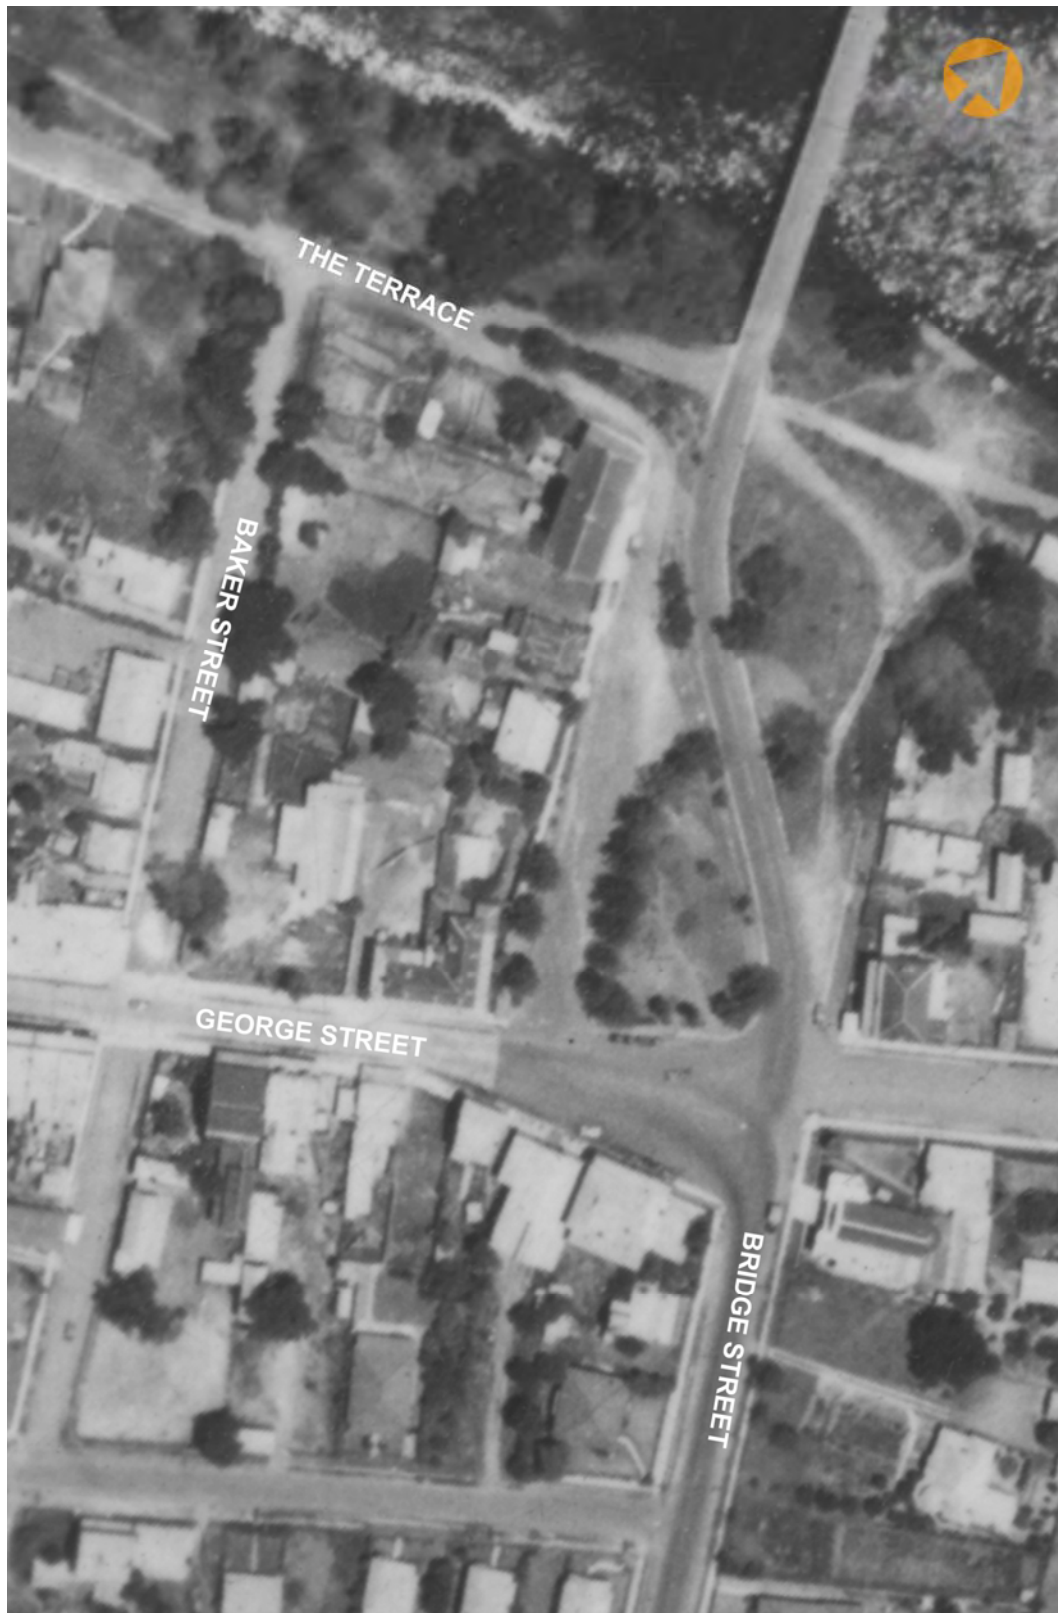
Figure 2. 83: 1947-51 aerial photograph. Note the alignment of the previous road through Thompson Square remains clearly visible in the tree plantings in the Upper Reserve. Source: NSW Spatial Services

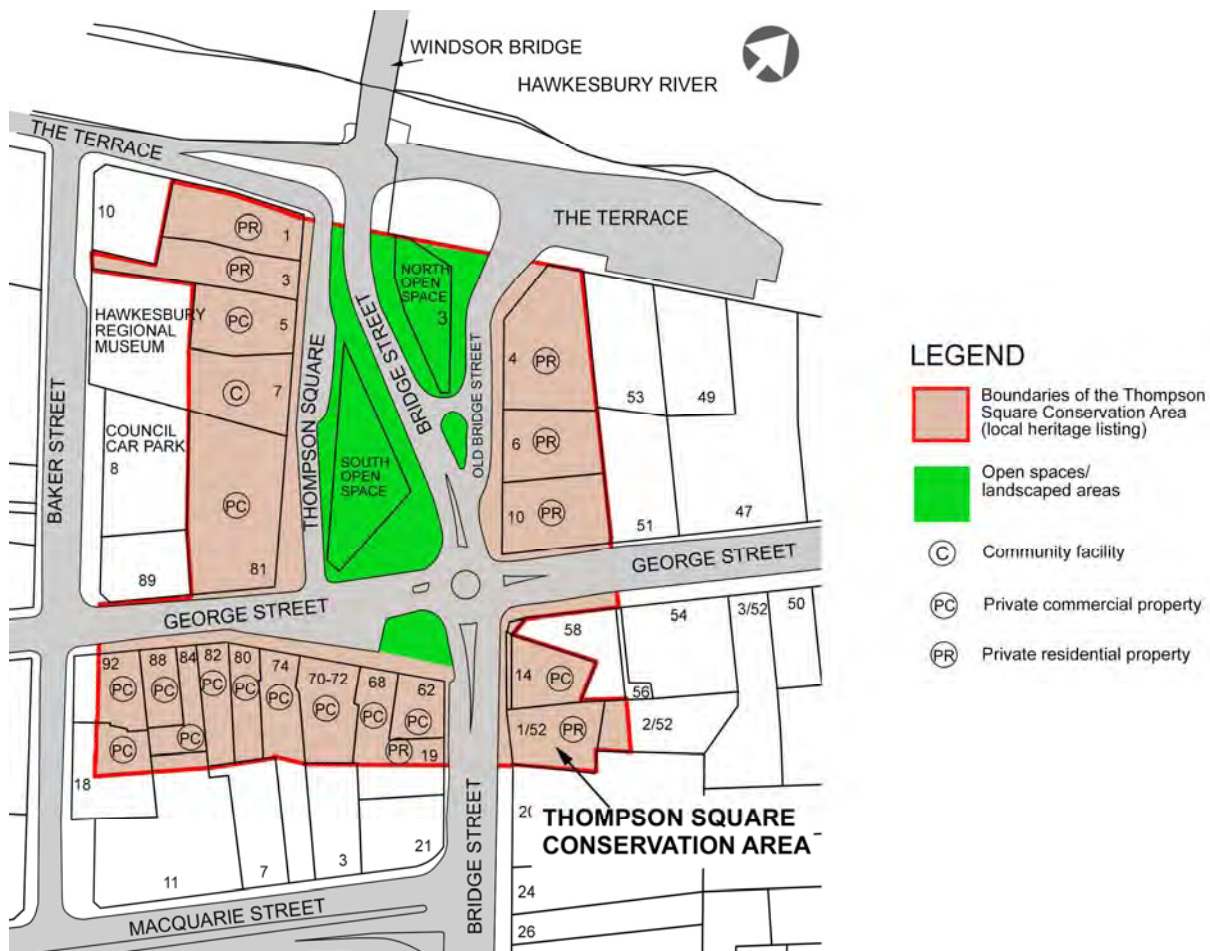
Figure 3. 1: The Study Area

The conservation area is centred around two open spaces bisected by Bridge Street: the north open space (lower reserve) and the south open space (upper reserve), which are together referred to as Thompson Square. The south, east and west boundaries of the conservation area are defined by a mix of commercial and residential buildings dating from the early 1800s through to the late 20th century, while the north boundary is defined by the southern alignment of the roadway running along the river foreshore, The Terrace.

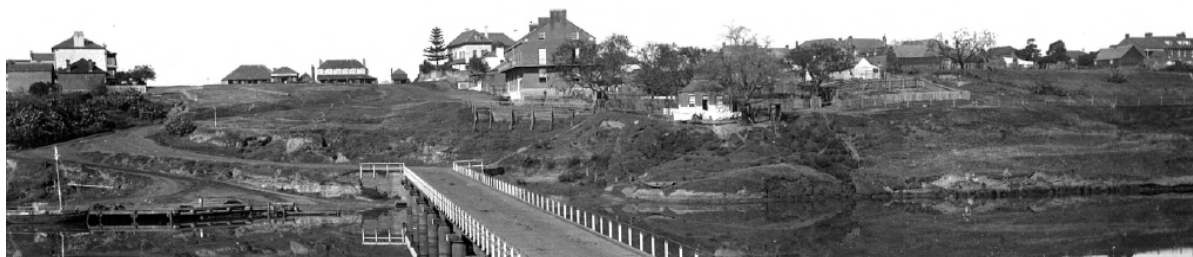
Figure 3. 2: Detail from 1879 photograph showing the condition of the river bank and terracing to Thompson Square. Source: SLNSW, GPO SH1658

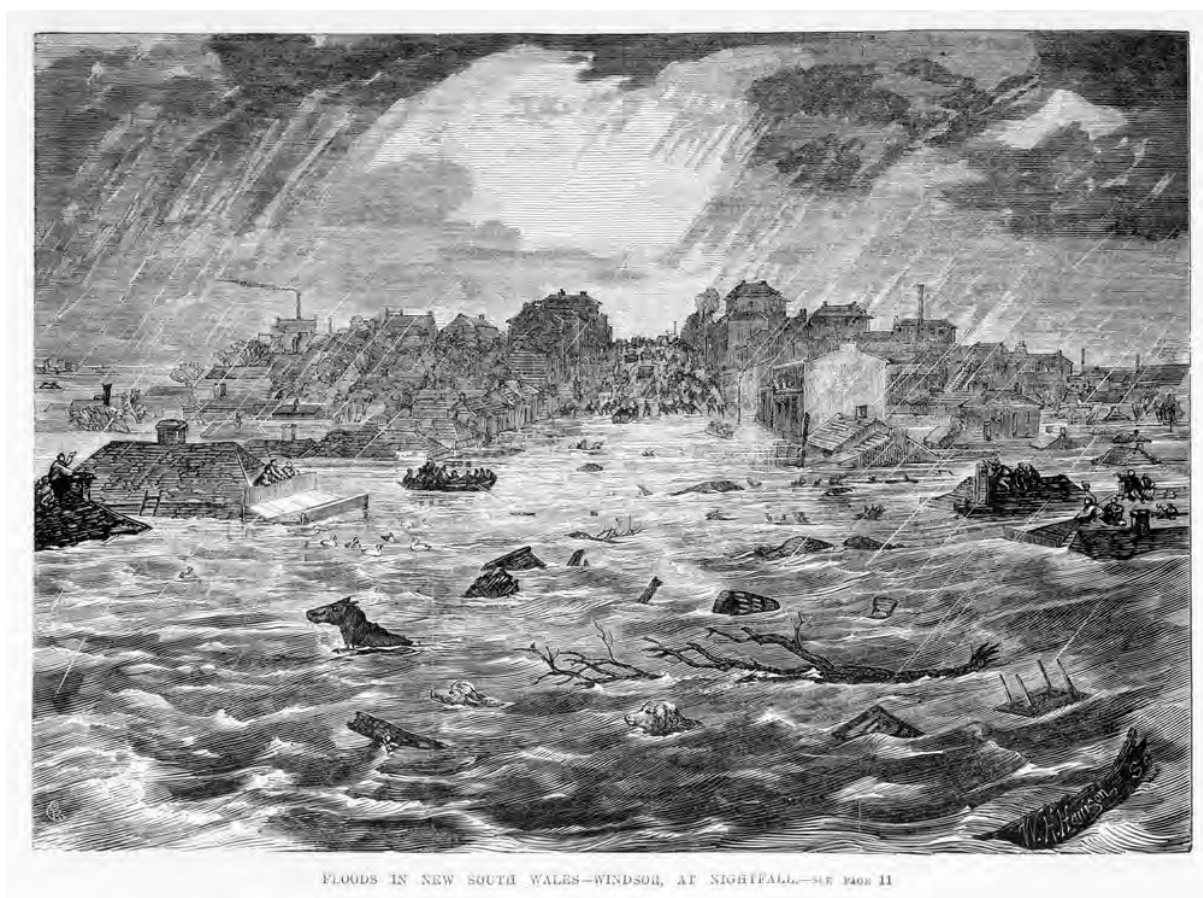
Figure 3. 4: Engraving by Oswald Rose Campbell entitled “Floods in New South Wales- Windsor, at Nightfall, dated 27th July 1867”. The image shows the flooding of the lower lands to the west of Thompson Square, looking west up George Street towards the top of the ridge. Source: State Library of Victoria, IAN27/07/67/8

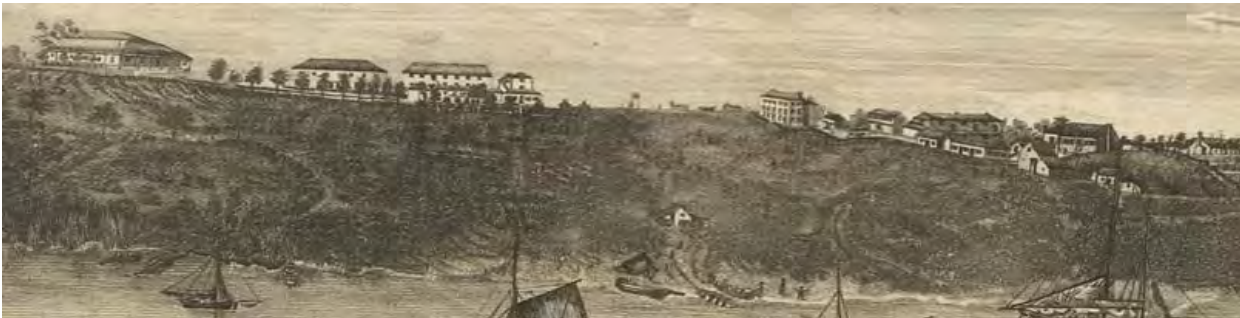
Figure 3. 6: Detail from P. Slaeger's 1813 engraving entitled A view of part of the town of Windsor in New South Wales, taken from the banks of the River Hawkesbury, showing the topographic character of the TSCA on the banks of the Hawkesbury River. Source: NLA

western side is generally more gradually sloped and less abrupt. This overall topographic character is still apparent in the present landscape with most of the Colonial era buildings on the western side of the square being sited over the intermediate terrace (see Figure 3.6).

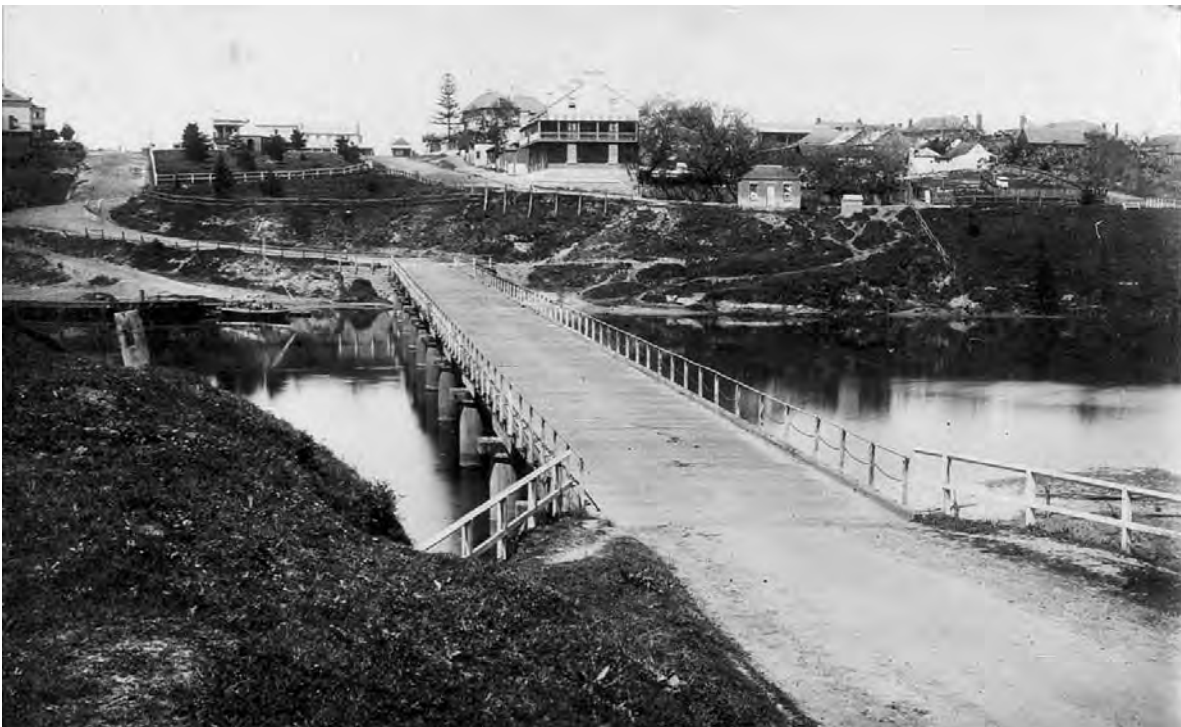
Figure 3. 9: c.1888 photograph of Thompson Square as seen from the northern bank of the Hawkesbury River. Note the absence of vegetation, although young trees are seen in the southern portion of the square. Source: SLNSW, At Work and Play - 04405

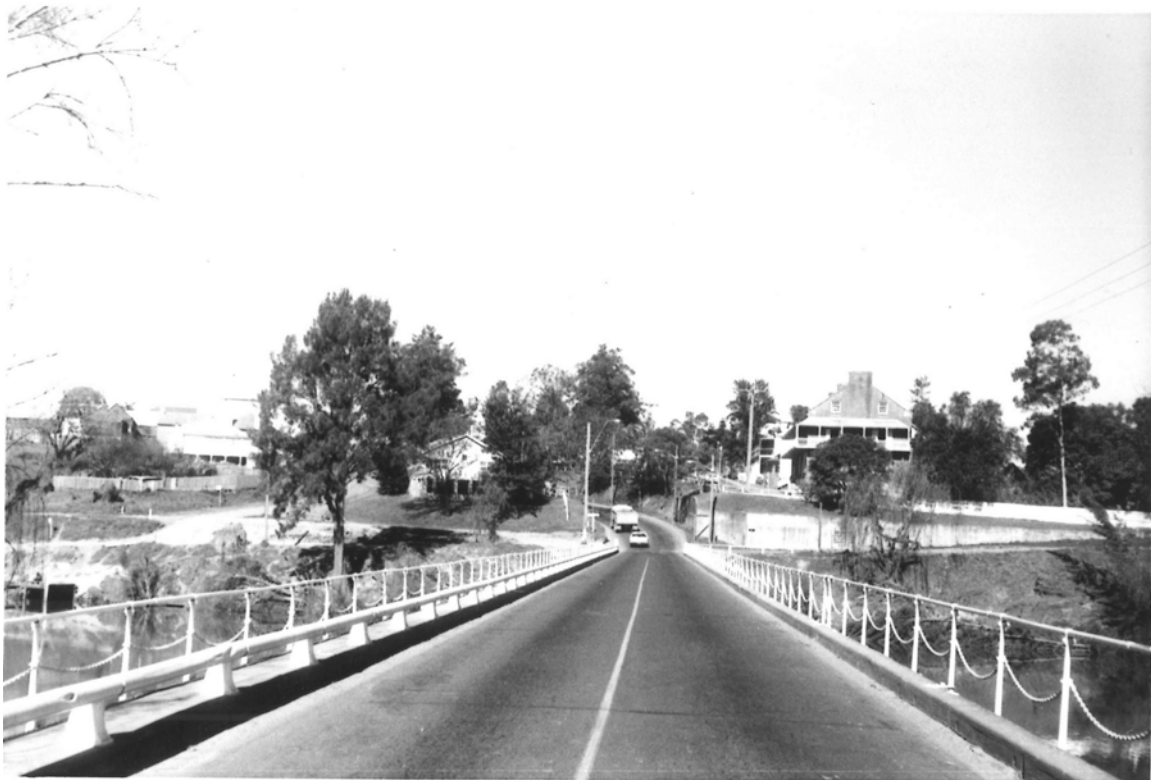
Figure 3. 10: 1975 photograph of Thompson Square as seen from the Windsor Bridge looking south. Note the relative absence of vegetation along the riverbank although the public reserves are quite well vegetated by this time. Source: LSJ archives

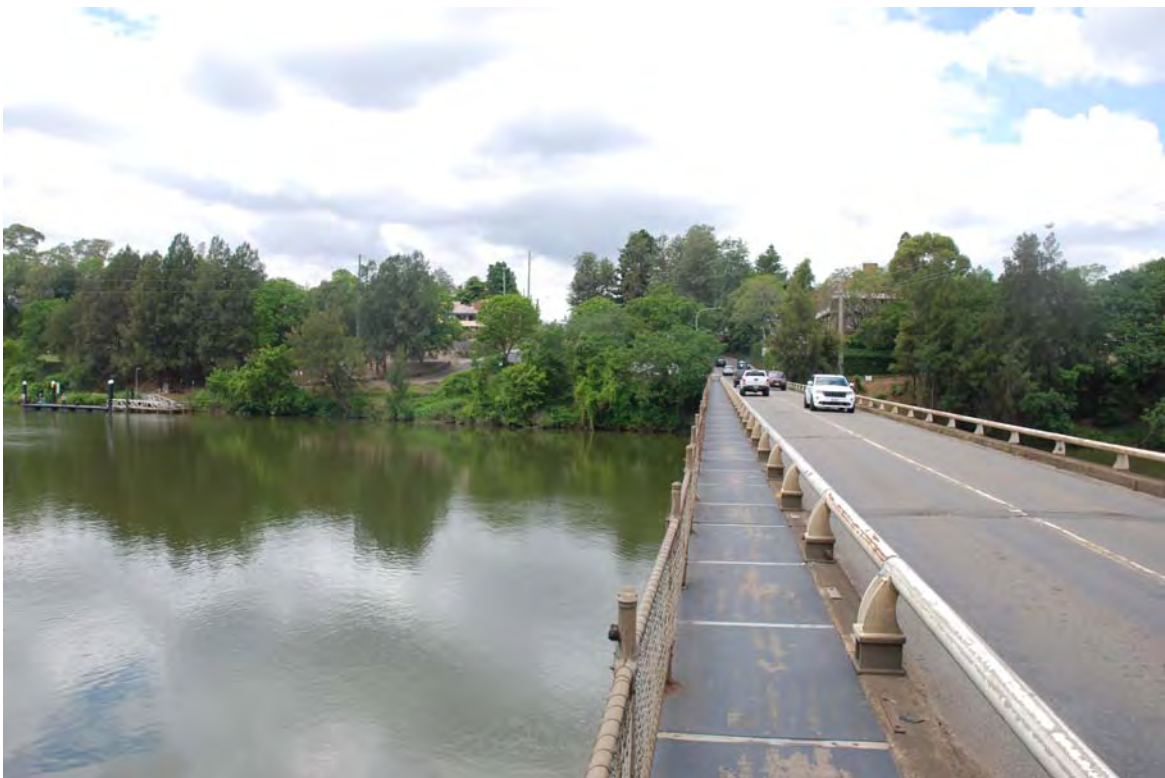
Figure 3. 11: Recent photograph of the view of Thompson Square as seen from the northern bank of the Hawkesbury River. Note the density of vegetation and maturity of trees prohibits clear views into the TSCA.

Other historic views which are still available include the views from the northern bank of the Hawkesbury River looking southwards to Thompson Square as illustrated in 1812 by G. W. Evans (see Figure 2.20) and following the construction of the Windsor Bridge in 1874, similar views were also documented by photographs. This documentary evidence illustrates the historic development of the buildings located on the east, west and southern boundaries of the place, as well as the alterations to the land form and road alignments through and around Thompson Square (see Figure 3.9). Today however, these views are somewhat obscured by the density of vegetation and tree growth along the bank of the river on the Windsor side area and within the open spaces of Thompson Square (see Figure 3.11).

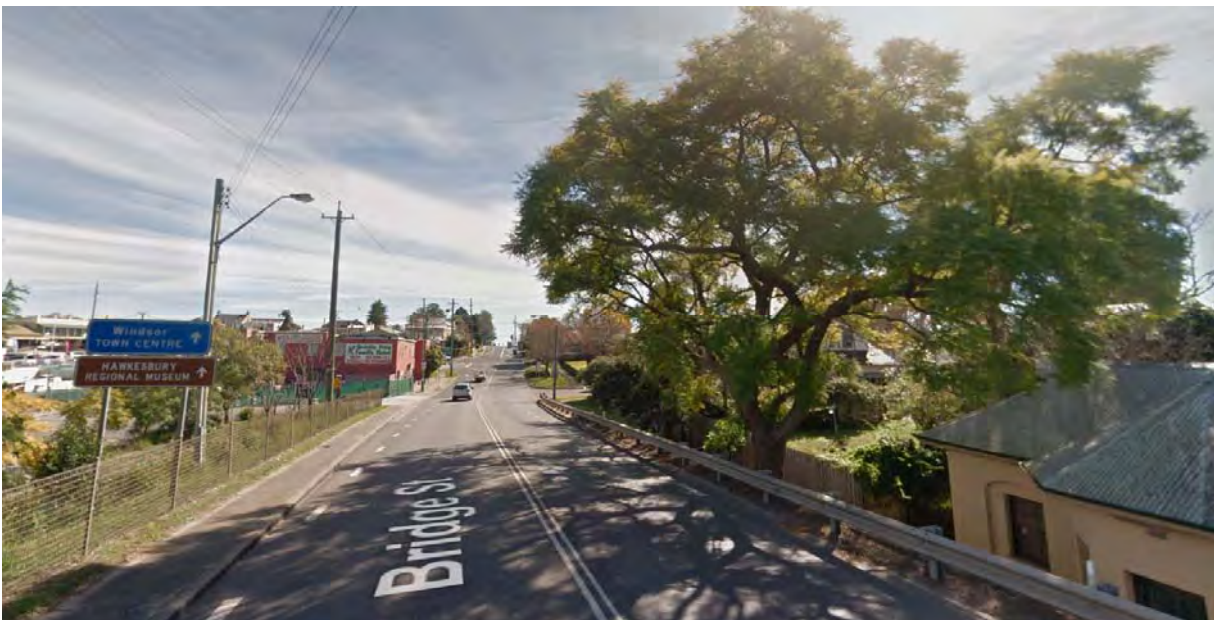
Figure 3. 13: Recent view looking up Bridge Street showing the clear view line to George Street at the top of the ridgeline. Source: GoogleMaps-street view, 2017

An opposite view of Thompson Square, as seen from McGraths Hill to the south, looking across the pasture lands and over South Creek to the southern side of the town as illustrated in 1824 by Joseph Lycett is not readily available due to vegetation and later development. Although the clear view up Bridge Street does remain (see Figure 3.13).

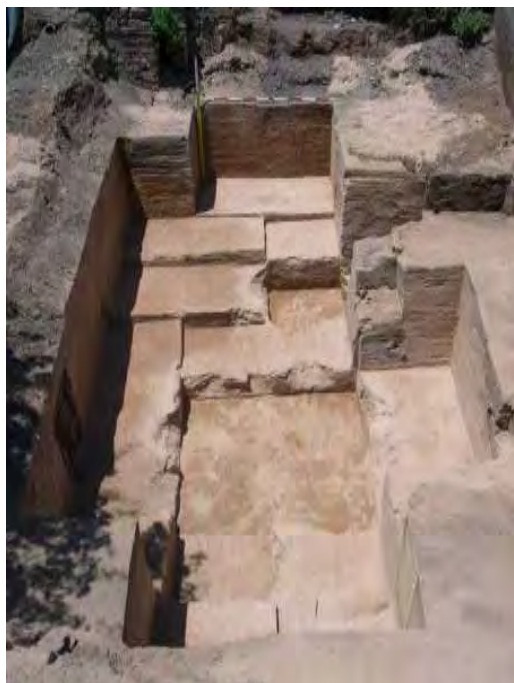
Figure 3. 35: Photographs of salvage excavation of the Hawkesbury Regional Museum site showing examples of intact archaeological deposit that can be expected beneath Windsor. Source: Austral Archaeology 2011: Figure 5.5

Excavation identified a deep (>1.8m) sandy-soil profile consisting of fine to medium grained and dull orange to bright reddish brown sand that overlay Londonderry Clay. The sand body may have begun developing up to 150,000 years ago¹⁴ and formed as a source bordering dune or sand sheet (the sand deriving from the river floodplain and channel) and appeared to extend along the high ground marked by George Street and to taper-off to the south east along Macquarie Street. Following the initial discovery of Aboriginal artefacts during historic-archaeological excavations at the site (that recorded AHIMS #45-5-3011), subsequent Aboriginal archaeological excavation of twenty-six contiguous sqm of deposit to depths of up to 1.8m resulted in the recovery of over 12,000 stone items from a sandy deposit believed to represent an intact Pleistocene (Aeolian) sand dune.

Artefacts were concentrated at depths below ground between 0.5m-0.8m but were also recovered as deep as 1.5m. Analysis of a sample of the finds showed mudstone (68.7%), followed by silcrete (13.8%) and quartz (7.6%) artefacts were dominant. Most finds were unmodified flakes, and no backed blades were recovered. Of four Thermoluminescence dates, one from the artefact bearing layers was dated to between 8,500 +/- 800 years to 33,900 +/- 1,700. It is a very broad range, but provides evidence of long term occupation of the river from the mid Holocene through to the late Pleistocene.

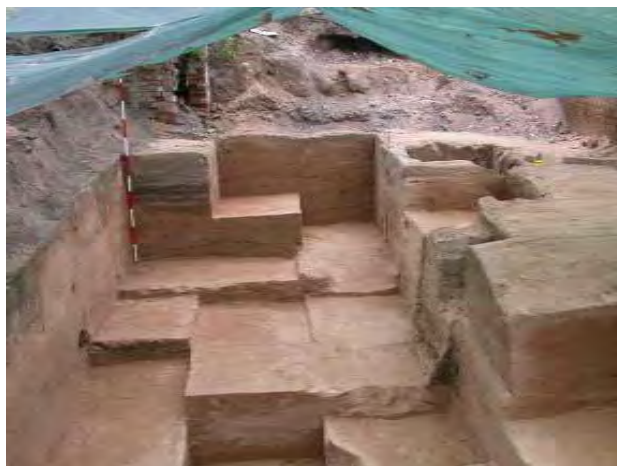
Figure 3. 36: Photographs of salvage excavation of the Hawkesbury Regional Museum site showing examples of intact archaeological deposit that can be expected beneath Windsor. Source: Austral Archaeology 2011: Figure 5.6.

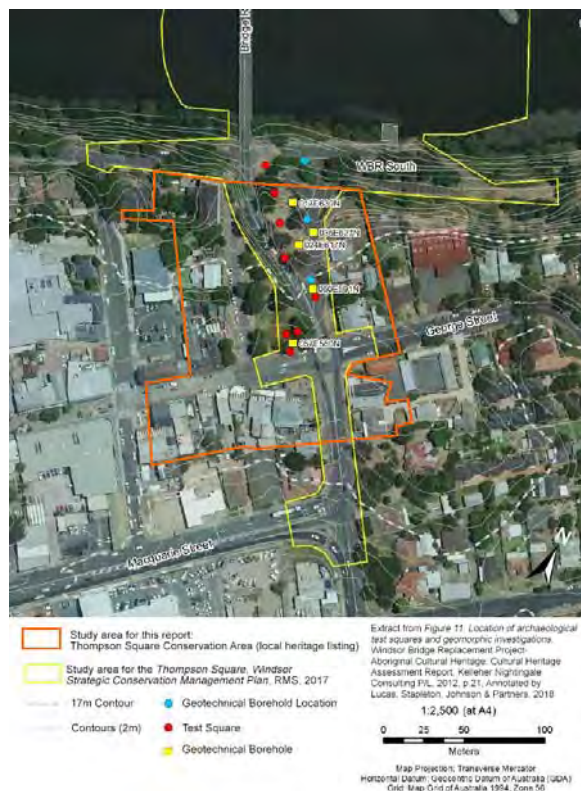
Figure 3. 37: Location of Aboriginal archaeological test squares within and adjacent to Thompson Square investigated in 2012.

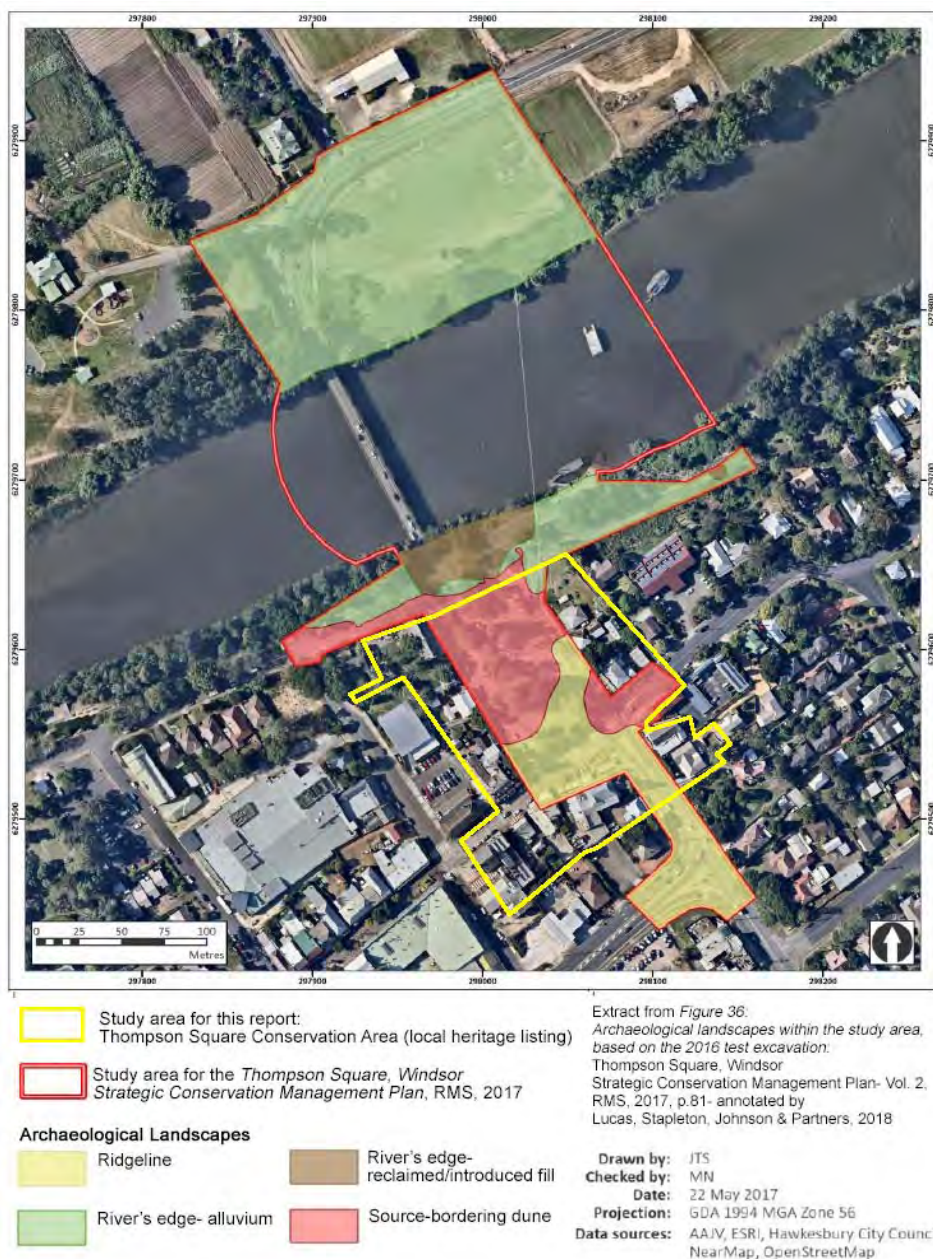
Figure 3. 40: Archaeological landscapes within the study area, based on the 2016 test excavation

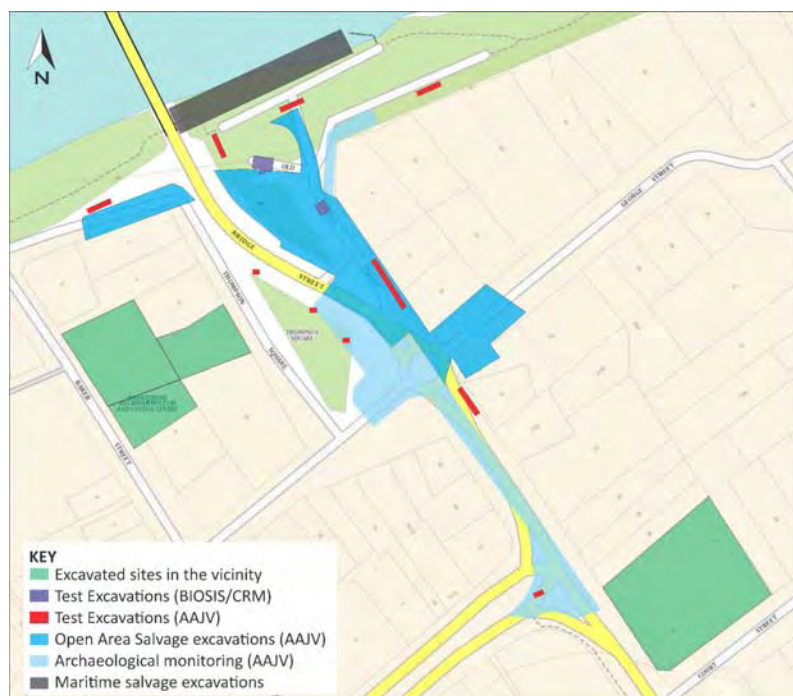
Figure 3. 42: Plan showing excavated sites (green) within the vicinity of Thompson Square, with testing programs in red and purple. The current excavation areas of the ongoing 2017-2018 RMS/AAJV salvage excavation program are marked here in blue, with grey indicating maritime salvage excavations. Source: base map-SIX MAPS (accessed 10/11/2017) with alterations by Casey & Lowe.

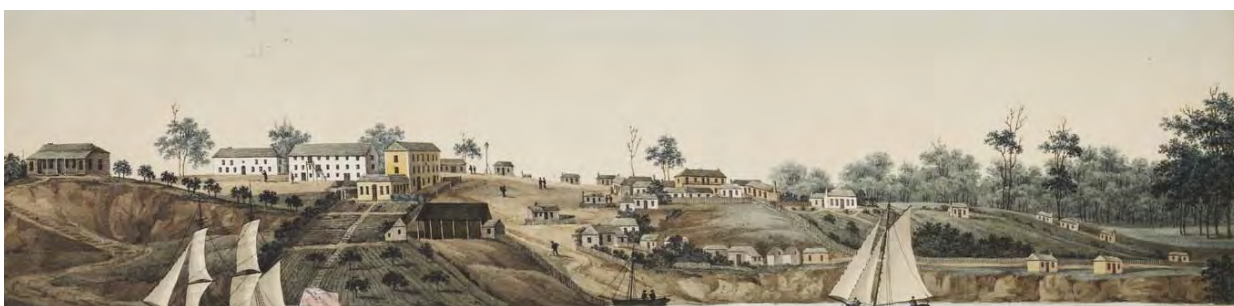
Figure 3. 43: Detail from G.W. Evan's 1809 painting of the “Settlement on the Green Hills” showing remnant woodland trees along the ridgeline. Source: ML, PXD 388 Vol 3, No 7

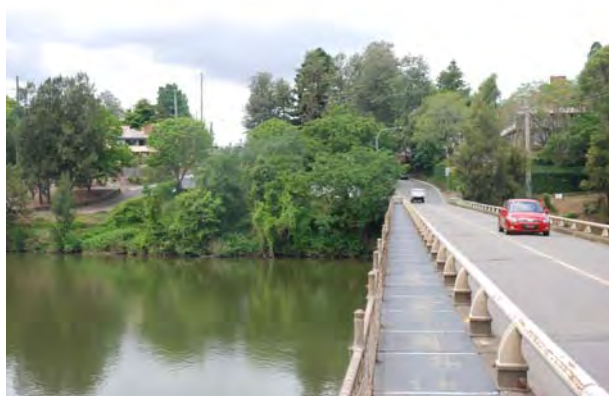
Figure 3. 44: Recent view of the northern side of the TSCA and the south bank of the Hawkesbury River showing existing vegetation.

Presently the river banks forming the lower end of Thompson Square include some locally indigenous species such as River Oak, White Cedar (*Melia azedarach*) and *Pittosporum undulatum*. There are also numerous exotic weed species present however some of these resemble desirable native species such that it is important to distinguish between them where any land management programs are undertaken. Some current bush regeneration work was noted at the north-eastern end of the study area (along The Terrace).

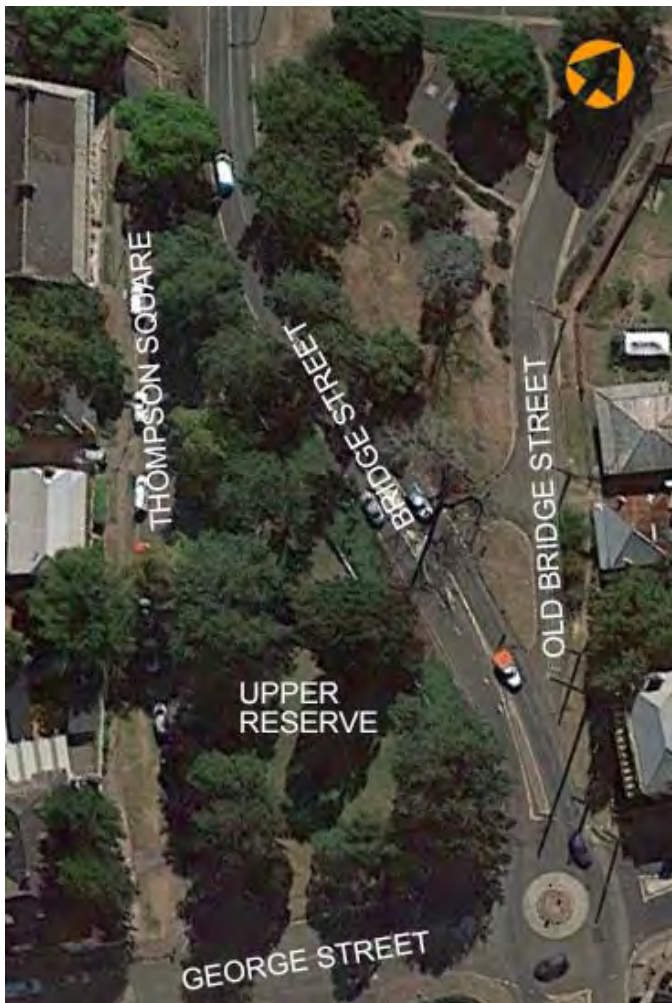
Figure 3. 54: Aerial view (c2015) showing the configuration of the upper reserve of Thompson Square. Source: NSW Spatial Services, SixMaps

Forming the larger portion of the original open ground of Thompson Square, the upper reserve (or south open space) is a triangular piece of land bounded by Thompson Square (the street) on the south-west, George Street on the south-east and Bridge Street on the north. As previously discussed the construction of the Bridge Street realignment in 1934 resulted in the current configuration of this space.

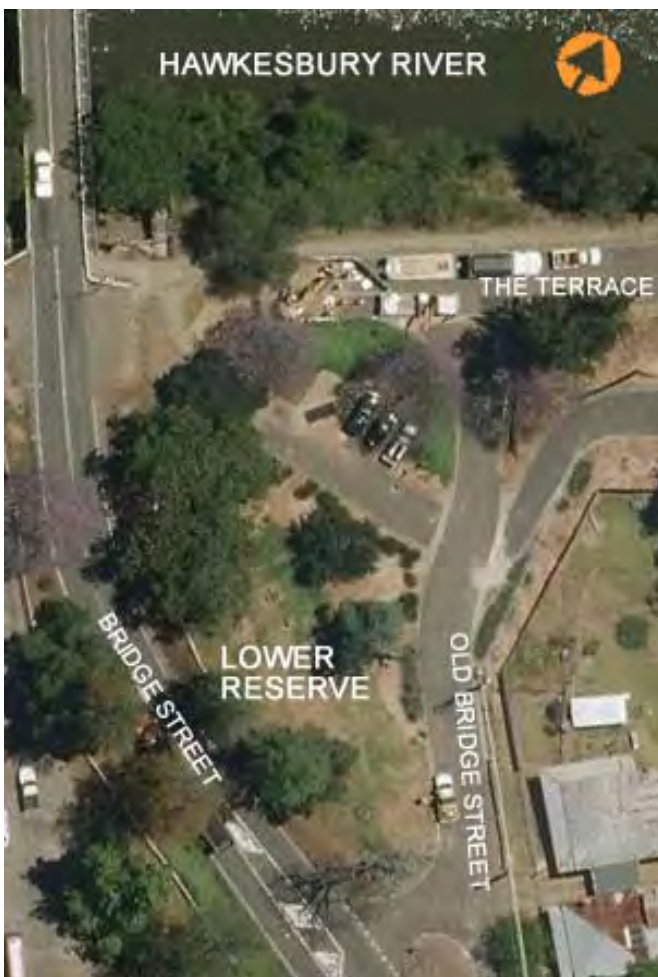
Figure 3.57: Aerial view (c2015) showing the configuration of the lower reserve of Thompson Square before the current archaeological investigations. Source: NSW Spatial Services, SixMaps

Photographic evidence including recent aerial photography indicates that the lower reserve consisted of an open grassed space with surrounding mature trees and car parking spaces located at its northern end (on the site of the former Hawkesbury Boat Club building, demolished in the 1980s). However, at the time of writing the report, this area was undergoing archaeological excavation in association with the proposed Windsor Bridge Replacement Project by the NSW government and access to this area was restricted.

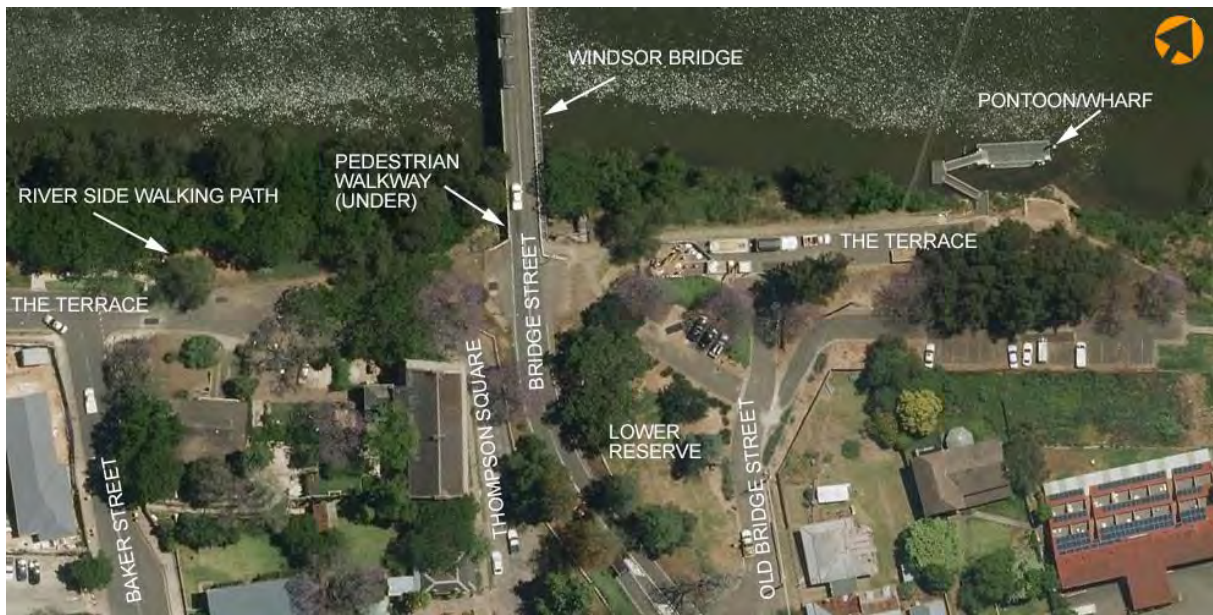
Figure 3. 66: Aerial view (c2015) showing the configuration of the lower reserve of Thompson Square before the current archaeological investigations. Source: NSW Spatial Services, SixMaps

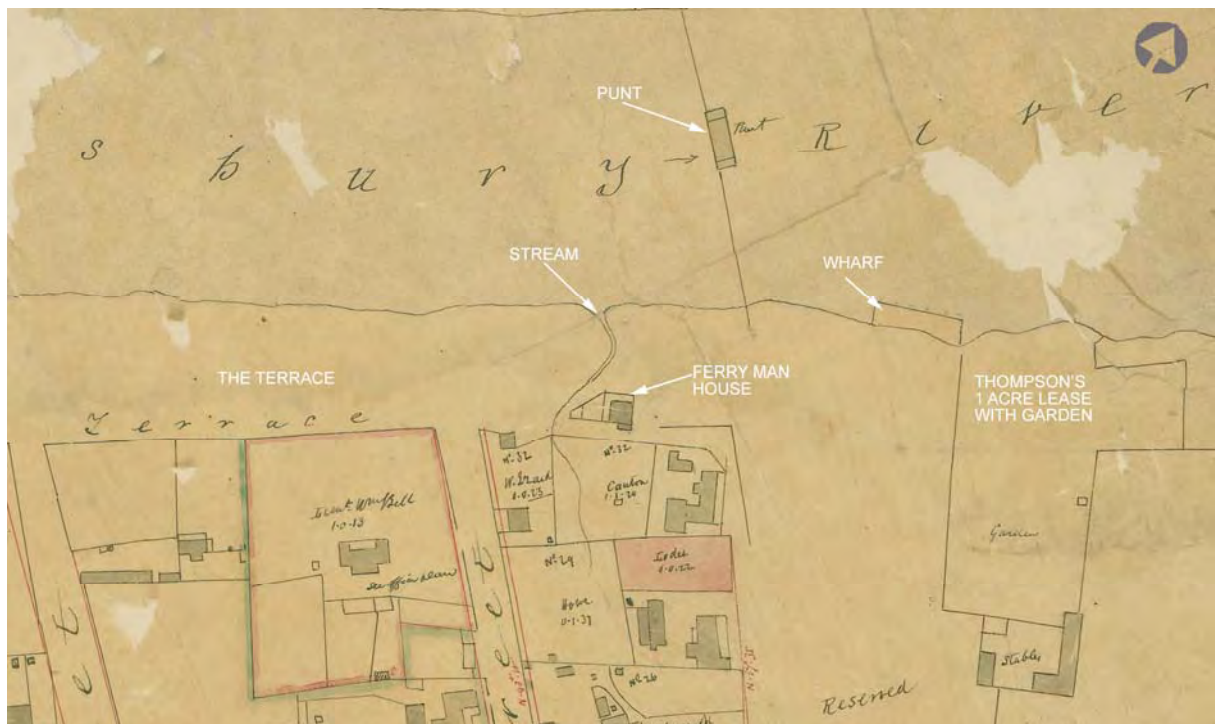
Figure 3. 67: Detail from 1840s plan of Windsor showing various features located along the riverbank lands. Source: SA Map 5968

Although not currently forming part of the TSCA, the river bank lands are an essential component of conservation area, being the *raison d'être* for the settlement of Green Hills and the eventual development of Thompson Square. The area is also notable for formerly containing some of the key historic features associated with the earliest development of Green Hills/Windsor, including the various wharves, the punt, the stream, connecting paths leading to the river and a portion of Andrew Thompson's garden (see Figure 3.67).

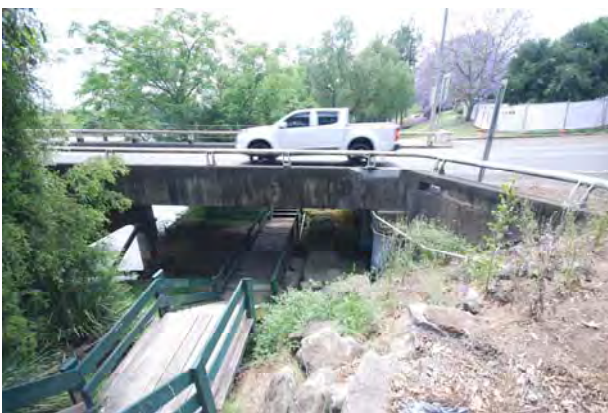
Figure 3.70: The timber pedestrian underpass providing access under the southern approach of the Windsor Bridge and connecting the western and eastern river bank lands.

To enable pedestrian access to both sides of the river bank, a pedestrian underpass has been constructed that runs under the southern approach of the Windsor Bridge. Currently in a poor condition, the underpass is accessed via timber stairs to both the east and west sides.
