Draft Thompson Square Conservation
Management Plan
Part 1

Thompson Square Conservation Area Windsor, NSW

Conservation Management Plan

Date:
7th August 2018

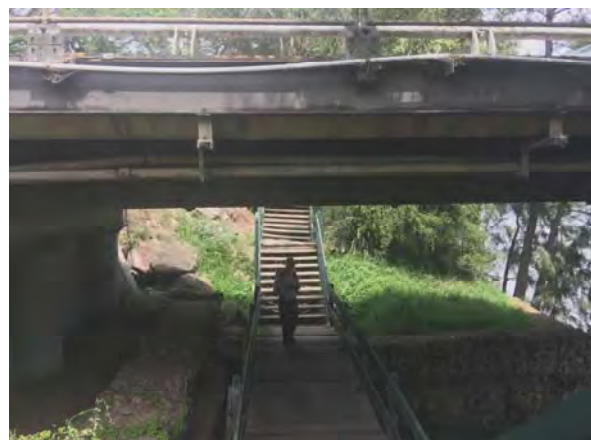
Figure 3.71: The pedestrian underpass under the Windsor Bridge.

To enable pedestrian access to both sides of the river bank, a pedestrian underpass has been constructed that runs under the southern approach of the Windsor Bridge. Currently in a poor condition, the underpass is accessed via timber stairs to both the east and west sides.

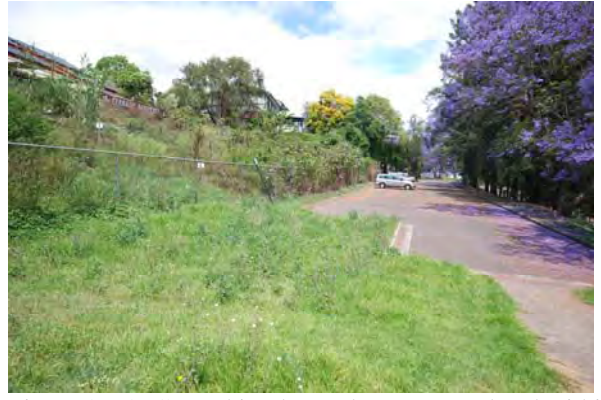
Figure 3.73: Carparking located at an upper level within the eastern River bank lands, emphasising the historic terracing of the land form.

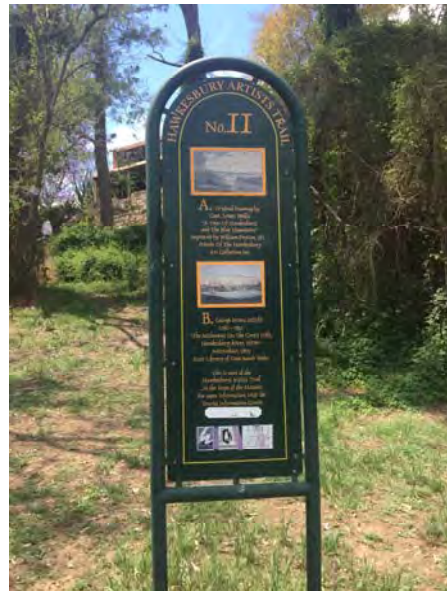
Figure 3.77: Signage for the Hawkesbury Artist's Trail located on the west river bank lands.

In contrast the eastern side of the river bank lands is not as well managed, although it also forms part of a walking trail: the Hawkesbury Artist's Trail (see Figure 3.77 below). Footpaths are concrete and access to The Terrace is via Old Bridge Street. On the southern side of this area the terracing of the land is formalised with The Terrace at a lower level and screened by landscaping is a bitumen paved carparking area located at the next step up. On the eastern side is also located a wharf structure with floating pontoon, jetty and intermediate landing platform (see Figure 3.75). Gabion walls line the river's edge, although weeds and other plants currently obscure these structures.

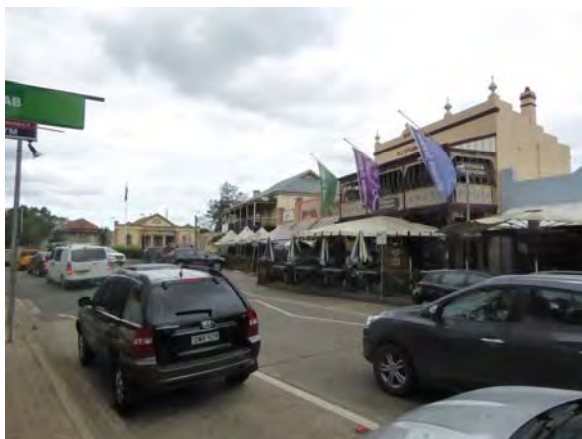
Figure 3. 78: View looking east down George Street with the School of Arts building in the distance.

At some stage utilities have been placed underground (assumed) and there are no longer utility poles lining the street as there once were (see Figure 3.78). Other than traffic signs and a small number of light poles, the western extent of George Street within the TSCA is uncluttered by ancillary services, which serves to emphasise the historic character of the street.

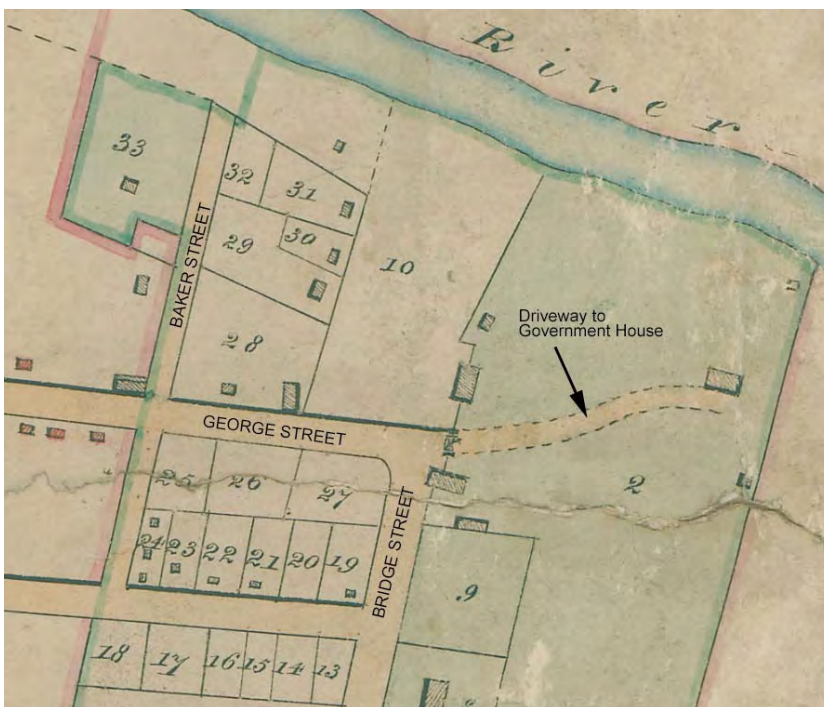
Figure 3. 82: Extract from 1827 survey plan by John Thompson showing location of the driveway from the George Street/Bridge Street intersection to the Government House. Source: SA Map SZ 526

The eastern portion of George Street was established in the mid-19th century following the removal of the government in the early 1840s and the subsequent sale and subdivision of the Government Domain lands. The alignment of the eastern portion of George Street roughly follows the line of the driveway that once led from the George Street/Bridge Street intersection westwards to Government House (see Figure 3.82).

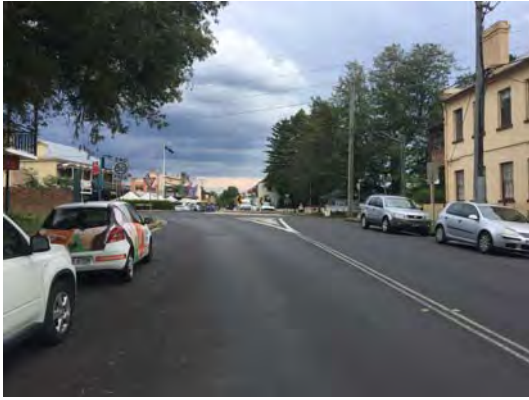
Figure 3. 83: View looking west to the intersection of George Street and Bridge Street. No. 10 Bridge Street is on the right of frame.

The eastern part of George Street that runs between No. 10 Bridge Street and the School of Arts Building is located within the TSCA. A quieter, residential street, this end of George Street contains a mix of mid to late 19th century buildings as well as 20th century houses and motel buildings. See Figures 3.83 and 3.84.

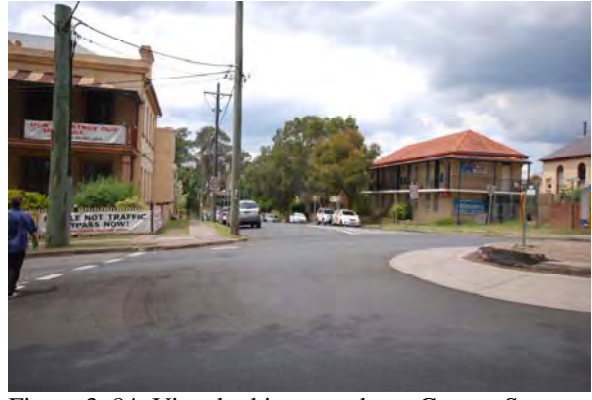
Figure 3. 84: View looking east down George Street from the intersection with Bridge Street. No. 10 Bridge Street is on the left of frame.

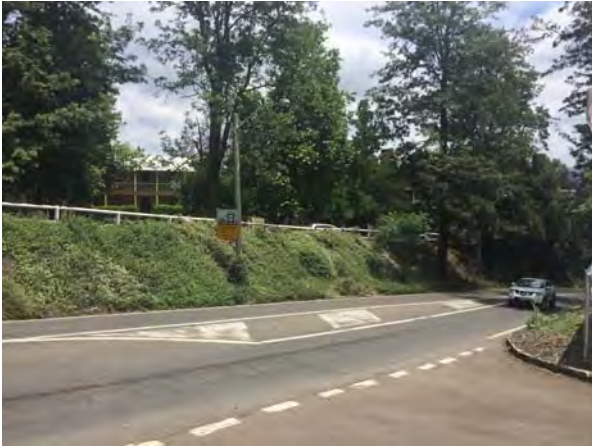
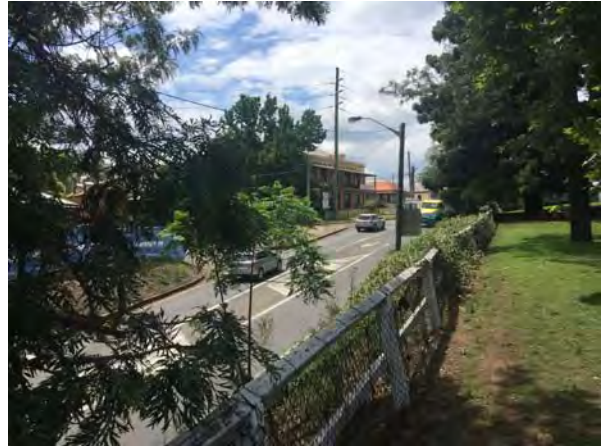
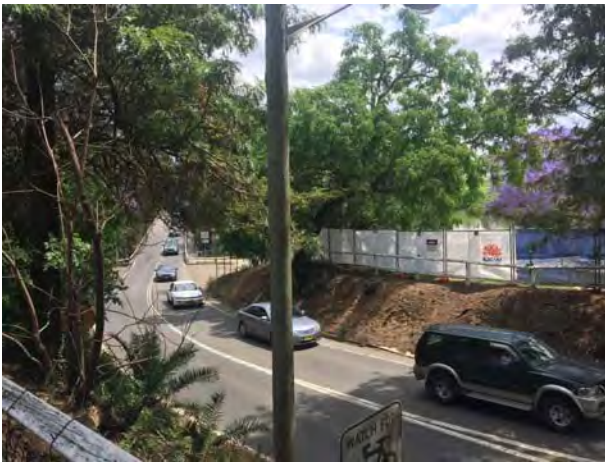
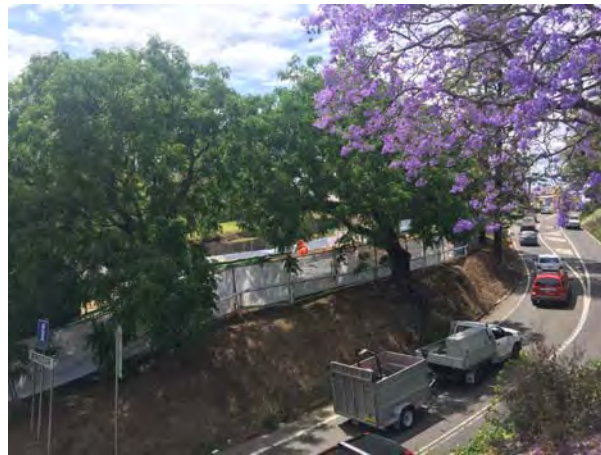
Figure 3.92: View looking northward down Bridge Street with the upper reserve of Thompson Square above (on the left).

Figure 3.93: View looking southward from the upper reserve of Thompson Square showing Bridge Street below.

Figure 3.94: View looking northward from the upper reserve of Thompson Square showing Bridge Street below approaching the bridge. The lower reserve surrounded by fencing is seen in the background.

Figure 3.95: View looking southward from the upper reserve of Thompson Square showing Bridge Street below with the lower reserve surrounded by fencing opposite.

The northern section of Bridge Street is a busy, two-lane through road, cutting across and through Thompson Square. The current configuration of Bridge Street from George Street to Windsor Bridge dates from the 1930s and the construction of the roadway resulted in substantial excavation works so that today the upper and lower reserves of Thompson Square are now located above the level of the roadway with an embankment on either side of the road.

The current form, alignment and the heavy use and speed of the traffic along the roadway creates a strong division through the centre of the TSCA, separating the eastern and western sides of the conservation area and physically bisecting the open spaces of Thompson Square. Bridge Street presents as an anomaly within the historic context of the TSCA and is out of character with its immediate surrounds.

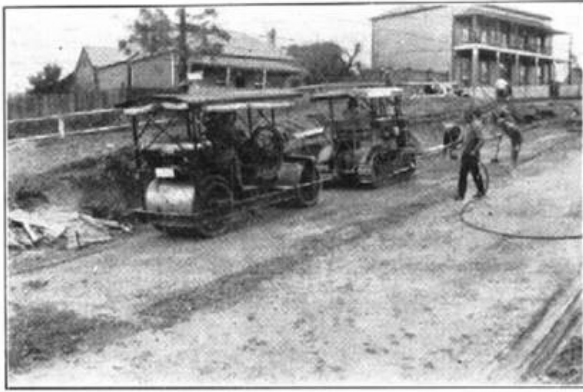
Fig. 1. Connecting road Windsor. Tractor towing roller.

Figure 3. 98: 1935 photograph of Old Bridge Street being realigned following the construction of the Bridge Street extension leading to the bridge. Source: Main Roads Journal May 1935 Vol XII No 1

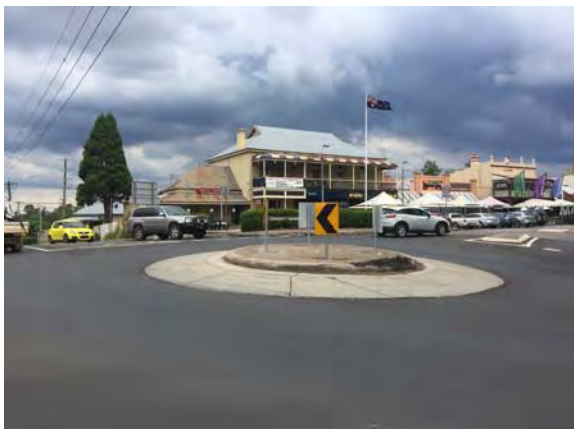
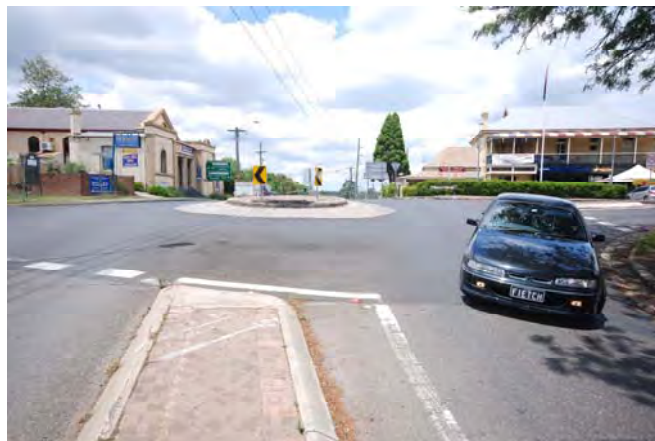
Figure 3. 103: George Street and Bridge Street intersection with George Street in the background.

Figure 3. 104: George Street and Bridge Street intersection with Bridge Street in the background.

Defined by a round-about, brick paved with sandstone kerbing and concrete apron. This feature appears to be a recent addition (post 1979) to the TSCA, not being visible in the historic aerial photograph of 1979 (see Figure 2.85), but it is visible in the 1991 aerial photograph (see Figure 2.86).

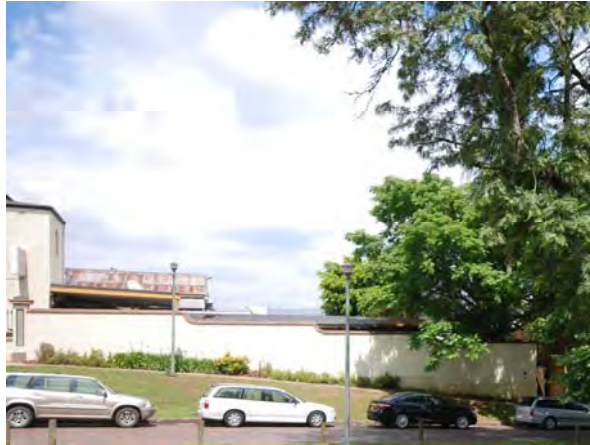
Figure 3. 106: c1819 wall on the eastern boundary of the Macquarie Arms Hotel.

An important feature of Thompson Square, the street and the landscape area, is the 1819 brick wall that defines the western boundary of the Macquarie Arms Hotel site. Although located on private land, it is a distinctive and rare colonial feature of the TSCA and one that delineates the eastern edge of the public space of Thompson Square (see Figure 3.103). It also displays a small plaque noting the height of the 1867 flood (see Figure 3.147).

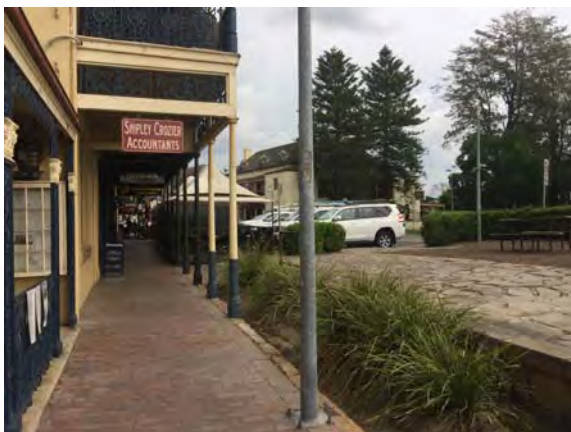
Figure 3. 109: The brick paved footpath with sandstone kerb along the southern side of George Street from No. 62 George Street to No. 74 George Street

Footpath materials are equally varied with brick paving being used along George Street from the corner of Baker Street, along most of the Thompson Square (street address), along the southern end of the upper reserve, around 10 Bridge Street and in front of 62-72 George Street. Concrete paving is used for the footpath around the School of Arts building and down the southern arm of Bridge Street while a bitumen path is used from 82 George Street to Baker Street. As if to highlight its historical importance within Windsor and the earliest surviving building of Thompson Square, a section of sandstone flagging is used along the eastern frontage of the Macquarie Arms Hotel.

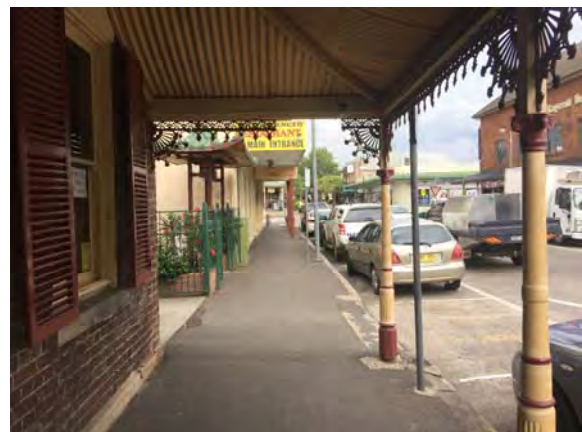
Figure 3. 110: The bitumen footpath with sandstone kerb along the southern side of George Street from No. 80 George Street and continuing westwards to Baker Street.

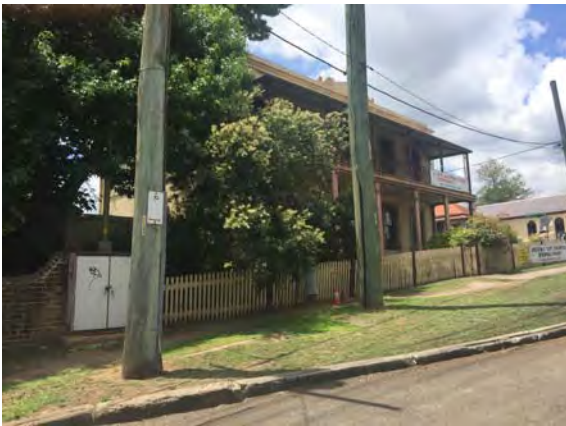
Figure 3. 111: The unformed footpath along the eastern side of Old Bridge Street with grassed verge and sandstone kerbing.

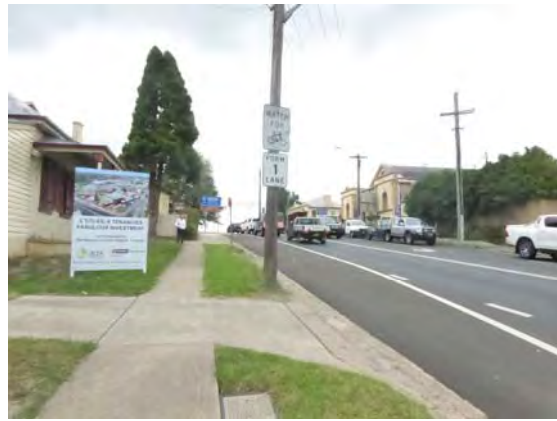
Figure 3. 112: The traditional concrete footpath, kerb and guttering and verge treatment found along the southern end of Bridge Street.

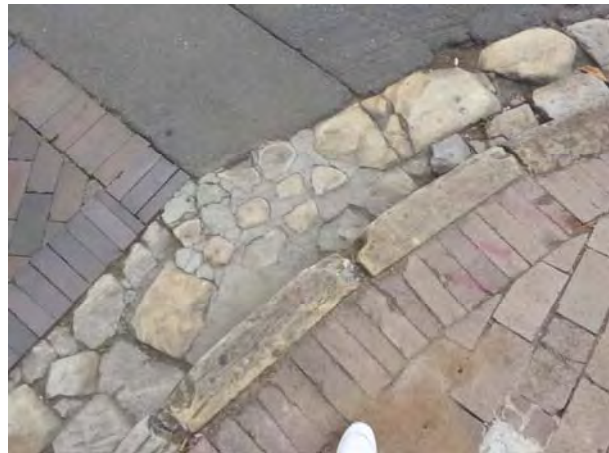
Figure 3. 114: Detail of sandstone kerb and edging with brick footpath paving at the junction of George Street and Thompson Square.

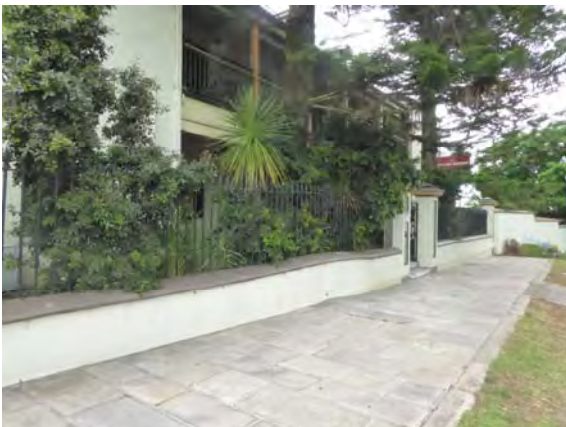
Figure 3. 115: Sandstone paved platform located on the eastern side of the Macquarie Arms Hotel.

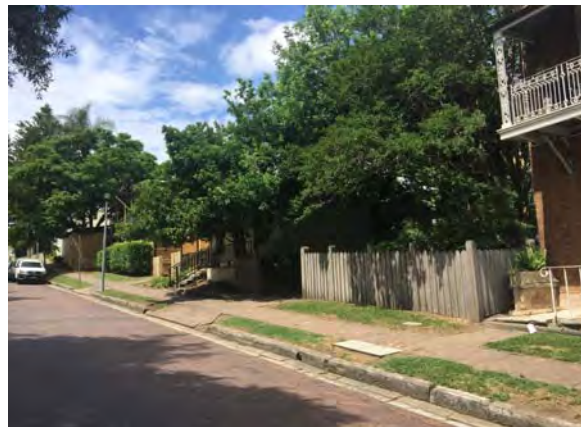
Figure 3. 116: View of brick paved footpath, road and driveways with sandstone kerb and guttering to the street known as Thompson Square.

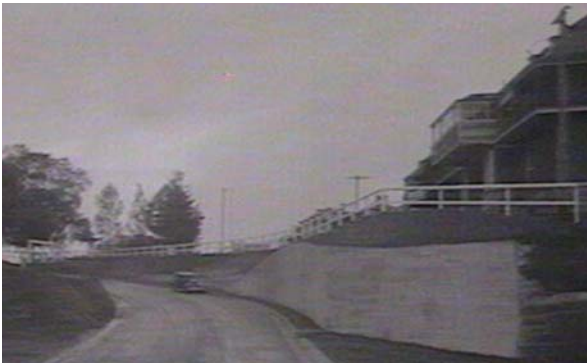
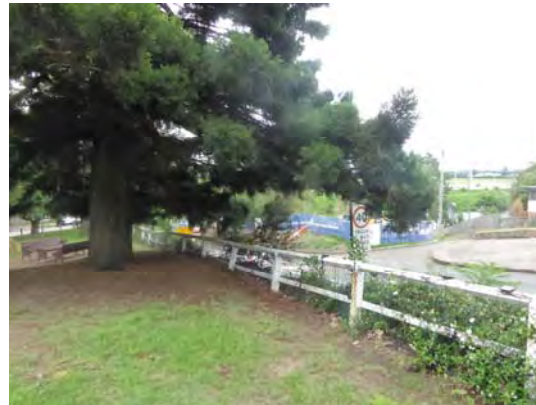
Figure 3. 121: 1934 photograph of the eastern boundary of the Upper Reserve with white timber post and rail fencing, as seen from Bridge Street below the road cutting. Nos. 1-3 Thompson Square is seen to right of frame. Source: SLNSW, GPO d1_01880h

Figure 3. 122: Existing white timber fencing on the eastern side of the Upper Reserve.

Very little fencing is found throughout the TSCA other than a few fences to the front gardens of the residential properties along Old Bridge Street and the street known as Thompson Square. Other fencing is located along the eastern boundary of the Upper Reserve and extending to the northern end of Thompson Square (the street), above the Bridge Street road cutting and this appears to be a remnant of 1930s fencing (see Figure 3.121). This is a robust white-painted, canted top-rail fence with a mid-rail and wire.

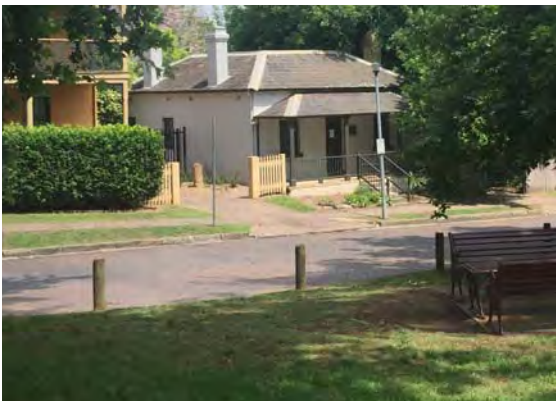
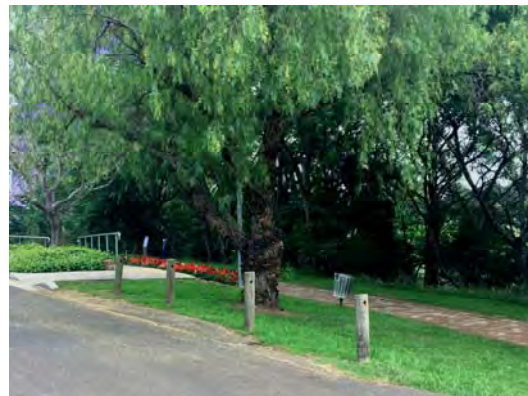
Figure 3. 123: Existing timber posts on the western edge of the Upper Reserve.

Figure 3. 124: Existing timber posts along The Terrace in the River bank lands.

Other safety provisions include treated pine posts of recent construction that are located along the western edge of the Upper Reserve and along the northern edge of The Terrace in the east River bank lands.

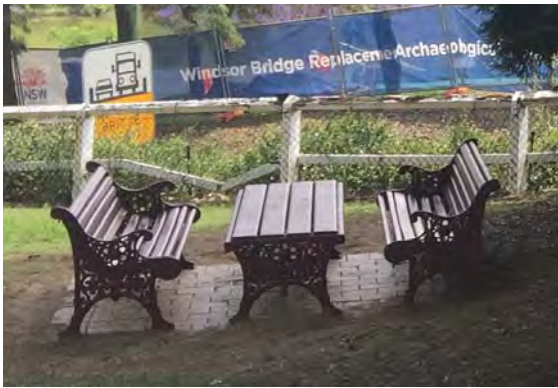
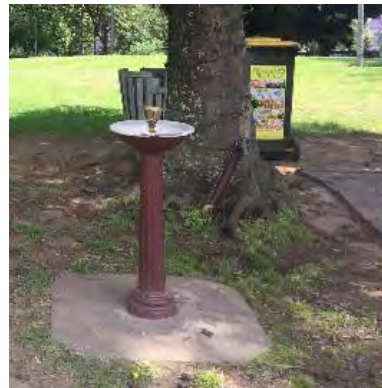
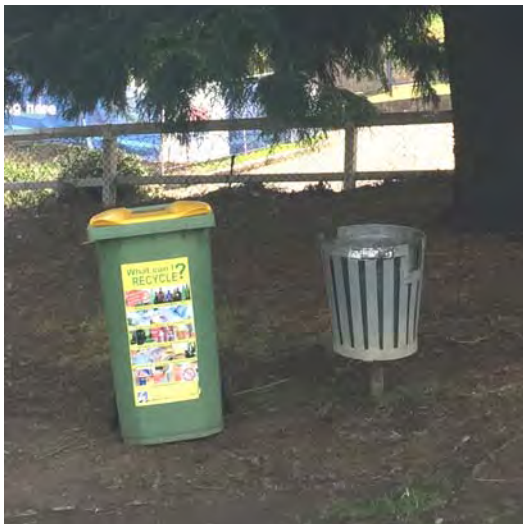
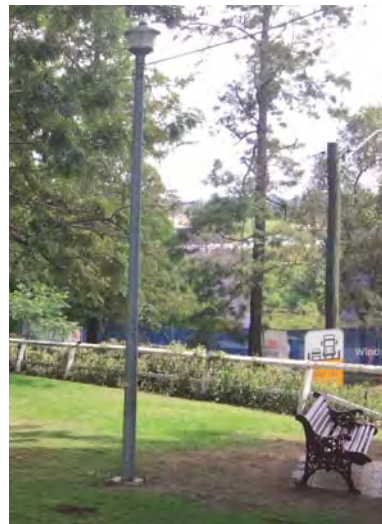
Figure 3. 125: Table and benches in the Upper Reserve on brick paved platform.

Figure 3. 126: Water bubbler in the Upper Reserve of Thompson Square

Figure 3. 127: Typical garbage bin in the Upper Reserve with accompanying “wheelie bin”.

Figure 3. 128: Light pole located throughout the Upper Reserve.

In the Upper Reserve, street furniture has an old fashioned or “heritage” character consisting of benches and tables in timber and ornate cast iron that is Victorian in style. Benches, tables and bubblers are painted in ox blood red and are placed on brick paved or concrete platforms. Light poles within the Upper Reserve are in steel, of a small scale and also have an old fashioned appearance.

It was also noted that the existing small garbage receptacles located in the Upper Reserve were not adequate as a standard council “wheelie bin” for recycling purposes was also placed next to the bins.

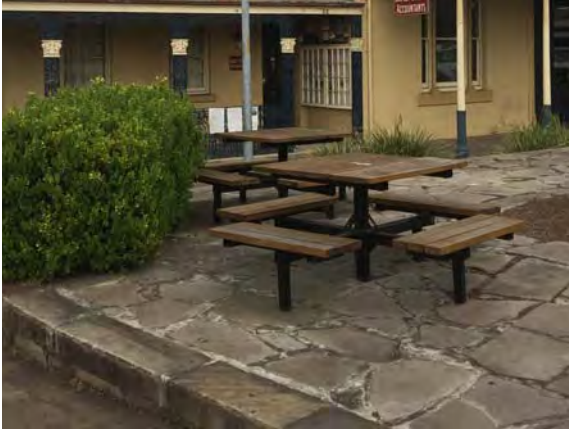
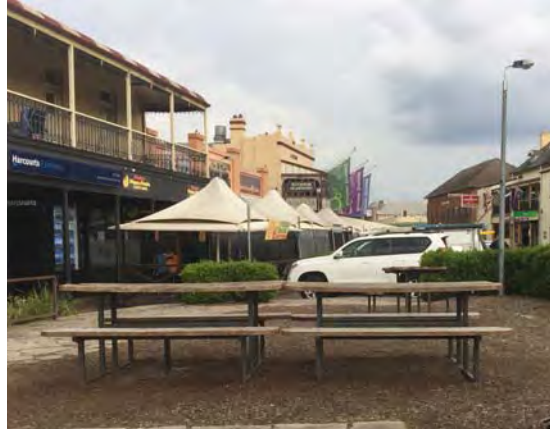
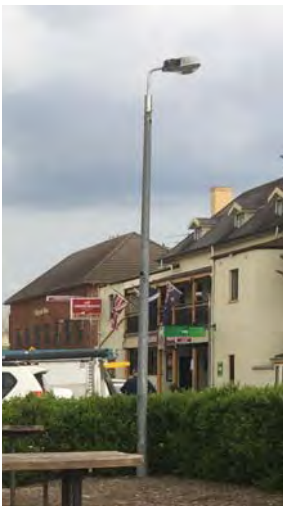
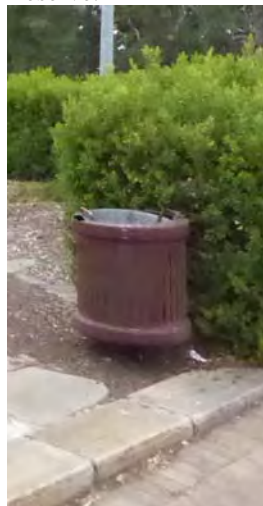
Figure 3. 129: Timber and metal fixed tables and benches in the Commemorative Reserve.

Figure 3. 130: A slightly different style of timber and metal tables and benches in the Commemorative Reserve.

Figure 3. 131: Street light located in the Commemorative Reserve providing light to George Street.

Figure 3. 132: Garbage receptacle located in the Commemorative Reserve.

Street furniture to the Commemorative Reserve is contemporary in style and form and there are two slightly different styles of tables and benches in this area, although both are in timber and metal. A small garbage receptacle is also located in this area that is similar to those found in the Upper Reserve. The light pole is actually a standard street light, providing light to the adjacent roadway of George Street.

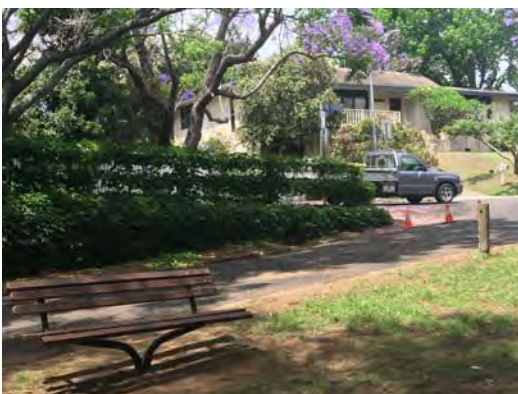
Figure 3. 133: The timber bench located in the River bank lands.

There are no public facilities such as garbage bins or benches located along the footpaths within the TSCA. However there is a single timber and metal bench and a metal garbage bin (similar to those found in the Upper Reserve) located in the River bank lands to the west of Bridge Street, adjacent to the walking track along the river's edge.

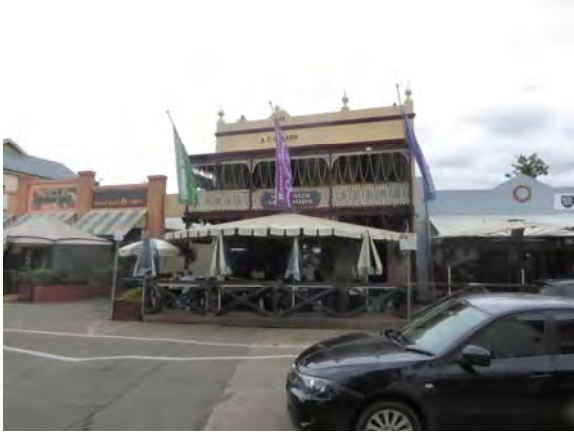
Figure 3. 134: The A.C. Stearn building with seating area in the road reserve and banners attached to the balcony.

Located on the southern road reserve of George Street in front of Nos. 64 to 80 George Street are a series of raised timber platforms with timber balustrading and umbrellas accommodating tables and chairs for the adjacent cafes and food outlets. The umbrellas and shade sails are considered to be intrusive as they obscure views of the street frontages of the historic buildings, restrict views from the footpaths to the surrounding conservation area and detract from the overall 19th century character of the street. Banners attached to the balcony of the A.C. Stearn building (No. 80 George Street) also obscure views of the street frontage of this building.

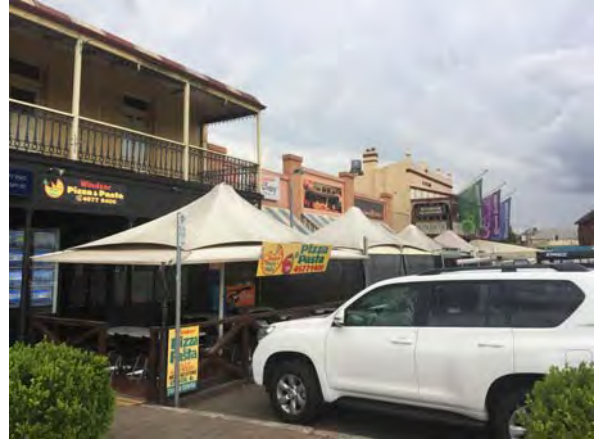
Figure 3. 135: View of Nos. 64 to 72 George Street with seating areas and umbrellas located in the road reserve obscuring views of the street frontages of the building.

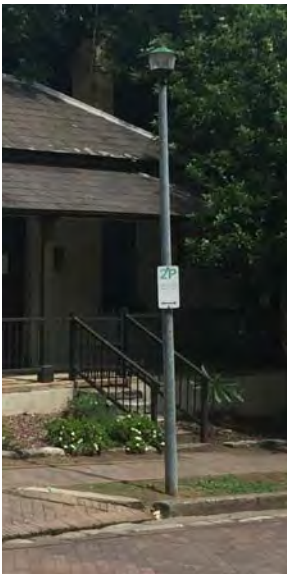
Figure 3. 137: Street light located along Thompson Square and to the western side of the River bank lands. This type of light is also located throughout the Upper Reserve.

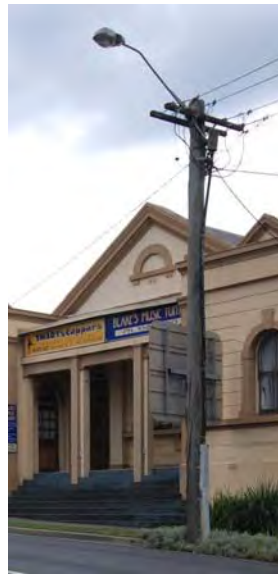
Figure 3. 138: Utility pole with street lighting found along Old Bridge Street and south Bridge Street.

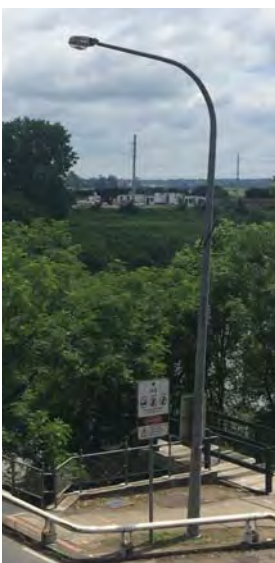
Figure 3. 139: Street light found along north Bridge Street leading to Windsor Bridge.

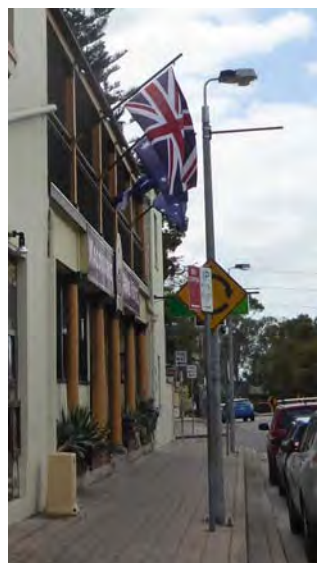
Figure 3. 140: Street light found along both sides of George Street

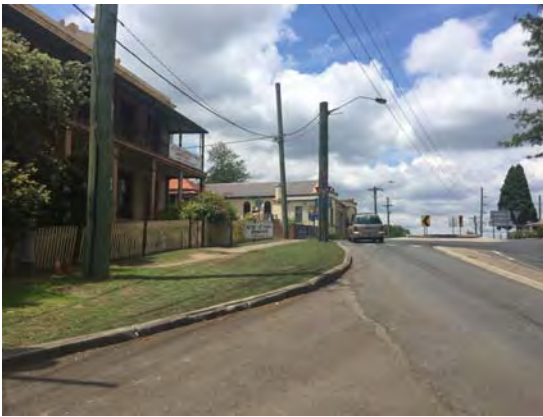
Figure 3. 145: View of Old Bridge Street looking south with utility poles and street lighting.

The exception to this is south Bridge Street and Old Bridge Street which are still lined with hardwood utility poles with street lighting and services wires.

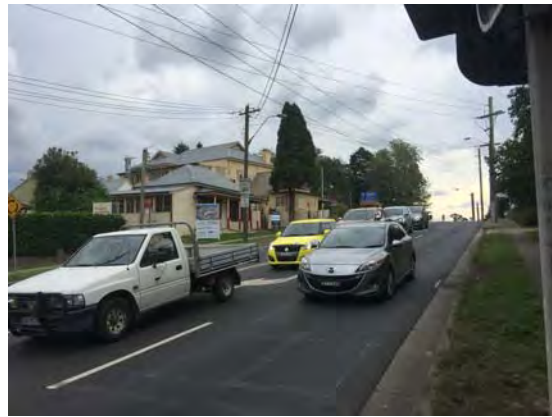
Figure 3. 146: View of south Bridge Street looking north with utility poles and street lighting.

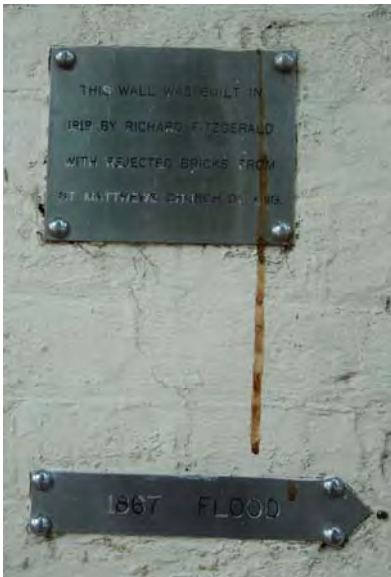
Figure 3. 150: Memorial No. 3- two plaques located on the eastern face of the east boundary wall of the Macquarie Arms Hotel fronting Thompson Square. The upper plaque notes that the wall was constructed in 1819 by Richard Fitzgerald by rejected bricks from St. Matthew's Church. The lower plaque identifies the height of the flood waters in the 1867 floods.

The Norfolk Island pines are important visual markers for both the hotel and the broader conservation area. The tall brick boundary wall built in 1819 from bricks rejected from St Matthew's Church has a marker showing the level of the 1867 flood (see Figure 3.150 above).

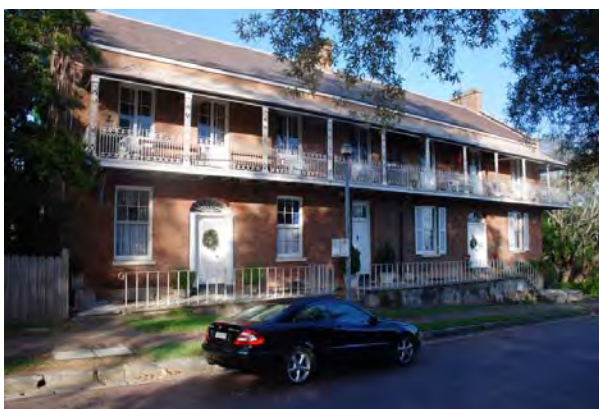
Figure 3. 156: The Doctor's House, 1-3 Thompson Square

The building dates from 1844 and was used as a post office from 1851 to 1855.⁸⁵ It was drawn by William Hardy Wilson in 1912, who also did a measured drawing of one of the front doors. It was measured and drawn by architect Allan G Robertson during the 1930s. In the 1950s a service wing was added by architect Morton Herman and the southern house was converted into flats with the addition of a door in the middle aperture of the front elevation.

The Doctor's House strongly defines the north-western corner of Thompson Square and makes a major contribution to the place's architecture character by virtue of its built quality and intactness.

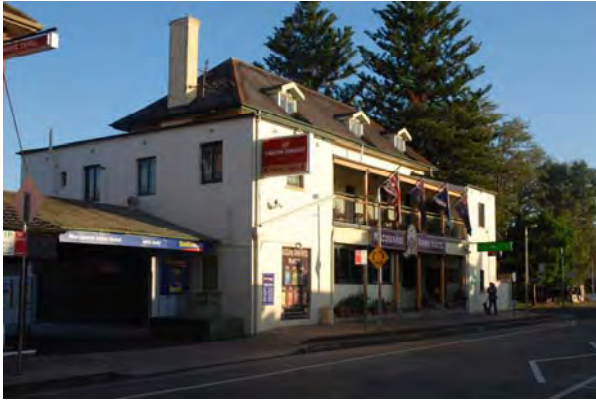
Figure 3. 164: George Street frontage of the Macquarie Arms Hotel

Located on an original land grant made to Richard Fitzgerald in c.1811 by Governor Macquarie, the public house was constructed by Fitzgerald at the direct request of Macquarie. An early painting shows it to have originally had face brick walls. The rendered finish may have been added some years later along with the ground floor verandah and corner box rooms. Its colonial appearance is somewhat spoilt by the first floor verandah and unsympathetic dormer windows but the quality of its original joinery, including two front doors and staircases, is outstanding.

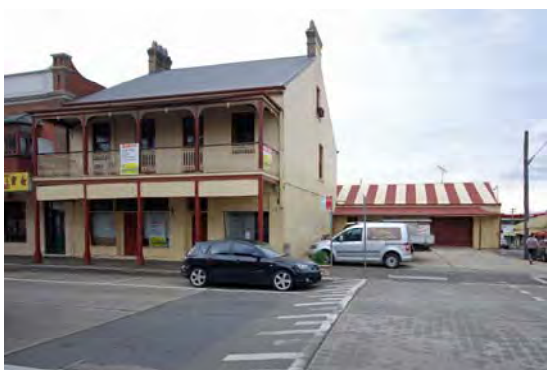
Figure 3. 168: No. 92 George Street

A rendered two-storey commercial building with a corrugated roof, rendered chimneys with slate pots and a reconstructed two-storey verandah. The building appears to date from the last half of the 19th century but the joinery in the front and side elevations is from the mid- or late-20th century. Photographic evidence from 1979 shows that the first floor has been completely reconstructed and that the roof was previously tiled or slated. Enough remains of the form and exterior detailing (e.g. chimneys, fenestration pattern) to make the main building worthy of retention as part of the Conservation Area.

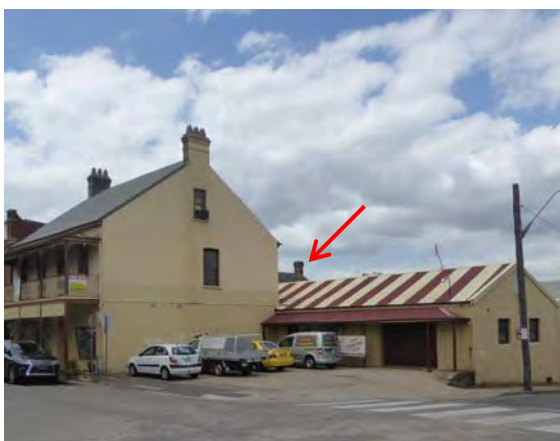
Figure 3. 170: The single storey garage adjoining No. 92 George Street. The roof and chimney of another (older) building on the site is also visible behind the main building (indicated with an arrow).

The allotment also contains a mix of later addition buildings including a single storey building set behind the main building which appears to be of mid-20th century origin but it has also been reconfigured to evoke an earlier period. There is also evidence of an earlier building located on the site that has been enveloped by the other buildings on the site, although its roof form and chimneys are visible from Baker Street. Further research is required to establish the history of this building and its intactness.

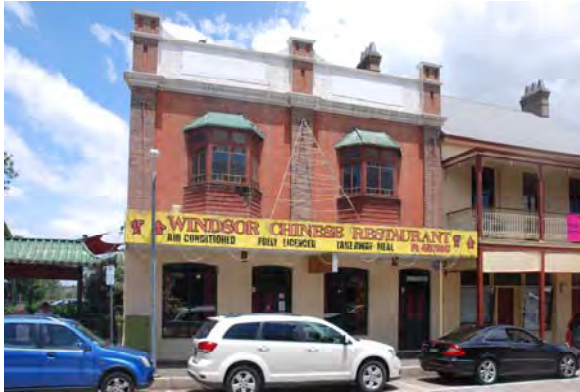
Figure 3. 171: No. 88 George Street

A two-storey parapeted commercial building c.1910. The first floor is of polychrome brick and render with bay windows and is intact. The ground floor has reproduction shopfront and front door joinery. The cantilevered awning is a mid-20th century replacement of the original lean-to awning which had columns. The building is of a scale compatible with George Street, the first floor adds interest and overall it contributes to the streetscape although it is marred by the unsympathetic awning and advertising.

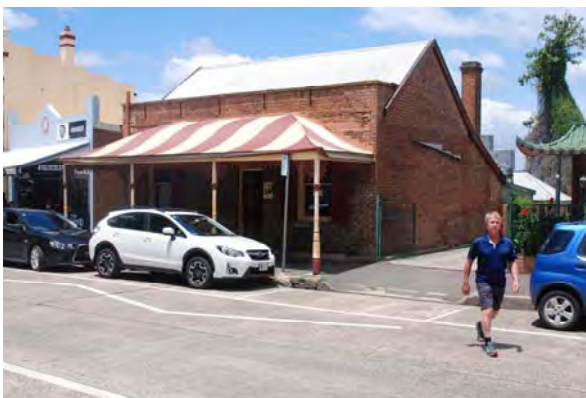
Figure 3. 173: No. 82 George Street

Brickwork in the front wall is laid in English bond, while the side wall is Flemish bond. There are stone sills and a stone plinth. The front door is not considered to belong to this building. Windows may have original frames and later sashes. To the rear is a detached dilapidated weatherboard outhouse.

Thanks to its intact envelope and reconstructed front verandah unobstructed by commercial advertising, this building makes an important contribution to this part of the south side of George Street. It deserves to be preserved.

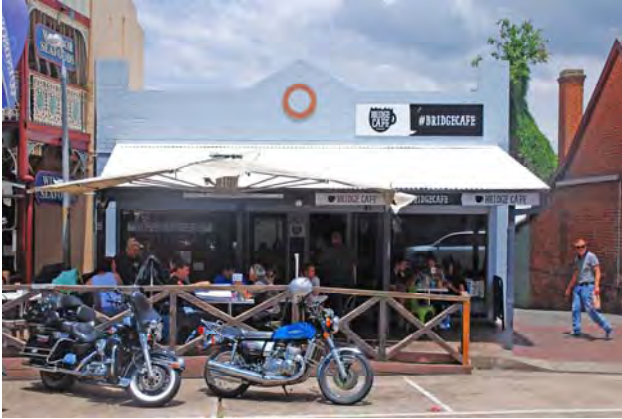
Figure 3. 175: No. 80 George Street

This painted brick single-storey commercial building is a relatively recent infill development with a simple parapet and lean-to verandah facing the street. It is sympathetic to the character of the Thompson Square Conservation Area but is somewhat spoilt by a dilapidated umbrella structure added to the edge of the verandah.

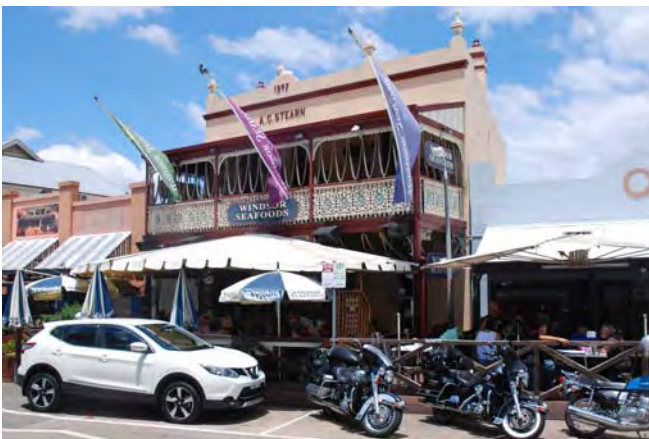
Figure 3. 177: The A.C. Stearn building

Originally single storey with a steep hipped roof behind a parapet with curved awning facing the street, this building was extended to two storeys in 1907. Currently the building functions as Windsor Seafoods. The earlier urns and lion on the parapet were salvaged and reused at that time. The two-storey timber and cast-iron verandah and first floor joinery were reconstructed in the 1980s by Clive Lucas.

There is a large permanent umbrella structure affixed to the ground floor verandah which obscures the shop front from the street and detracts from the otherwise valuable contribution this building makes to the Conservation Area.

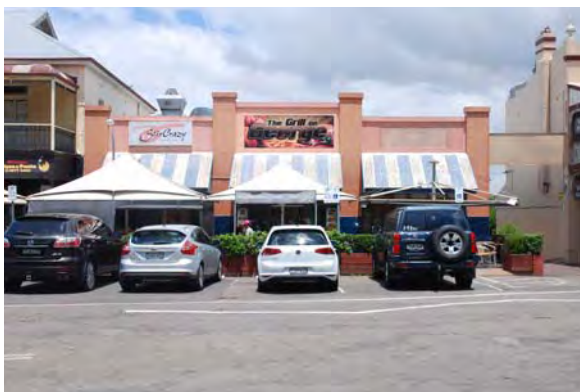
Figure 3. 179: No. 70-72 George Street

This single storey commercial building was once a service station. It has a rendered parapet with a dado of blue glazed tiles and cantilevered lean-to awnings designed in a neo-Federation style somewhat at odds with the 1923 date of the building.

The façade is of a sympathetic scale and colour with the Conservation Area and the building adds to the variety and interest of the streetscape. The three, free-standing, fixed umbrella structures in front detract from the building.

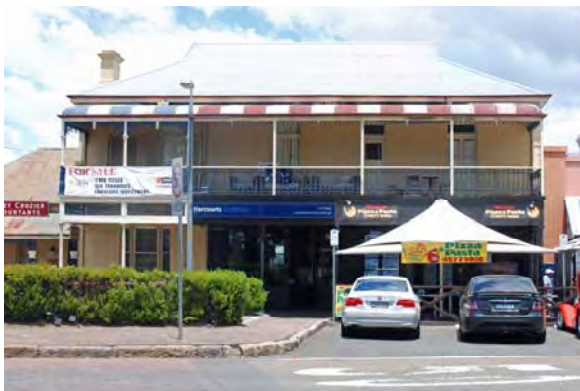
Figure 3. 181: No. 64-68 George Street, street frontage

The two-storey verandah, first floor French windows and shop fronts of both buildings are all reconstructions carried out in the 1980s by Clive Lucas. A difference in the colour scheme and detailing of the reconstruction distinguishes the two sections.

The building makes a valuable contribution to the southern side of Thompson Square but the rear carpark and unattractive enclosed verandah are visible from Bridge Street.

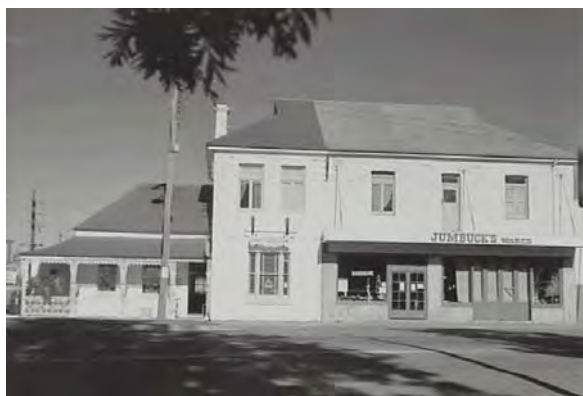
Figure 3. 183: Nos. 62 (left) and 64-68 George Street in 1979 before restoration. Source: Photo by M Chadwick, Hawkesbury Library, 004489

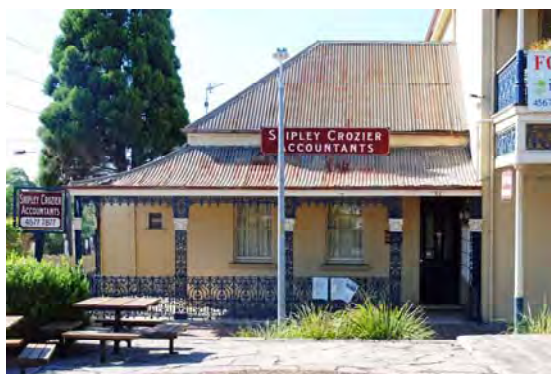
Figure 3. 184: No. 62 George Street, street frontage

As seen in the early plans of Windsor, a building appears on this site for the first time in 1835.⁸⁹ This cottage, believed to have been built in c1830, is a remnant of that building which is assumed to have been a terrace containing two or more dwellings. It has rendered walls, a corrugated iron hipped roof and curved verandah with a stone flagged floor. Early six-pane window sashes survive but there is a Victorian overlay of cast iron balustrading and columns to the verandah and a four-panel front door. The verandah wraps around the eastern side, terminating at an enclosure on the south side behind a round-topped paling fence on the Bridge Street boundary. Together with the Macquarie Arms opposite, this cottage is a key component of the Conservation Area and reinforces the colonial character of the south side of Thompson Square.

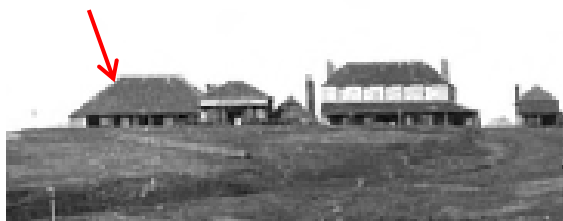
Figure 3. 187: Detail from 1879 photograph showing what appears to be No. 62 George Street (indicated with an arrow) before the alterations to the eastern portion of the building and the construction of 68 George Street. Source: SLNSW, GPO SH1658

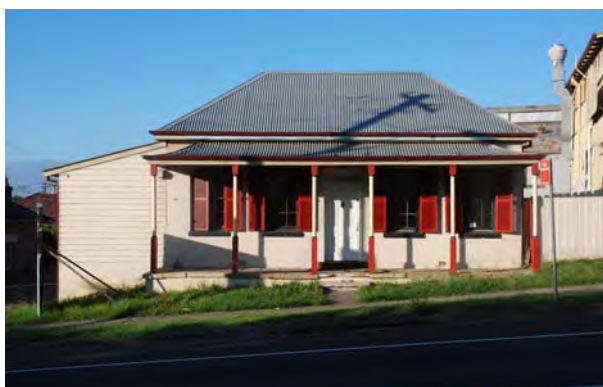
Figure 3. 188: No. 19 Bridge Street, street frontage

This Colonial Georgian cottage first appears on the c.1842 survey plan by White. It has a hipped roof with concave curved verandah awning, stone flagged verandah floor and original front door with a pair of original sash windows either side. The verandah columns and window shutters are reconstructions. There is a lean-to addition to the south. Internally it appears to retain at least one original chimneypiece.

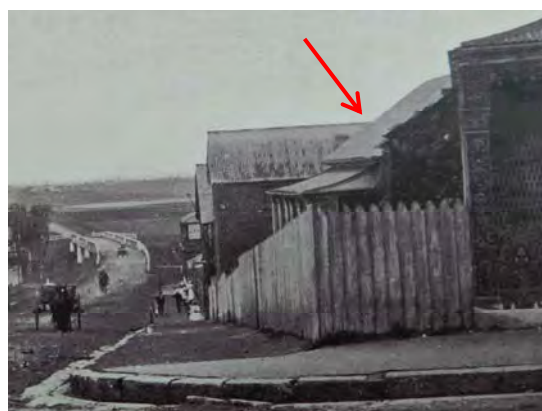
Figure 3. 191: Detail from 1870s postcard showing the roof and verandah of No. 19 Bridge Street (indicated with an arrow). Source: SLNSW, ML.SPF#A745

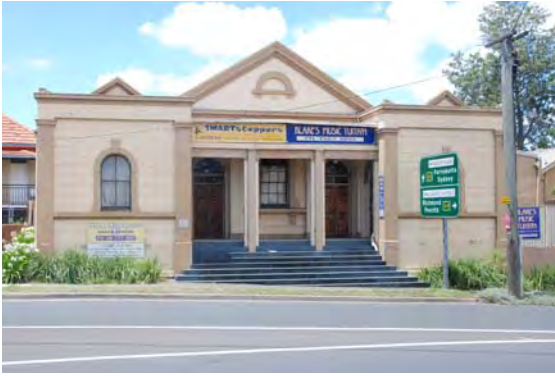
Figure 3. 192: The School of Arts building, 14 Bridge Street

Built in 1861, this fine Italianate hall with temple front and apsidal rear has had side wings jutting forward and a verandah or loggia added to the front in the early 20th century, leaving little room between it and the heavy traffic of Bridge Street. The original hall has a rendered street façade and a slate roof. Side walls are of painted brick. The wings are similar but with skillion roofs in corrugated steel.

This building gives the Conservation Area added architectural quality and civic status. Advertising, road signs and a power pole clutter somewhat from its appearance.

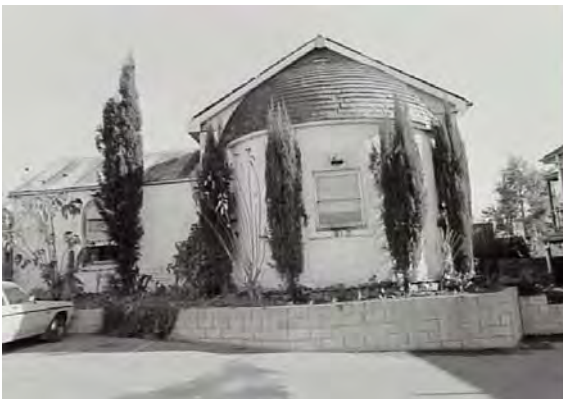
Figure 3. 194: The apsidal rear of the School of Arts building in 1979. Source: Photo by M Chadwick, Hawkesbury Library/004497

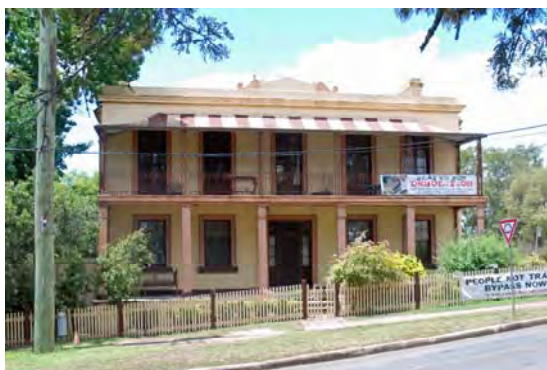
Figure 3. 198: No. 10 Bridge Street, street frontage.

The two storey rendered house at 10 Bridge Street known as Lilburn Hall is believed to have been built in the late 1850s for Doctor Joshua Howe. By 1923, it was a private hospital. Although mid-Victorian in date, it is of an old fashioned Regency style with a simple parapet front, French windows with margin bars and light balcony ironwork. The ground floor verandah is stone flagged and is supported on flat timber pillars. It has a hipped corrugated iron roof. The exterior is remarkably intact, including joinery.

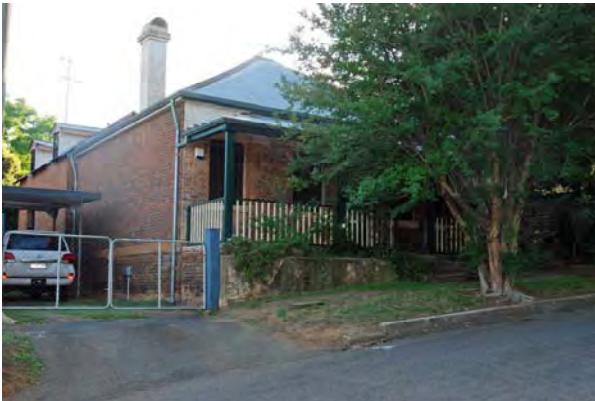
Figure 3. 202: No. 6 Old Bridge Street

The brick cottage at no. 6 Bridge Street, dates from the 1860s but it is of an earlier vernacular Georgian appearance. It has a hipped corrugated iron roof, two painted brick chimneys and hipped roofed verandah with timber balustrade, separated from the street only by a rendered planting box. The brick walls are painted although the front wall has been mainly stripped. The plinth, sills and lintels are all sandstone. It has two sash windows either side of the central front door and the joinery appears to be early and intact. The original cottage has two rear wings and a detached building containing garages and dormer windows but the latter is screened from the street by vegetation.

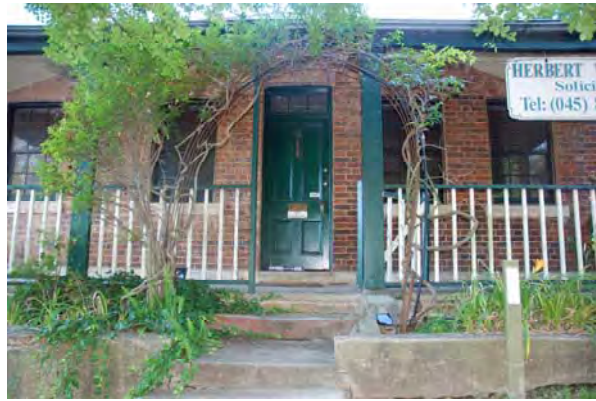
Figure 3. 203: Front door to No. 6 Old Bridge Street

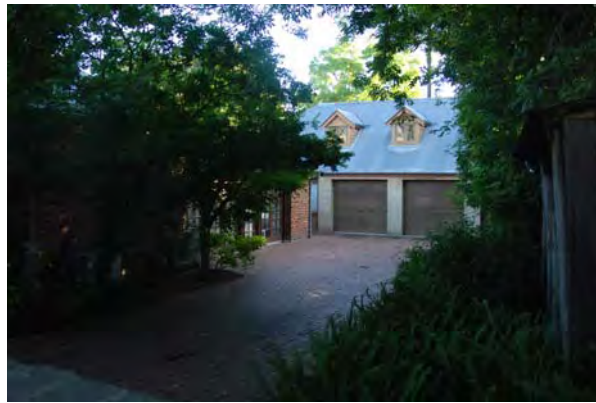
Figure 3. 205: View of rear outbuilding/garage to No. 6 Old Bridge Street

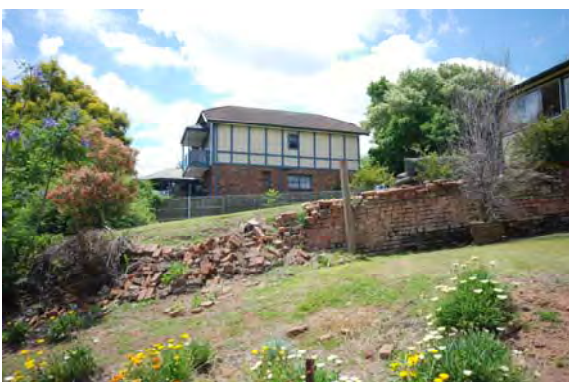
Figure 3. 207: Brick wall located within the north garden area of No. 4 Old Bridge Street.

Built on a portion of Andrew Thompson's original 1 acre allotment of land which contained his garden until c1840s. The land remained un-development until the construction of the current house in 1955. The single storey house is of a scale sympathetic with the Conservation Area. Its garden contains a dilapidated brick wall which is thought to be a remnant of Thompson's garden boundary wall.
