Draft Thompson Square Conservation
Management Plan
Part 1

Thompson Square Conservation Area Windsor, NSW

Conservation Management Plan

Date:
7th August 2018

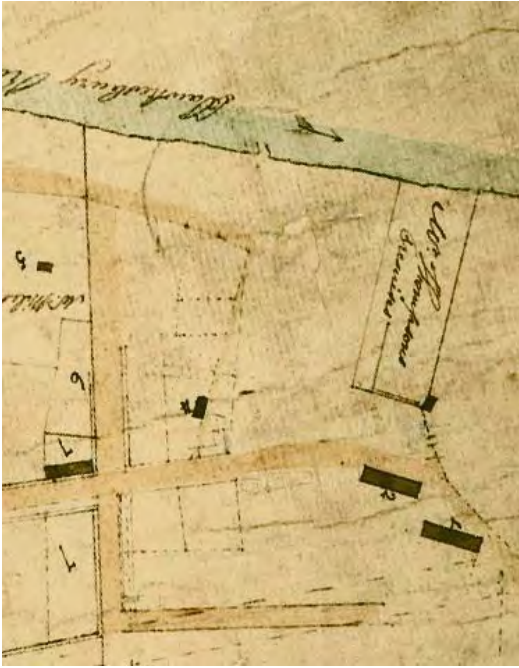
Figure 4. 12: Detail from Meehan's 1811 plan with the subdivision pattern marked up by Meehan. Source: SA Map SZ 529

When Meehan laid out the town of Windsor in 1811, his plan for the town showed a strong, quadrangular arrangement of allotments, roads and a public square to the west of the already existing township centred on Thompson Square. In the area of the early town encompassed by the TSCA, Meehan's plan shows light pencil markings of allotments on the western and southern sides of Thompson Square, the clear marking out of Thompson's 1799 1 acre lease of land and the firming up of the alignments of George Street, Macquarie Street and Baker Street. By 1827, when White prepared his survey of the town of Windsor, further allotment boundaries were defined on his plan, in particular on the western and southern boundaries of Thompson Square.

Evidence of these early town plans remain in the road alignments for Baker Street, George Street, Macquarie Street and The Terrace and in some of the property allotment boundaries today, notably the allotment granted to Richard Fitzgerald in 1811 for the building of the Macquarie Arms Hotel and the western extension of this land for his cottage which he built in 1819, and the allotments leased to James Mileham and William Blady in 1809 on the southern side of George Street (see Figures 4.12 and 4.13).

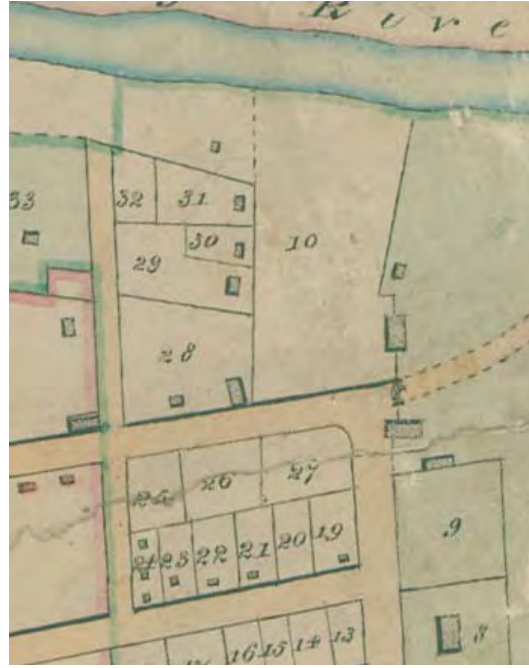
Figure 4. 13: Detail from Thompson's 1827 plan showing a more established subdivision pattern around Thompson Square. The Macquarie Arms Hotel allotment (No. 28) has been extended to Baker Street to the west. The two allotments granted to Blady and Mileham on the south side of George remain in place. Source: SA Map SZ 526

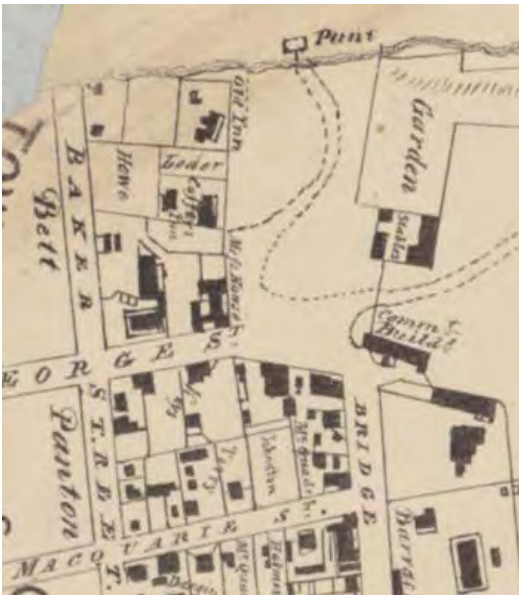
Figure 4. 14: Detail from Armstrong's plan of 1842 showing the progression of subdivision on the west and southern sides of Thompson Square. This is the first time the skewed alignment of George Street at the intersection with Bridge street is seen on plan. Source: ML Map M2 811.11222/1842/1

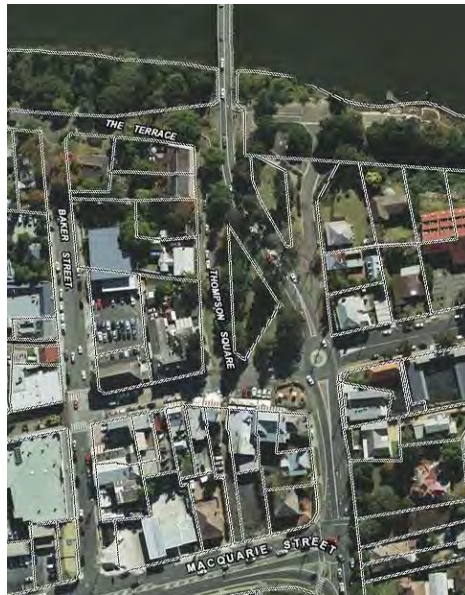
Figure 4. 15: Recent aerial photograph (c2015) showing present day cadastral boundaries. The Macquarie Arms Hotel allotment first granted in 1811 and extended in 1819 remains discernible as does the allotment for No. 5 Thompson Square and (in part) the allotment to Mileham on the corner of Baker and George Street, granted in 1809. Source: NSW Spatial Services

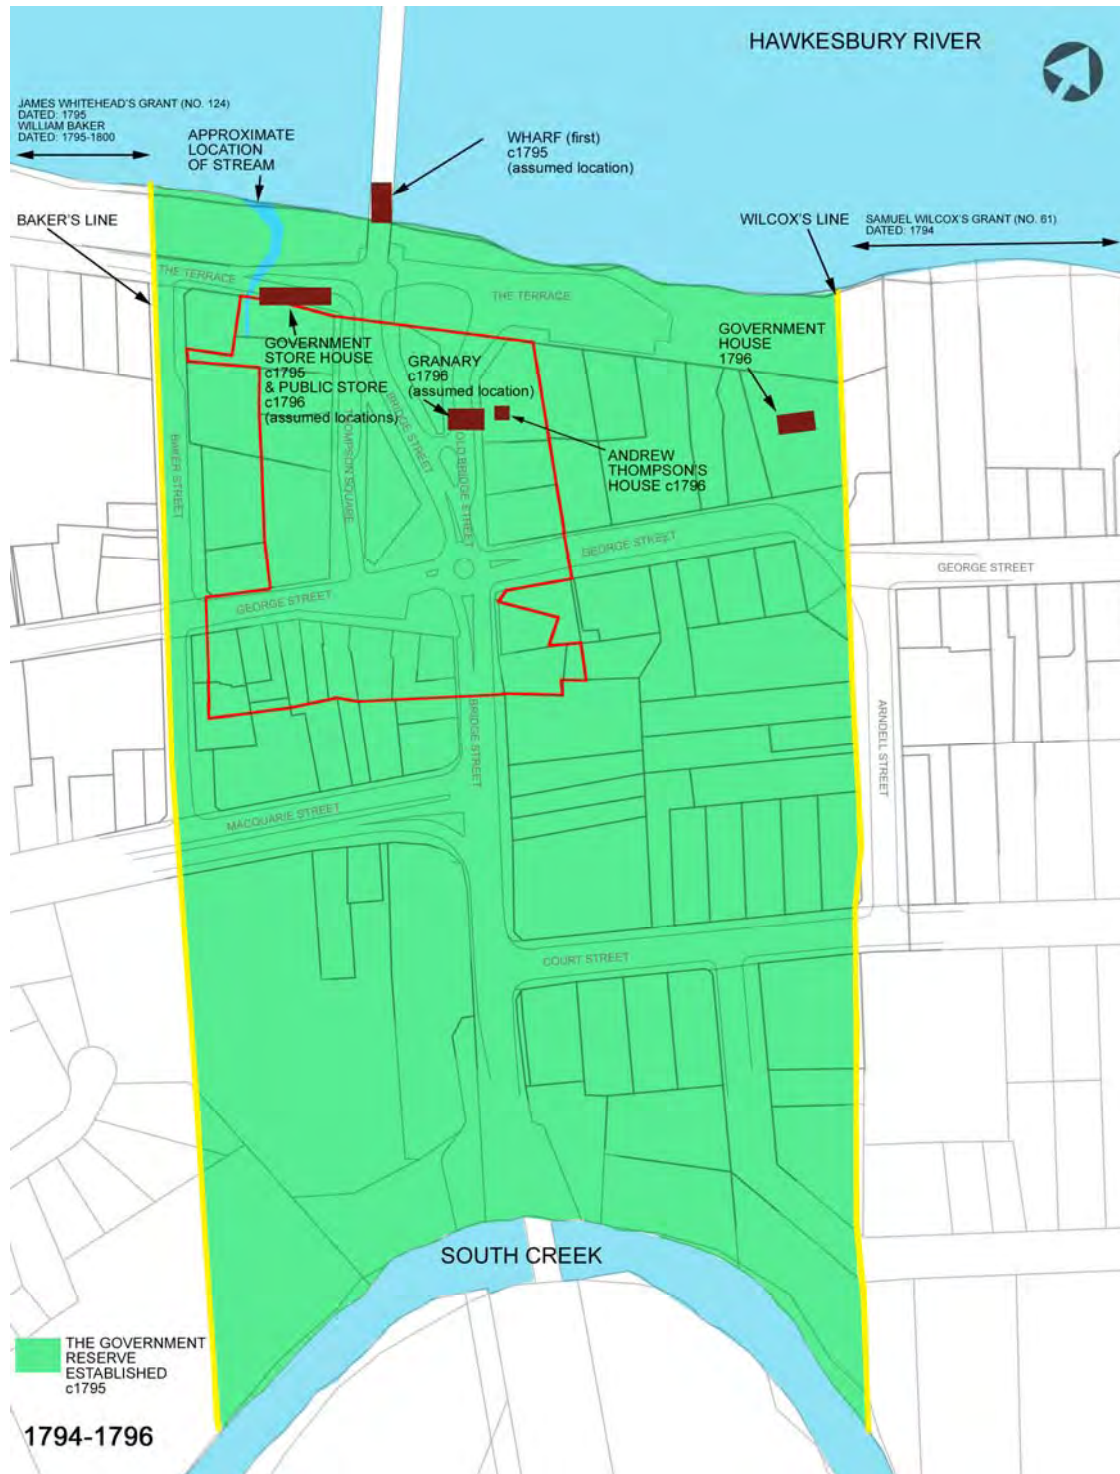
Figure 4. 16: Diagram showing the assumed early layout of the Green Hills: 1794-1796.

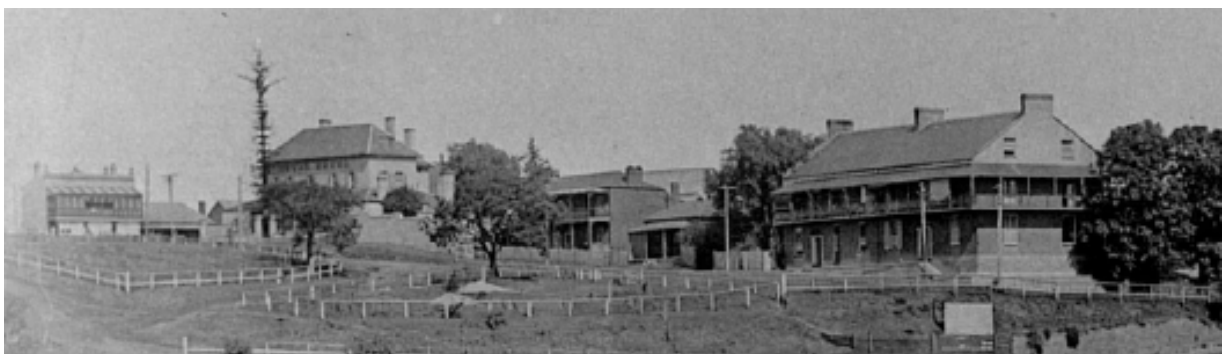
Figure 4. 24: Detail from 1890s photograph of Thompson Square showing the group of colonial buildings defining the western side of the square. Source: ML SPF

All of those on the western side of the square were built in the colonial period but all have later overlays. The Macquarie Arms and the Doctor's House are of exceptional quality. There is only one colonial building on the south side of the square (No. 62 George Street) but it retains its 1830s form, is in a key position on the corner of Bridge Street and on the centreline of the square. The eastern side of the square contains three Victorian buildings. The fine Italianate former School of Arts is truly Victorian, but the other two display an earlier colonial character: the Georgian style Lilburn Hall, No. 10 Bridge Street and the colonial style cottage at No. 6 Old Bridge Street. Even the mid-twentieth century cottage at No. 4 Old Bridge Street has an important colonial brick wall standing in its front garden.

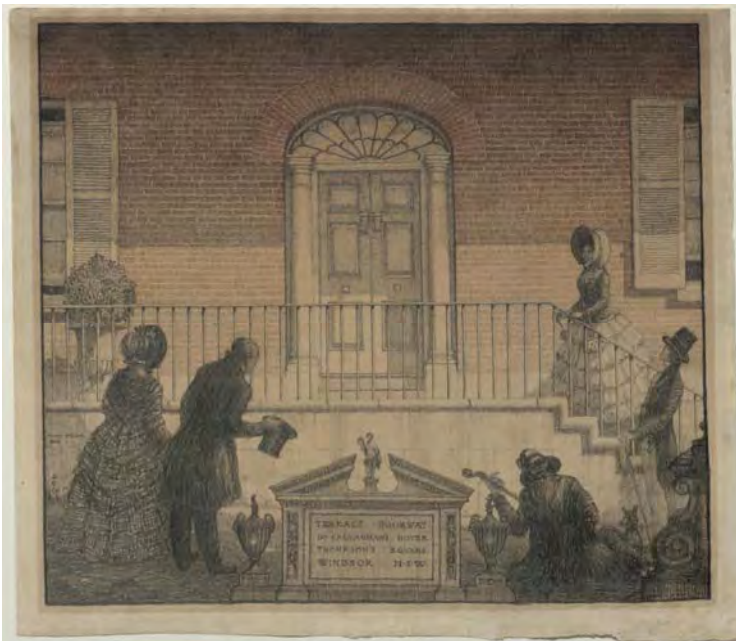
Figure 4. 25: 1915 drawing of the doorway to the Doctor's House, No. 1 Thompson Square by William Hardy Wilson. Source: NLA, PIC R548 LOC1361

The architectural quality of the buildings of the TSCA and the colonial character of the precinct has interested architects and others from the early years of the 20th century to date. Over 100 years ago the architect William Hardy Wilson (1881-1955) measured up and recorded both the Doctor's House, Nos. 1-3 Thompson Square and the Macquarie Arms Hotel, followed by out of work architects during the Great Depression who prepared measured drawings which are now held in the Mitchell Library.
