8 | IA1 Southern Drainage Route East

8.1 Drainage Issues

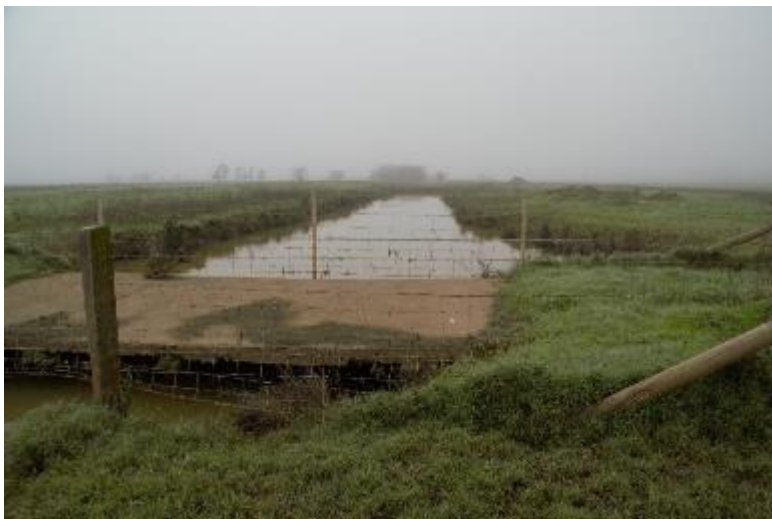
Photo 105

- paddock which cannot drain into the channel because the paddock is lower than the top bank of the drain (Photo 93)
- a disused channel crossing (Photo 105) which has substantially blocked flow and is causing ponding a long way upstream
- flood gates under Cupitts Lane would appear to not be working properly (Photo 118)

The choking of the channel with silt and vegetation can only be dealt with by using an excavator to remove them. The terrain is quite flat and the channel is not particularly wide or deep where most of the choke points occur. Along most of the channel length there are cleared paddocks. Where there are trees or shrubs preventing direct access to the channel the are mostly introduced species so their removal should not be an impediment to gaining access to the channel. If the work is to be done by Council then access will need to be arranged with property owners. The same earth moving equipment could be used to remove the disused channel crossing which is blocking flow. As the crossing is clearly no longer used this should not create a problem. If access needs to be maintained or restored at a later date then a bridge should be used.

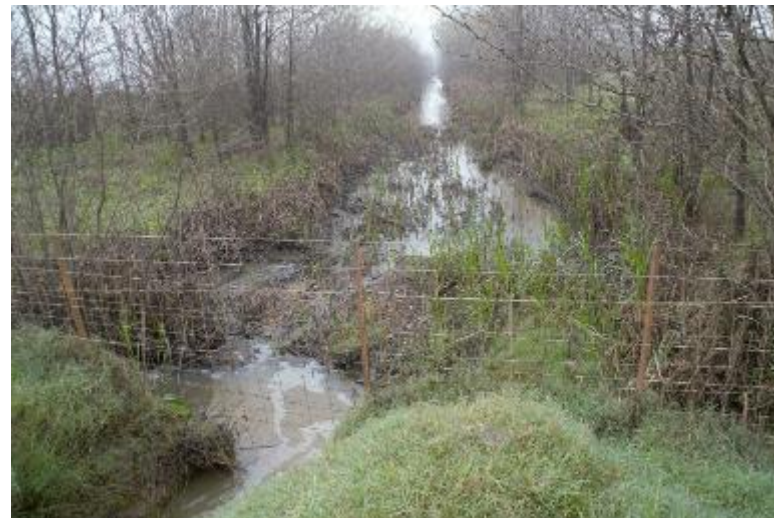
Most of the mapped wetland area is mapped as PCT 781 – Coastal Freshwater Lagoons (Figure 63). This is not consistent with field observations. As can be seen from Photo 107 through to Photo 111. The terrestrial vegetation is all introduced species dominated by a Honey Locust canopy and kikuyu ground cover. There are some native reeds within the channel. However, this section of channel does not appear to be ecologically distinct from those upstream and downstream.

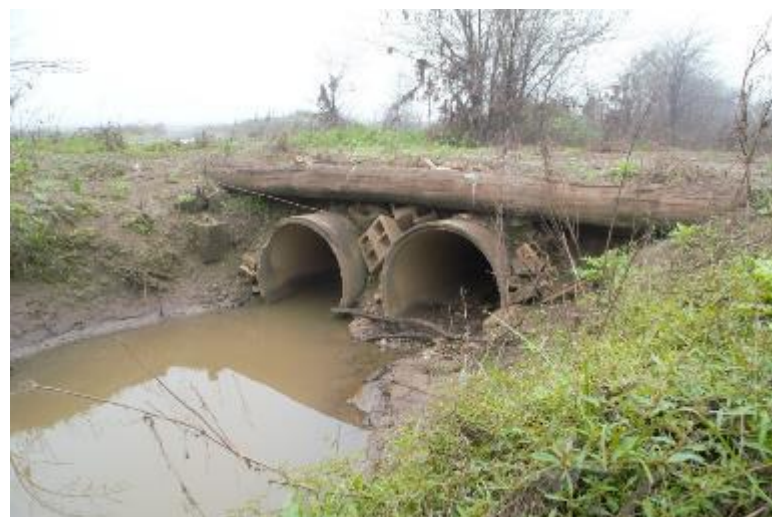
There is one wetland identified on the HLEP Wetlands Map and in R&H SEPP along IA1SC (Figure 62). However, at the time of the field work there was no discernible wetland in this location as evidenced by Photo 108, Photo 109 and Photo 110.

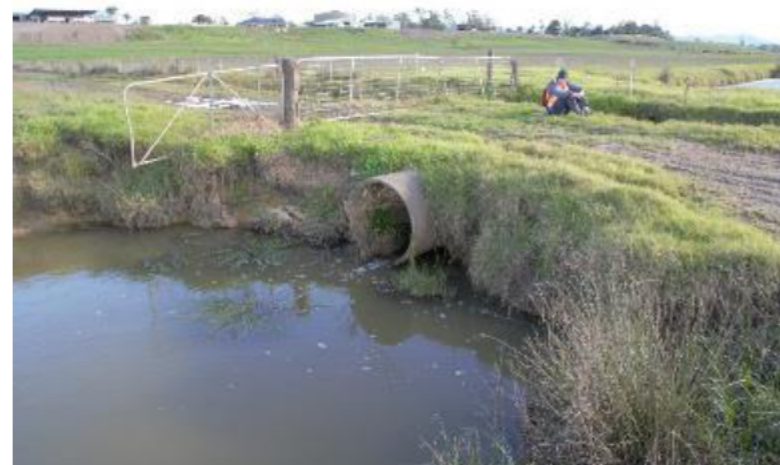
Photo 121

The other channel in this investigation area enters the main channel from the south. It starts as a deep, relatively wide channel in paddocks north of Dight Street (Photo 119) and heads east under a series of closely spaced crossing with pipes of various sizes under them (Photo 120). The water is ponded in this section of the channel by the invert of a pipe at the second of two closely spaced crossings (Photo 121 and Photo 122).

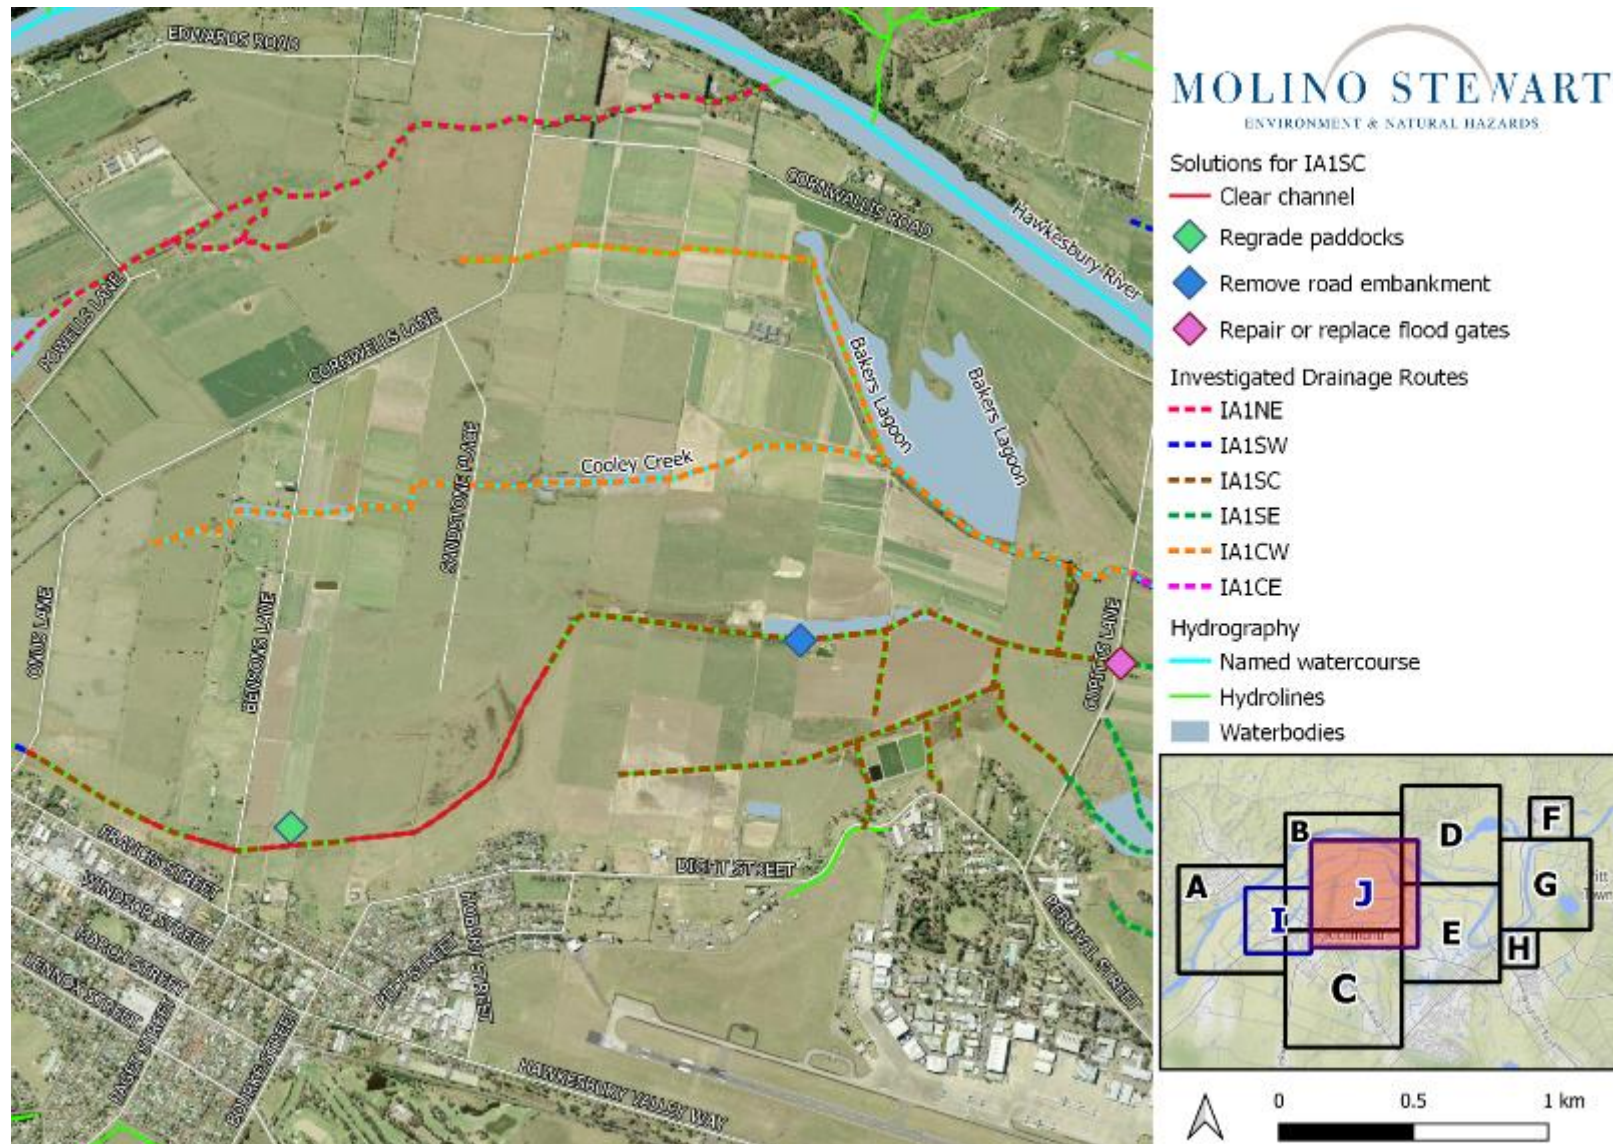
Figure 56: Solutions for IA1SC

Possible solutions are displayed in Figure 56.

Where paddocks are lower than the bank of the drain, drainage points could be cut through the bank or the entire bank and paddock regraded so that it drains to the channel.

A detailed inspection and testing of the flood gates would be needed before deciding on whether they need to be repaired or replaced.

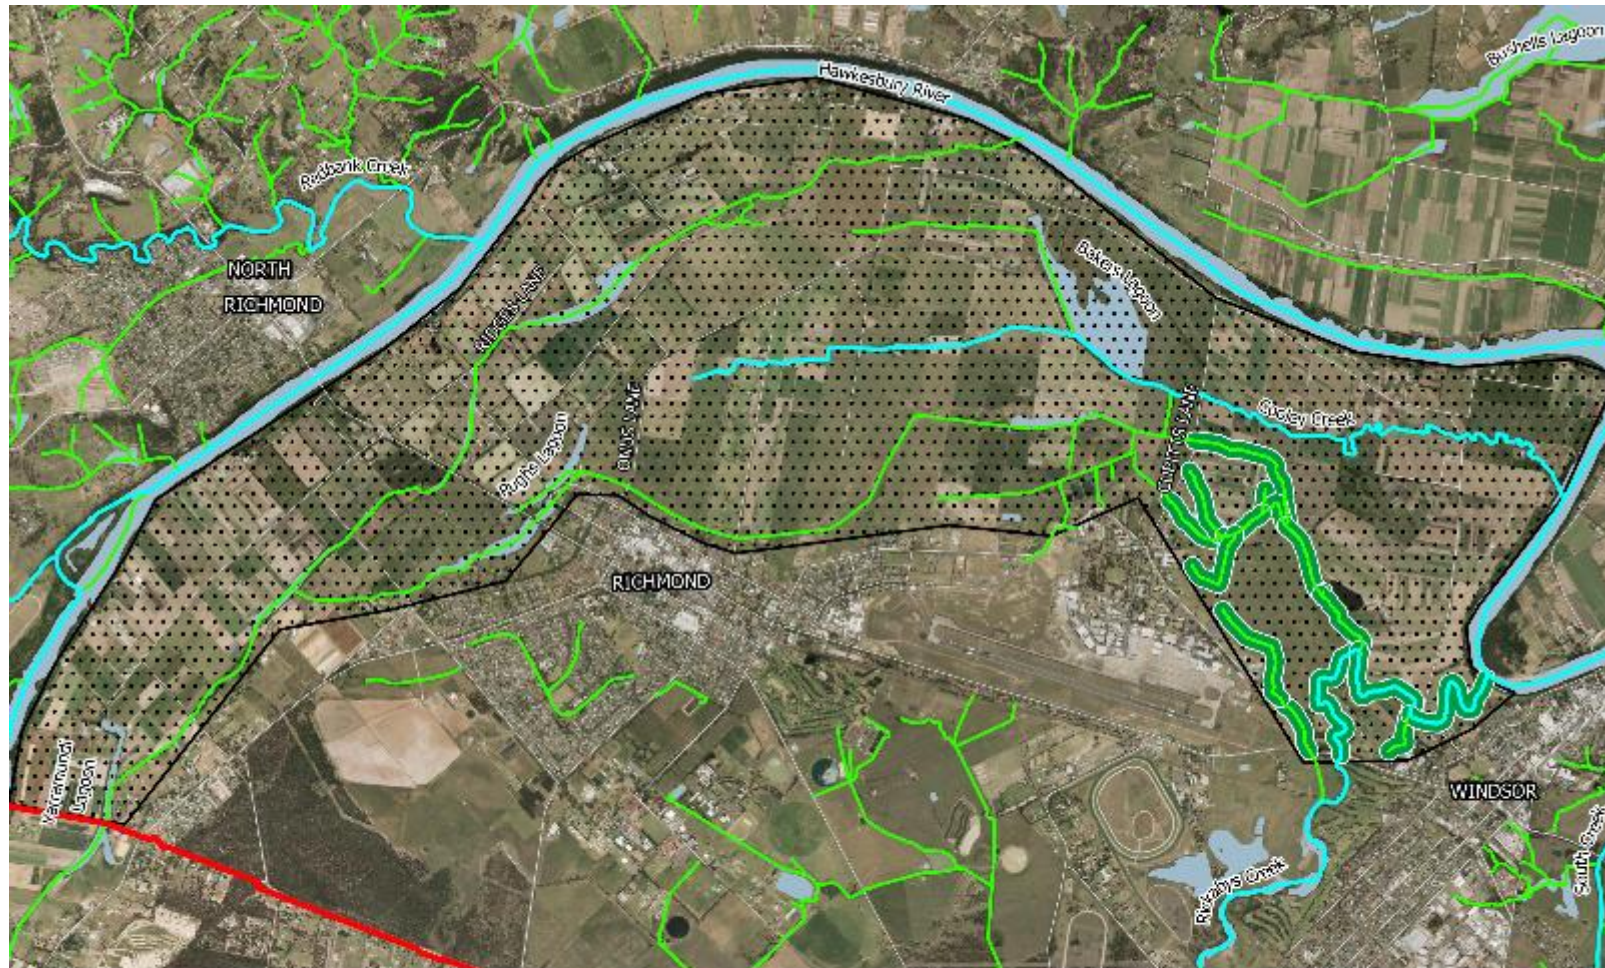
Figure 68: Investigation Area 1 Southern Drainage Route East (IA1SE)

The eastern section of the southern drainage route (IA1SE) is quite complex with three main branches, several tributary drains and two cross connections (Figure 68).

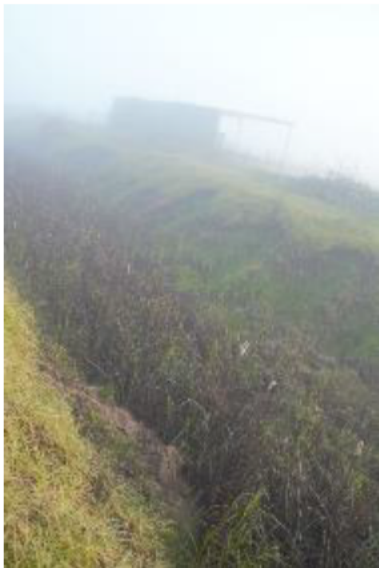
Photo 133

Downstream of Cupitts Lane the main channel is full of vegetation which is constricting flow (Photo 131) and further downstream there is plastic debris within the reeds which is further constricting the flow (Photo 132). The channel becomes deeper further along and there is evidence of numerous small bank slumps (Photo 133) which are pushing sediment into the channel.
