2.2 Existing Trees

3. REFERENCE DESIGN REVIEW

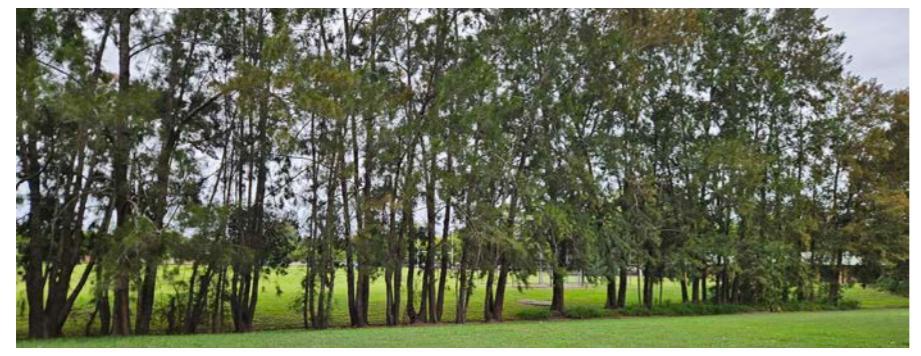
Figure 9: Clump of Casuarinas on western edge

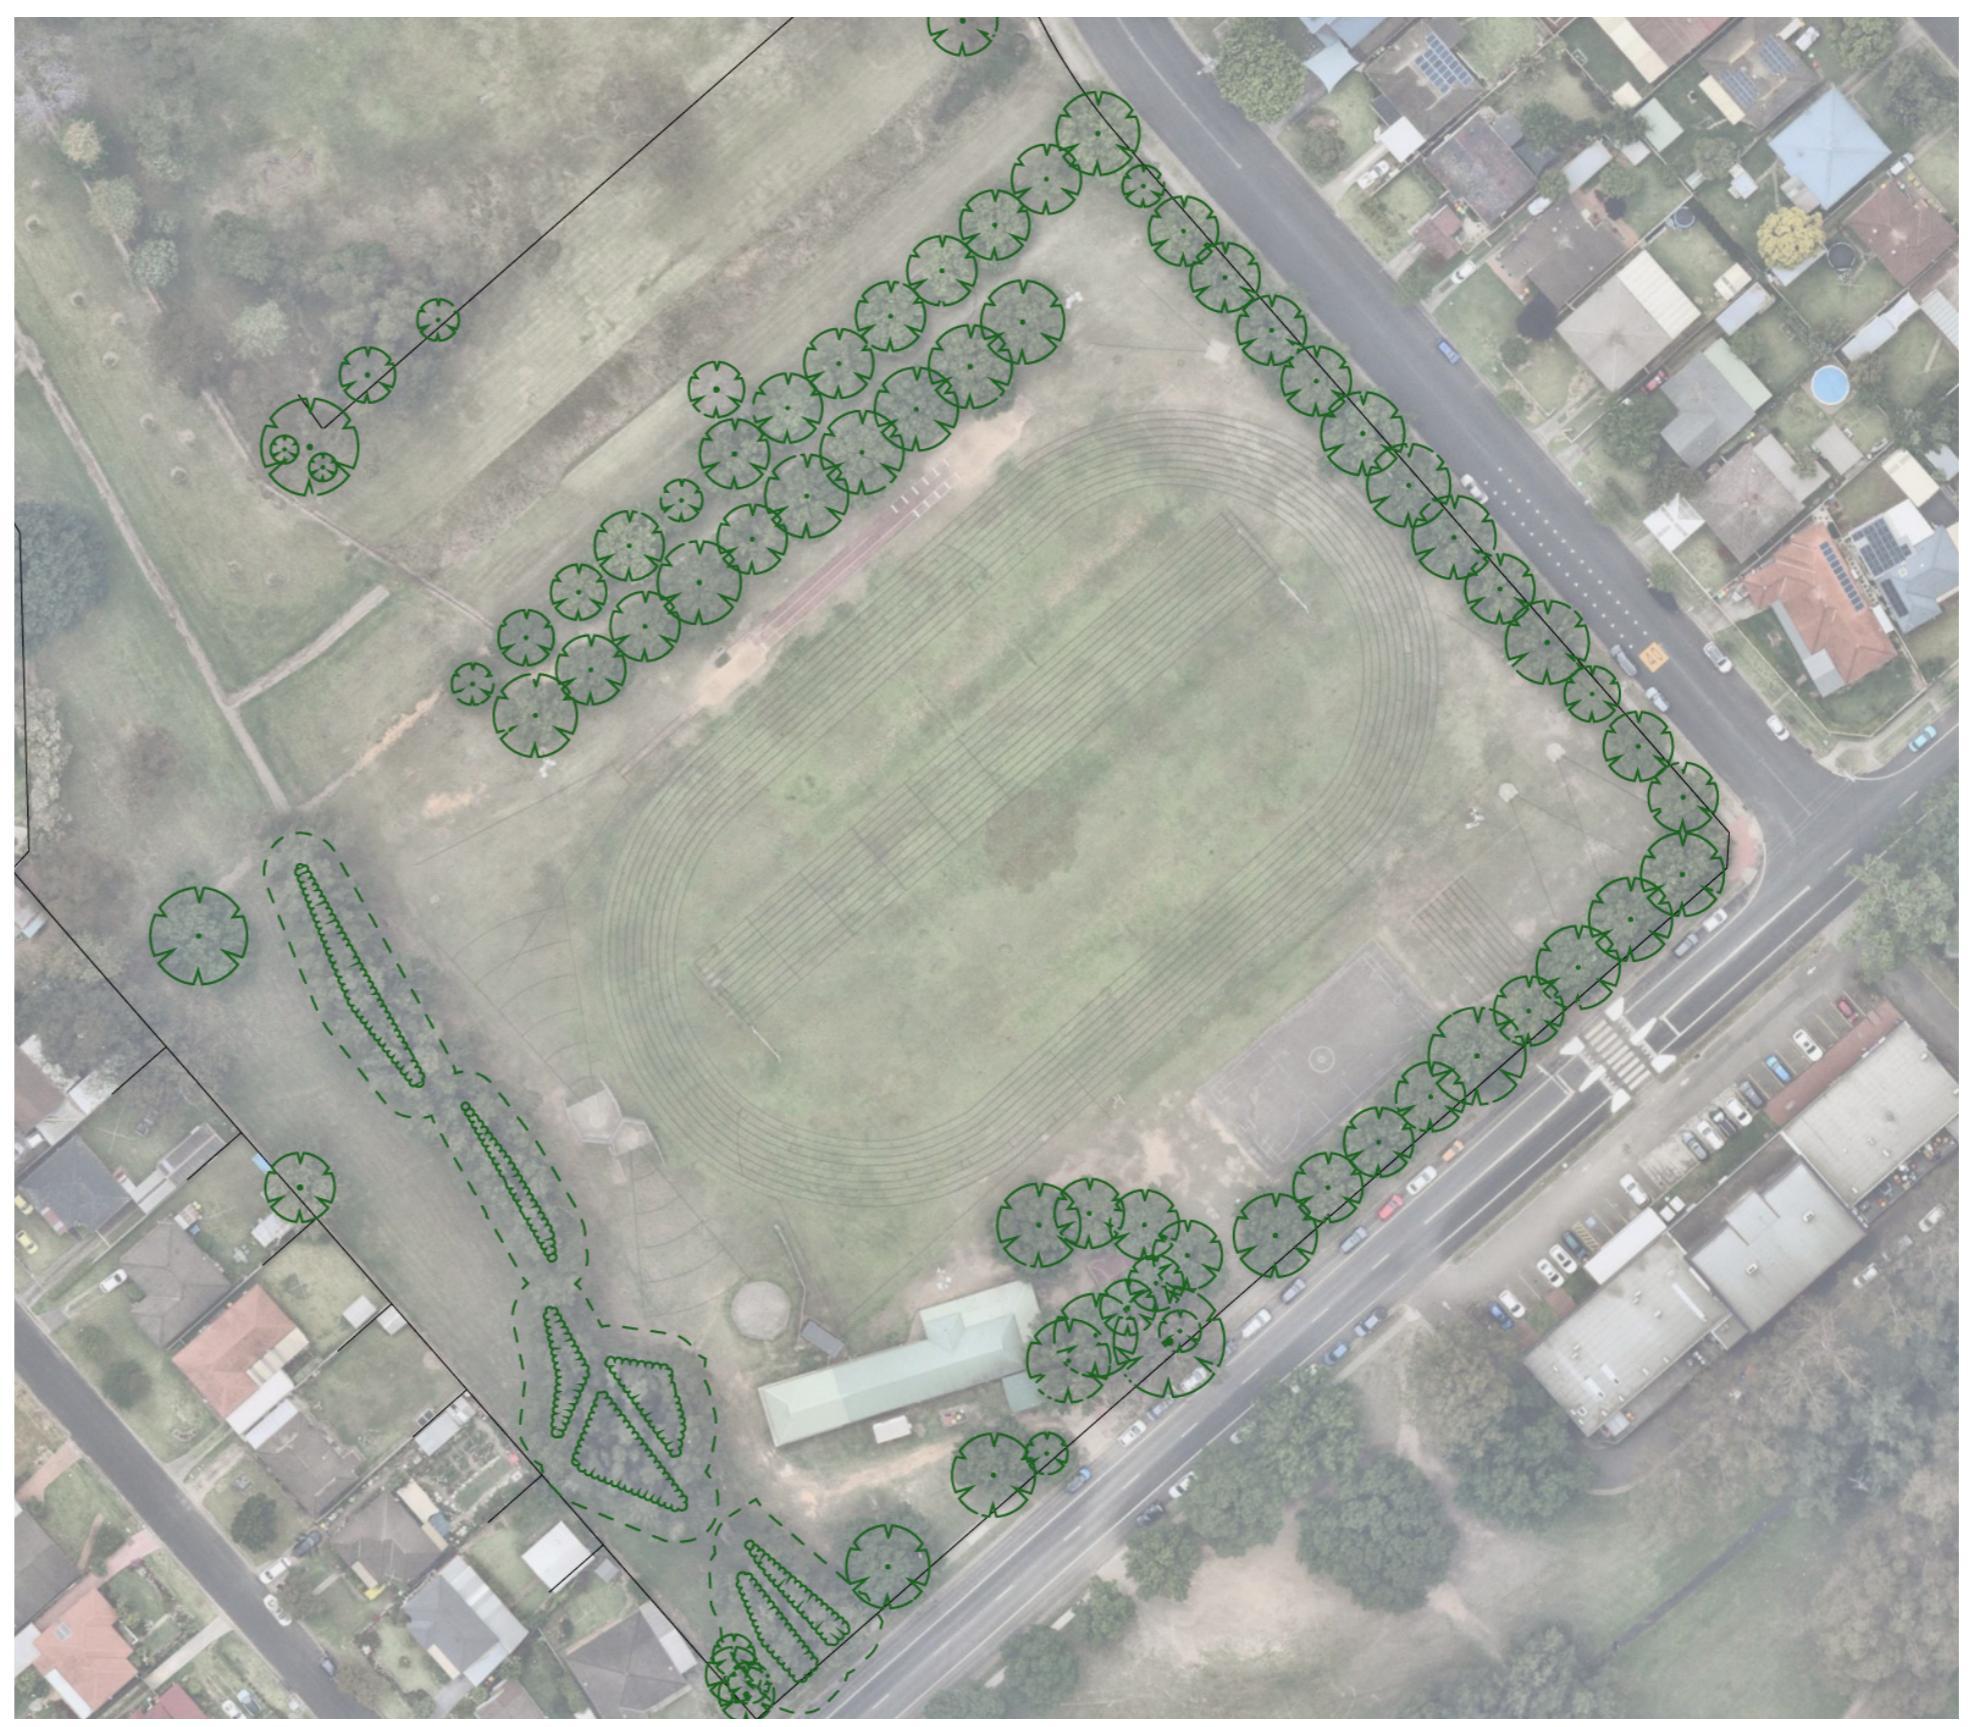
Figure 6: Existing trees plan

Trees play a vital role in shaping the character of Tamplin Field. Mature Chinese elms are located along the northern, southern, and eastern boundaries, creating a sense of enclosure, offering shade, and contributing seasonal aesthetic changes. On the western edge, a dense clump of casuarinas runs along the stormwater channel and forms a screen towards the private properties.

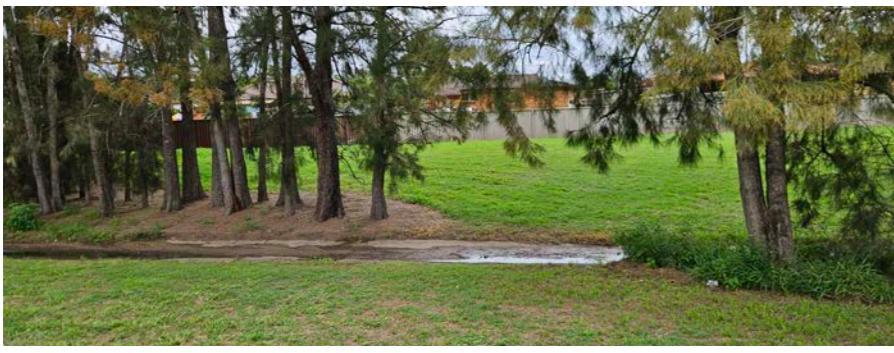
Figure 11: Open concrete drainage channel through Casuarina stand

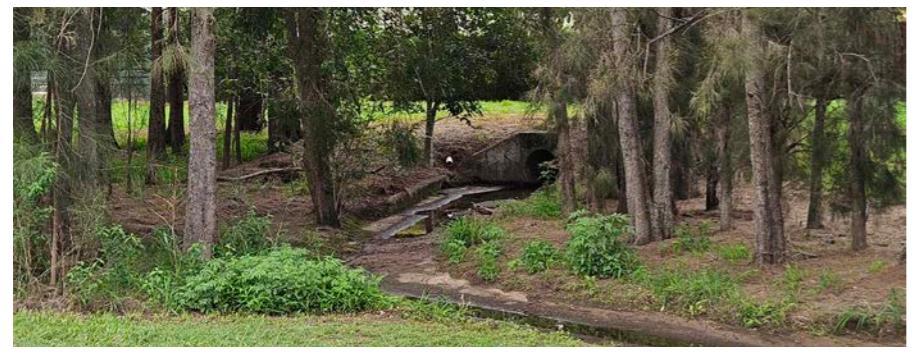
Figure 12: Drainage culvert opening

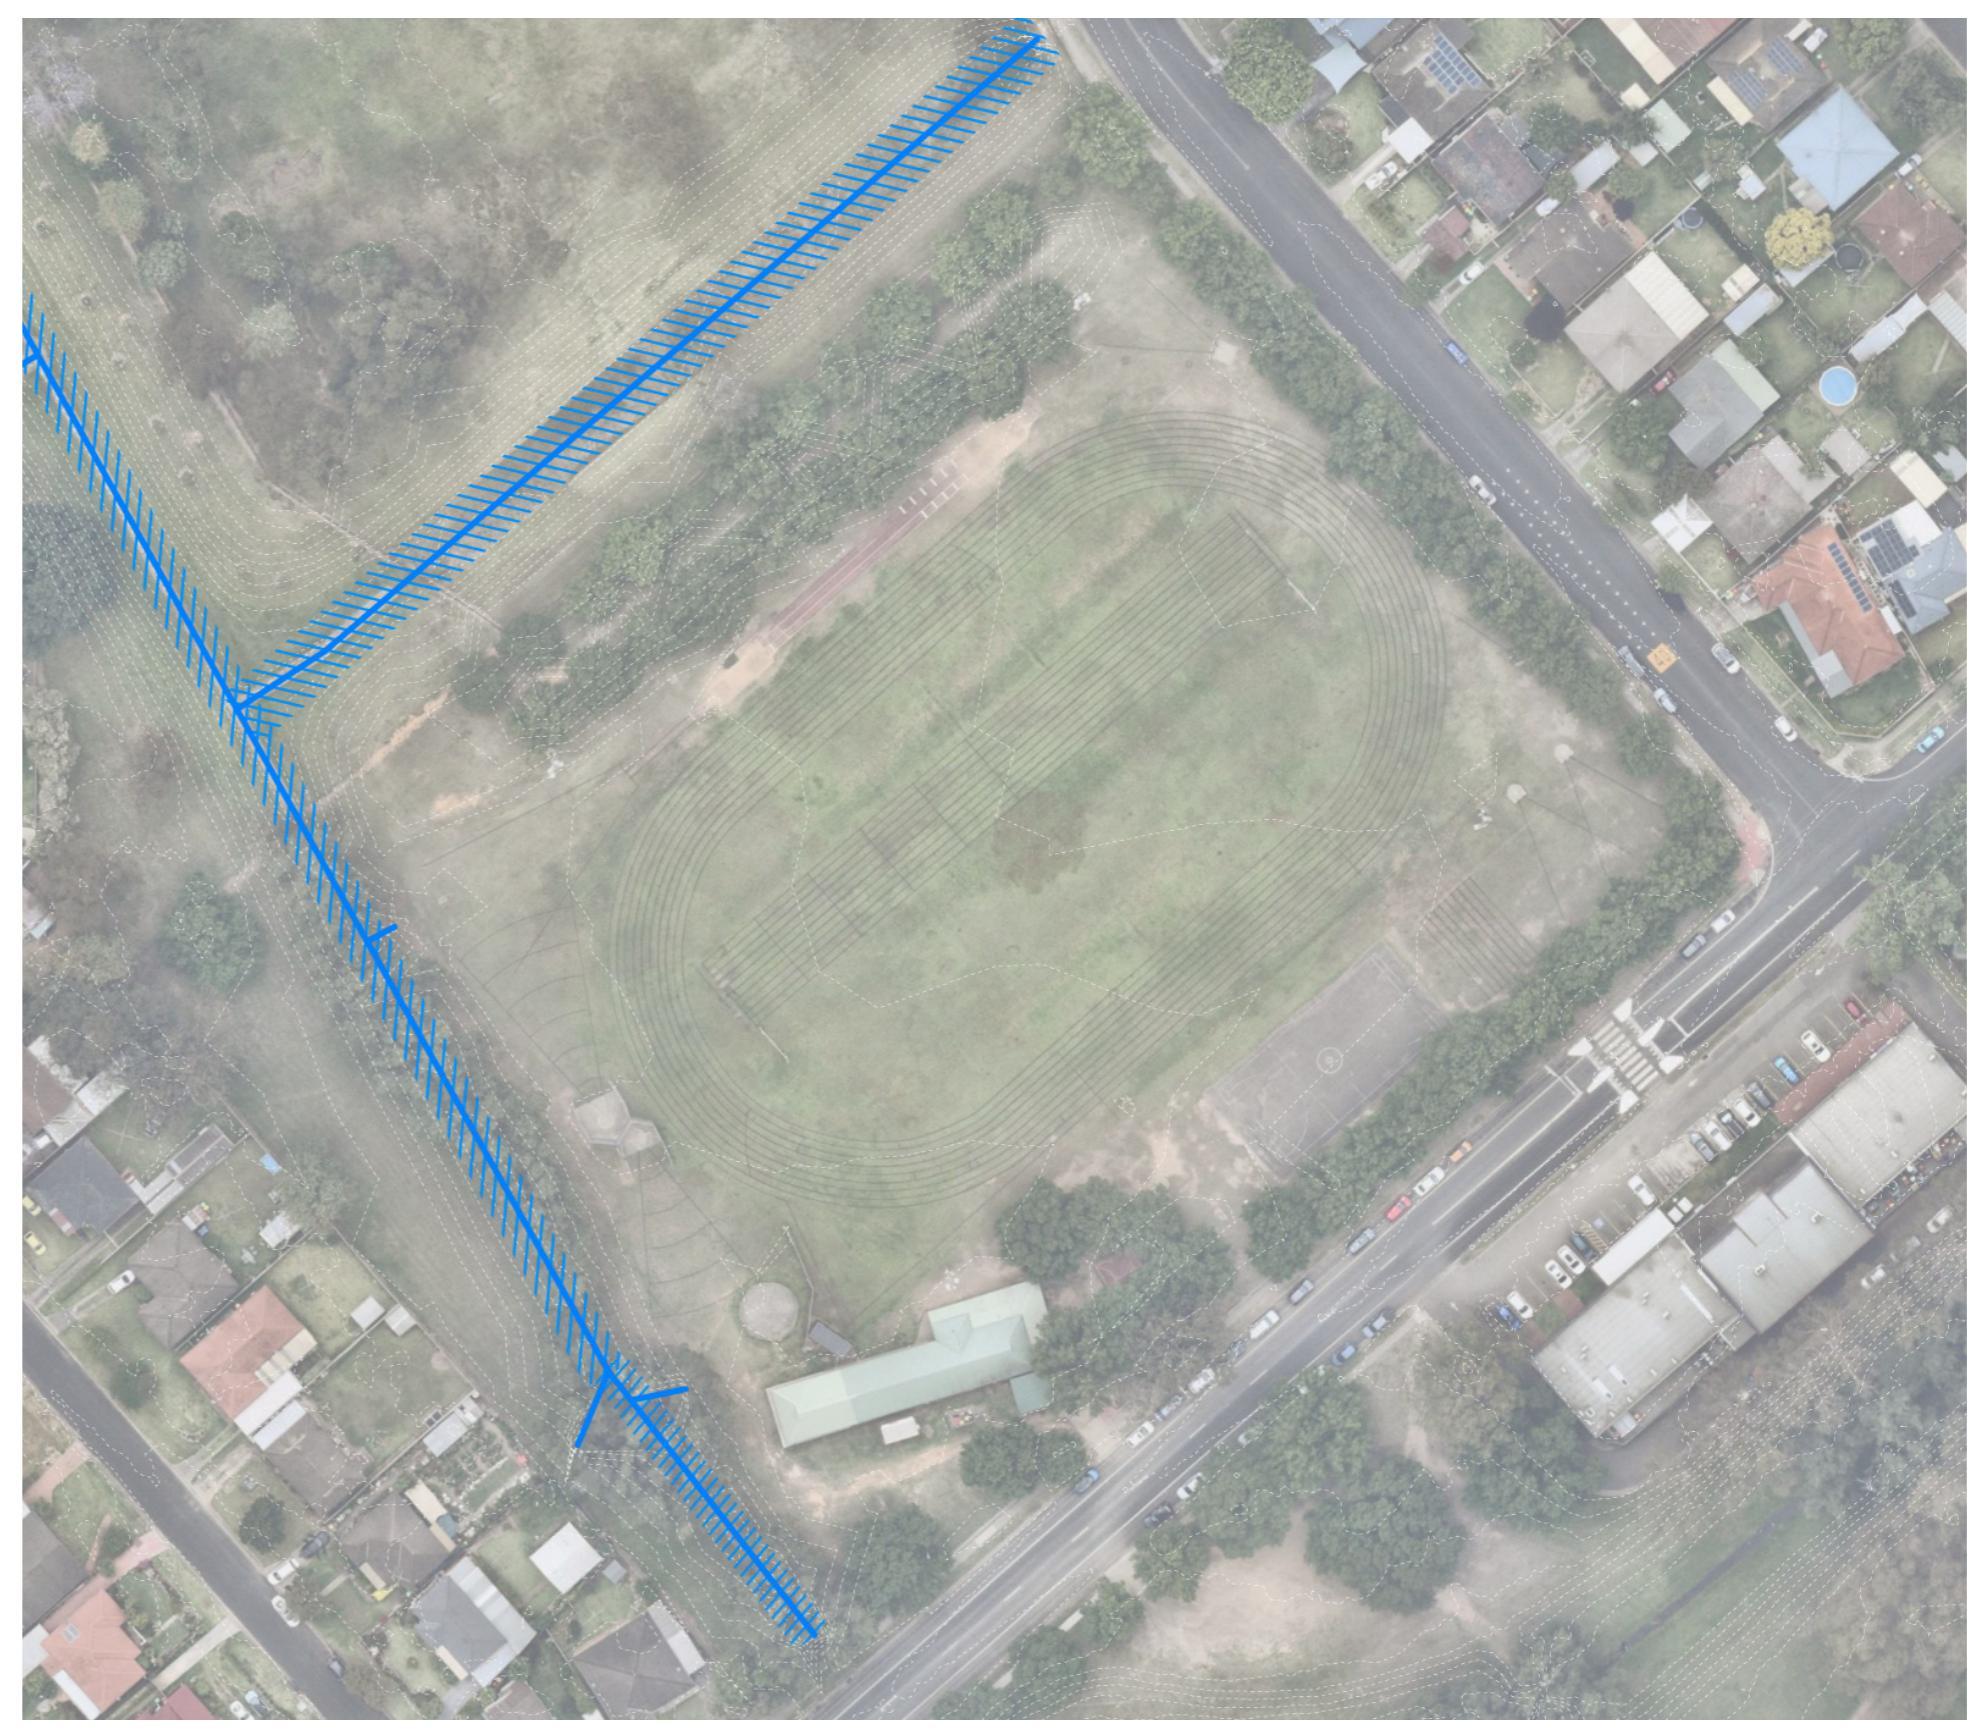
Figure 10: Stormwater channels analysis

The site and its immediate surroundings includes tormwater drain age channels with concrete base. One of the channels runs along the north-west of the oval, which is fed by a culvert flowing onto the site from beneath Powell Street. A second stormwater channel enters the site from culverts under Laurence St. The two channel merge continue further north.

An embankment with two rows of trees runs along the northern channel and the western channel is lined by mature casuarinas.

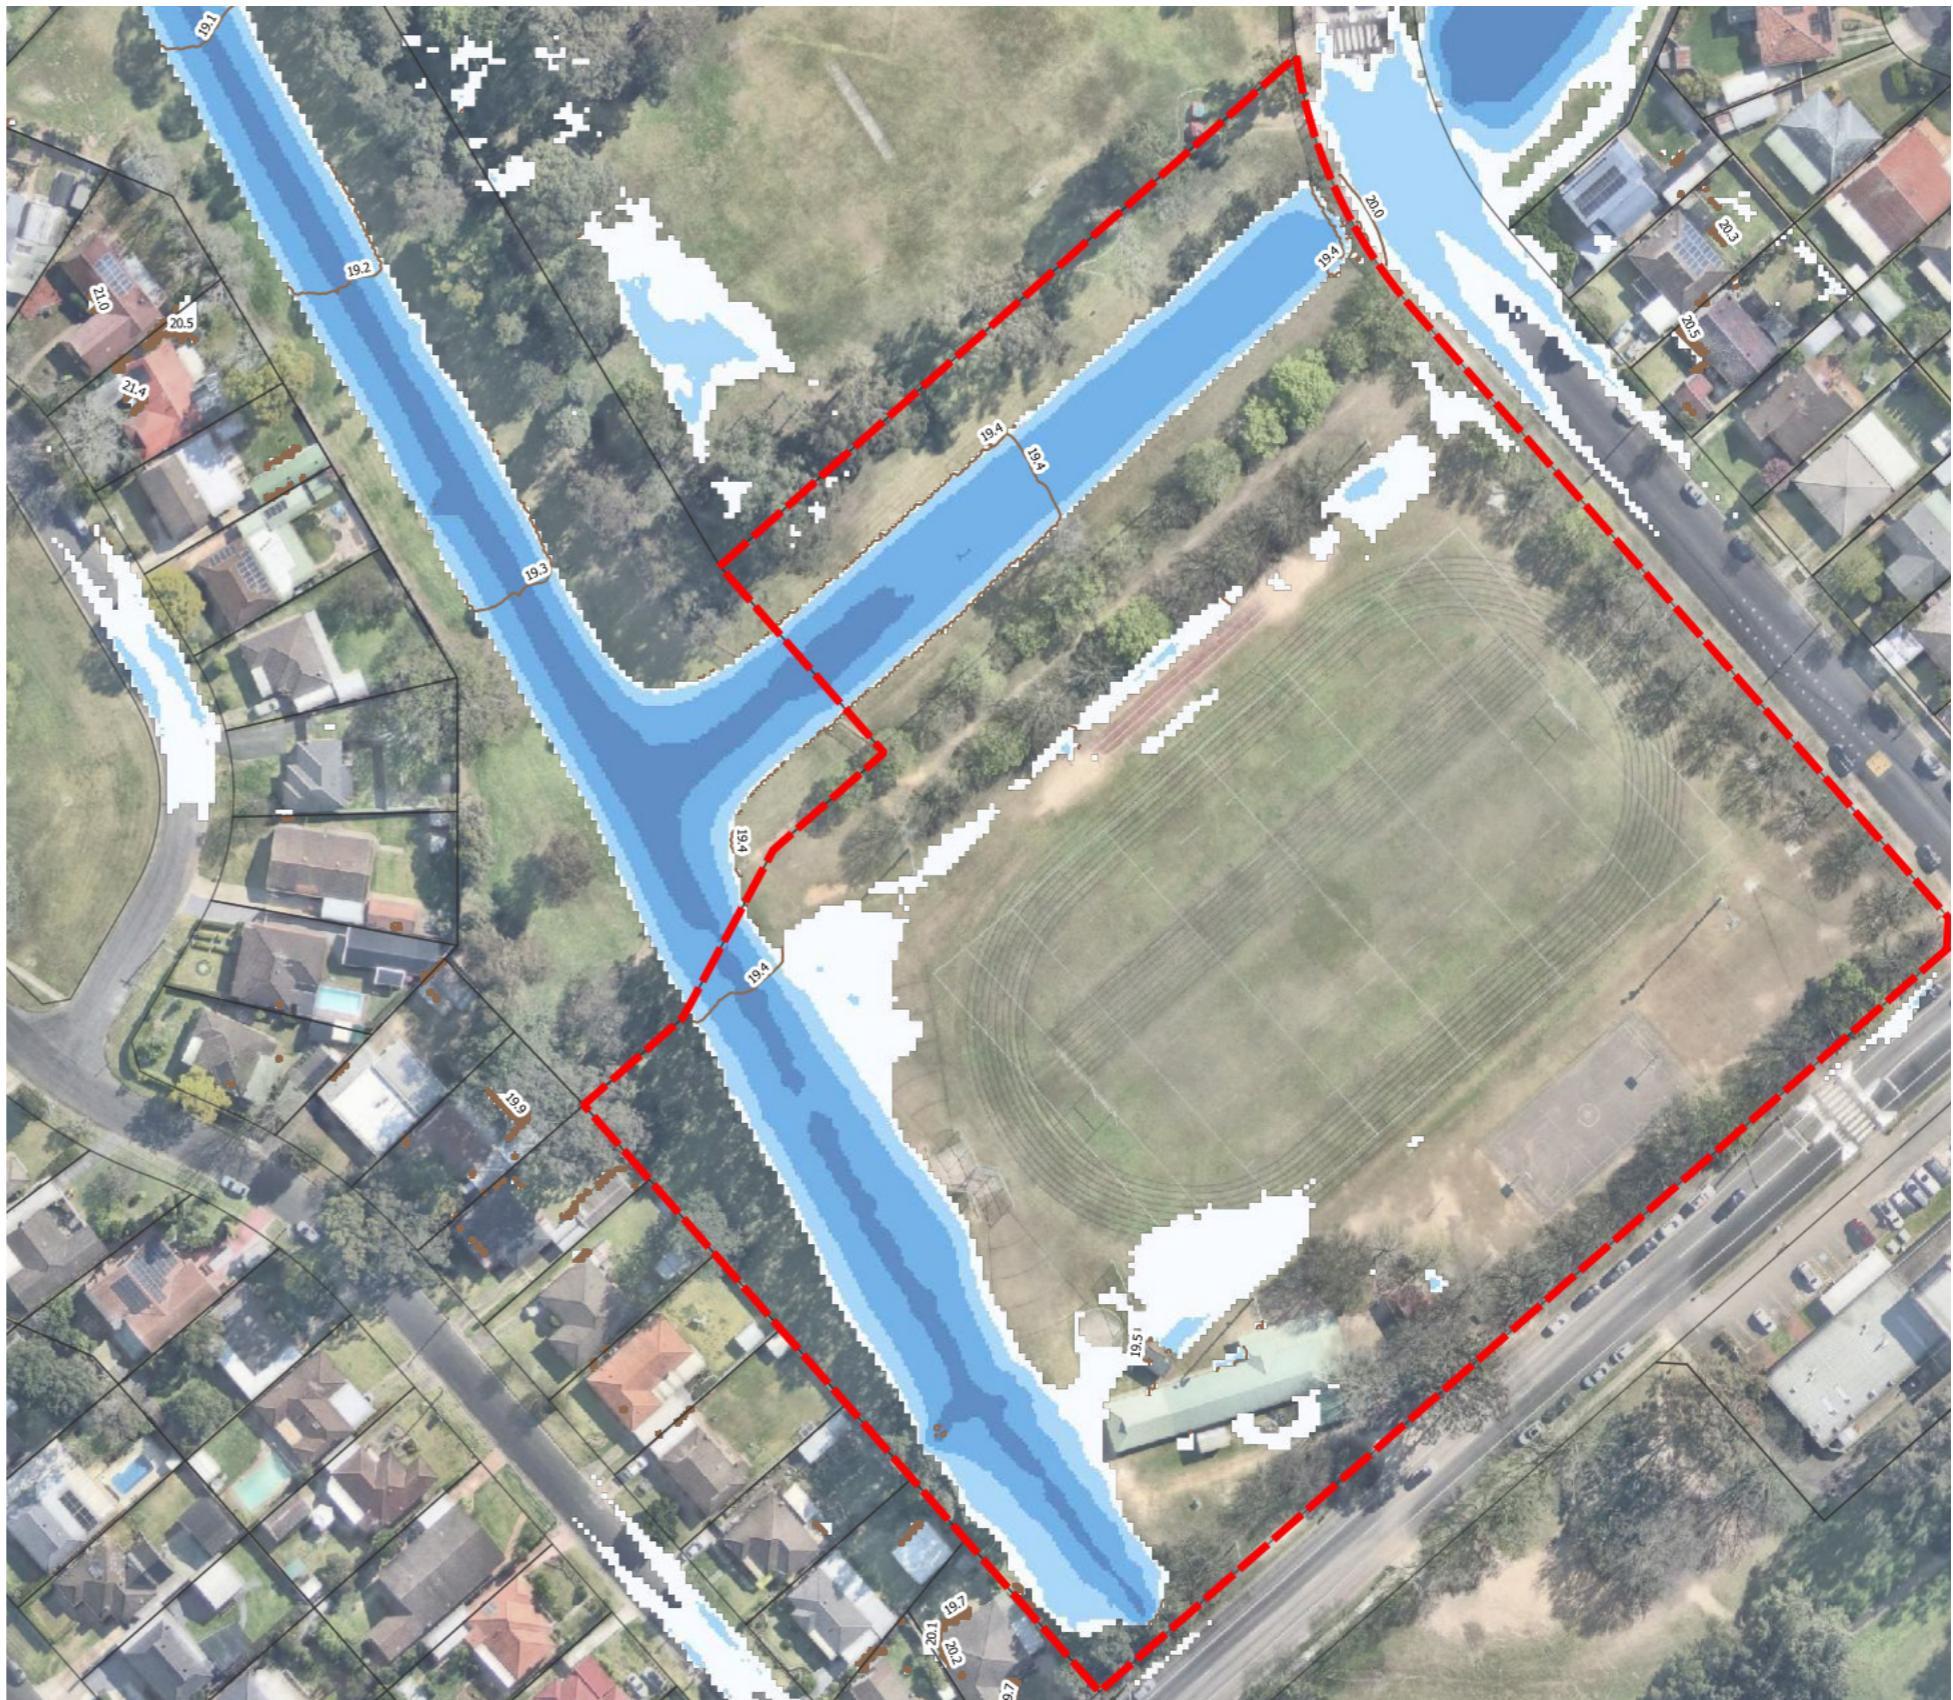
Figure 14: Flooding plan (1% AEP)

The draft flood study by AT&L (2024) illustrates that currently the sports field is only moderately affected by 1% AEP flood events, with flood depths of less than 0.2m along the edges of the field, with relatively short duration periods.

The study also illustrates the site is only affected by the 0.5% (1/200Yr) AEP up to PMF from flooding in the Hawkesbury River, with durations ranging from 24-96 hours.

Upgrades to the sports field will have to ensure flooding does not worsen. Proposed design levels will be provided to the hydraulic engineers to rerun the flood model to test and confirm all flood requirements are met.

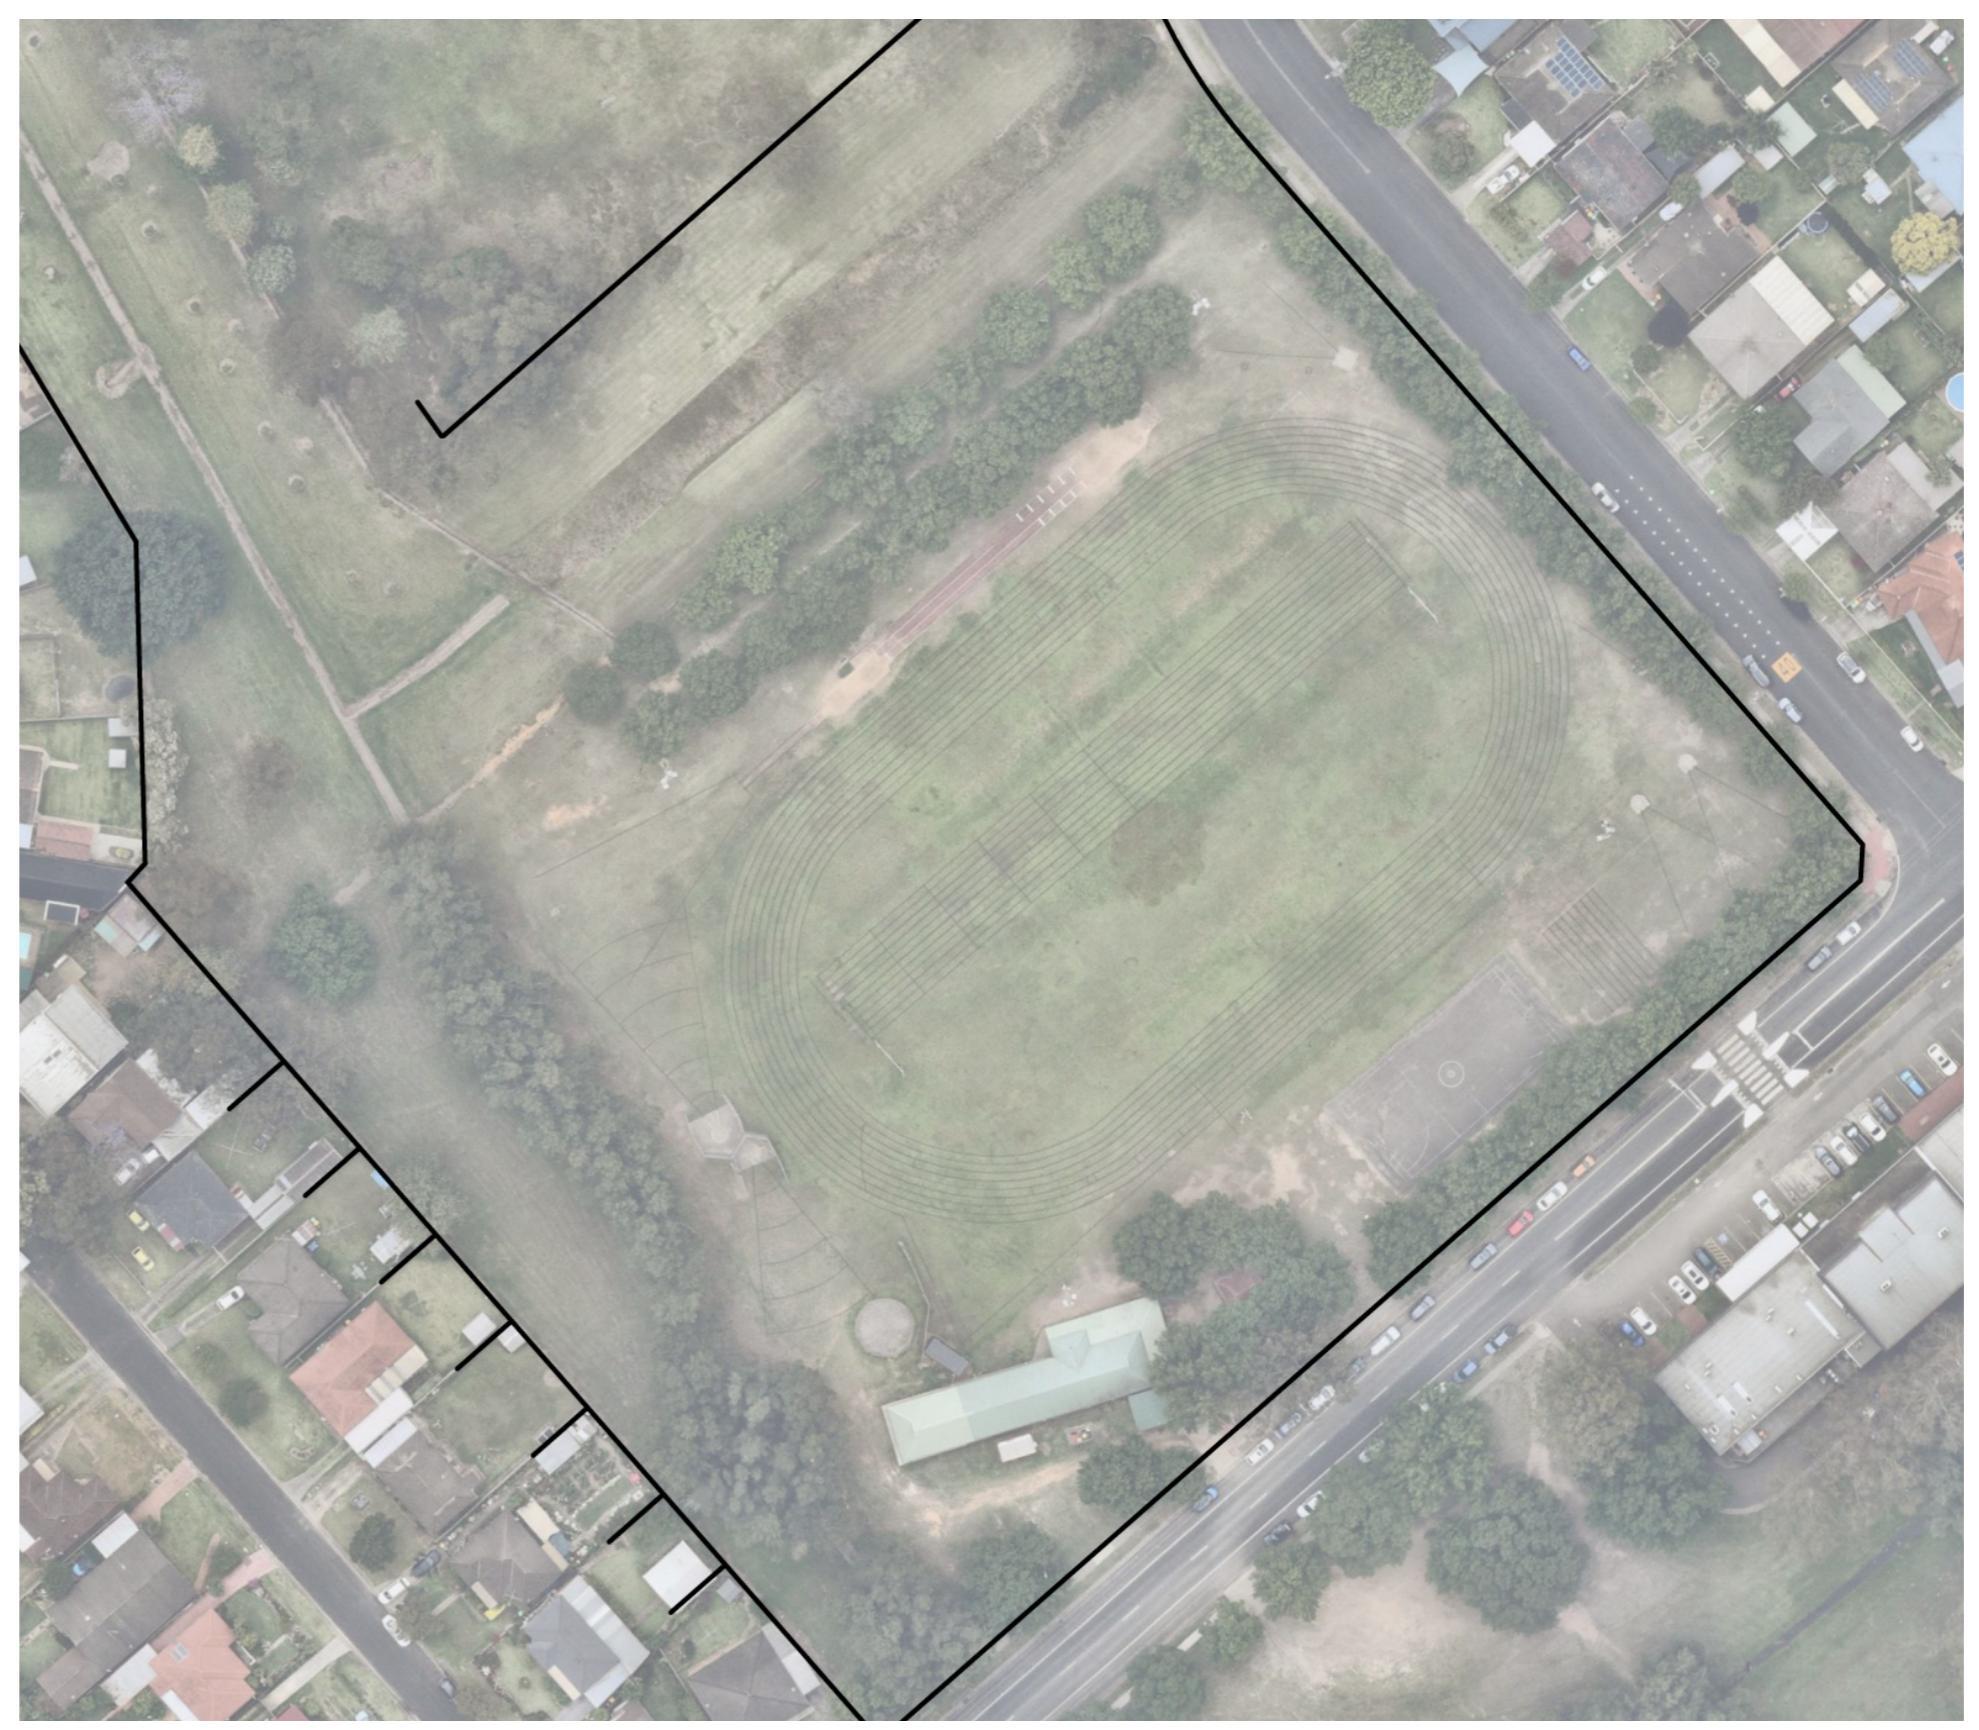
Figure 15: Boundary condition plan

Tamplin Field is bordered by several different land uses and features. Approximately ten low-rise private residences share a boundary fence with the western edge of the site.

The site is also adjacent to two roads, Laurence Street to the south-east and Powell Street to the north-east. To the south, across Laurence Street, there is a strip of local shops accessible via a pedestrian crossing.

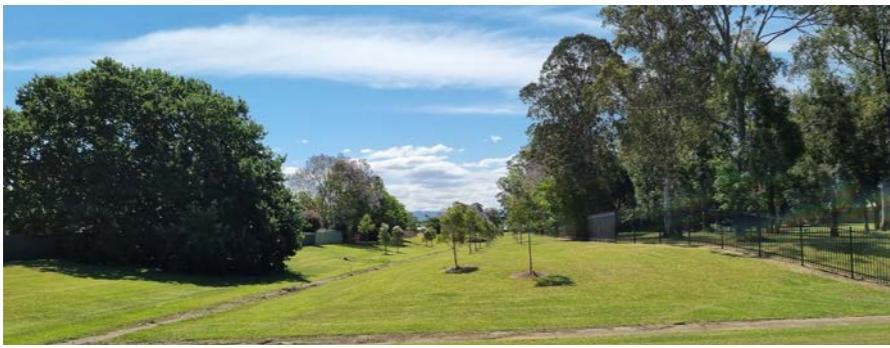
Figure 20: Open culvert running alongside school to the north of Tamplin field

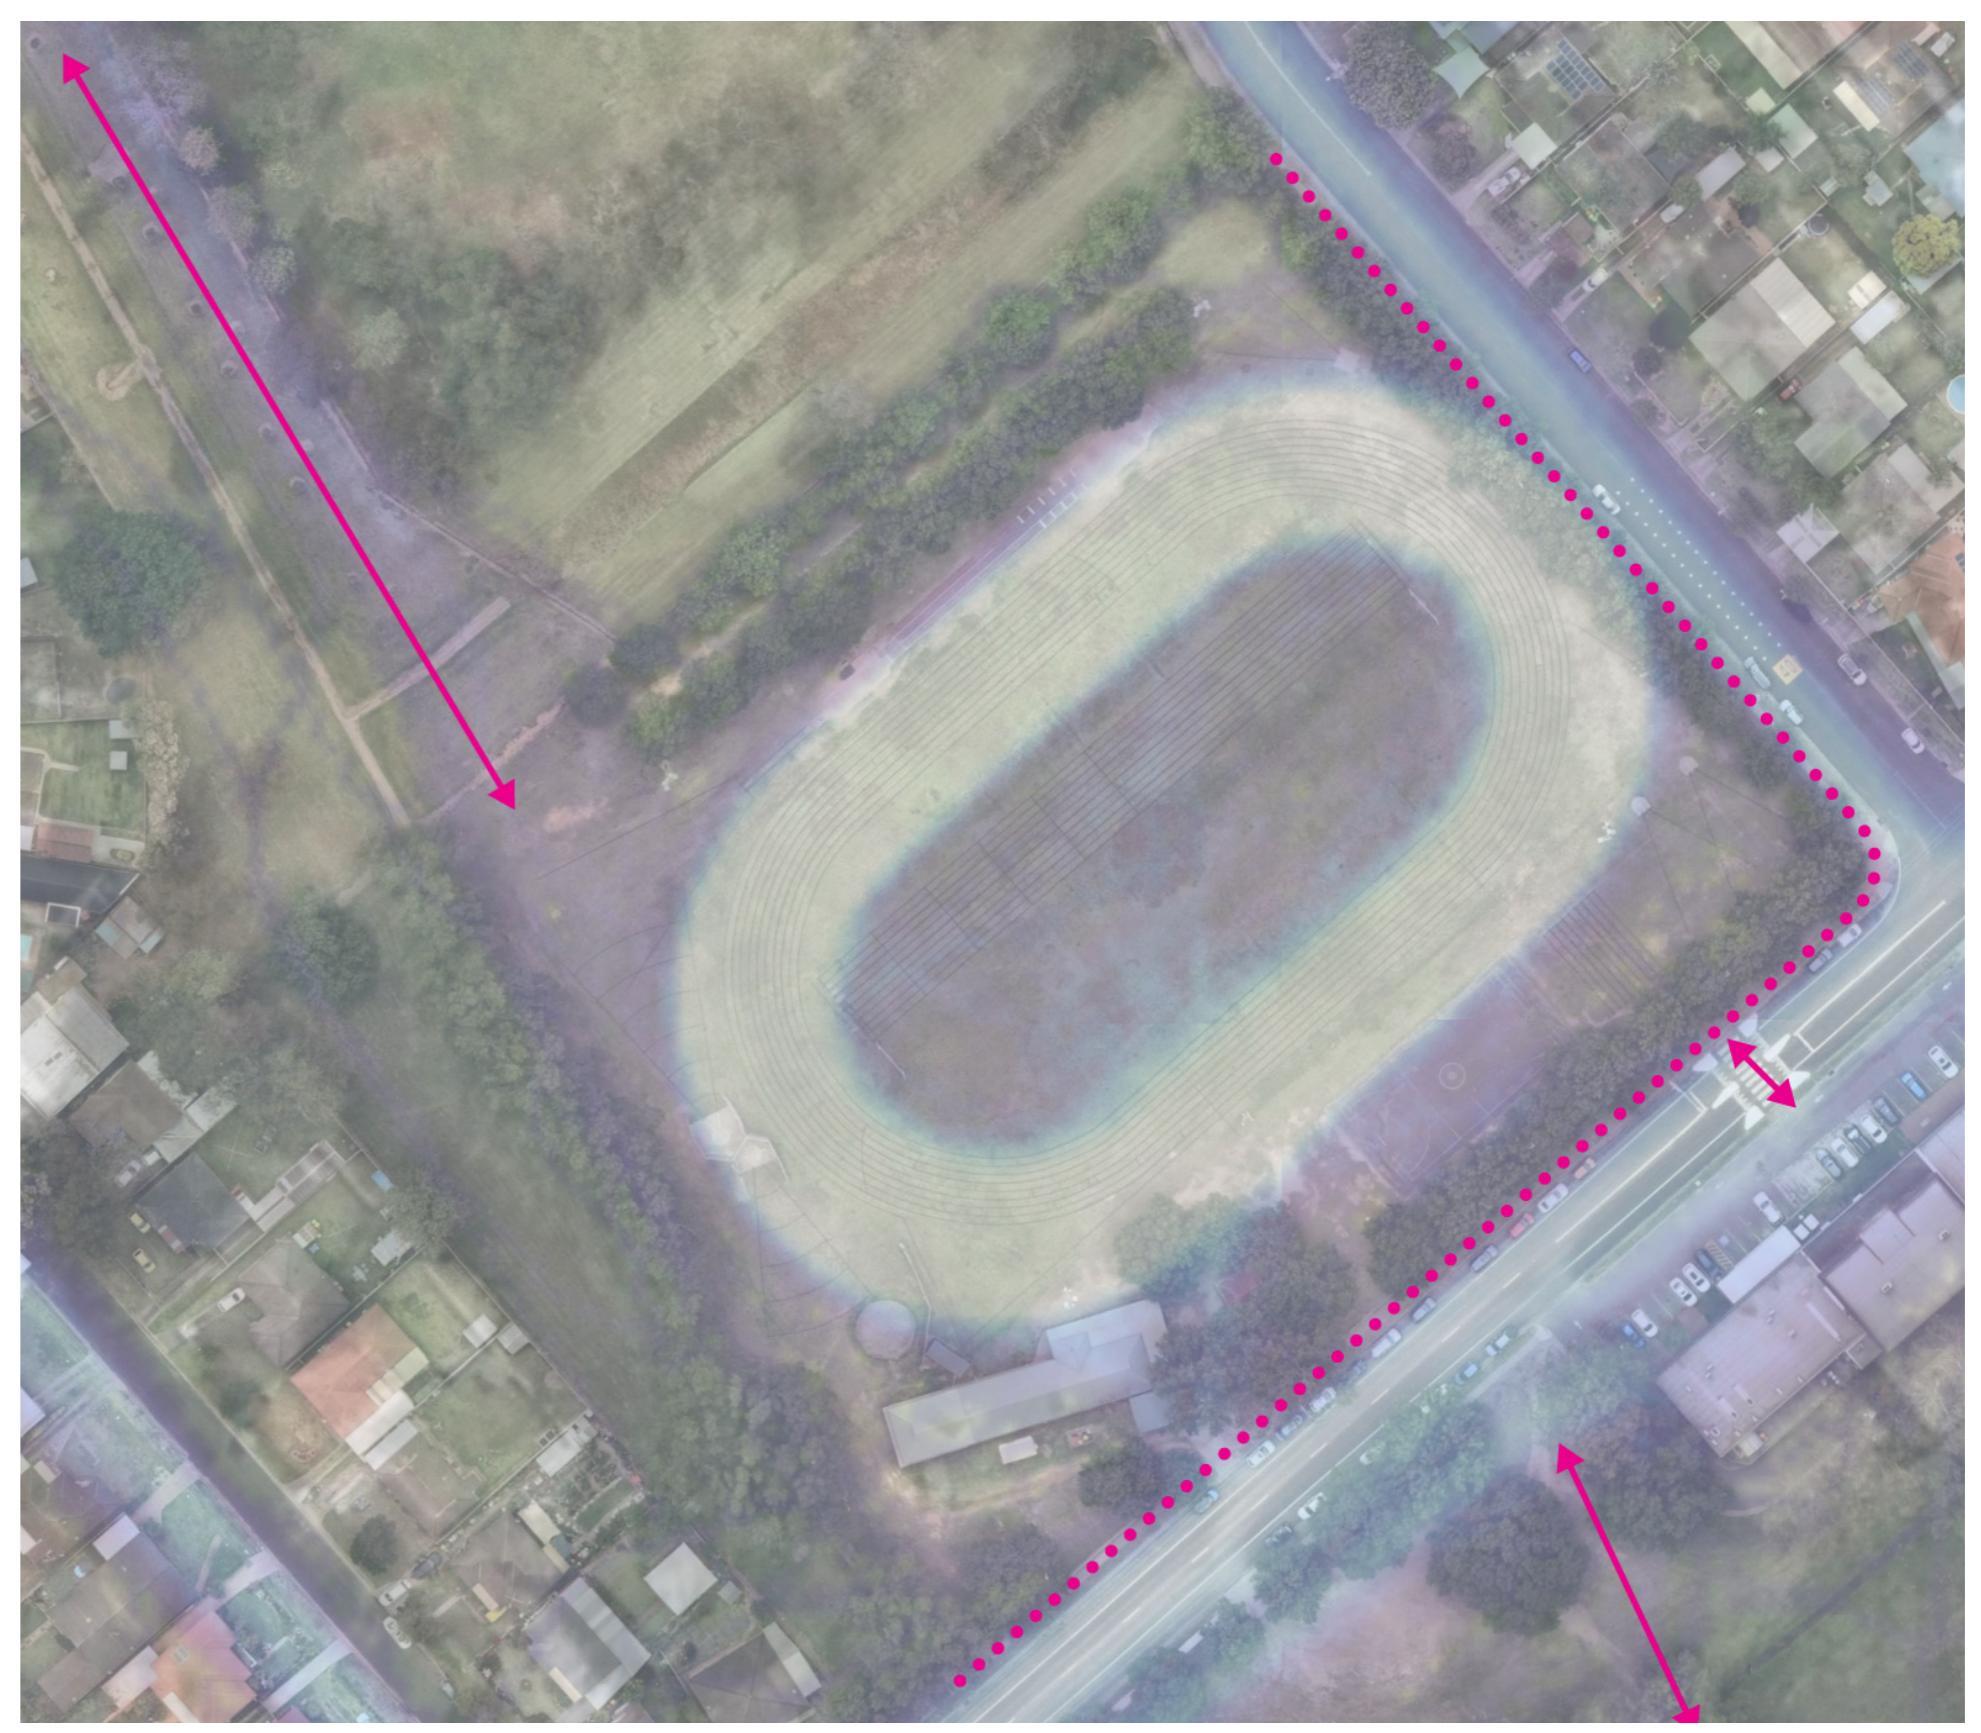
Figure 19: Strava heatmap overlay on movement plan

Access to Tamplin Field is provided from the north-east and south-east boundaries via Powell Street and Laurence Street respectively. The site's location facilitates movement to and from key surrounding areas, including Hobartville Public School to the north and the shops located to the south across Laurence Street.

Overlayed Strava heatmap data shows active movement along the North-South channel easement, as well as desire-line movement across the open space to the south of Laurence St.

A second pedestrian crossing on Powell St, north of the culvert, connects the channel easement with the school. Despite these access points, the majority of the park that is street facing is enclosed by a low wire fence, with only a limited number of designated openings or entries.

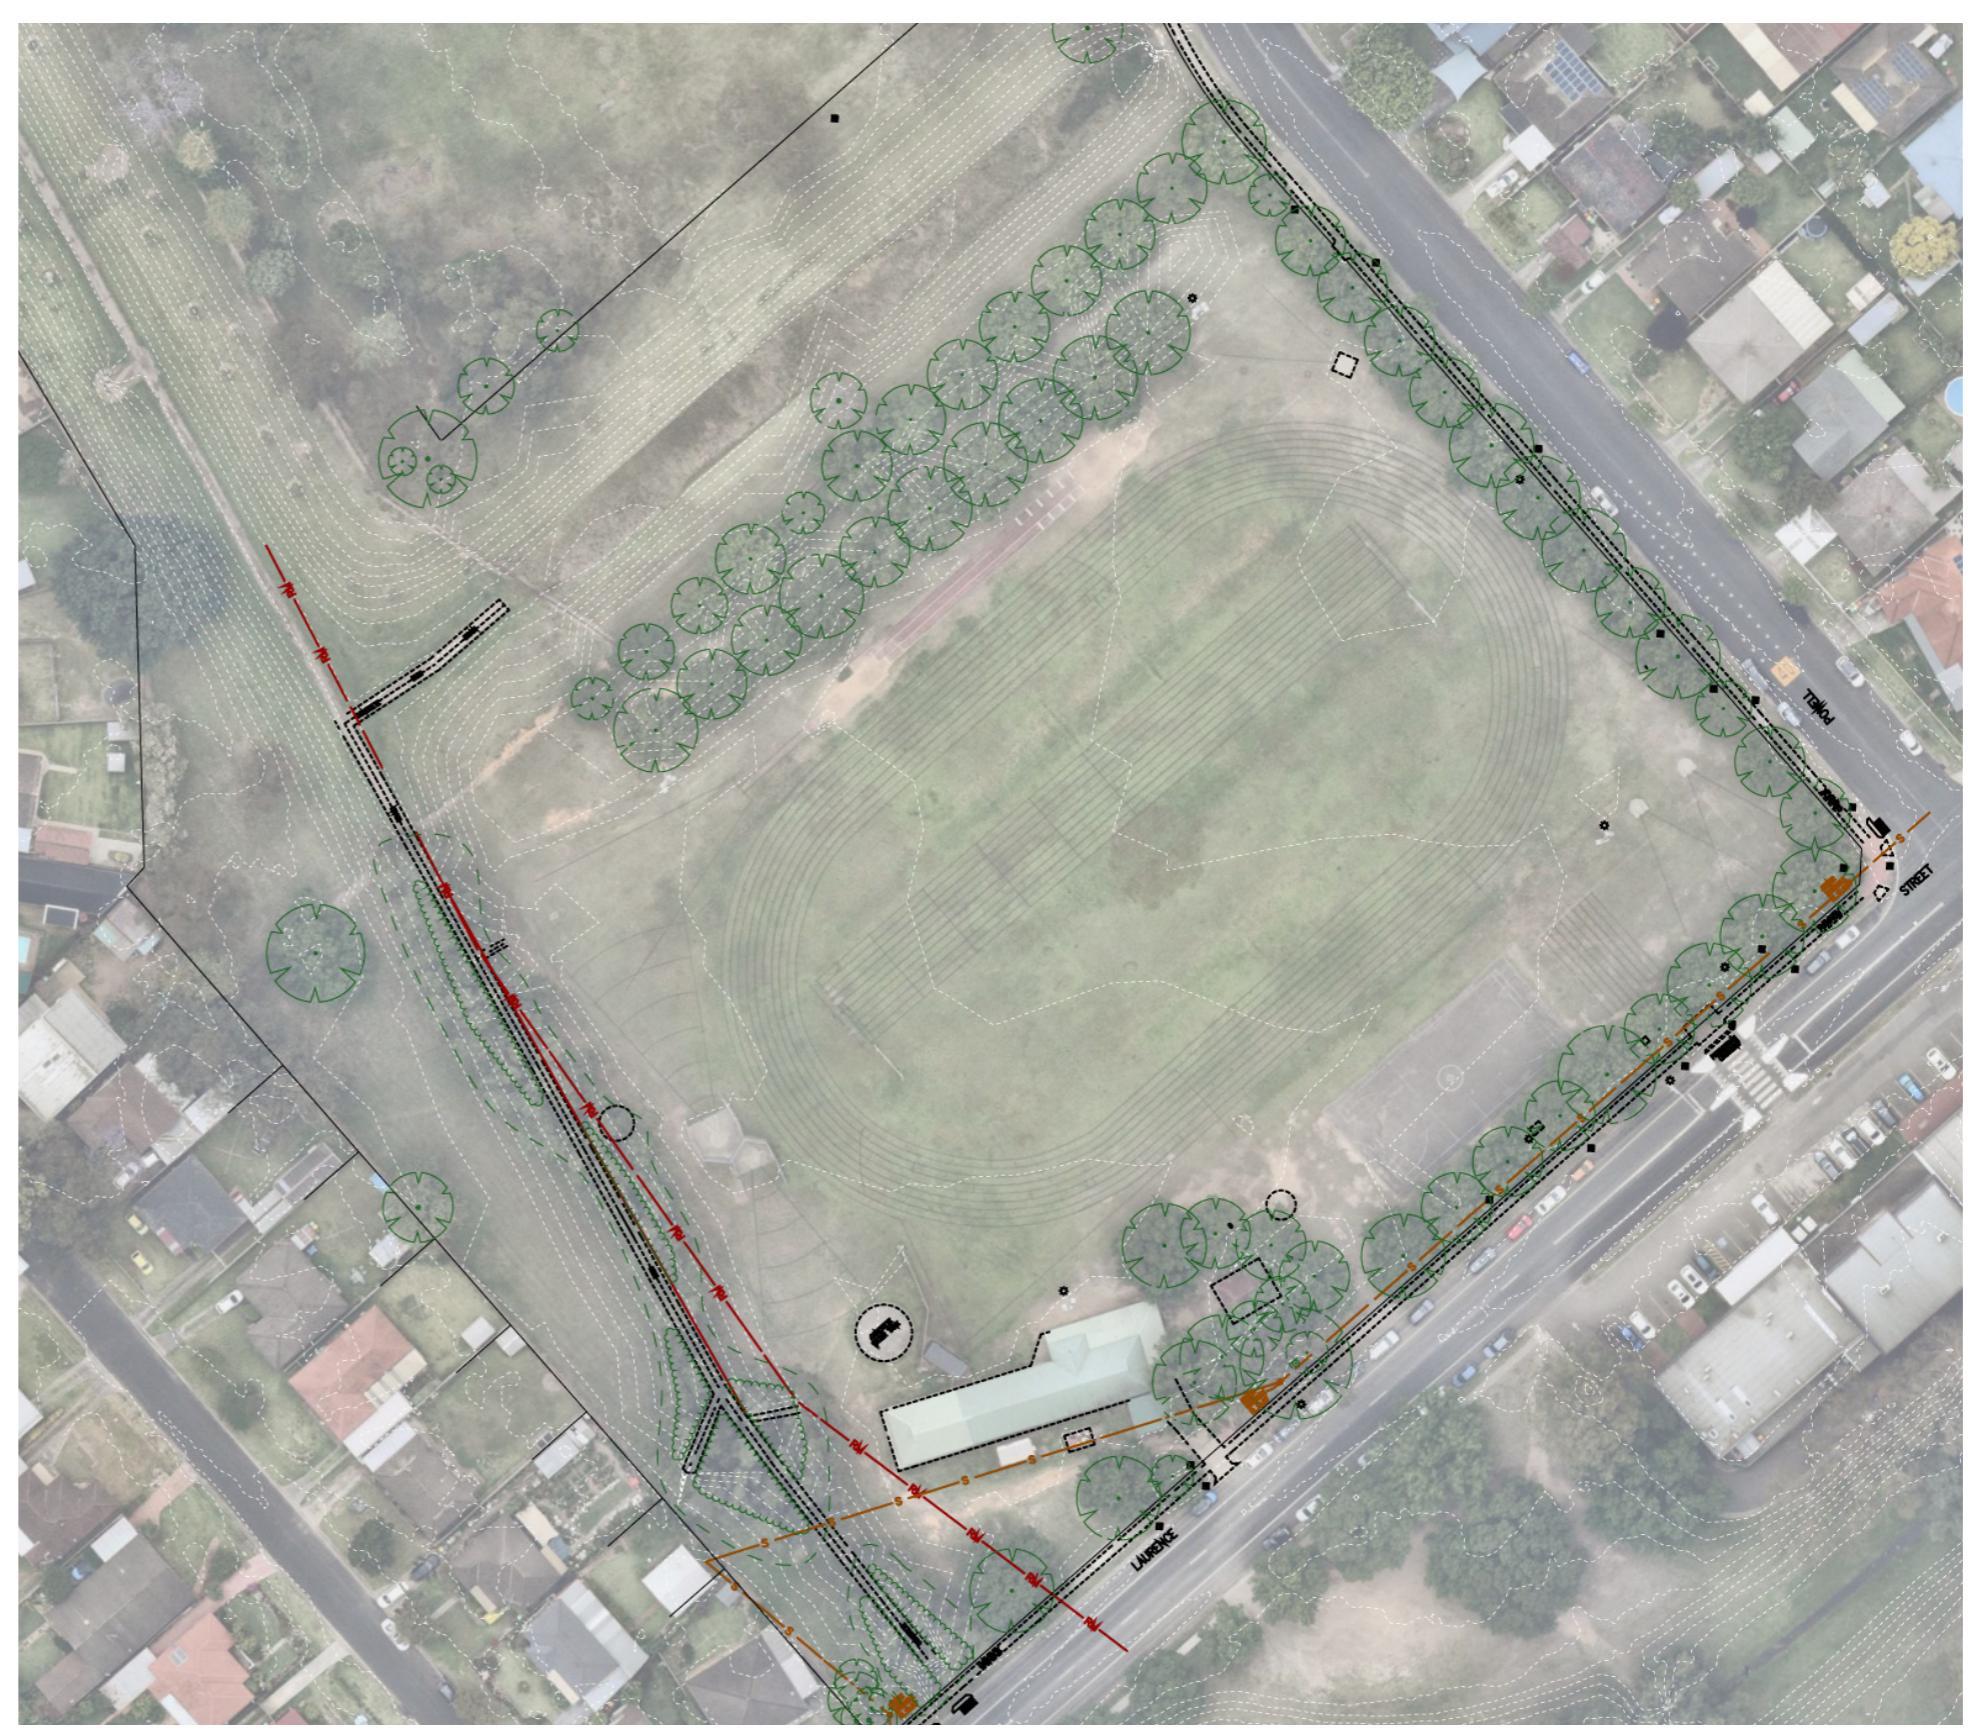
Figure 23: Existing services plan

Underground services, including a rising main along the western side of the existing field and a sewer main on the south of the site, present design constraints.
