2.2 Existing Trees

3. REFERENCE DESIGN REVIEW

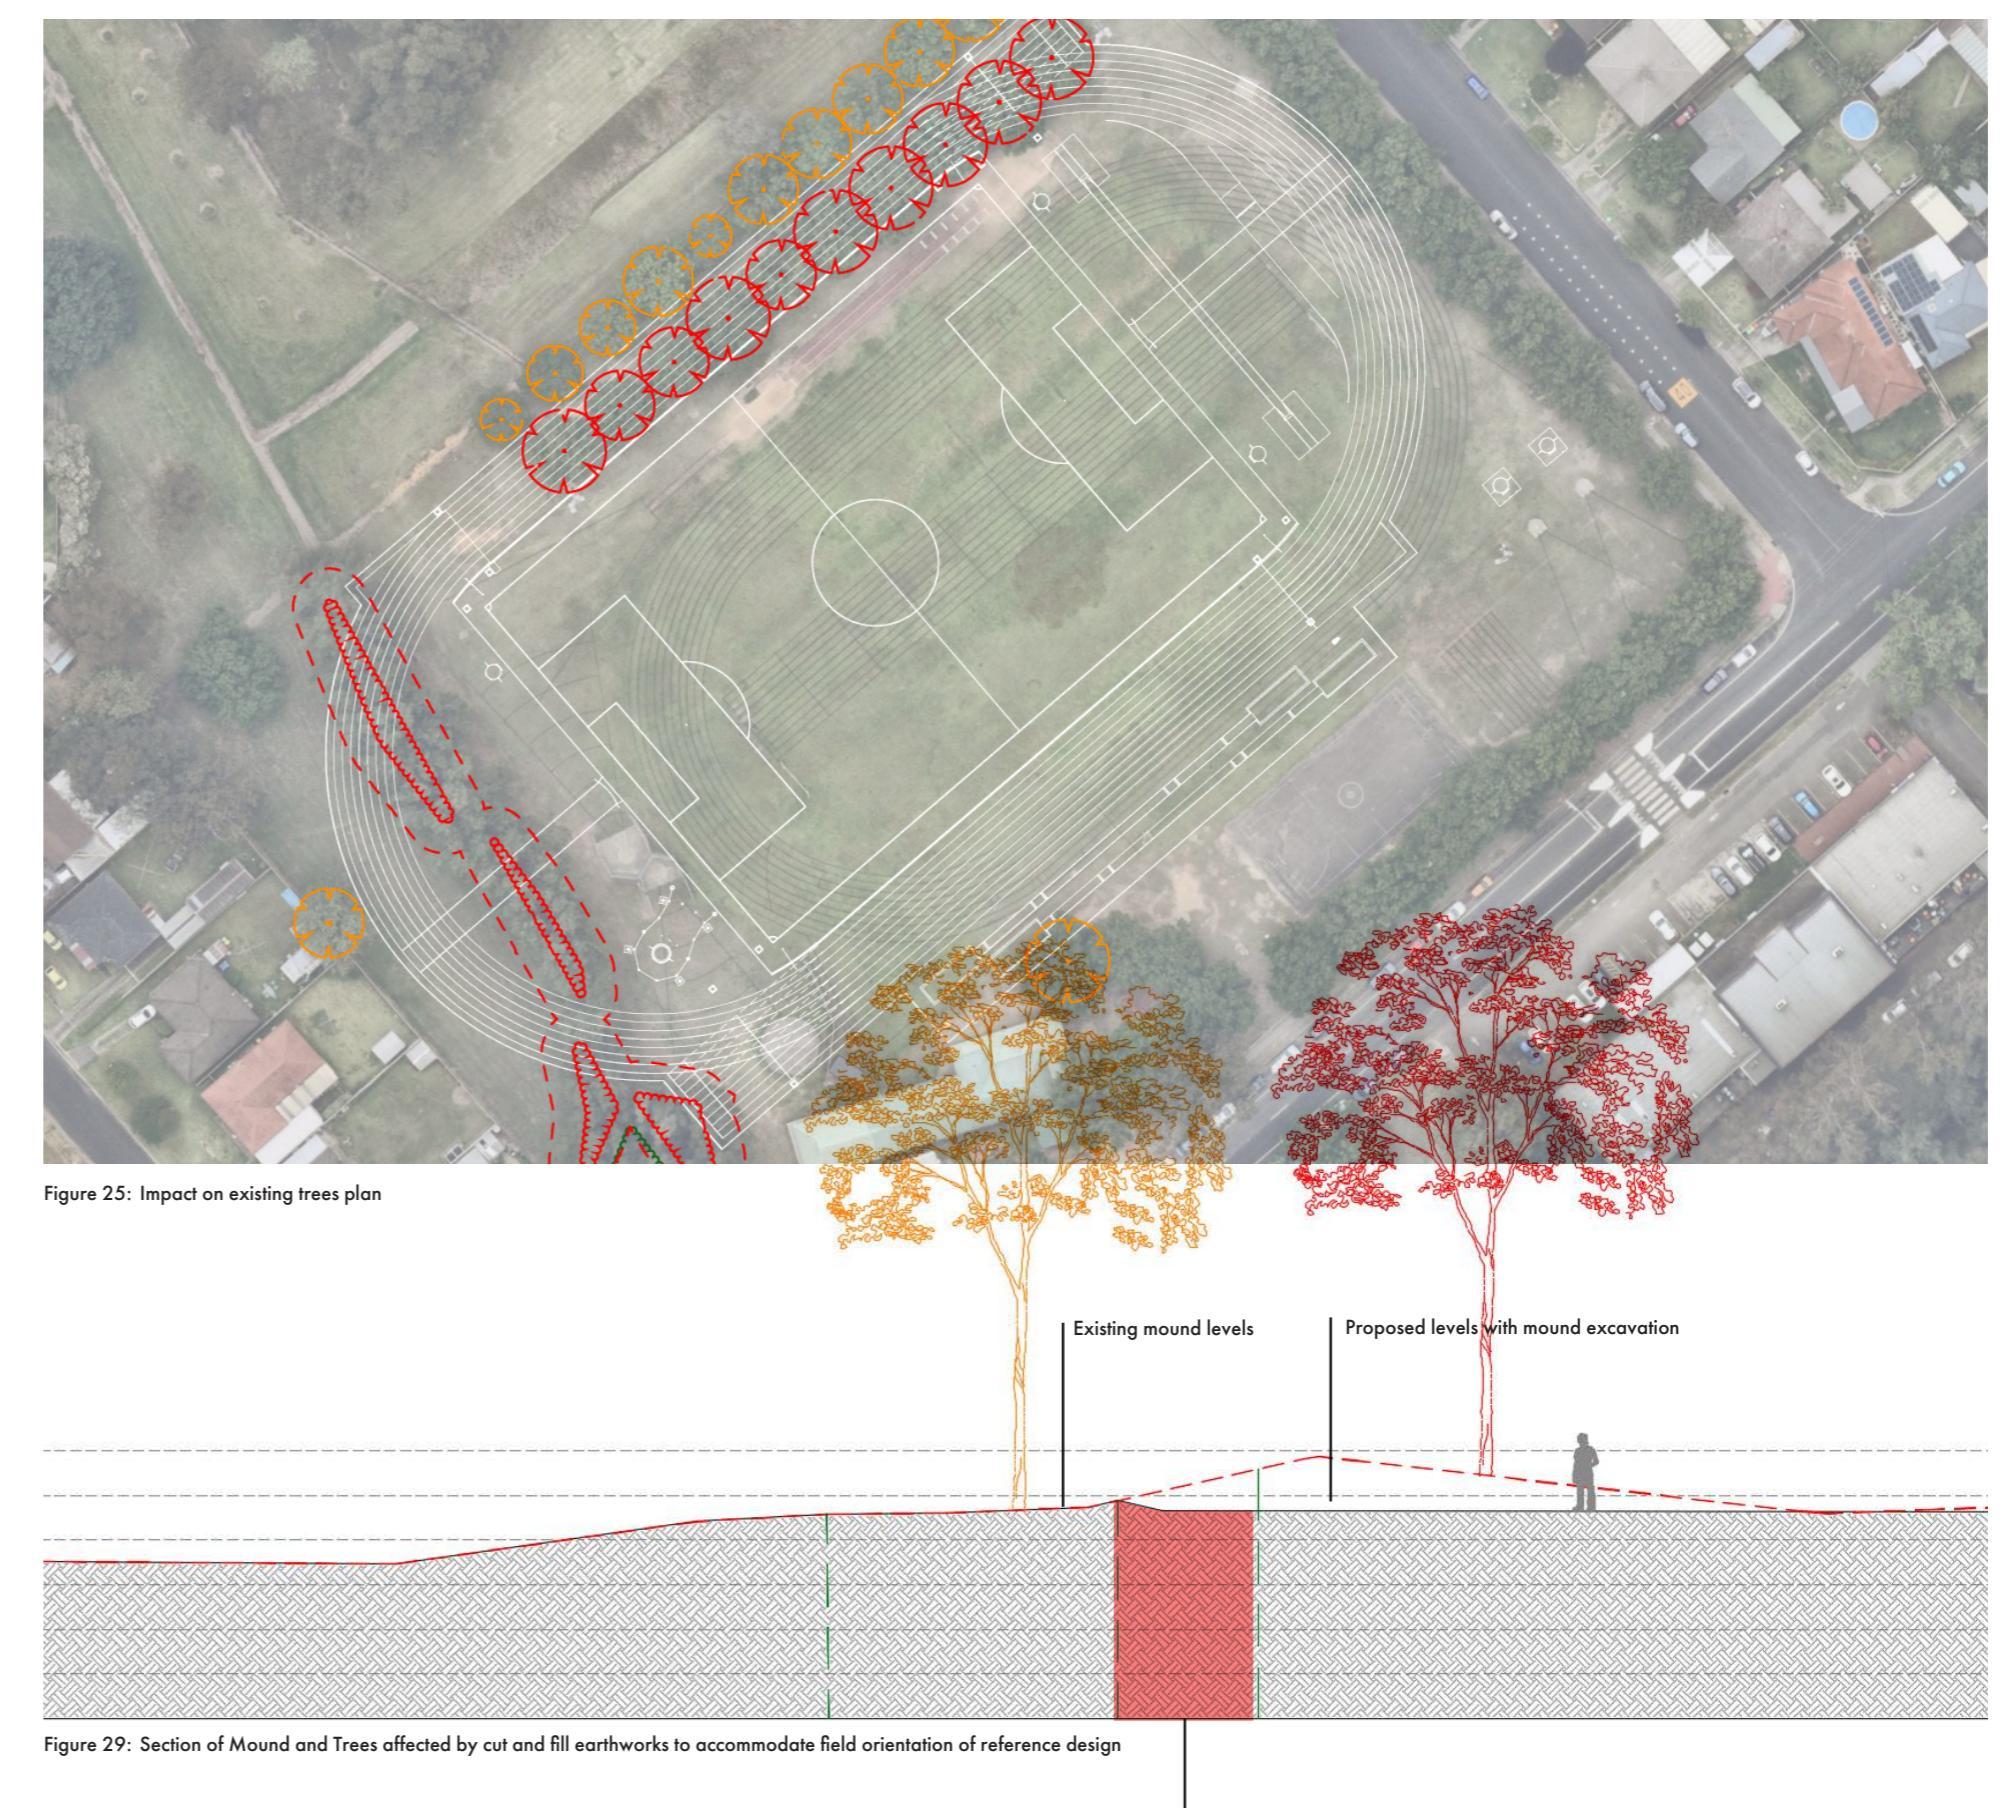
The proposed orientation of the athletics field poses a significant threat to the existing tree population. Construction would necessitate the removal of trees along the south-western channel, all ten trees on the eastern side of the mound, and likely eleven trees on the western side. Furthermore, a large tree located north-east of the existing building and a large tree along the boundary fence are also slated for removal.

The current layout necessitates cutting into the mound adjacent to the south-west channel resulting in the removal of all trees on the eastern side of the mound and likely all trees on the western side (shown in orange), as approximately 30% of their structural root zones are impacted.

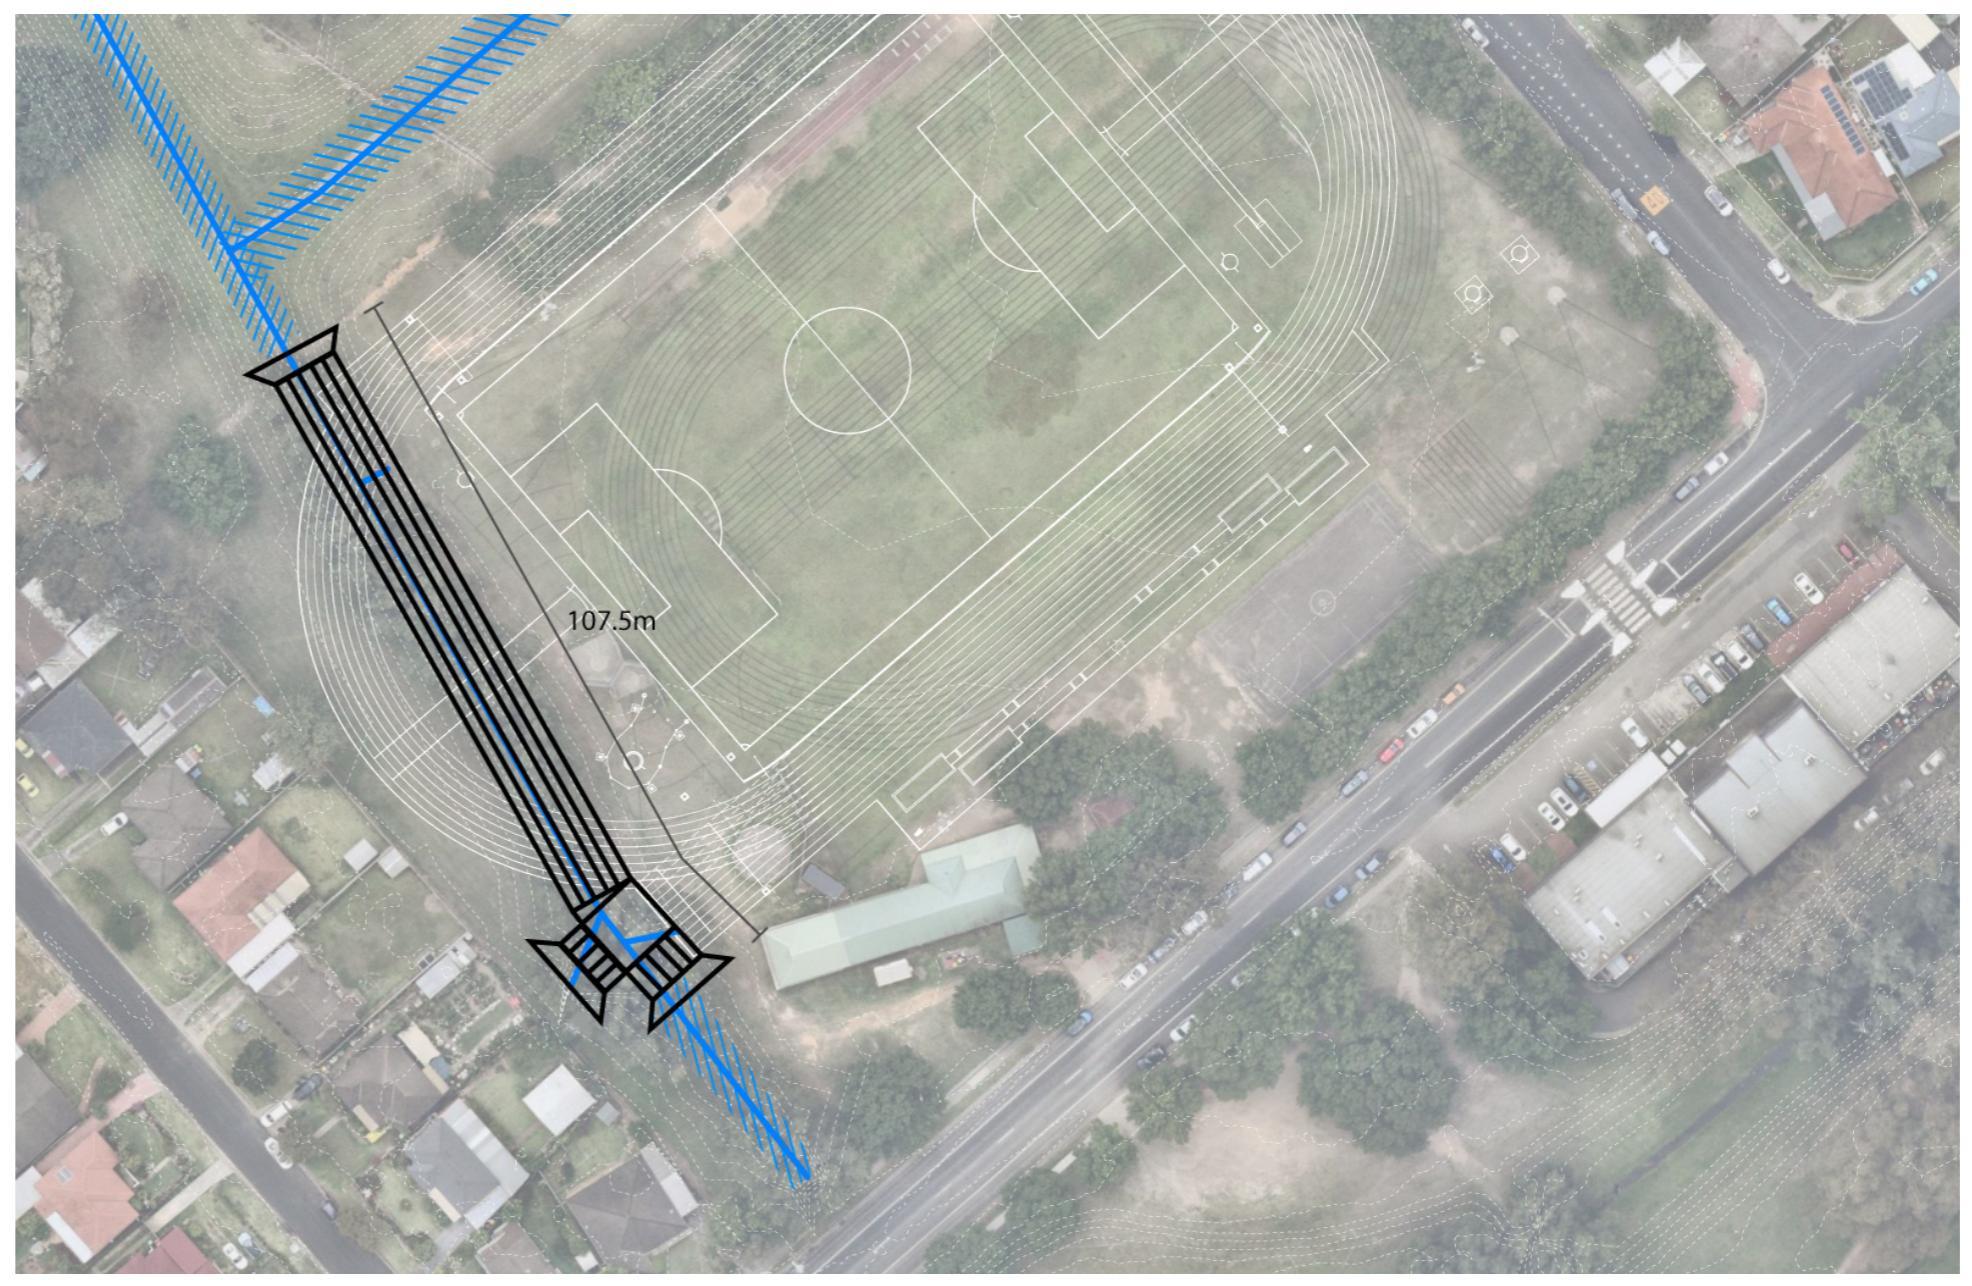
Figure 30: Culvert required for proposed field orientation

The reference design proposes the installation of an approximately 107m long culvert on the western side of the field, to accommodate the larger athletics track.

The current layout necessitates the installation of culverts, with approximate dimensions of $5x \ 2mx \ 0.9m$, spanning an estimated 107.5 meters. This culvert construction is projected to cost \$1,075,000 (calculated as \$10,000 x 107.5m).

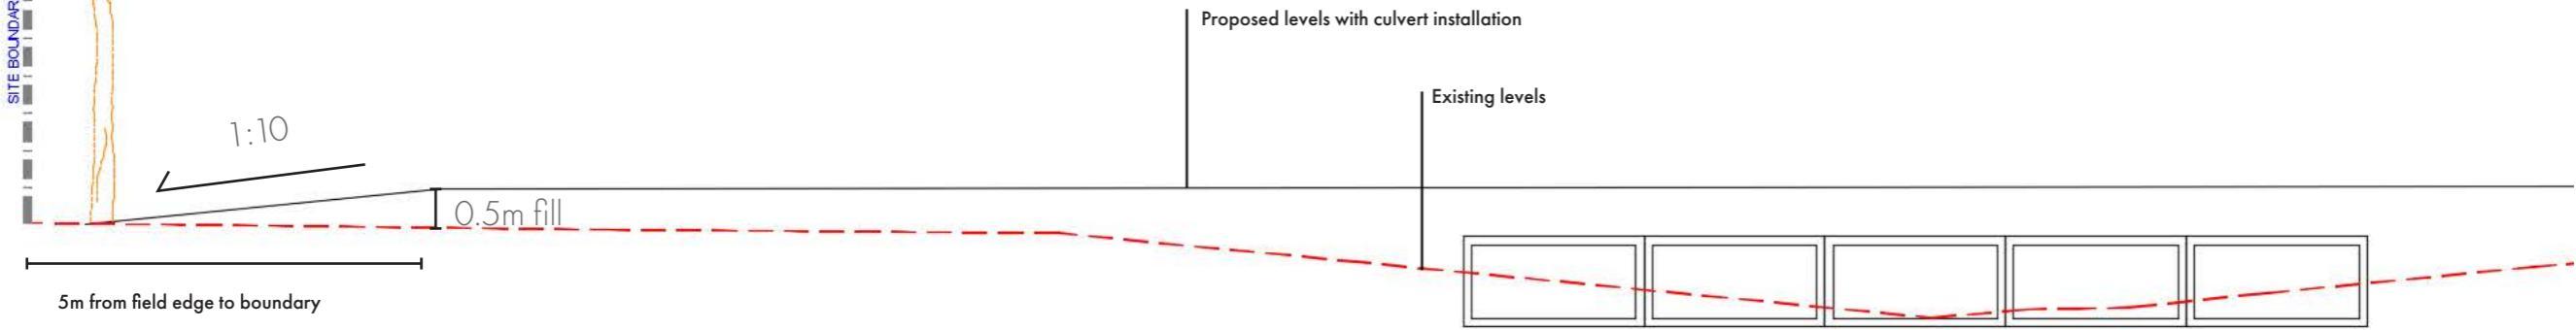
The levels along the site boundary will be raised by approximately 0.5m (to allow for sufficient cover for the sports field), which requires the removal of a tree on the boundary due to the placement of approximately 500mm of fill over its Structural Root Zone (SRZ). Raising the levels will also negatively impact privacy. Figure 31 is a cross section illustrating the culvert, raised levels, proximity to boundary/fence and the likely removal of the existing tree.

Figure 31: Section of culvert installation cut and fill affecting boundary tree to accommodate proposed field orientation
