STREETON LOOKOUT

FREEMANS REACH

Plan of Management

Adopted by Council: 14 July 2009

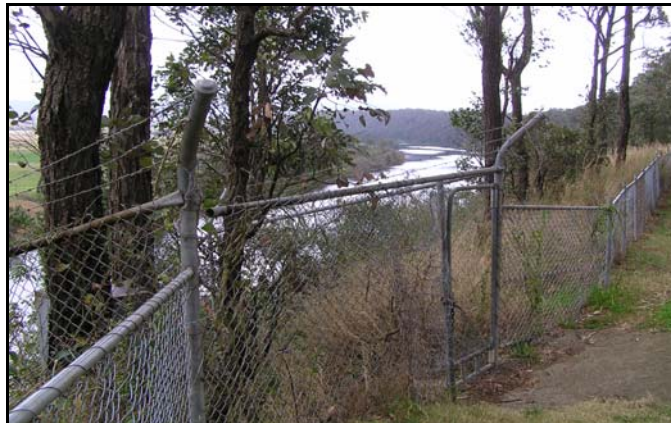
PHOTO 1: South-western view over Hawkesbury River to Blue Mountains. Security/ safety fencing [foreground] (3.09.2008).

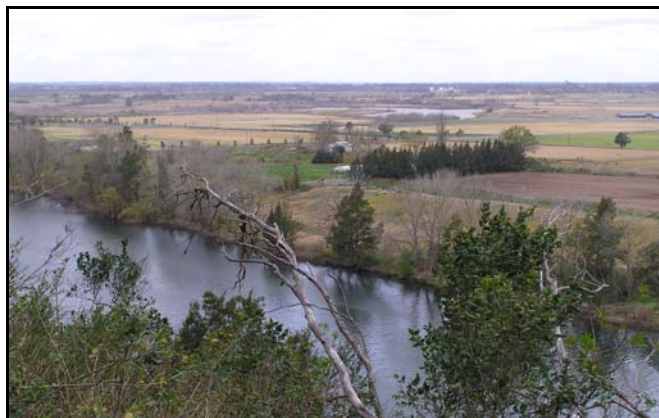
PHOTO 2: South-eastern view over Hawkesbury River floodplain/ Richmond Lowlands from the lookout (3.09.2008).

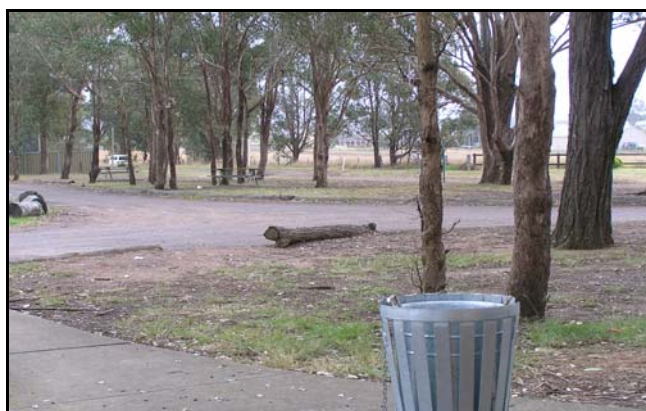
PHOTO 3: View of picnic area/ natural setting (fragmented native woodland) looking west from amenities building (3.09.2008).

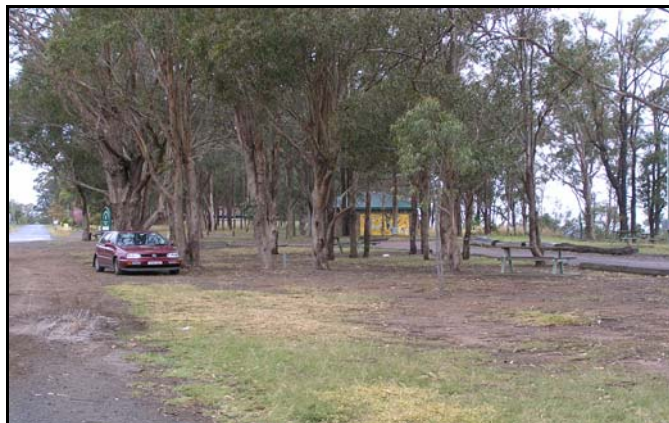
PHOTO 5: Further investigation is needed to determine Aboriginal/ archaeological significance as a natural resources site (3.09.2008).

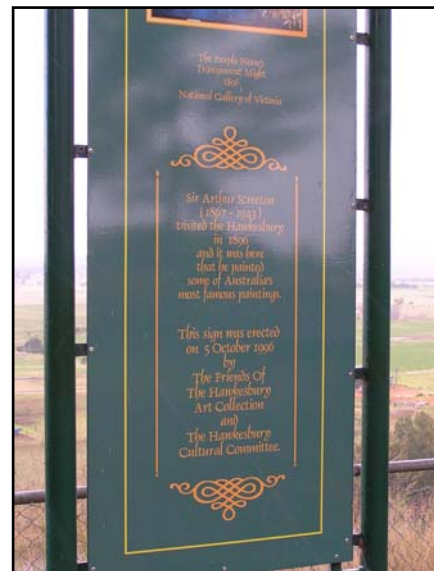
PHOTO 7: Hawkesbury Artist’s Trail signage describing Arthur Streeton’s world famous painting “*The purple noon’s transparent might*” (3.09.2008).

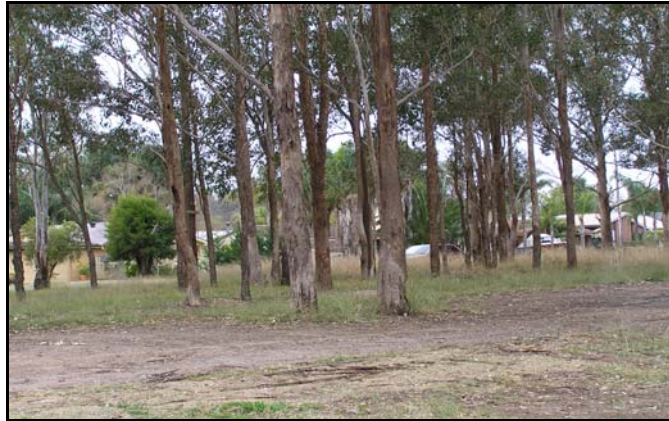
PHOTO 8: View of fragmented Cumberland Plain Woodland [Moist Shale Woodland] in eastern portion of lookout (3.09.2008).

Full description:	Cumberland Plain Woodland (sub-group: Shale Hills Woodland or Moist Shale Woodland) – upper terrace (incl. lookout/ picnic area) adjacent to Cliff Road and Terrace Road.
Former descriptions:	n/a
Condition/ status:	fragmented/ modified; varies up to 30-70% cover); varying condition and health with many canopy trees displaying some degree of decline and crown die-back; shrub understorey is virtually absent and exotic grasses/ weeds dominate the groundcover stratum.
Age structure:	25-40 years+ [dom.] regrowth some old growth specimens (up to 100 years+)
Current threats:	uncontrolled traffic movements/ parking, physical damage, soil compaction, increased nutrients (septic toilet system), altered drainage, current mowing/

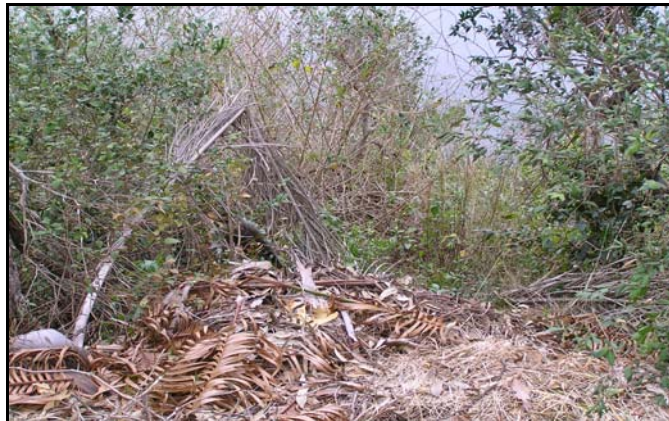
PHOTO 9: Western Sydney Dry Rainforest on escarpment – highly impacted by clearing, dumping and weed invasion (3.09.2008).

Full description:	Western Sydney Dry Rainforest in the Sydney Basin Bioregion.
Former descriptions:	Dry Rainforest and Vine Thicket.
Condition/ status:	native canopy cover largely cleared (<5-10%)/ fragmented/ remnant mesic understorey; vines/ shrubs [dom.]; varying level of exotic weed invasion.
Age structure:	some old growth vines/ shrubs (up to 100 years+)
Current threats:	increased nutrients, altered drainage, clearing for views, dumping garden refuse/ exotic weeds and climate change.
Emergent canopy species:	Narrow-leaved Ironbark (<i>Eucalyptus crebra</i>), Grey Gum (<i>Eucalyptus punctata</i>), Forest Red Gum (<i>Eucalyptus tereticornis</i>), Grey Box (<i>Eucalyptus moluccana</i>), Kurrajong (<i>Brachychiton populneus</i>) and White Cedar (<i>Melia azedarach</i> var. <i>australasica</i>).
Small tree/ shrub stratum:	Grey Myrtle (<i>Backhousia myrtifolia</i>) [dom.], Large Mock Olive (<i>Notelaea longifolia</i> forma. <i>longifolia</i>), Blackthorn (<i>Bursaria spinosa</i>), Common Breynia (<i>Breynia oblongifolia</i>), Native Quince <i>Alectryon subcinereus</i> , Hop Goodenia (<i>Goodenia ovata</i>) [dom.], Orange Thorn (<i>Citriobatus pauciflorus</i>) and Native Indigo (<i>Indigofera australis</i>).

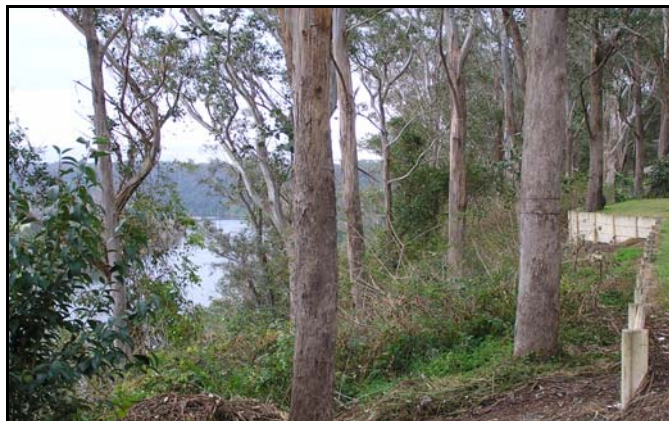
PHOTO 10: Shale Sandstone Transition Forest [eastern portion of reserve adjacent to residences] looking west (3.09.2008).

Full description:	Shale Sandstone Transition Forest (low sandstone influence) – escarpment/ slopes (eastern and western sections of reserve).
Former descriptions:	Ironbark-Red Gum-Grey Gum Woodland.
Condition/ status:	largely intact/ 70-100% native canopy cover; generally good condition and health/ some crown die-back; small tree/ shrub understorey largely intact; varying level of disturbance/ exotic weeds in understorey/ ground stratum.
Age structure:	30-60 years+ [dom.] some old growth specimens (up to 80-100 years+)
Current threats:	adjoining residential development – increased nutrients, altered drainage, clearing for views, dumping garden refuse/ exotic weeds and die-back.
Canopy species:	Narrow-leaved Ironbark (<i>Eucalyptus crebra</i>) [dom.], Broad-leaved Ironbark (<i>Eucalyptus fibrosa</i>), Grey Gum (<i>Eucalyptus punctata</i>), Forest Red Gum (<i>Eucalyptus tereticornis</i>) and Grey Box (<i>Eucalyptus moluccana</i>).

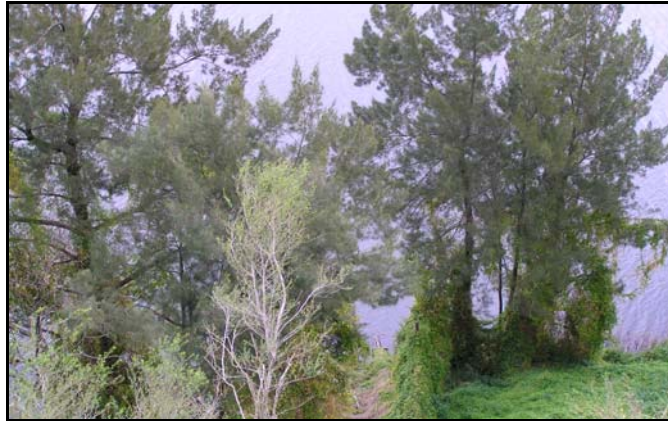
PHOTO 11: View from lookout to riverbank [below] of River Oaks
– highly disturbed/ fragmented River-flat Eucalypt Forest (3.09.2008).

Full description:	River-flat eucalypt forest on coastal floodplains of the NSW North Coast, Sydney Basin and South East Corner bioregions.
Former descriptions:	Sydney Coastal River-flat Forest (Alluvial Woodland/ Riparian Forest).
Condition/ status:	highly fragmented/ modified; generally <10-30% native canopy cover; exotic weeds dominate understorey/ ground stratum.
Current threats:	bank instability, erosion and exotic weeds.
Canopy species:	River Oak (<i>Casuarina cunninghamiana</i>) no further details.

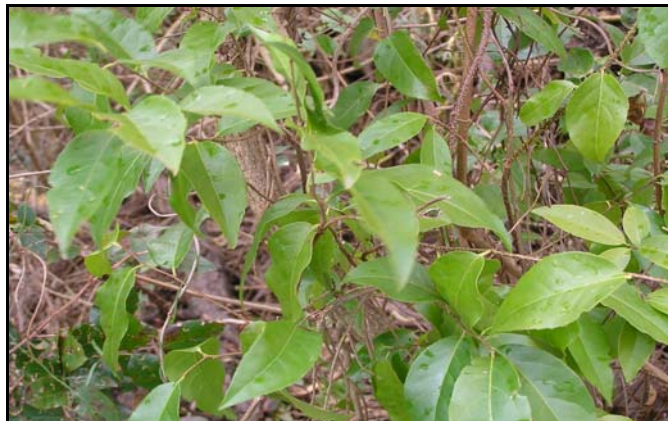
PHOTO 12: The reserve's rare and endangered Western Sydney Dry Rainforest community supports regionally significant species such as this Staff Vine (*Celastrus australis*) (3.09.2008).

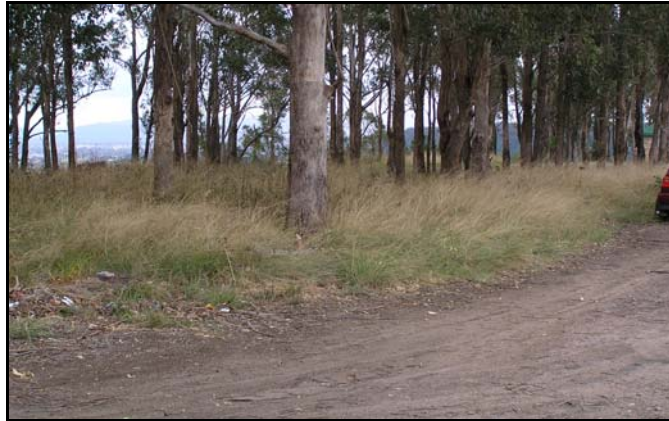
PHOTO 13: The Cumberland Plain Woodland ground stratum, although dominated by exotic weeds (eg. African Love Grass) retains high native biodiversity (3.09.2008).

Exotic grasses such as African Love Grass (*Eragrostis* spp.), Common Couch (*Cynodon dactylon*) and Kikuyu Grass (*Pennisetum clandestinum*) dominate the ground stratum of the open woodland at the lookout and picnic area. Exotic shrubs and vines such as Lantana (*Lantana camara*), Broad-leaved and Small-leaved Privet (*Ligustrum* spp.), Moth Vine (*Araujia sericiflora*), Cape Ivy (*Delairea odorata*), Japanese Honeysuckle (*Lonicera japonica*), Choko Vine (*Sechium edule*), Bridal Creeper (*Asparagus asparagoides*) and Trad (*Tradescantia fluminensis* and *Tradescantia* sp. [large-leaf form]) are common components of the shrub/ ground stratum of the escarpment. These exotic weed species vigorously compete with remnant native dry rainforest species. Although providing some protection and stability to the steep escarpment, introduced weed species have an overall negative impact on natural biodiversity values, native regeneration/ recruitment, scenic character and visual amenity. Refer to *Appendix III – Schedule of Exotic Weed Species*.

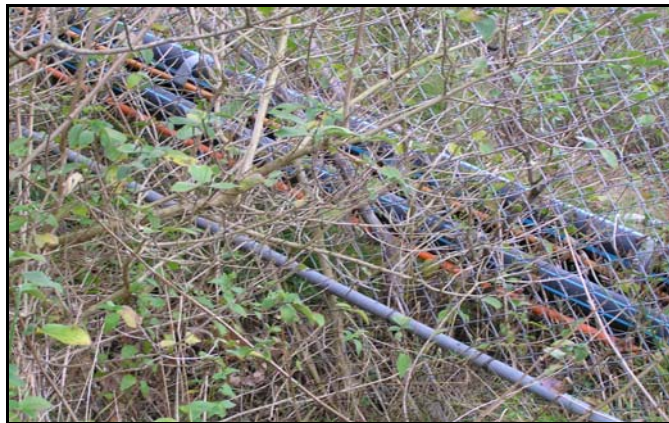
PHOTO 14: Exotic weeds (eg. Lantana) grow over irrigation pipe-work. Weeds dominate much of the ground/ shrub strata of the escarpment/ Western Sydney Dry Rainforest (3.09.2008).

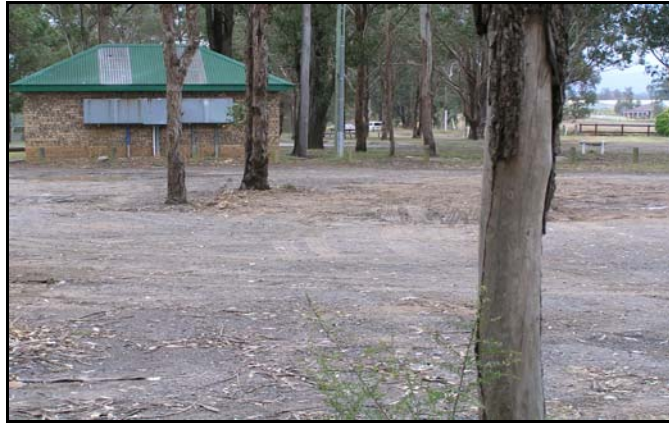
PHOTO 15: The reserve is highly impacted by uncontrolled vehicular movements – dusty in dry periods and muddy in the wet. Vehicles are increasing soil compaction, erosion and 'die-back' of native vegetation leading to loss of scenic quality and recreational values (3.09.2008).

Unsealed vehicular access and car parking/ turning areas lead to the top of the escarpment (adjacent to the amenities building) and to the north-western corner of the reserve. Treated timber log post and rail barriers/ bollards and log edging to internal roads are ubiquitous features. A log post and rail vehicular barrier, located adjacent to the amenities block, restricts internal vehicular thru traffic between the western and eastern section of the lookout. Most of this recreational infrastructure is in fair to poor condition. Some log barriers with exposed steel rods are in need of urgent repair.

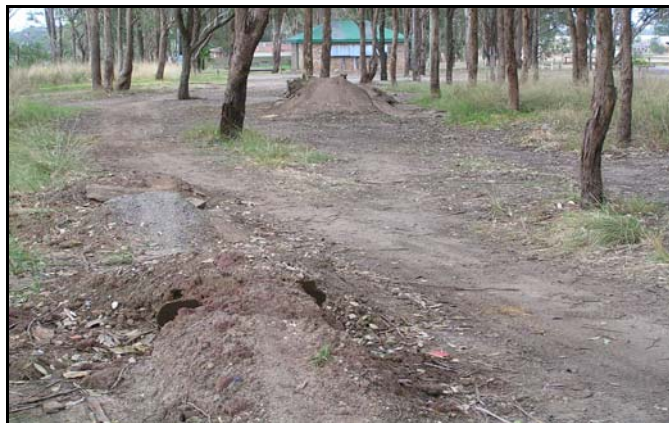
PHOTO 16: Construction of BMX jumps/ multiple tracking by vehicles, rubbish dumping and vandalism are restricting opportunities for natural recruitment and regeneration (3.09.2008).

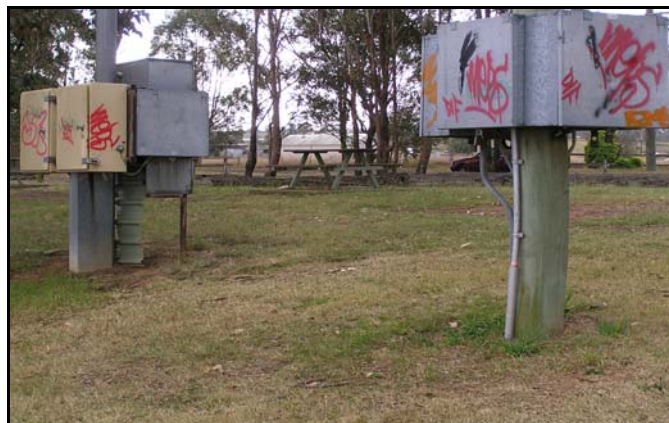
PHOTO 17: Irrigation infrastructure including power poles, attached meter boxes, electrical cabling and pipelines compete for space in the picnic area and visually disrupt the scenic vistas.

Existing irrigation infrastructure: To address issues relating to irrigation infrastructure. To ensure consistency with legislative requirements. To address ongoing issues in relation to public safety and risk management.	A9		Recommendations implemented in accordance with relevant legislation and this Plan of Management.	very high
	A10		All public safety/ risk management issues addressed.	very high
To restrict ad hoc and incremental additions, protect scenic character and quality of setting. To improve security and monitoring of anti-social behaviour in reserve.	A11		Works implemented in accordance with this Plan of Management.	high

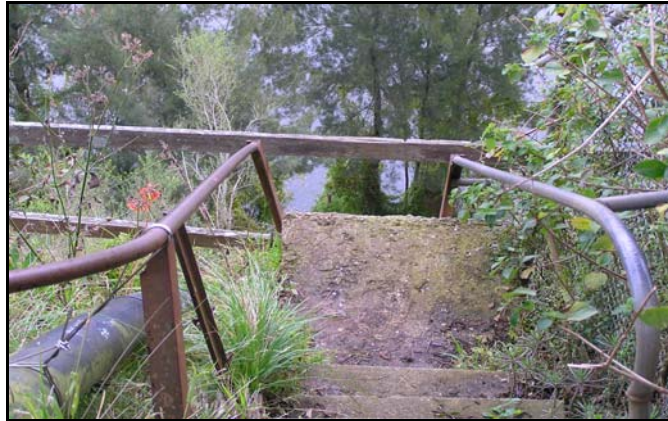
PHOTO 18: Security gate/ fencing has been repeatedly vandalised allowing unrestricted access to cliff-top steps and ladder.(3.09.2008).

A vandalised security gate in this location currently allows public access to derelict steps and a steel ladder perched on a precipitous cliff-face. This damaged infrastructure raises public safety concerns and is in need of urgent attention and repair. As a further priority action, private infrastructure and easements traversing community land need to be addressed in accordance with local government legislation governing the use of community land.

Currently, the chain-wire safety fence extends only along the top of the escarpment adjacent to the picnic area (western section). This fencing should be extended along the top of the escarpment (eastern section of lookout) to restrict public access and promote environmental protection.
