HAWKESBURY LOCAL HERITAGE ASSISTANCE FUND 2023/2024

Examples of Minor Maintenance/Conservation Works Carried out to Heritage Listed Properties

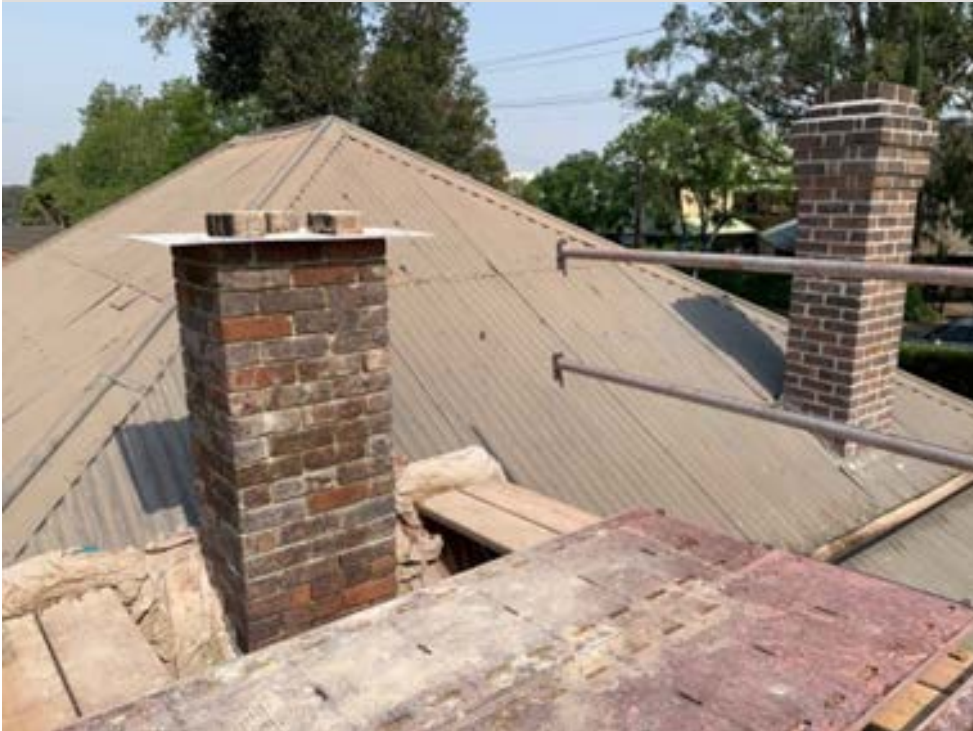
BEFORE COMPLETION

Damaged chimneys needed repointing.

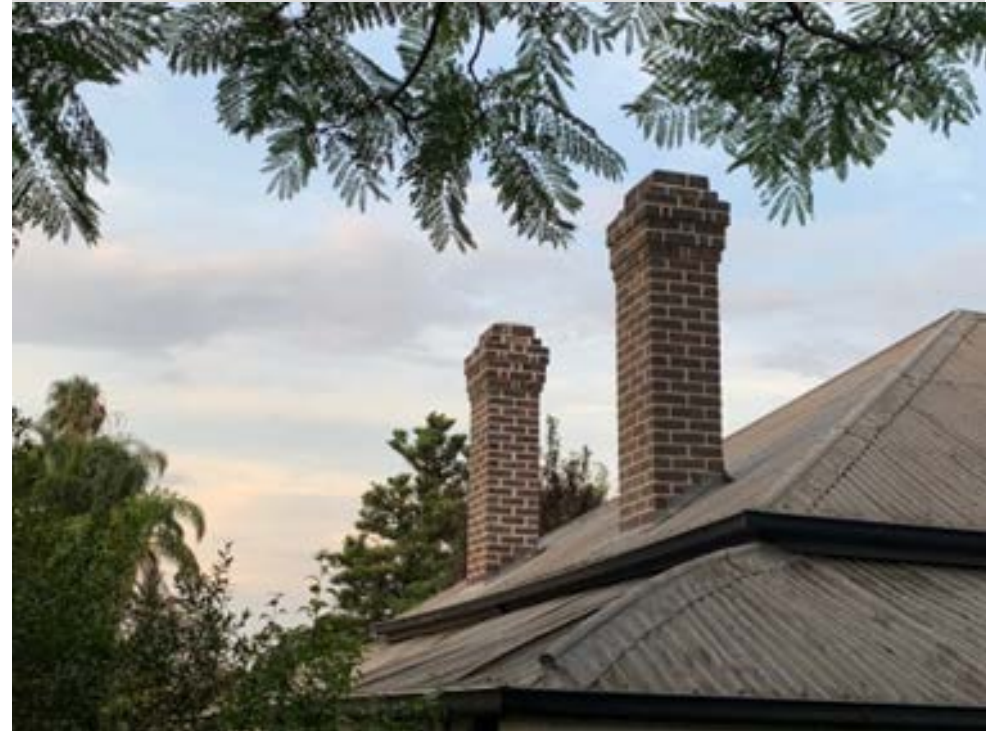
AFTER COMPLETION

Completed repointing works to chimneys helps retain the heritage value and character of this heritage listed house, and brought back the chimneys' original appearance.

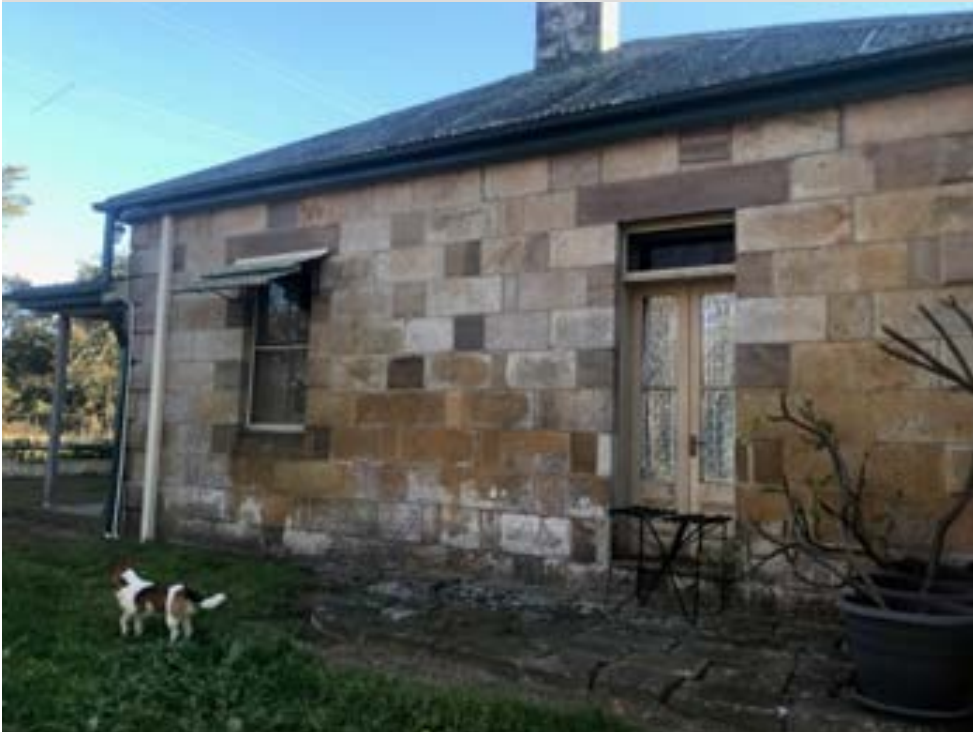
BEFORE COMPLETION

To prevent further fretting of this wall and the sandstone chimney, replacement of the existing cement mortar with lime based mortar was needed.

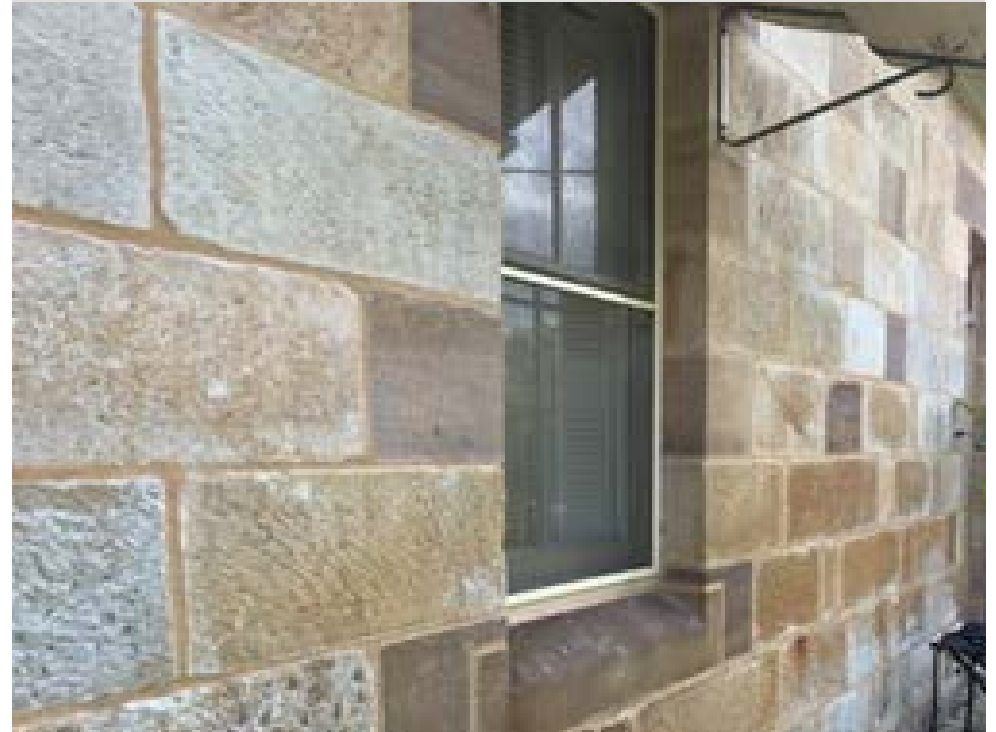
AFTER COMPLETION

Repointed wall with lime based mortar with the correct mixture prevents further fretting. The completed works provide improved protection to the wall.

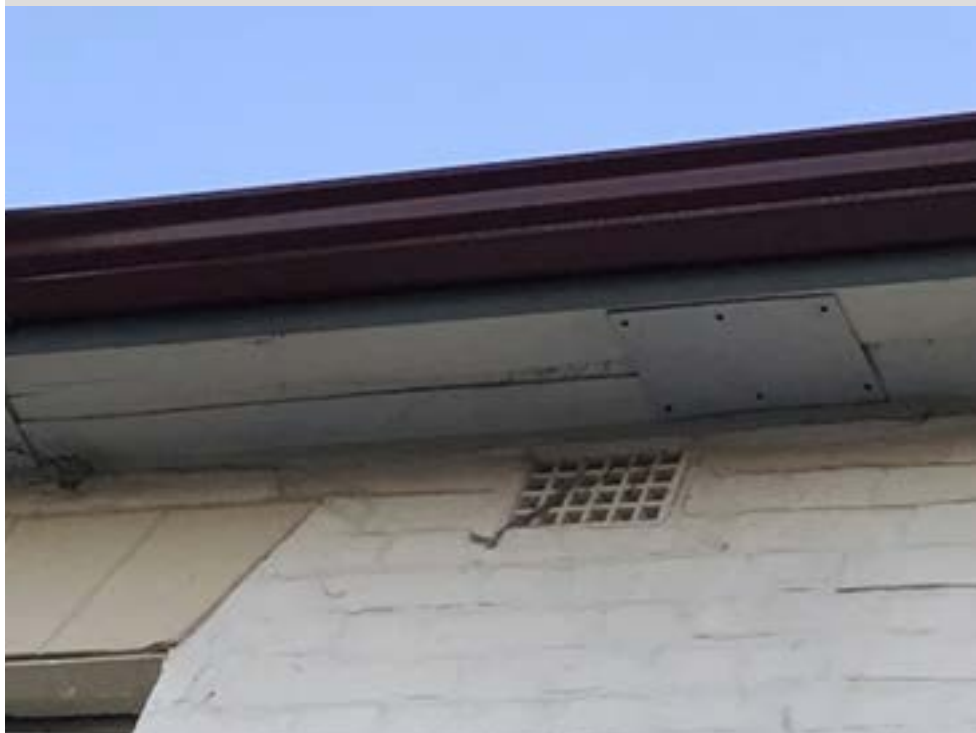
BEFORE COMPLETION

Minor maintenance was needed to replace badly deteriorated timber eaves.

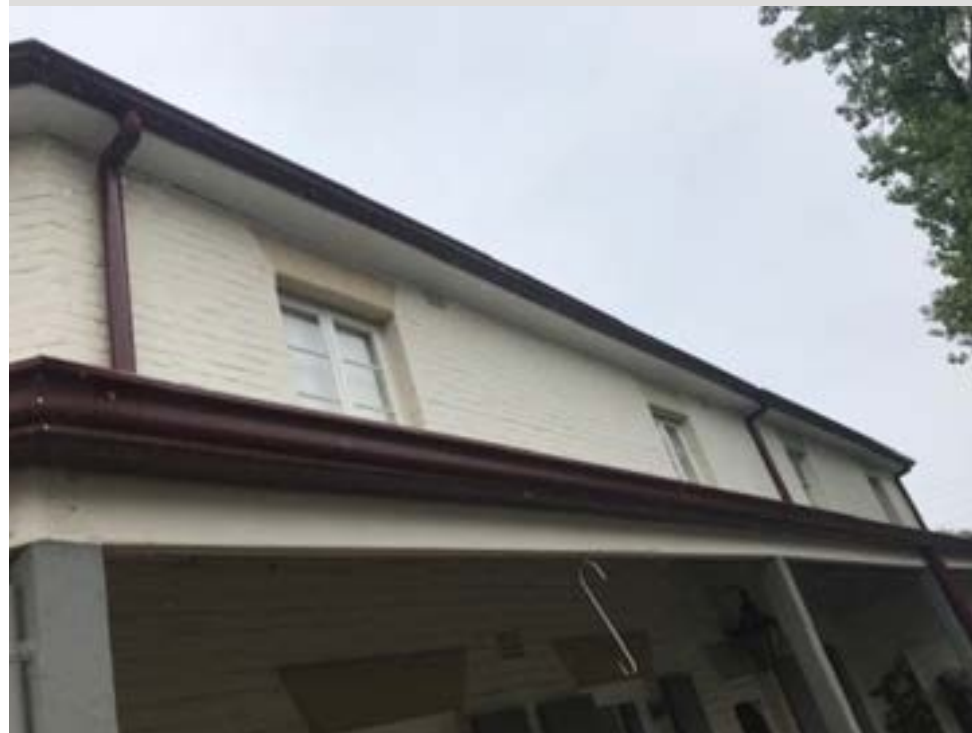
AFTER COMPLETION

Completed works provides improved protection and good appearance to the timber ceiling as well.
